Report on the investigation of  
the collision between

***Osprey and Osprey II***

resulting in serious injuries to one passenger

19 July 2016

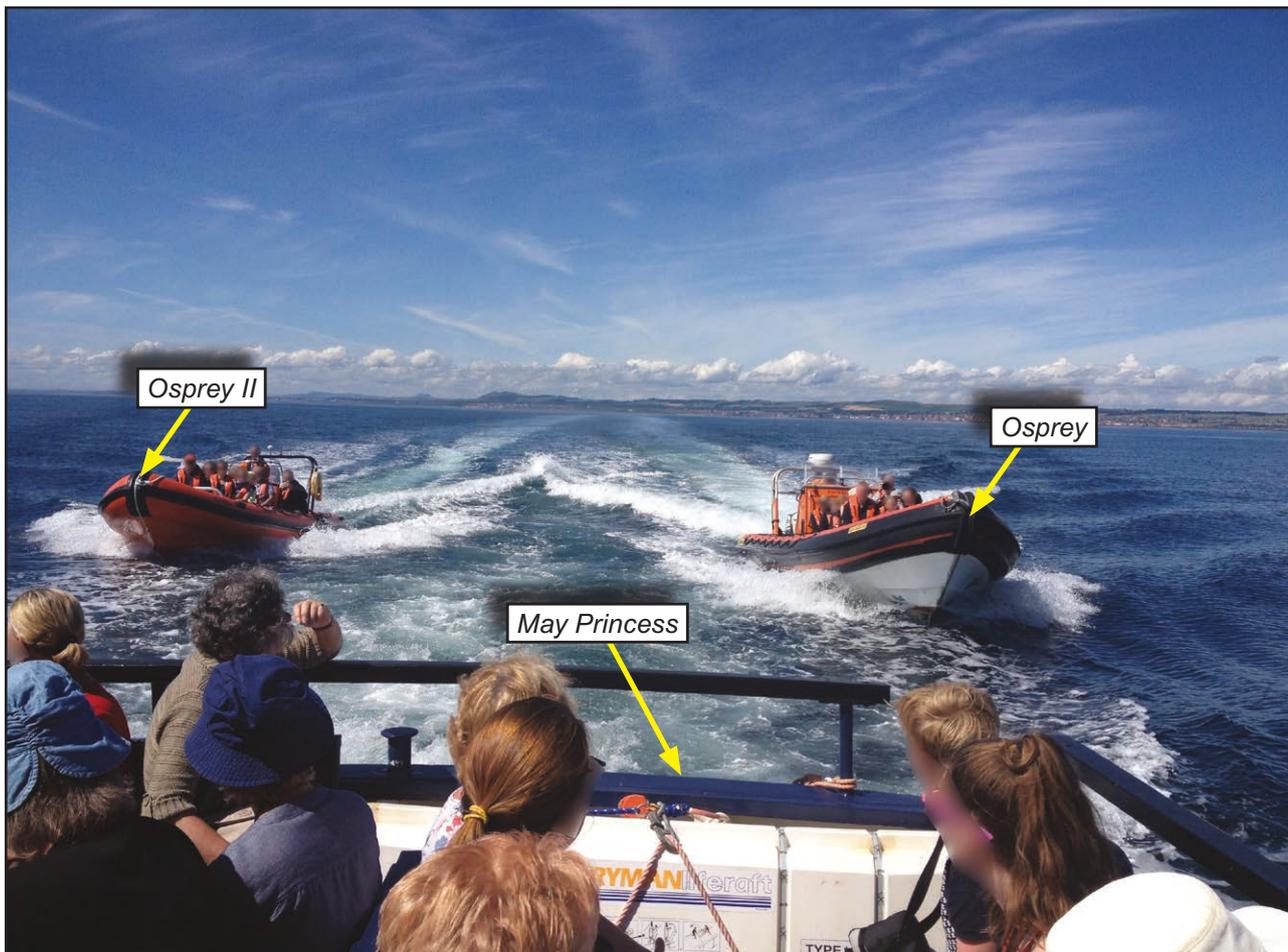
Figure 3: Both RIBs approaching the stern of *May Princess*

As the RIBs approached *May Princess*'s stern, they slowed down to match its speed (**Figure 3**).

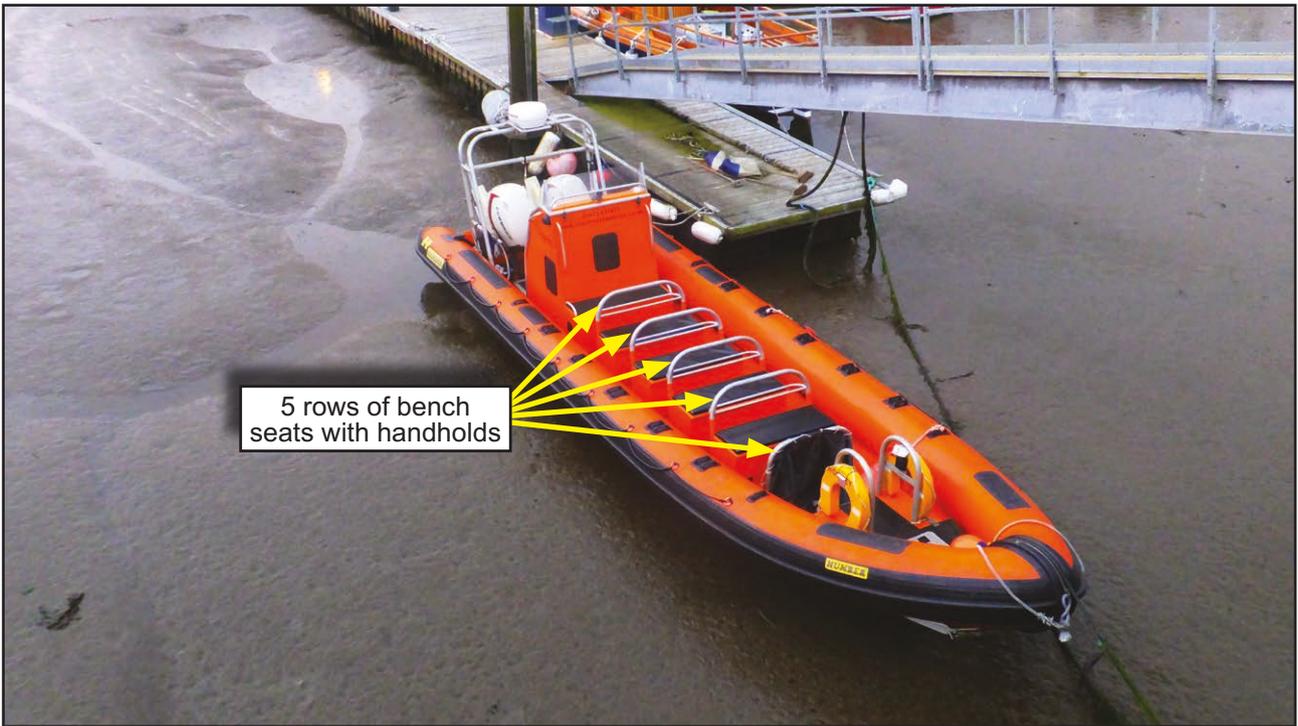
Figure 7: *Osprey*

Isle of May Boat Trips Ltd operated an online booking system. Bookings could also be made in person at the harbour office. While 12 passenger spaces were available for tours on *Osprey* (**Figure 7**), passenger spaces on *Osprey II* were normally limited to the eight spaces available on its four bench seats (**Figure 8**). However, in good weather, two additional spaces for *Osprey II* were sold, allowing 10 passengers to be carried, the additional 2 sitting in designated positions on its inflatable tubes. Each of the designated positions on the inflatable tube had a handhold on the tube on either side of the seating position.

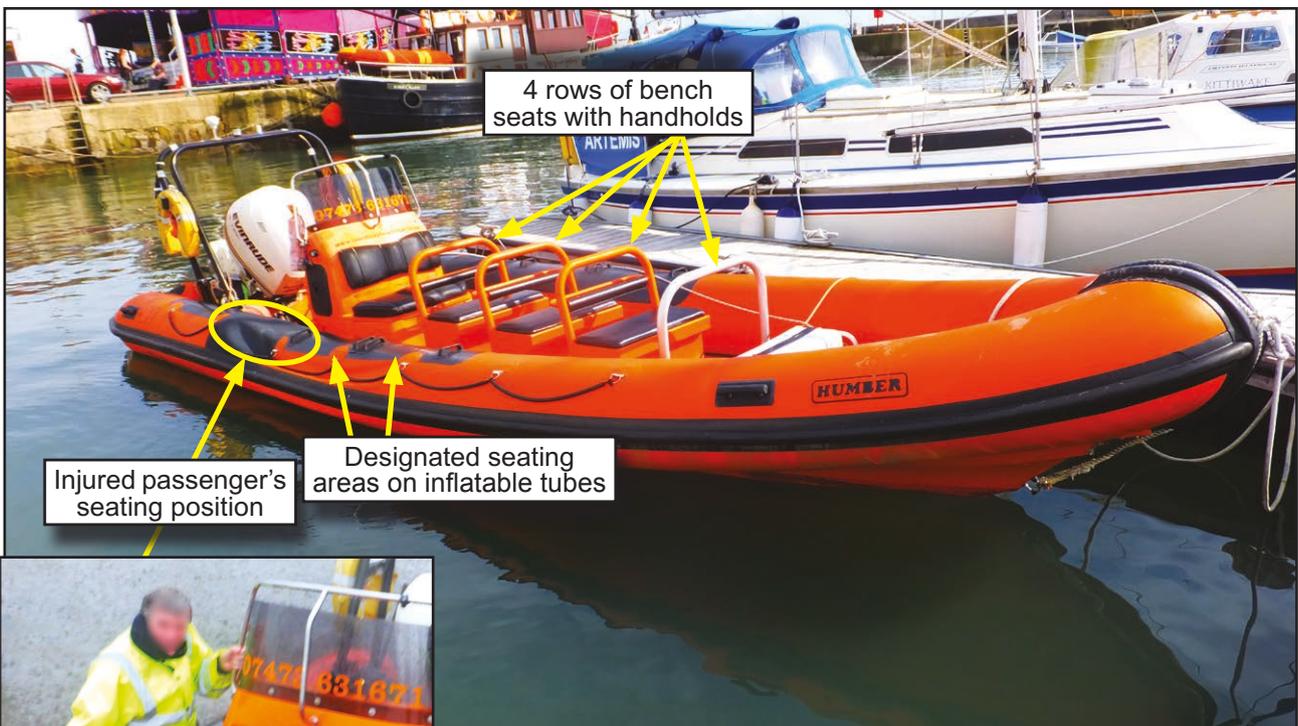
Figure 8: *Osprey II*

On the day of the accident the additional passengers on *Osprey II* were directed to sit on the tubes in a position aft of the two designated positions. This allowed them a handhold on the tube, and a handhold on the stainless steel frame around the helm console (**Figure 8 inset**).

The company neither provided instructions on twin RIB operation nor specified the limiting weather conditions when allowing passengers to sit on *Osprey II*'s inflatable tubes.

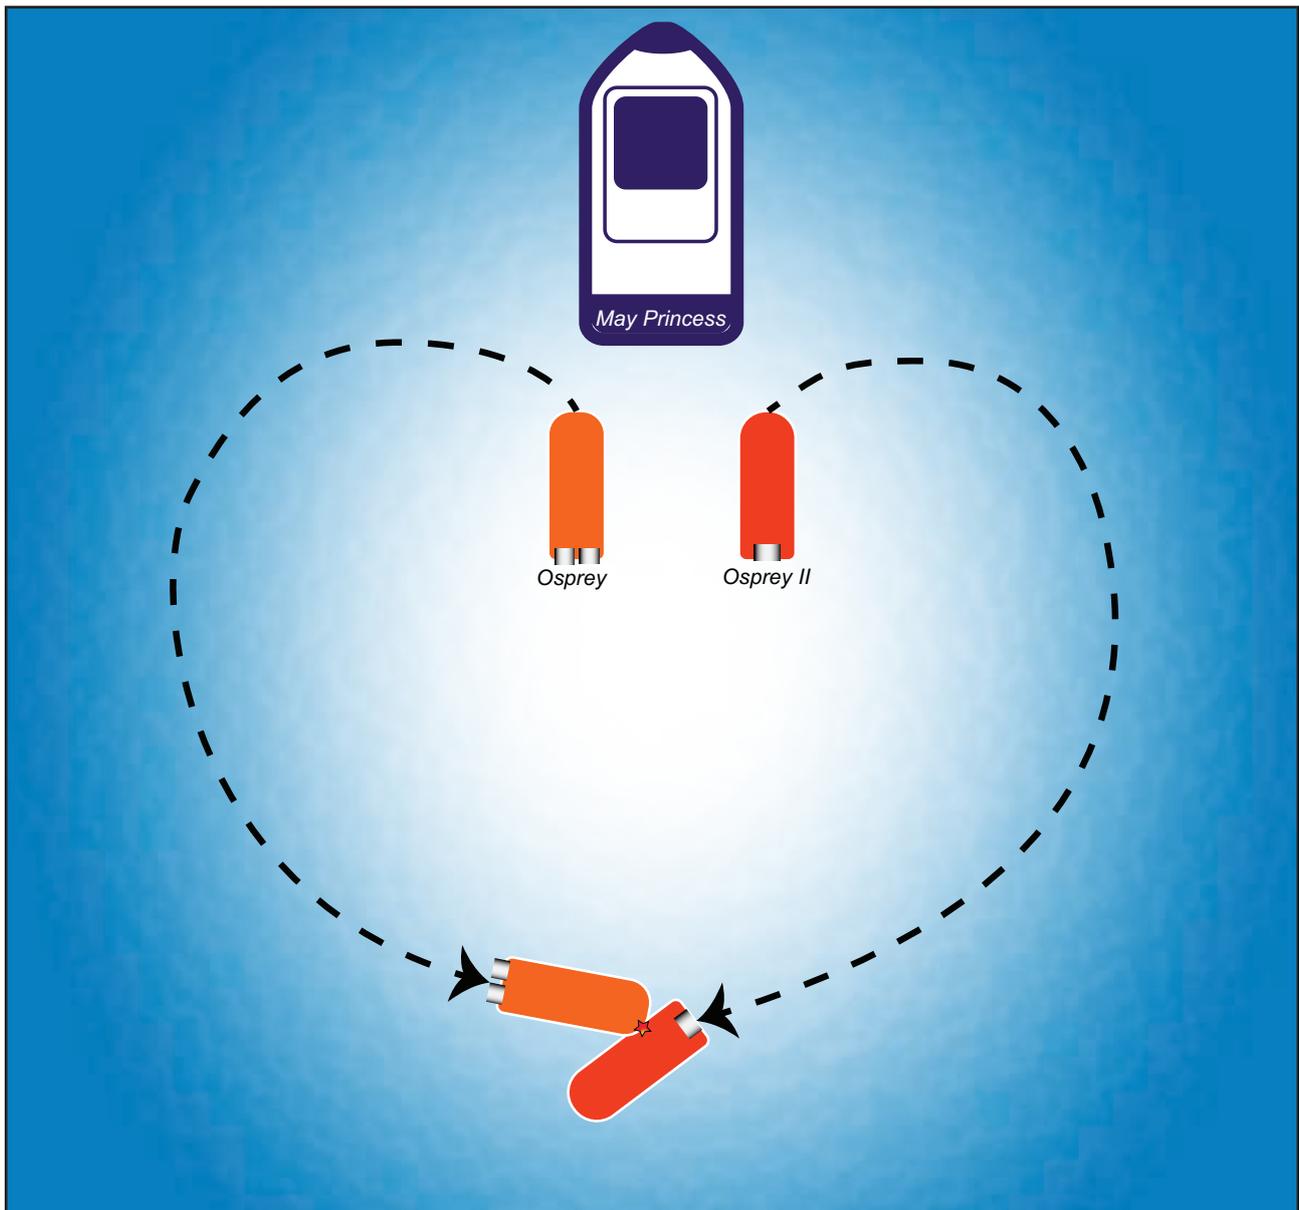
**Figure 11:** Power turn manoeuvre

*Osprey* and *Osprey II* collided as a result of turning towards each other at close range (**Figure 11**). The power turn manoeuvre had previously been carried out successfully on several occasions but it had not been formally risk assessed and no thought had been given to what to do if a potential collision situation developed.
