ACCIDENT

Aircraft Type and Registration:	Westland Wasp HAS1, G-KAXT	
No & Type of Engines:	1 Rolls-Royce Nimbus MK 10301 turboshaft engine	
Year of Manufacture:	1967 (Serial no: F9669)	
Date & Time (UTC):	23 September 2016 at 0845 hrs	
Location:	Bishopstone, Salisbury, Wiltshire	
Type of Flight:	Private	
Persons on Board:	Crew - 1	Passengers - 1
Injuries:	Crew - None	Passengers - None
Nature of Damage:	Broken universal joint and collective pitch control rod, damaged tail rotor and driveshaft, structural damage	
Commander's Licence:	Private Pilot's Licence	
Commander's Age:	63 years	
Commander's Flying Experience:	984 hours (of which 379 were on type) Last 90 days - 21 hours Last 28 days - 8 hours	
Information Source:	AAIB Field Investigation

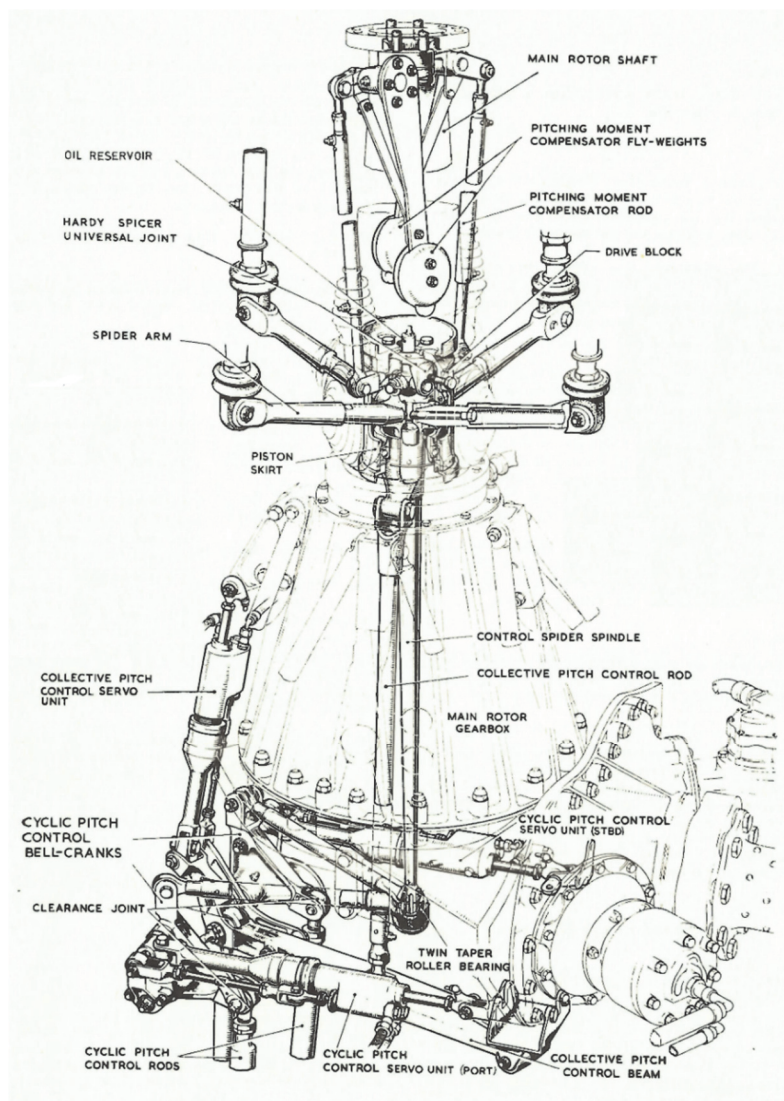
Figure 1

The control rods from the collective pitch and cyclic control column run aft under the cabin floor and, through a series of bell cranks and levers, extend upwards to the control spider at the base of the main rotor shaft (Figure 1).

Main rotor gearbox controls
