Rail Accident Investigation Branch

Rail Accident Report

Fatal accident involving a train passenger near Balham 7 August 2016

Report 09/2017
May 2017

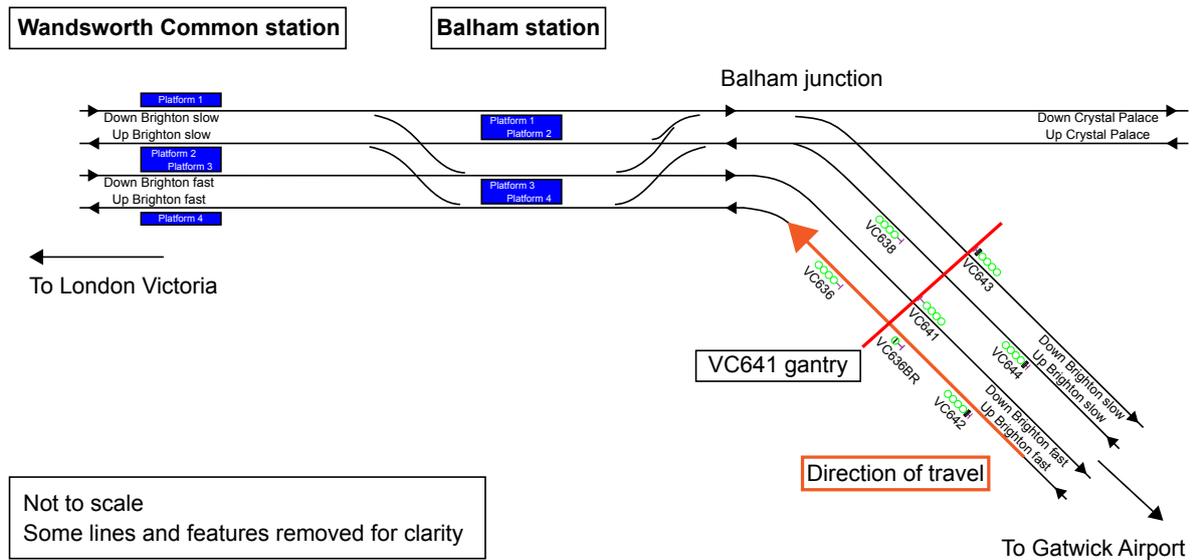
Figure 2: Schematic diagram of the track layout

- 4 The signal gantry is located at around 5 miles 12 *chains*¹ on the line from London Victoria to Brighton (*engineer's line reference* at this location is VTB1). The railway at this location comprises four tracks: the *up* and *down* Brighton fast lines, and the *up* and *down* Brighton slow lines (figure 2).
- 5 Signalling in this area is controlled by the Victoria Area Signalling Centre (ASC).
- 6 The train was travelling on the *up* Brighton fast line. The maximum permitted speed is 70 mph (113 km/h) at this point, reducing to 60 mph (97 km/h) shortly after the signal gantry.

- 7 In the direction of travel of the train, the gantry is located on a left-hand curve with a radius of 600 m.

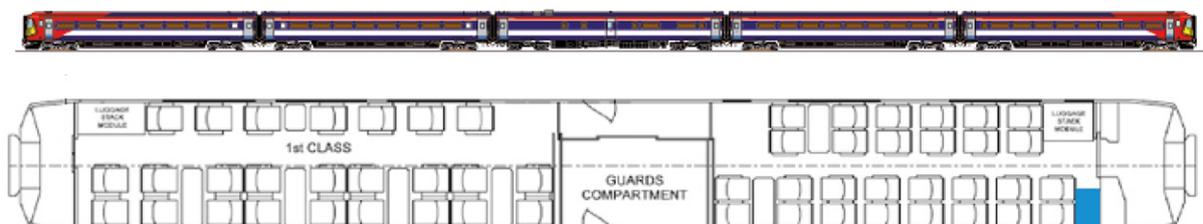
Figure 3: Layout of the Class 442 unit and detail of middle carriage (courtesy of GTR)

- 13 Each Class 442 unit comprises five carriages, and each carriage is 23 metres long (compared to 20 metres on the Class 460 and Class 387 units). The formation includes a driving cab at each end of the train and a guard's compartment at the centre of the middle carriage. This compartment separates two areas of passenger seating; a corridor running along one side of the carriage adjacent to the guard's compartment allows passengers to move between these areas (figure 3).
