ACCIDENT

Aircraft Type and Registration:	Rans S6-ESD (Modified) Coyote II, G-MYES	
No & Type of Engines:	1 Jabiru 2200A piston engine	
Year of Manufacture:	1992 (Serial no: PFA 204-12254)	
Date & Time (UTC):	30 May 2016 at 1557 hrs	
Location:	Near Shifnal Airfield, Shropshire	
Type of Flight:	Private	
Persons on Board:	Crew - 1	Passengers - 1
Injuries:	Crew - 1 (Fatal)	Passengers - 1 (Fatal)
Nature of Damage:	Aircraft destroyed	
Commander's Licence:	UK National Private Pilot's Licence	
Commander's Age:	64 years	
Commander's Flying Experience:	185 hours (of which 8 were on type) Last 90 days - 13 hours Last 28 days - 10 hours	
Information Source:	AAIB Field Investigation

Synopsis

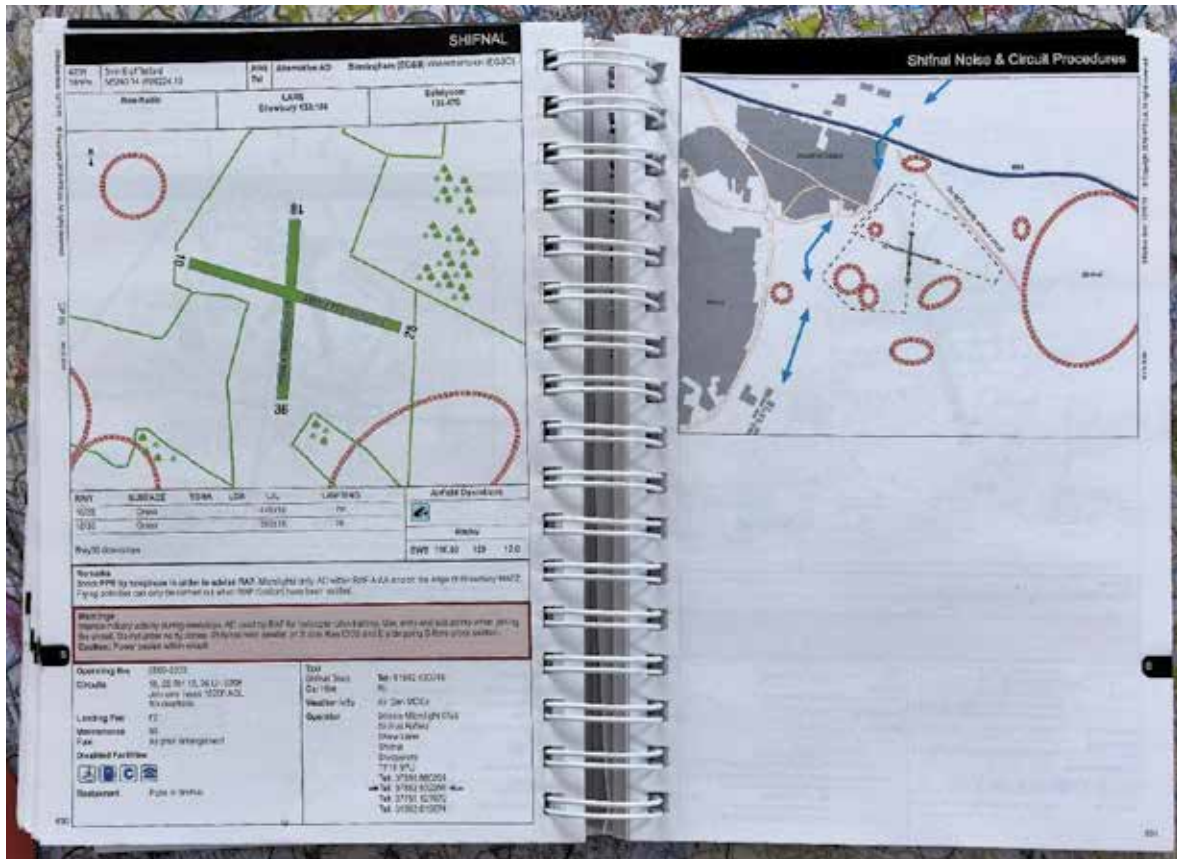
Figure 3

The information on Shifnal Airfield, and its noise and circuit procedures, in the commercially published airfield guide

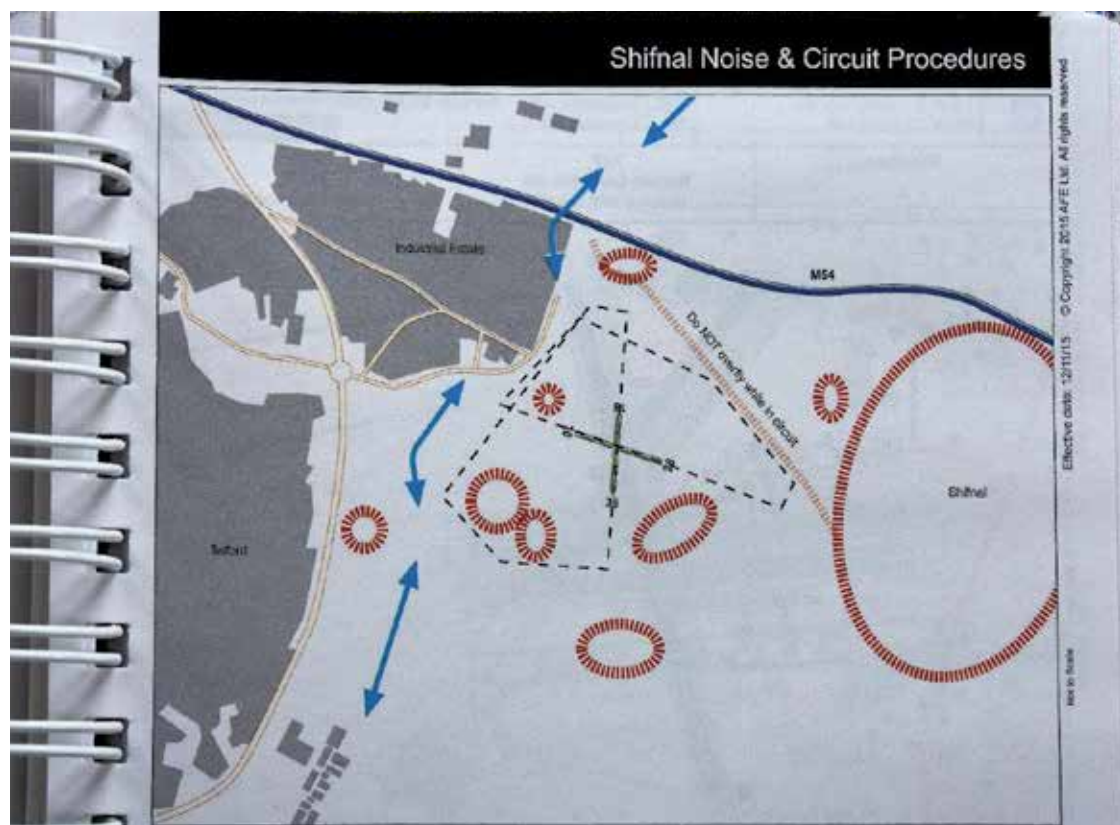
Figure 4

The 'Noise and Circuit Procedures' chart (Figure 4) in this guide showed one hachured line north of the airfield, which the circuit parallels, but, although it followed the line of the A464 trunk road, the guide did not indicate whether it was a road, railway, or other line feature.

The Noise and Circuit Procedures chart from the guide
