Report on the investigation of the failure of a mooring line on board the LNG carrier **Zarga** while alongside the South Hook Liquefied Natural Gas terminal, Milford Haven

resulting in serious injury to an officer

on 2 March 2015

**REPORT NO 13/2017**

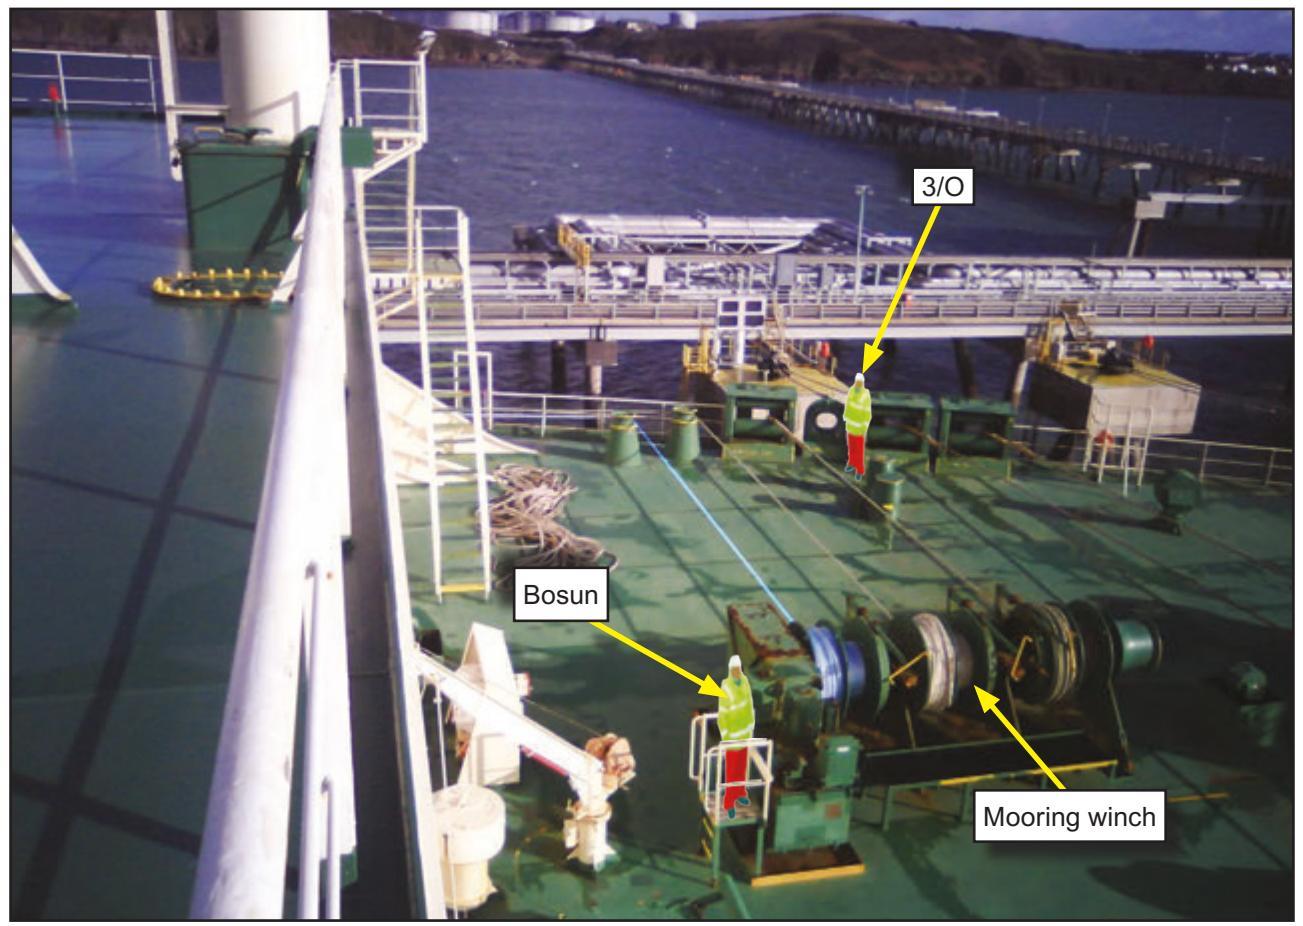
The master, in consultation with the pilot, decided to use the forward spring lines to reposition the vessel. As the OiC, bosun and 6-12 3/O had not left the forward mooring station, the OiC directed the bosun to take control of the mooring winch **(Figure 4)** and the 3/O to act as his signaller. The OiC stood outboard of the cargo tank casing aft of the spring lines' universal roller fairleads **(Figure 5)**. The signaller stood on the port side of the fo'c's'le in line of sight with the OiC and the bosun.

The bosun, following the signals relayed to him by the 3/O, repeatedly set the winch to heave until it stalled under load. Each time the winch stopped, the bosun released its control lever, and then operated it again. On several occasions, the winch rendered slightly as he released the lever.

Figure 4: Zarga for'd mooring deck: winch and crew positions

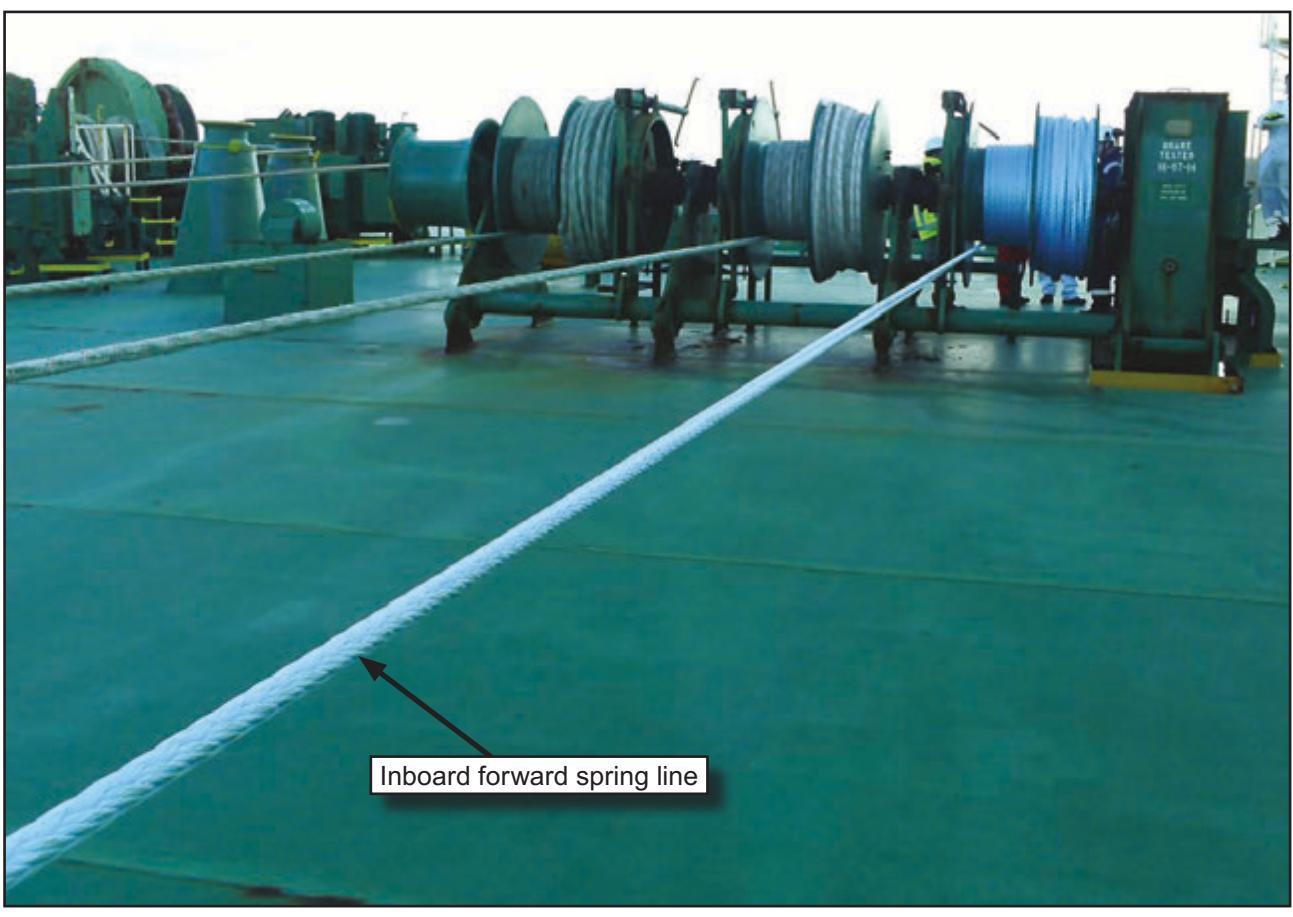
The forward winch in use at the time of the accident was positioned at the aft end of the fo'c's'le, slightly to port of the vessel's centreline, with the axis of the drums aligned forward to aft. It had three drums: the after two drums were used for the spring lines and the forward one for a breast line. When *Zarga* was connected port side to the berth, mooring lines were led from the bottom of the drums (**Figure 11**).

Figure 11: Zarga forward spring winch (Note: Inboard forward spring line shown was a replacement to the failed rope and was of a different manufacture and construct)

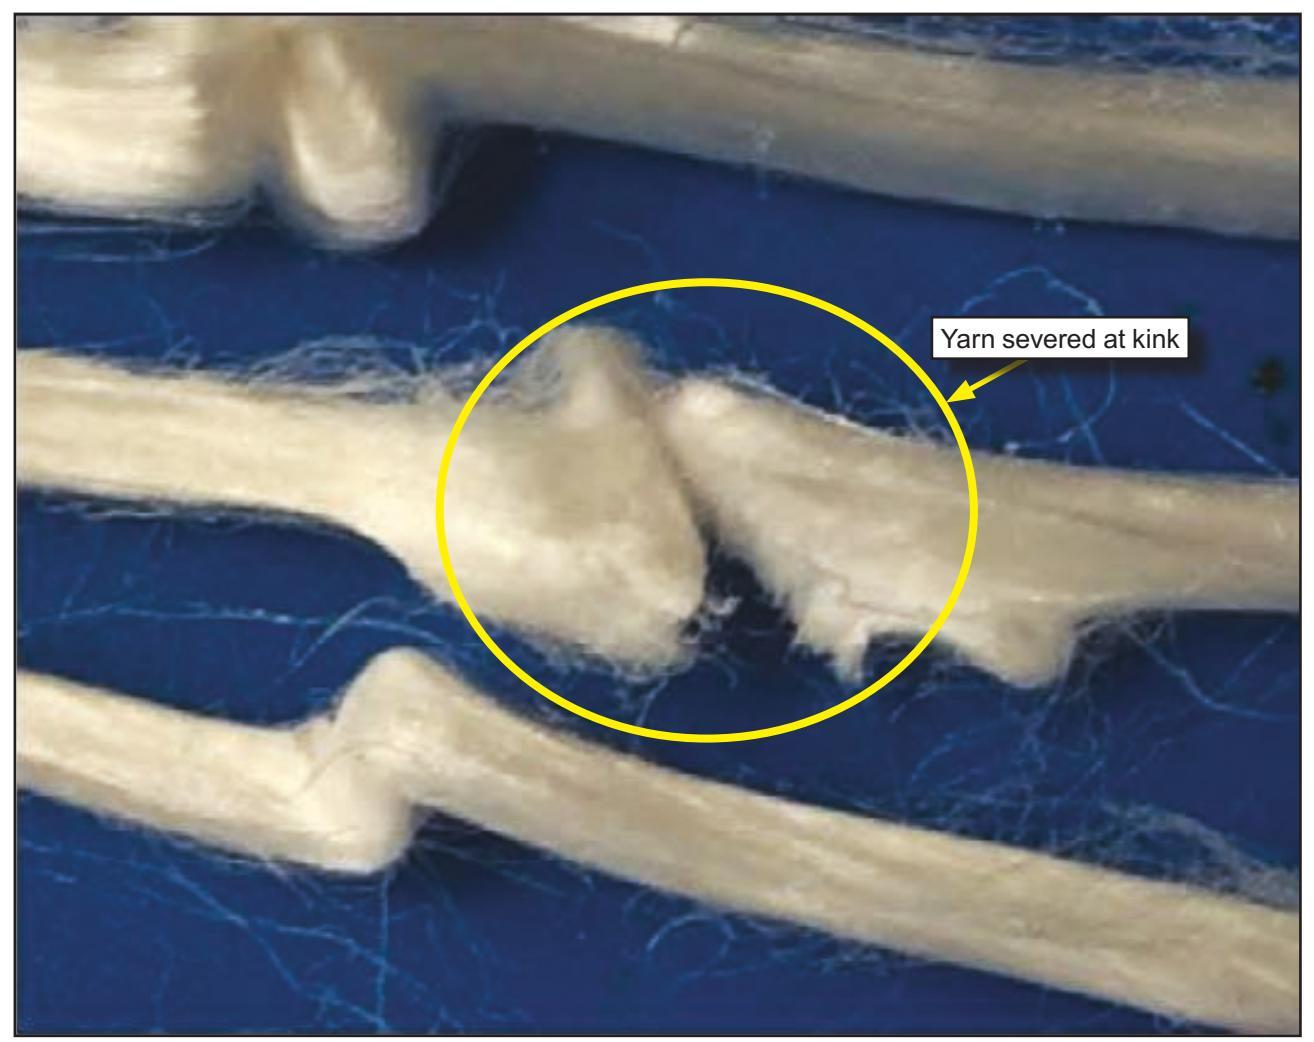
Axial compression fatigue is the tendency of a fibre to fail when it is subjected to cyclic loading, which exerts compression along its axis. In a rope where the fibre filaments are unrestrained, the filaments will gently flex without suffering any physical damage (Figure 14). Where the rope's load-bearing yarns and filaments are restrained, and subject to axial compression, individual filaments are prevented from slipping axially to equalize the load. Unable to gently flex, the yarns form sharp buckles, which induce "plastic hinges" or z-shaped kinks (Figure 14) and kink bands at filament level (Figure 15). The most dominant mechanism likely to induce axial compression and axial compression fatigue in a rope under tension is low mean load cycling; axial compression can also be caused when a rope is twisted or bent around a fairlead. Frequent flexing can introduce fatigue at the kink hinge point and cause fibres to fail at the kinks. This can lead to a rope yarn failure that has the appearance of a cleanly severed cut (Figure 16).

Figure 16: Z-kinks in HMPE rope yarn

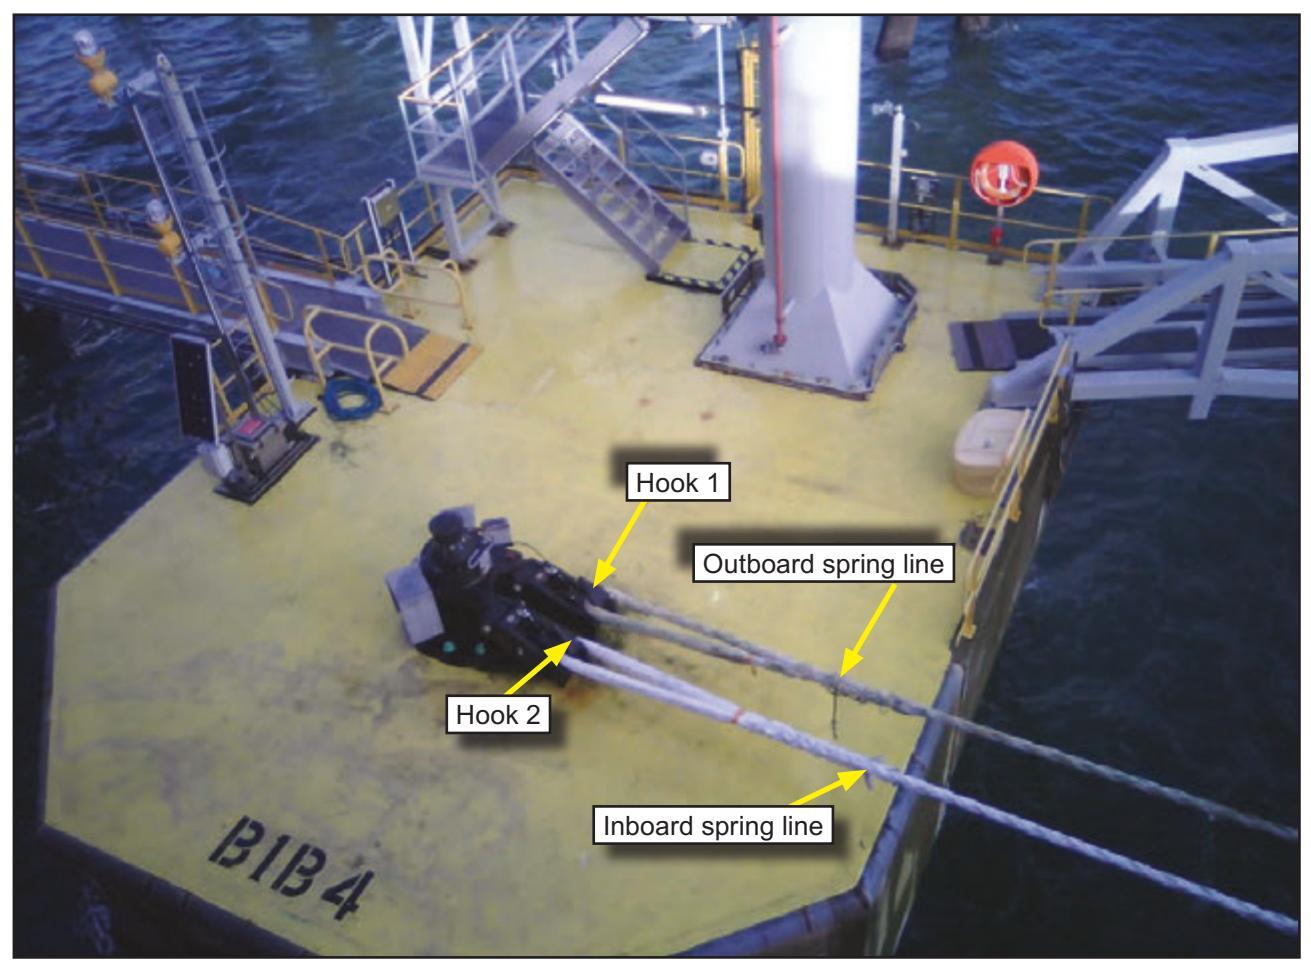
The dolphins and their respective hooks on the South Hook jetty berths were labelled for identification; *Zarga*'s failed spring line was connected to B1B4-2, which was berth 1, dolphin B4, hook number 2 (**Figure 21**). Each hook was fitted with an *Exaquantum* load tension sensor that enabled the load in each mooring line to be continuously monitored and recorded ashore. The hook loads were recorded to a database at 5-second intervals, and the high and low hook load alarms were set at 80t and 0t respectively. The hook load cells were tested and calibrated yearly and had previously been inspected on 24 June 2014. Line tension monitoring equipment is commonly only installed at LNG terminals.

Figure 21: South Hook jetty berth 1 dolphin hook B1B4-2

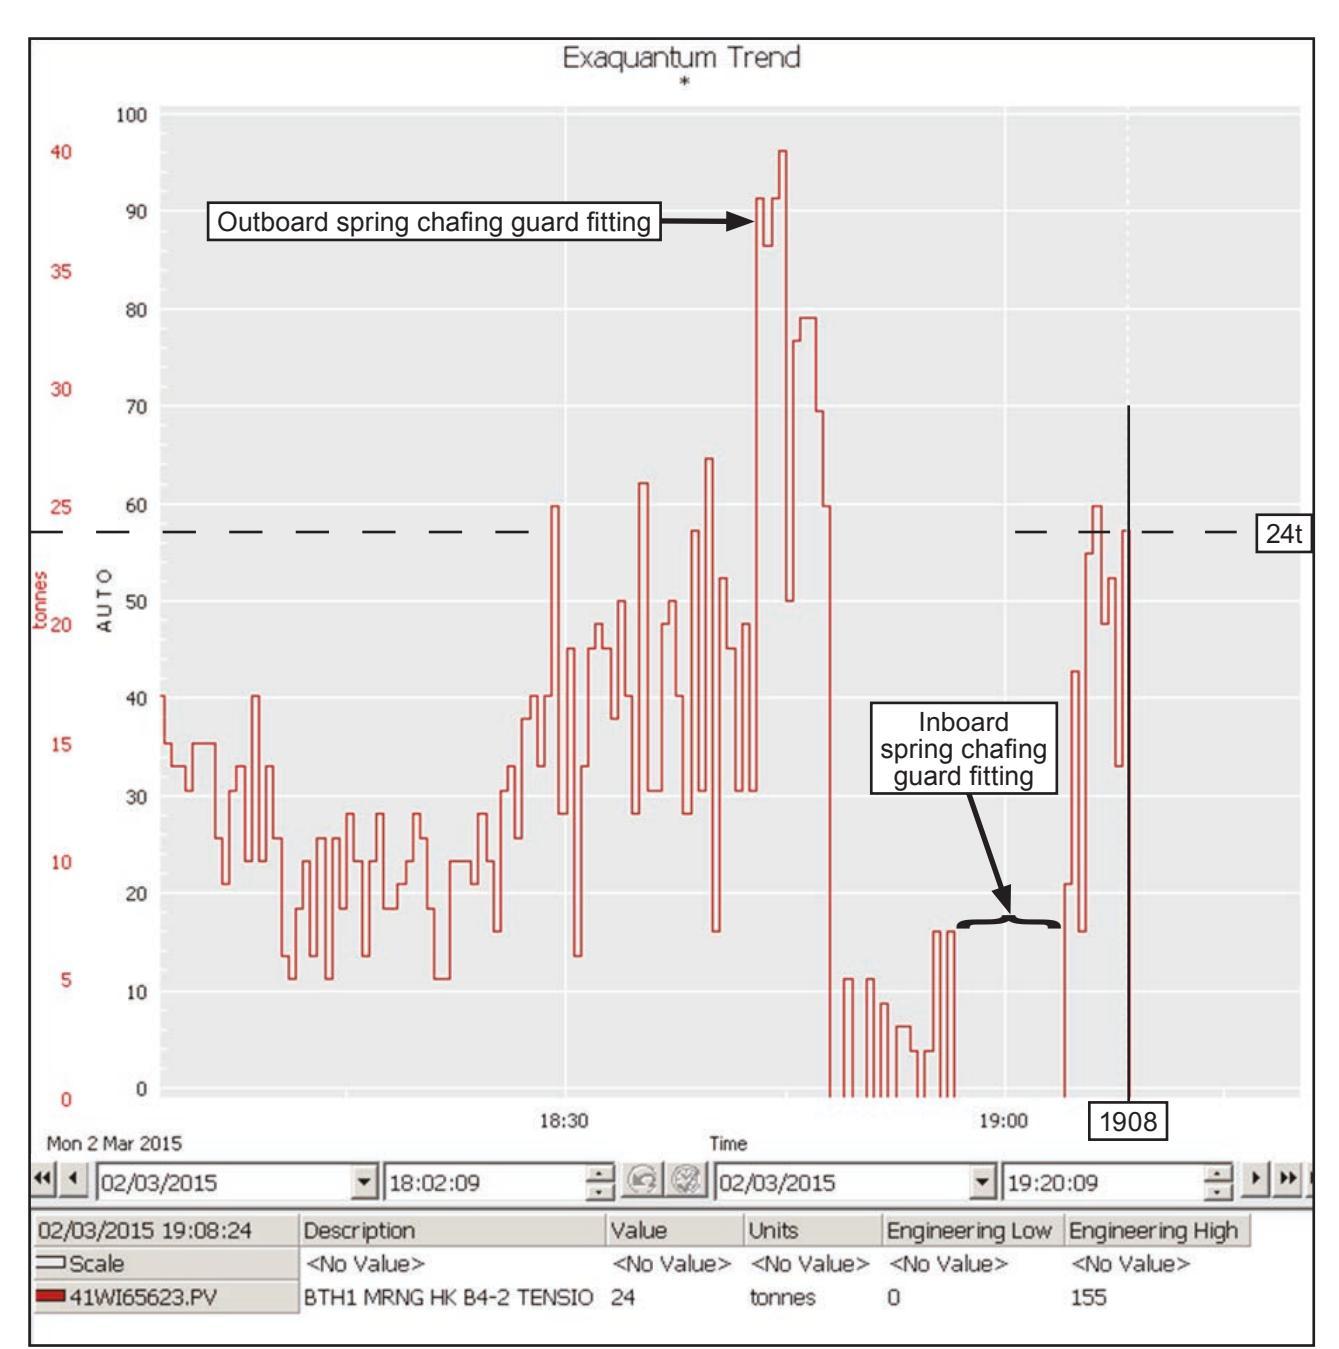
The hook load records on the day of failure (**Figure 25**) showed that the load on the failed mooring line fluctuated between 0 and 40t. At about 1843, the average load increased from about 17t to about 30t; it remained there for about 5 minutes, with a peak load of 40t being recorded at 1845. At about 1848, the average load dropped to about 5t, and at 1857 it dropped to zero, where it remained for about 7 minutes. The load then increased rapidly to 25t. At 1908, when the line parted, the recorded load was 24t.

Figure 25: Inboard spring line hook electronic load readings for 2 March 2015

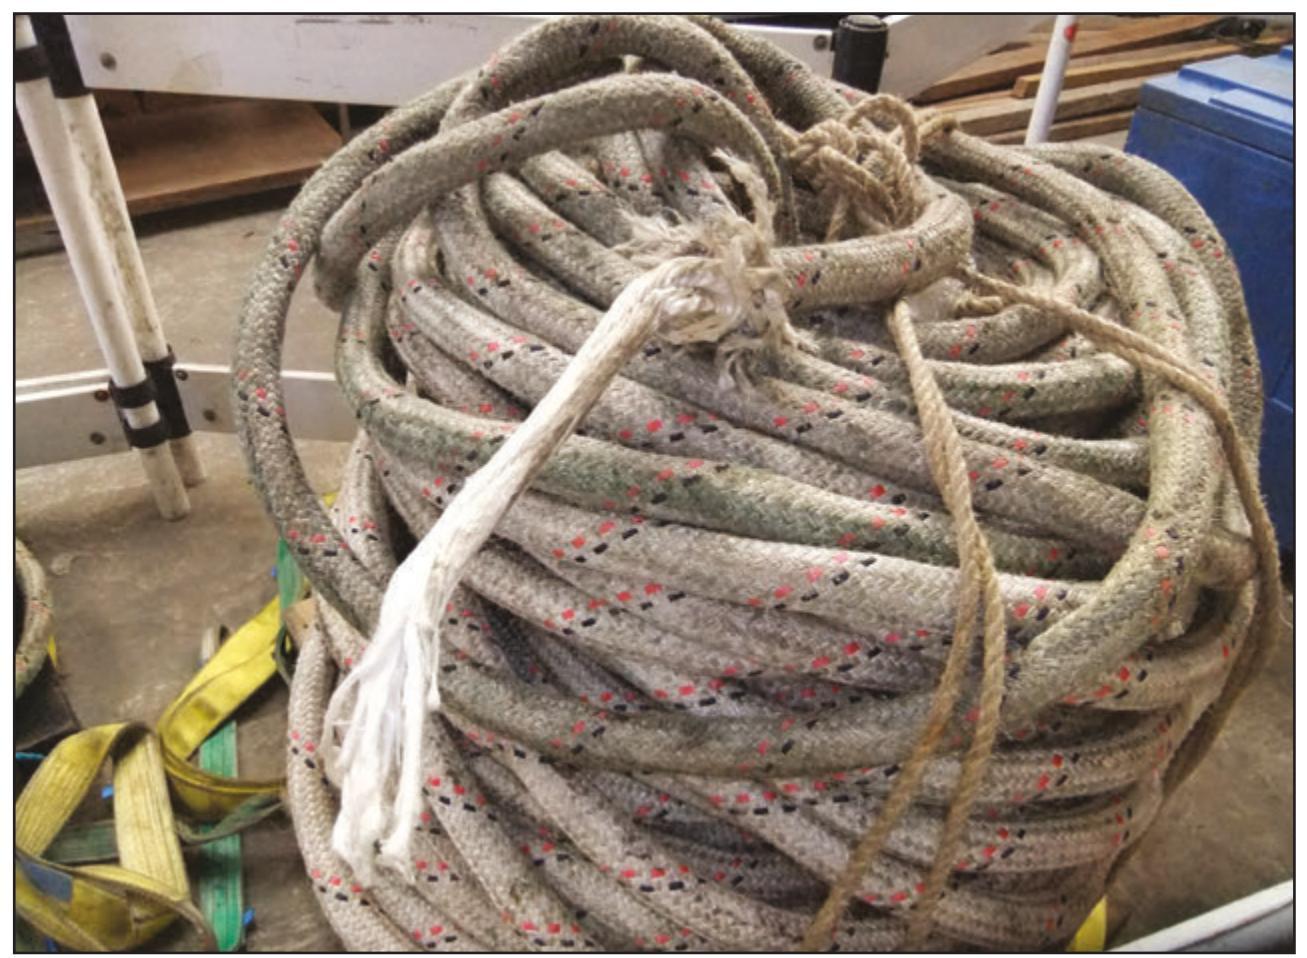
Both parts of the failed mooring rope, and its tail, were coiled onto pallets (Figure 27) and taken ashore for further examination.

Figure 27: Failed rope on pallet for delivery to MAIB

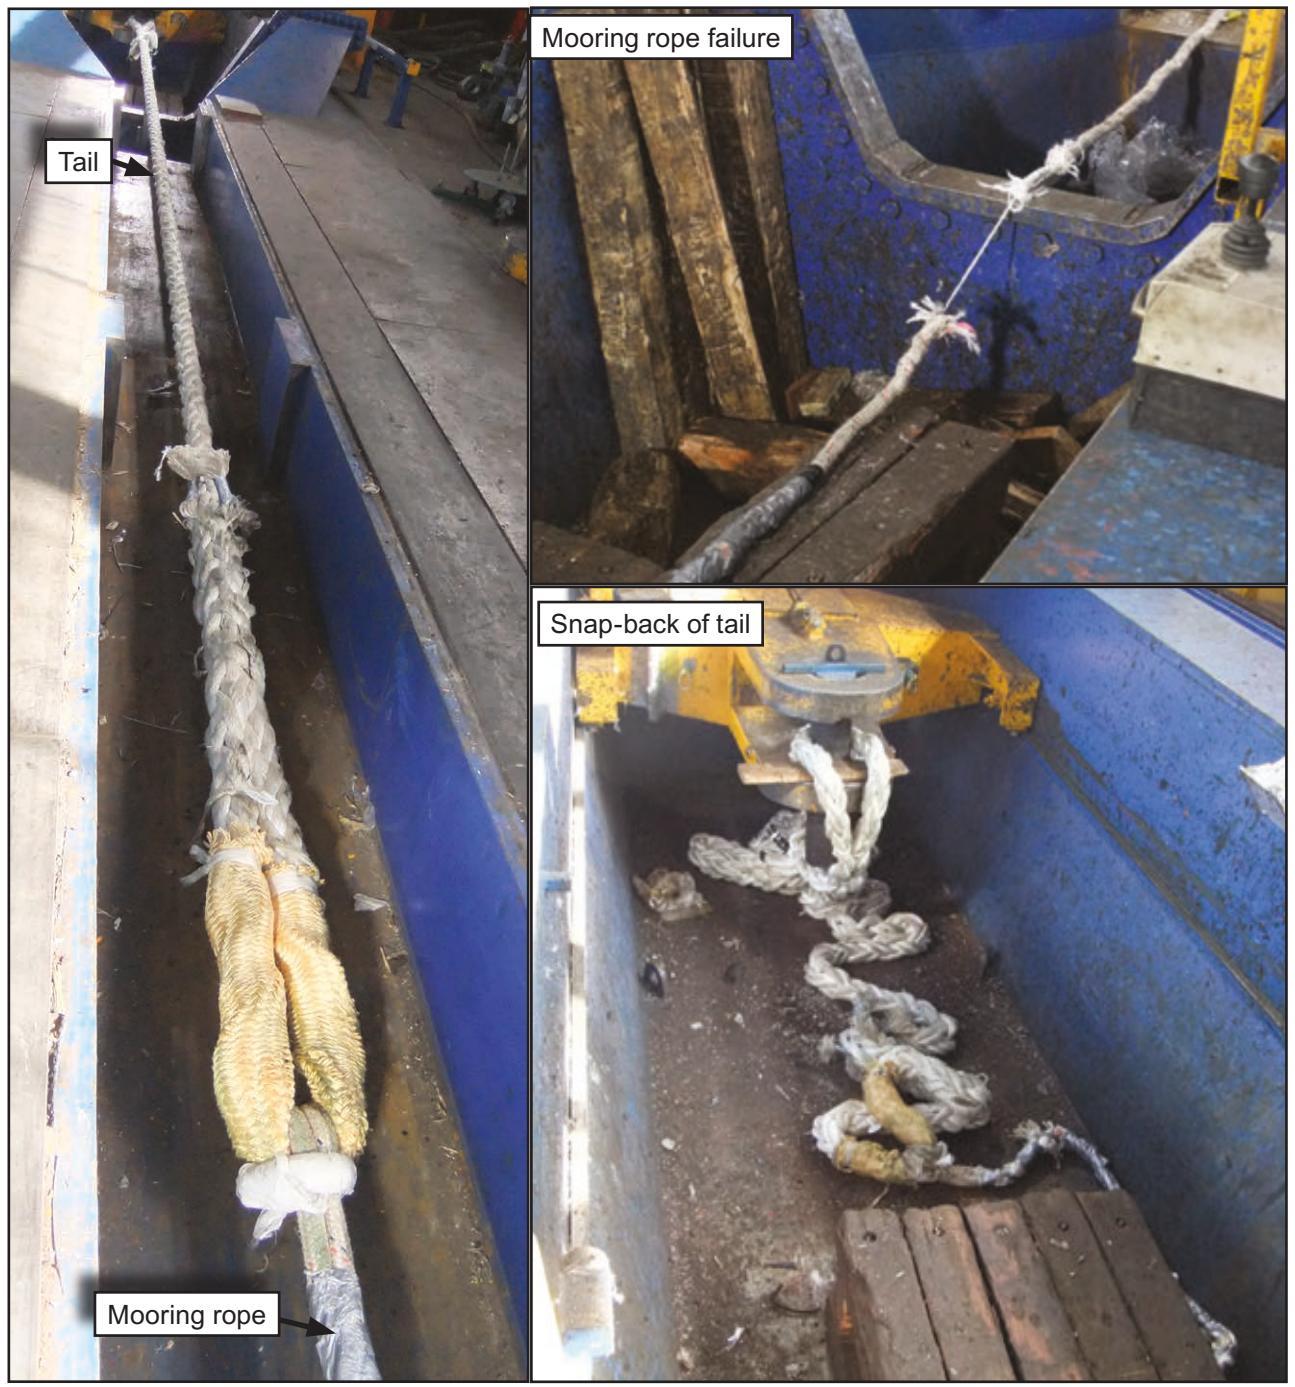
Three rope samples were connected directly to the test bed and subjected to full load break tests; the fourth was tested with the tail connected. The tests were recorded using high speed cameras<sup>32</sup> operating at 5000 and 10000 frames per second, and the footage was used to study the mechanics of the rope failure and its snap-back trajectory (**Figure 34**).

Figure 34: Zarga rope break and snap-back testing

**Table 3** shows the recorded loads and residual unspliced strength, as a percentage of the specified MBL (137t), at failure:

Test	Rope Section	Load at failure kN tonnes-force (tf)	Residual Strength: % of original MBL
1	Shore end – 10m from failure point	671kN 67.34tf	50.2
2	Vessel end – adjacent to failure point	465kN 46.66tf	34.8
3	Vessel end – opposite end of rope to failure	847kN 85tf	63.37
4	Vessel end - middle of rope + 15m tail	645kN 64.73tf	48.26

The effect of the *Euroflex* tail on rope snap-back was visually evident during the break load tests. The tail end of the rope recoiled violently as the stored energy was released; whereas the other end of the rope, which had stiffened under the strain, fell to the floor. It was apparent from witness evidence that the inboard section of *Zarga*'s failed rope also suffered minimal recoil before falling to the deck.

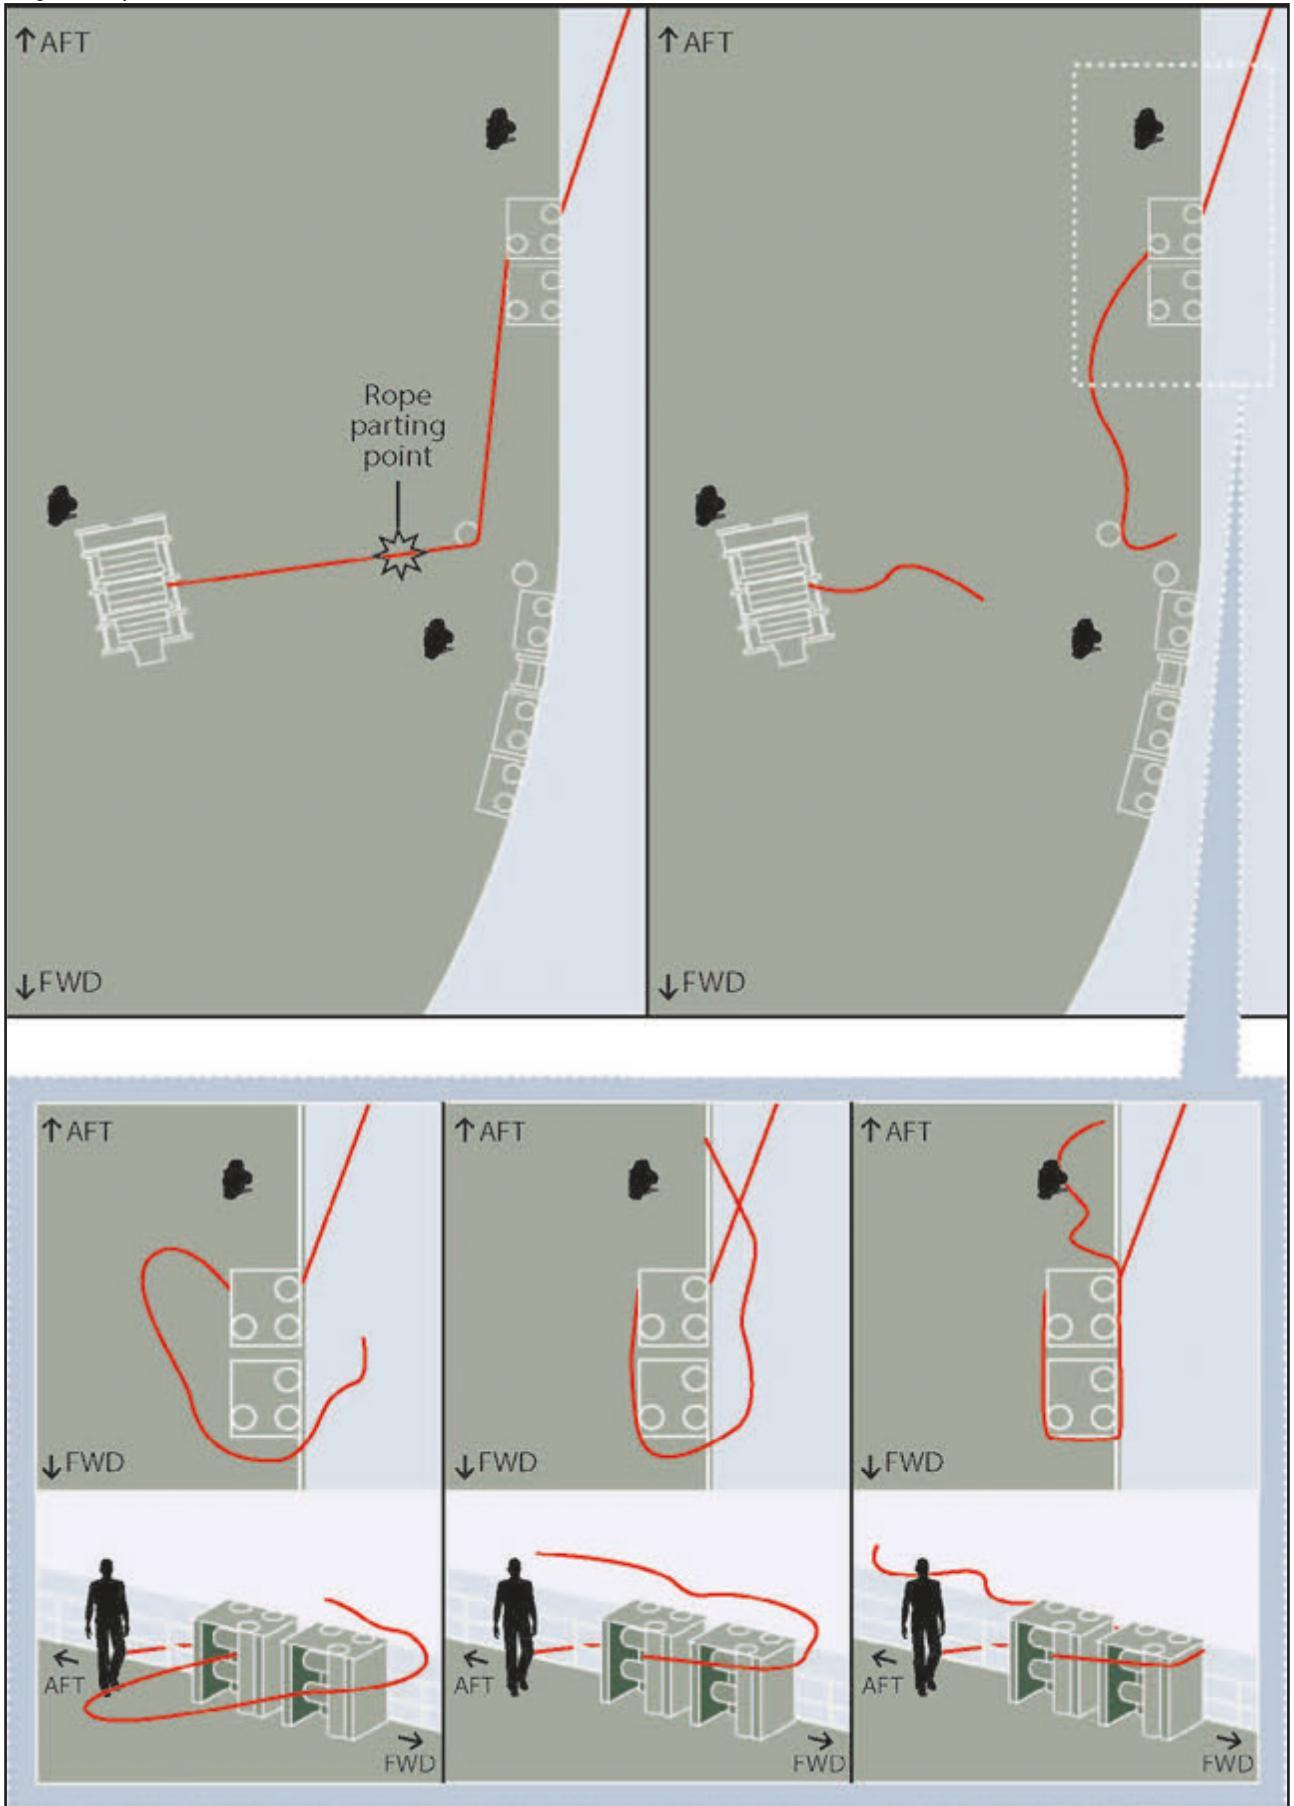
TTI utilized the results of the snap-back testing to carry out a computer modelled trajectory analysis of the failed rope. The trajectory analysis indicated that the parted end of the outboard section of rope whipped around the pedestal roller fairlead and then looped outboard and aft of the spring line's universal roller fairlead. It then whipped inboard and forward before being pulled through the fairlead into the water **(Figure 35)**. The computer modelling analysis also estimated that the outboard section of rope recoiled overboard at approximately 150m/s (335mph).

Figure 35: Trajectory analysis of failed rope

TTI's computer modelled snap-back analysis indicated that the outboard end of *Zarga*'s parted spring line recoiled around the pedestal roller fairlead and looped outboard and aft of the spring line's ship's side roller fairlead. It then whipped inboard and forward, striking the OiC on the back of his head before passing through the fairlead into the water **(Figure 35)**. It is likely that the force of the impact knocked the OiC forward of where he was standing.

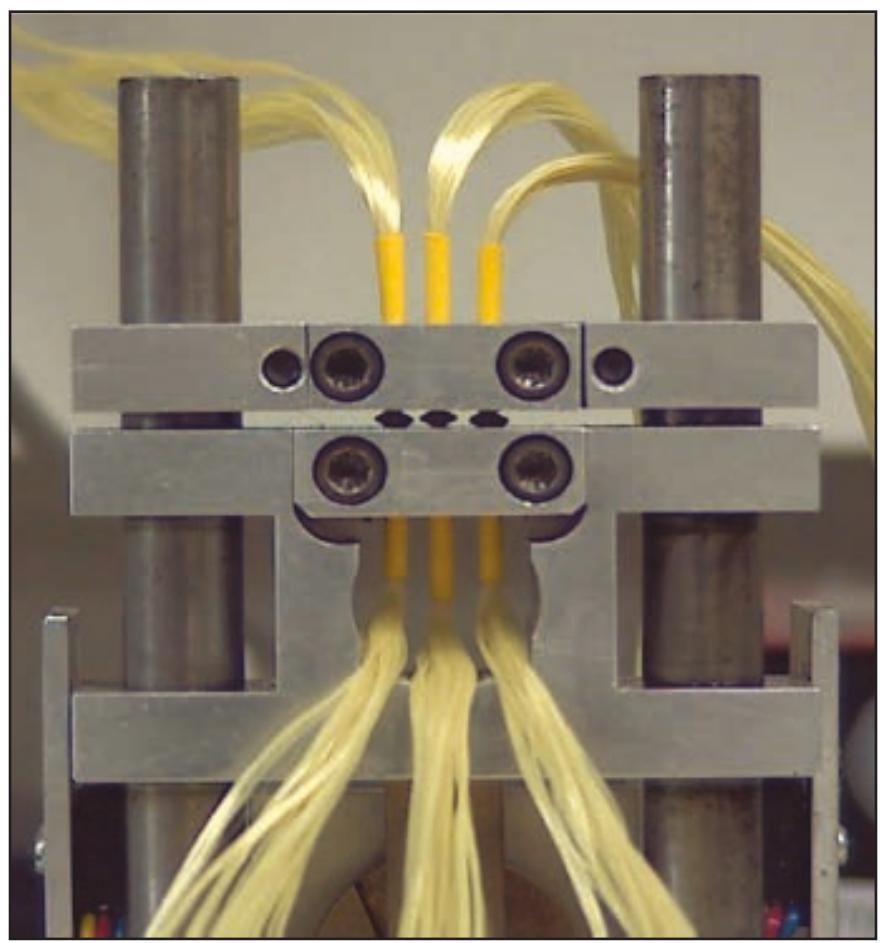
The selected yarns were placed in the yarn buckling test machine (Figure 36) and exposed to between 22,000 and 110,000 cycles. The subsequent residual strength of the yarns was found to vary between 87.5% and 60.3% across the cycle range for the restrained yarns and 88.1% and 62.1% for the unrestrained yarns. This data indicated that 21,500 cycles was needed to create axial compression fatigue.

The practical tests results were consistent with the theoretical modelling calculations, and indicated that the increased radial pressure of a jacket causes damaging buckles to be induced in the yarns more quickly. In addition, specially marked test samples were examined after cycling and found that the break points occurred at buckle points.

Figure 36: Practical yarn buckling test
### 1.17.3 New rope examination

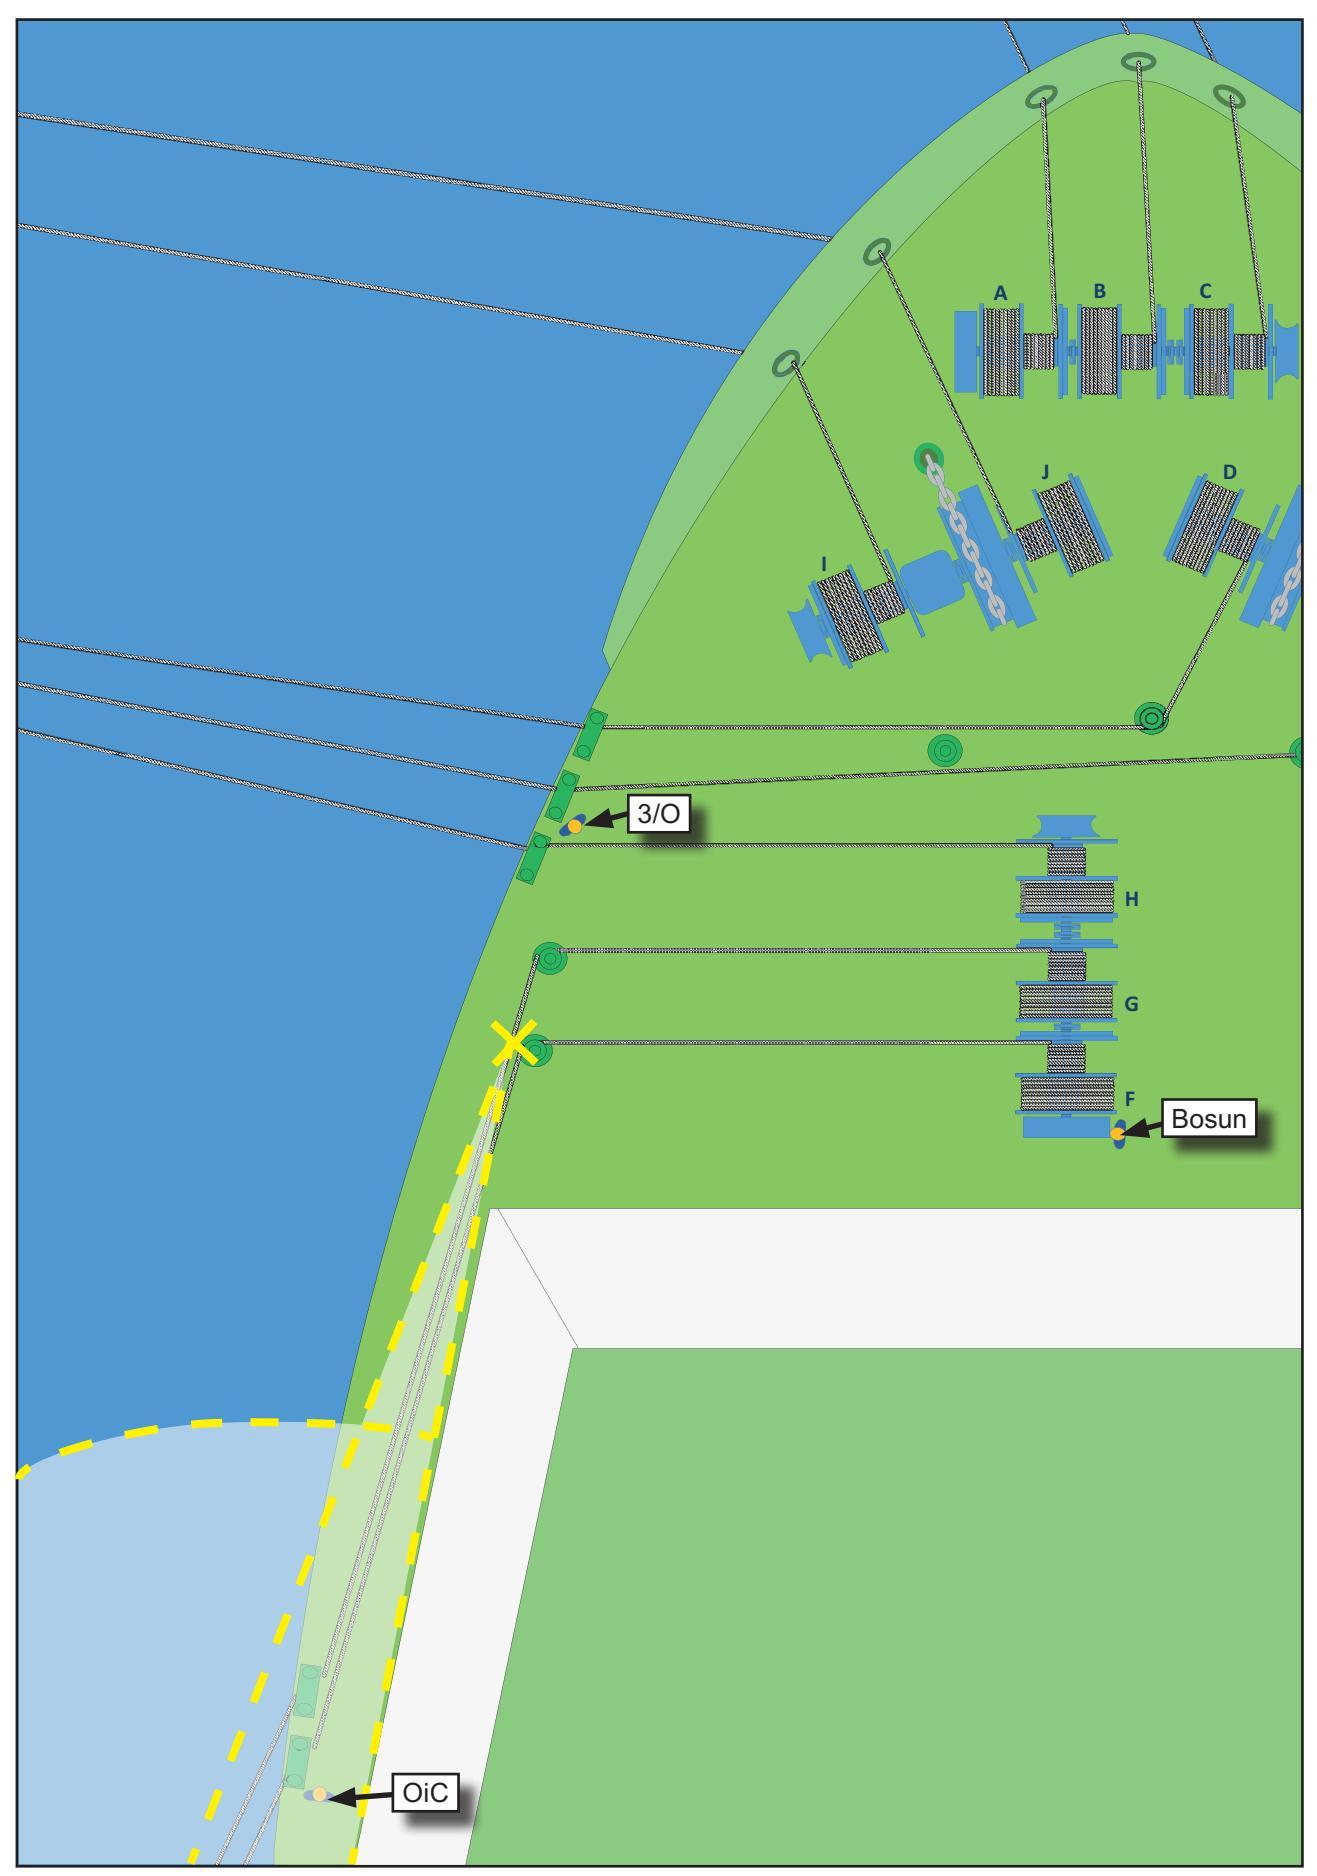
The complex snap-back trajectory and dynamics of the outboard section of the failed spring line could not have been accurately predicted without the type of practical test-based data and computer modelling software used by TTI. However, had more thorough snap-back assessments been carried out for the mooring deck's high risk failure points, such as the pedestal rollers, it would have been apparent that the area aft of the ship's side fairleads was a potential snap-back danger zone **(Figure 40)**.

Figure 40: Simplified illustration of snap-back zone for spring line break point at deck pedestal roller fairlead
