Report on the investigation of
the grounding and evacuation of the
domestic passenger vessel

Surprise

at Western Rocks, Isles of Scilly

on 15 May 2016

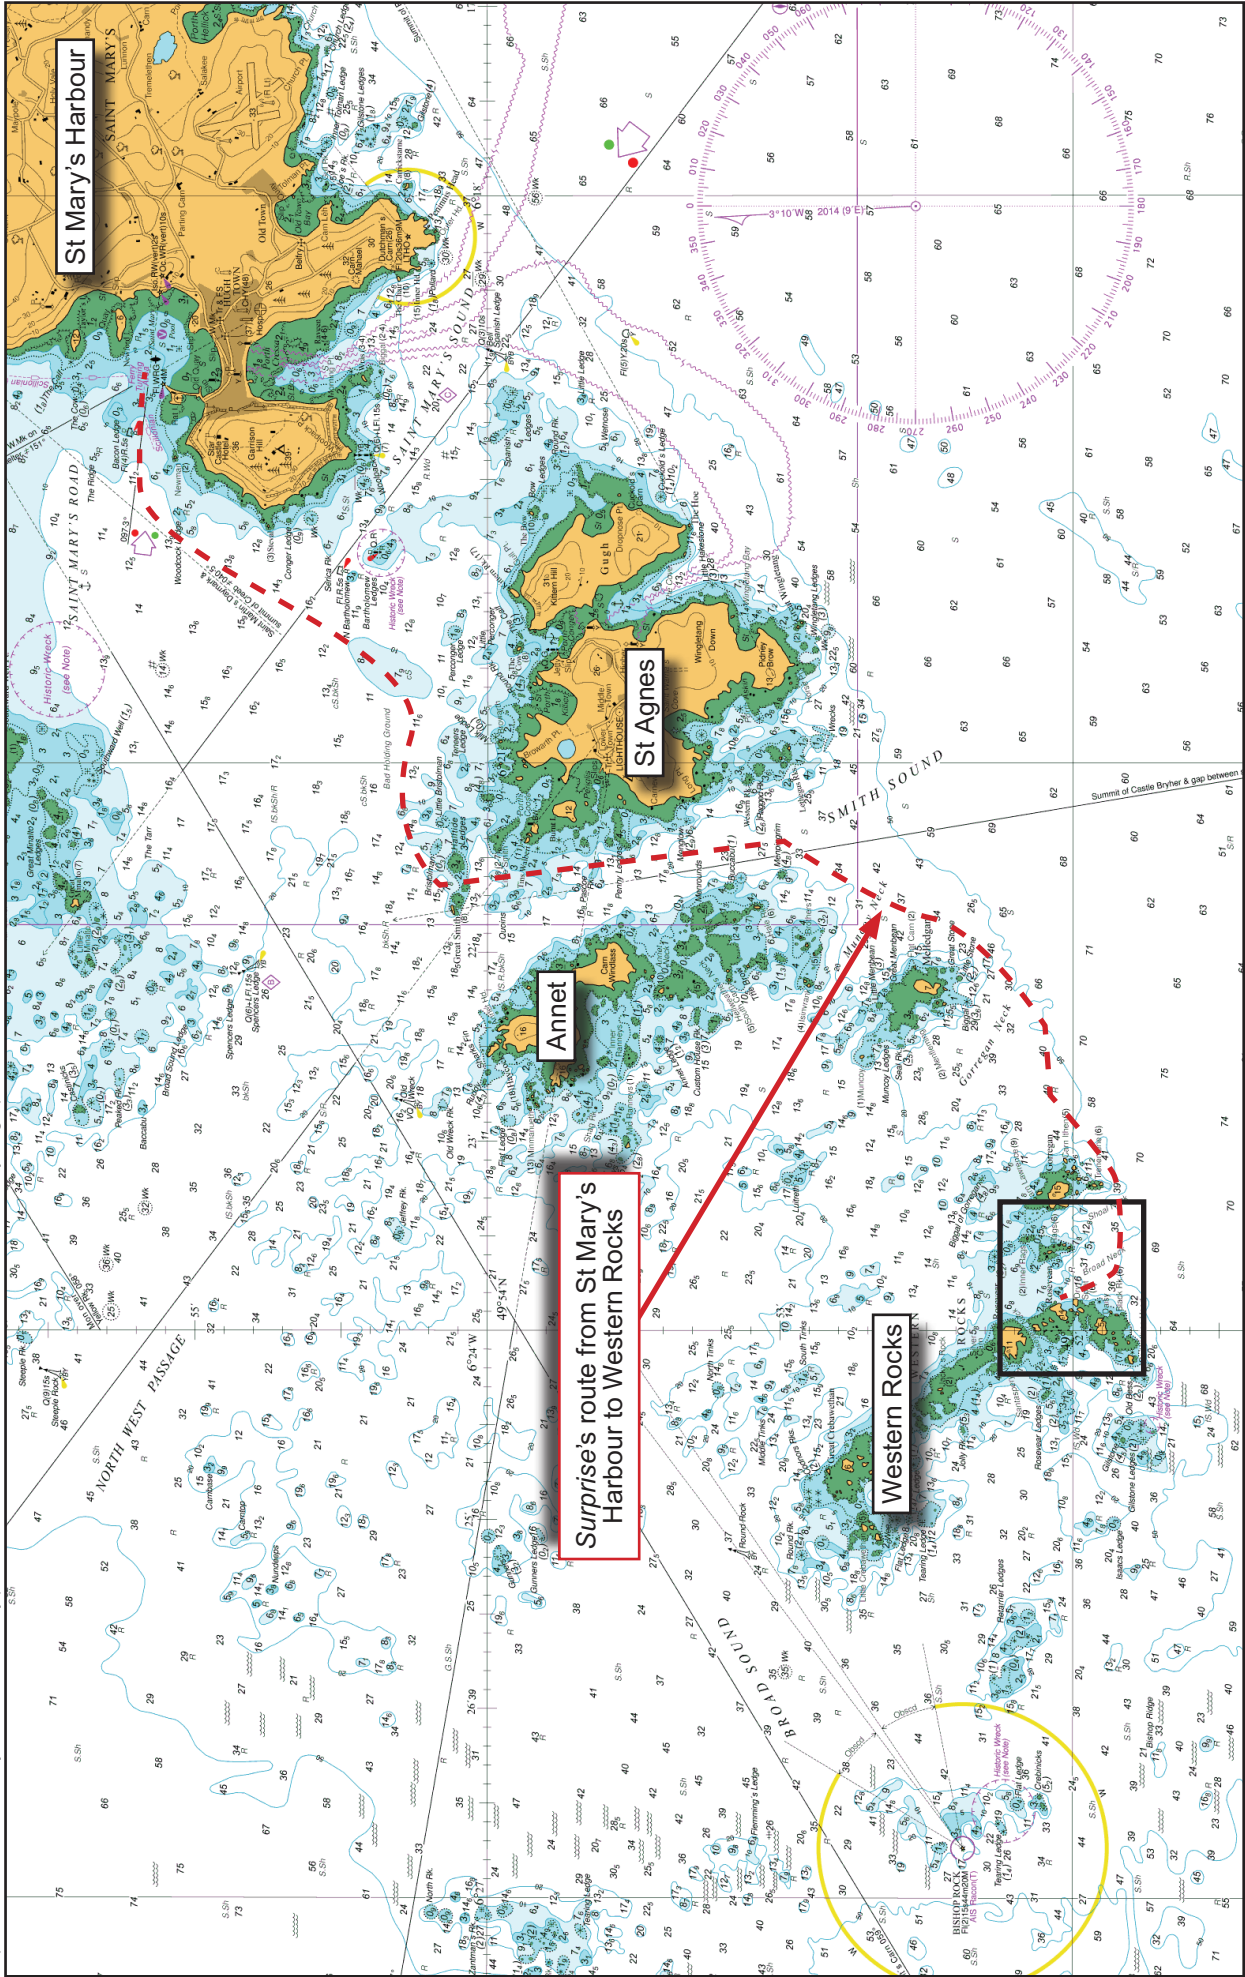
Figure 2: Overview of Surprise's route from St Mary's Harbour to the grounding location

At about 1015, the skipper unberthed *Surprise* and reported the passenger numbers to the SMBA ticket office. Once clear of the berth, the skipper made a safety announcement to the passengers on the vessel's public-address system then manoeuvred *Surprise* out of the harbour. To provide close-up views of seals and birds, *Surprise* passed close to several islands during the passage to Western Rocks (**Figure 2**).

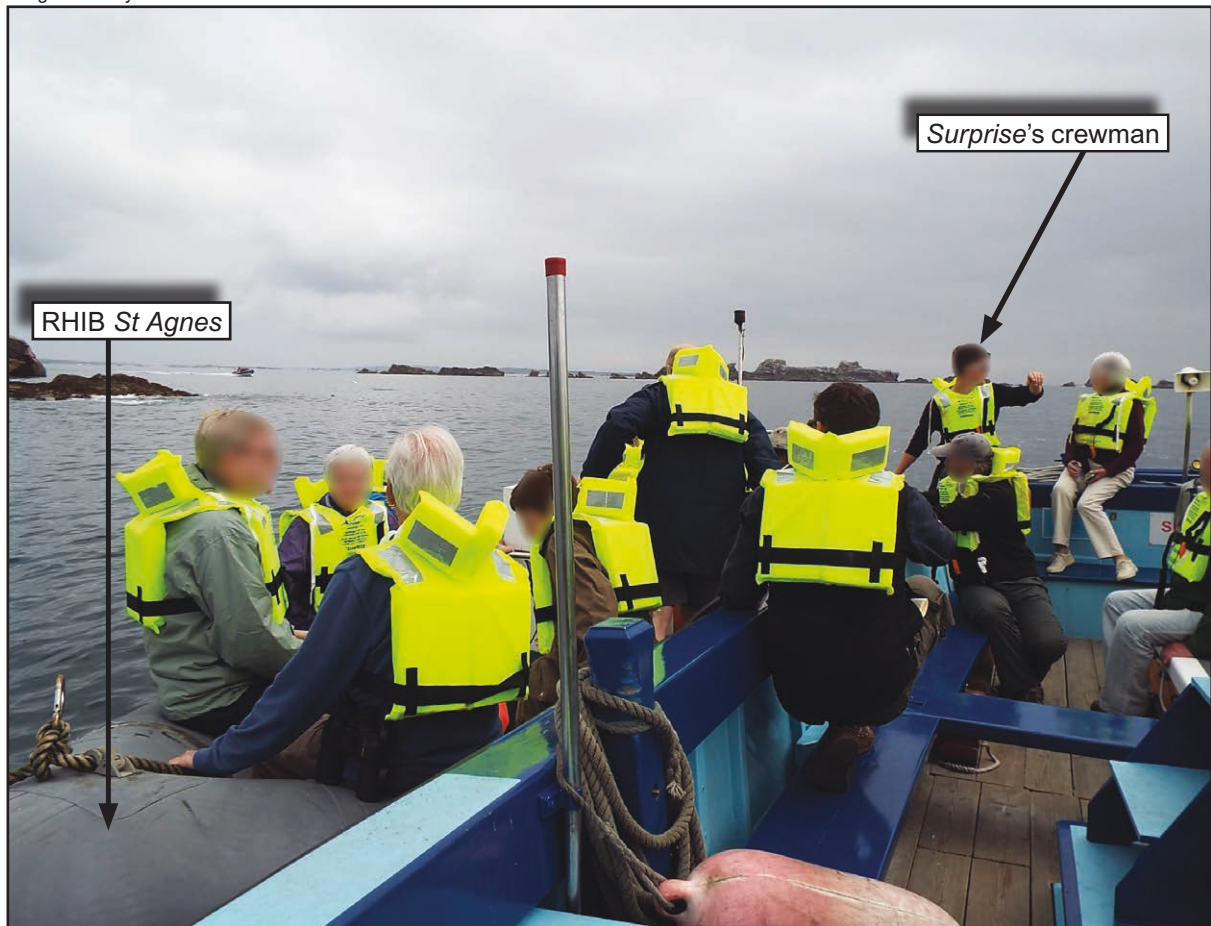
Figure 4: Passengers transferring from *Surprise* to *St Agnes*

The skipper's "Mayday" was heard by Falmouth Coastguard and numerous local vessels that were operating nearby. The coastguard tasked a search and rescue helicopter and requested the launch of the St Mary's Royal National Lifeboat Institution (RNLI) lifeboat. Three small local boats - *Pioneer*, *St Agnes* and *Orca* - all proceeded immediately to assist *Surprise* and the Isles of Scilly ambulance boat arrived soon after. By about 1150, all the passengers had been transferred from *Surprise* to the assisting boats (**Figures 4, 5, and 6**). After the passengers had been evacuated, *Surprise* floated off the rock unaided (**Figure 7**).

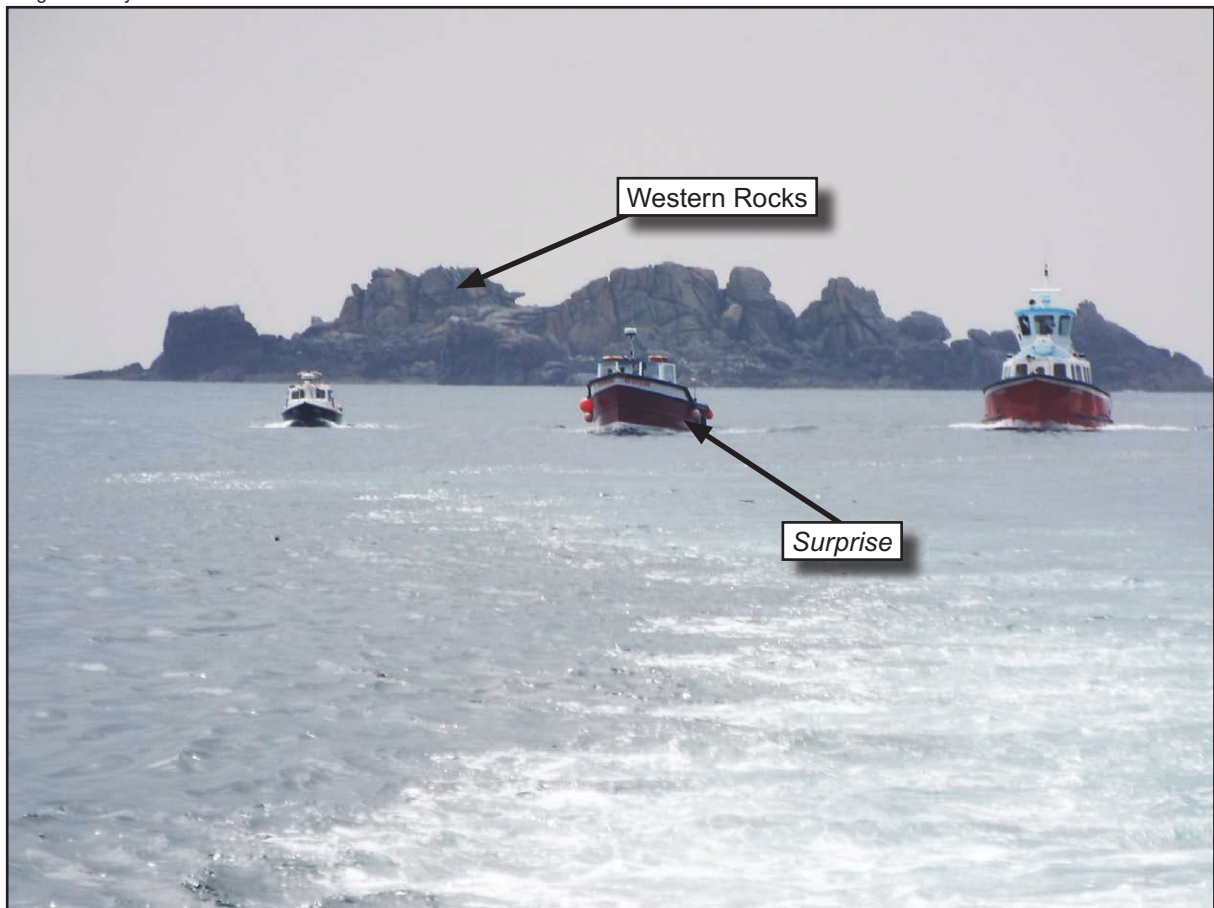
Figure 8: *Surprise* heading back to St Mary's Harbour in company with other local boats

At 1155, the lifeboat arrived on scene and *Surprise* came alongside it to embark a member of its crew and a portable salvage pump. Content that the situation was stable, *Surprise*'s skipper started heading back to St Mary's in company with several other local boats (**Figure 8**). Each of the local boats with *Surprise*'s passengers on board then took it in turn to transfer them to the lifeboat. By about 1210, all the passengers were safely on board the lifeboat.

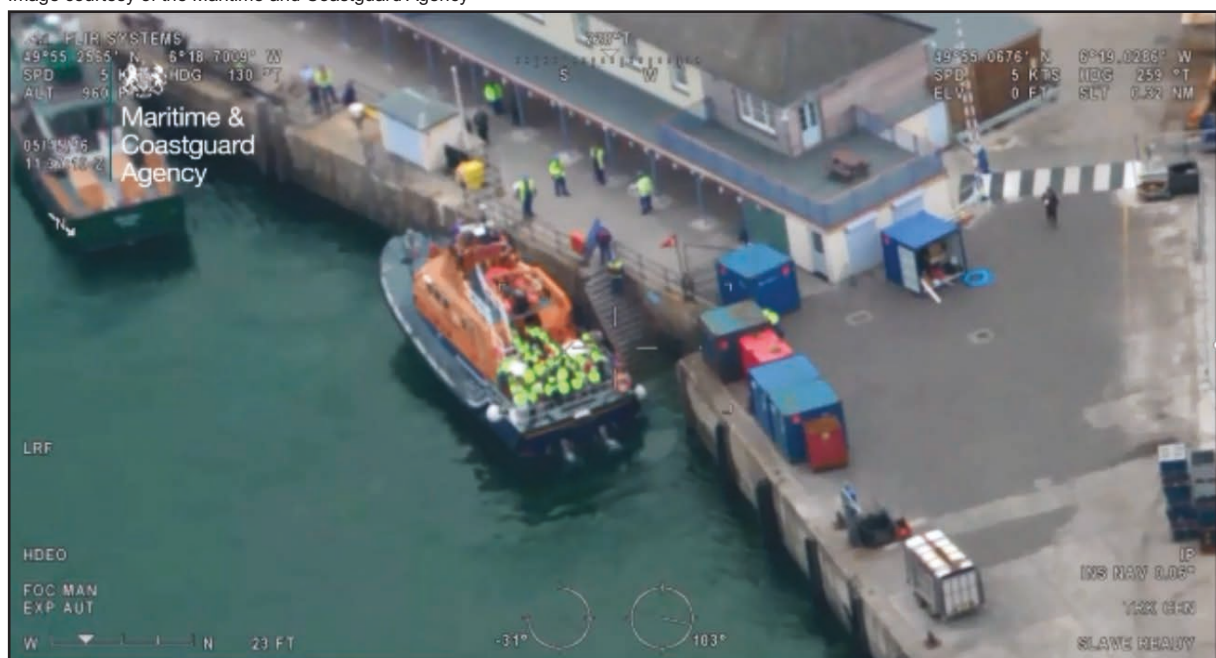
Figure 9: *Surprise*'s passengers disembarking from the lifeboat at St Mary's Harbour

The lifeboat arrived in St Mary's at 1235 and disembarked the passengers (**Figure 9**). A doctor, a nurse and the Isles' police officer were waiting on the quay to help assess the condition of the passengers; none of them required medical assistance

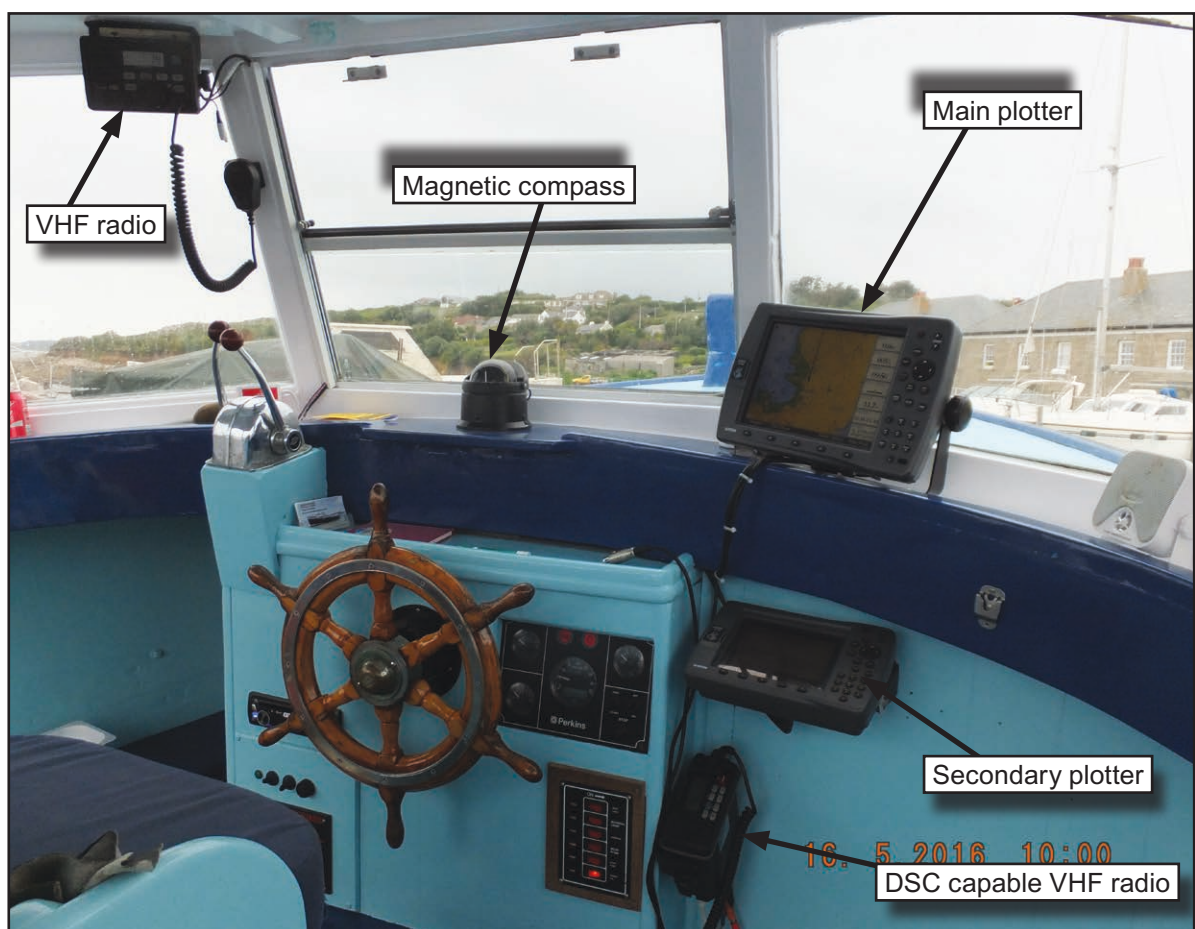
Figure 13: *Surprise's* wheelhouse showing the navigation equipment

The wheelhouse was equipped with two Garmin chart plotters, a magnetic compass and two VHF radios, one of which had a digital selective calling (DSC) function (**Figure 13**). The main chart plotter was a Garmin GPSMap 3010C unit that included a navigation alarm function to indicate when the vessel was off course by a pre-set distance. The main plotter's electronic chart data information had not been updated since 2006. *Surprise* was not fitted with an echo sounder.

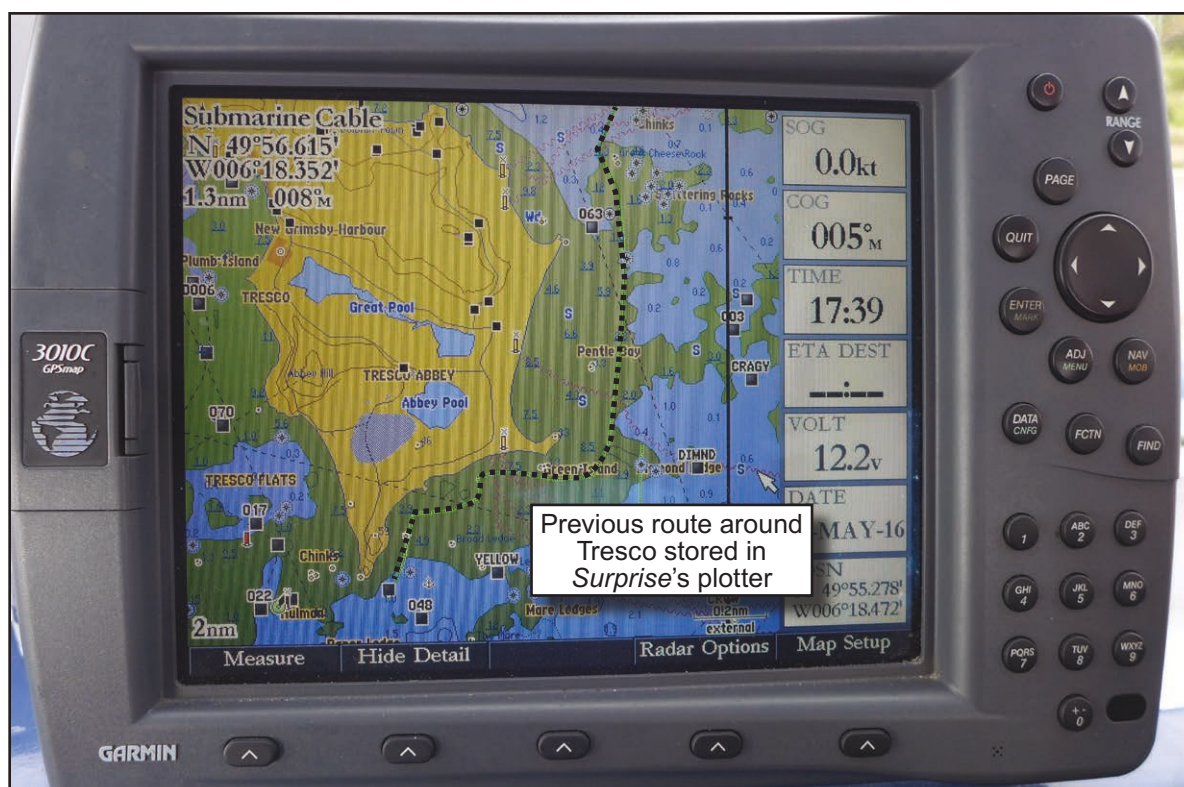
Figure 16: Historical track around Tresco stored in *Surprise's* chart plotter

Although primarily navigating using his local knowledge and visual references, the skipper gained additional situational awareness from his electronic chart plotters. The skipper had saved routes on his plotter for some of his regular passages, such as the route east of Tresco (**Figure 16**), but he did not routinely enter pre-planned tracks or waypoints for his circular sightseeing trips.
