Capsize of tug *Domingue* while assisting *CMA CGM Simba* resulting in two fatalities Tulear, Madagascar 20 September 2016

The scope of the MAIB investigation has focused on aspects concerning the involvement of *CMA CGM Simba* (**Figure 1**) with only observations relating to the tug *Domingue* (**Figure 2**) owing to limited access to evidence. The Madagascar maritime authority, Agence Portuaire, Maritime et Fluviale (APMF), has confirmed it is conducting a safety investigation into the causes and circumstances of the accident in accordance with the International Maritime Organization's Casualty Investigation Code, but has not advised when its report will be published.

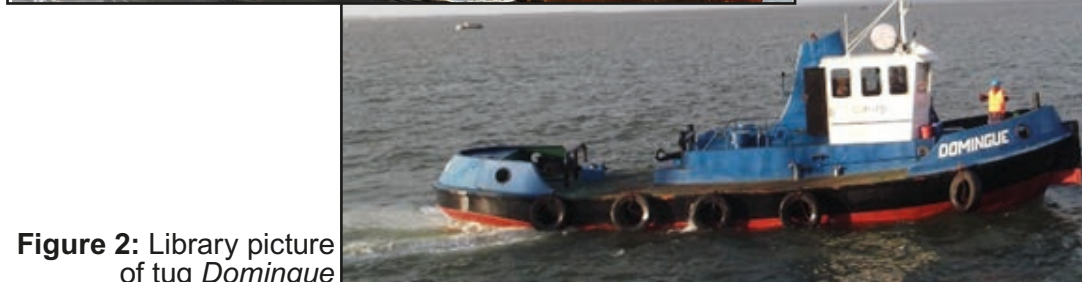
Figure 2: Library picture
of tug *Domingue*

Domingue, a Madagascar registered tug, had a 320hp engine driving a single shaft with a fixed pitch propeller in a nozzle. *Domingue* was normally based at a neighbouring port and used to move barges. It had been moved to Tulear to temporarily replace the port's normal 1,200hp Voith tug, which was away from the port undergoing maintenance.

Single screw tugs with a low freeboard, such as *Domingue*, are at particular risk of girting. To reduce the dangers associated with girting, especially with small tugs, the following is recommended by the Shipowners P&I Club's Tugs and Tows – A Practical Safety and Operational Guide:
