Report on the investigation of the foundering of the  
fishing vessel

***Louisa SY30***

while at anchor off the Isle of Mingulay

on 9 April 2016

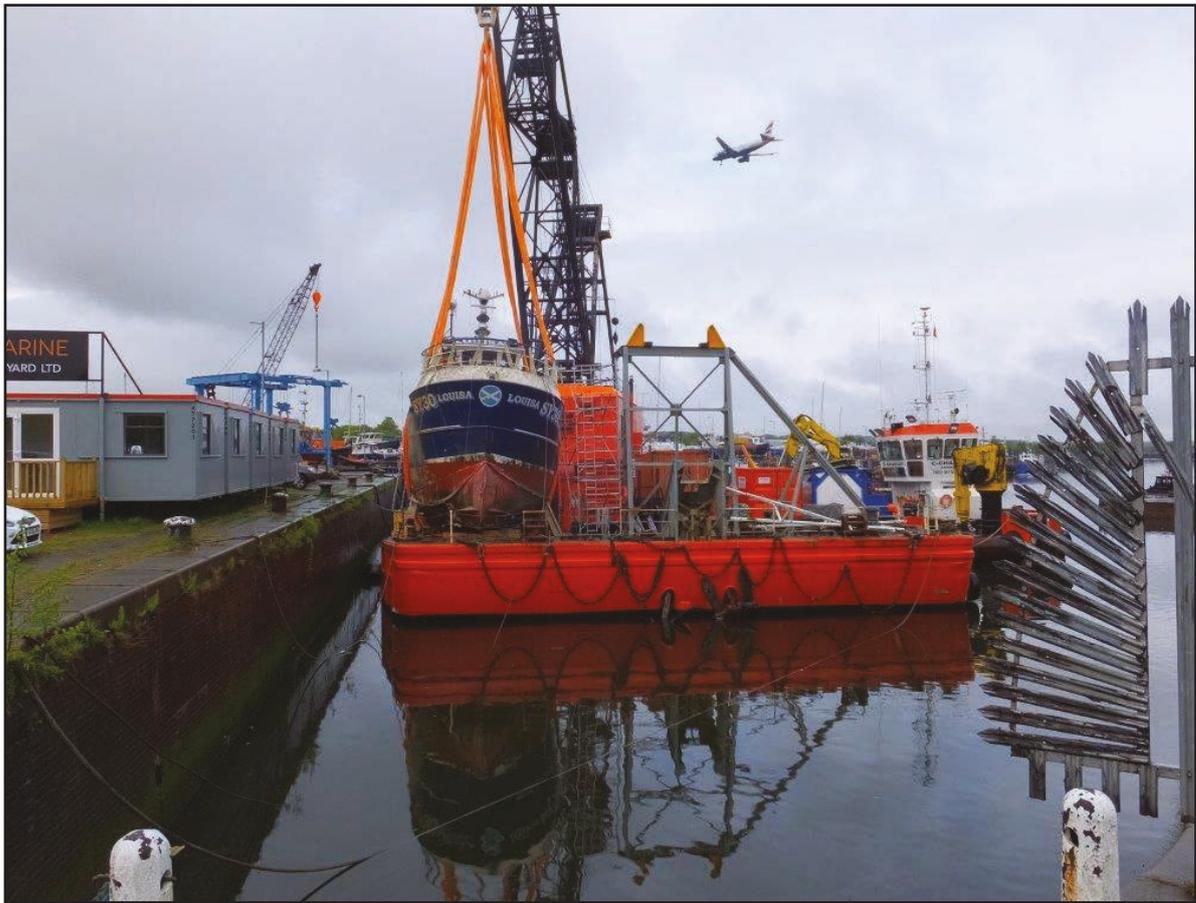
**Figure 4:** *Louisa* - transporting to River Clyde

The wreck was then secured to the barge and transported to a facility on the River Clyde, where it was prepared for inspection (**Figure 4**).

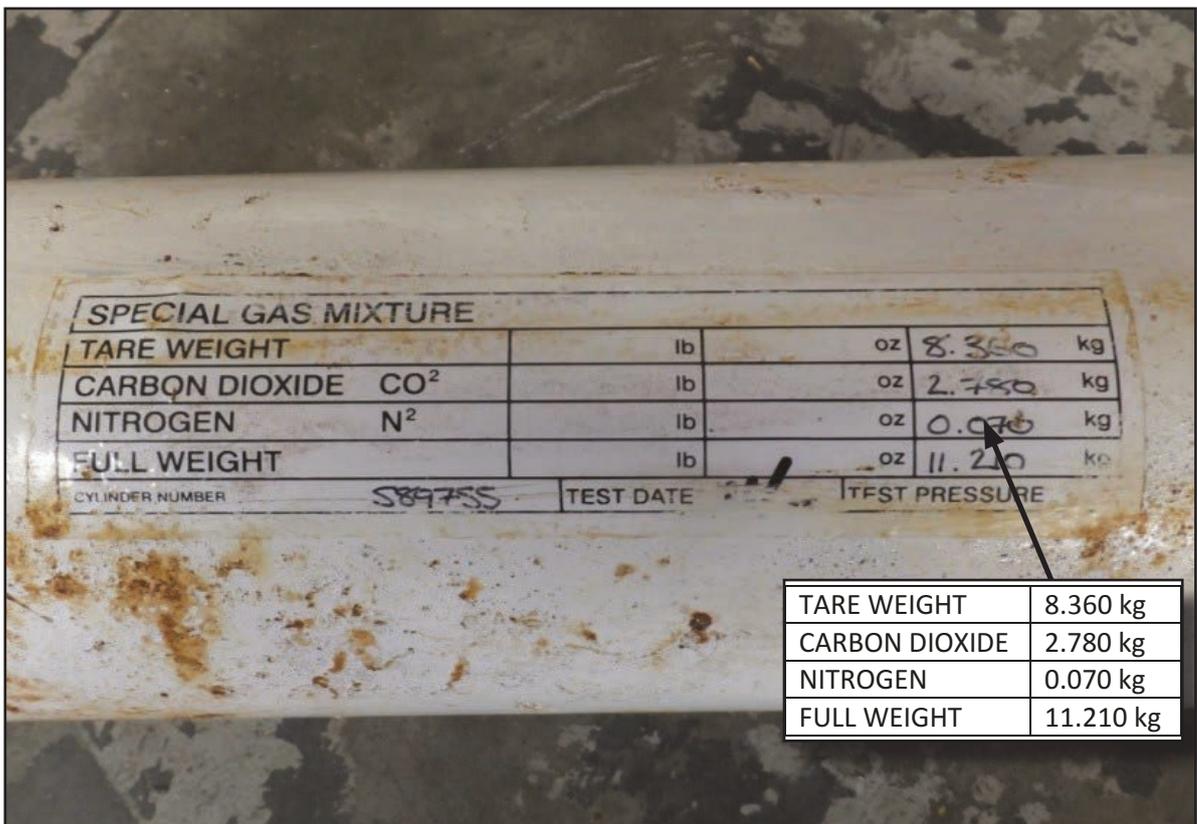
Figure 9: Recalled CO<sub>2</sub> cylinder of a similar type to that of *Louisa's* cylinder

Following this discovery, MAIB inspectors arranged for the remaining eight cylinders from the batch of nine to be recalled and weighed. All were found to have been correctly filled and labelled. One of the recalled cylinders of a similar type to that of *Louisa's* cylinder is shown in **Figure 9**.

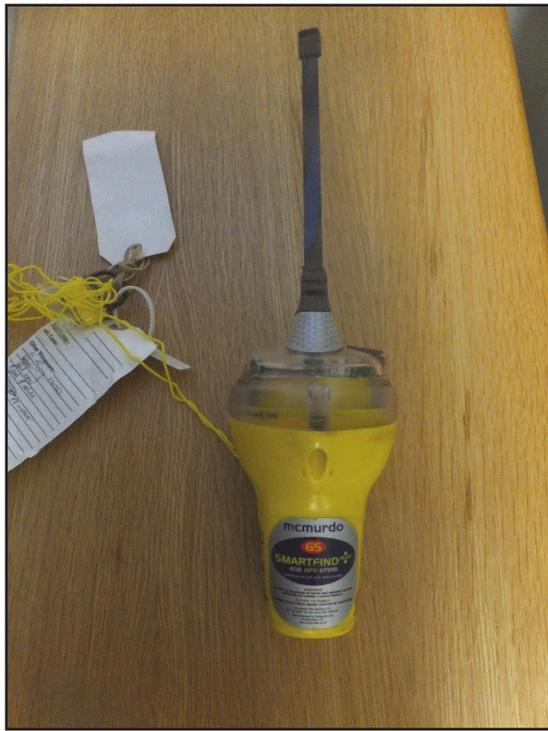
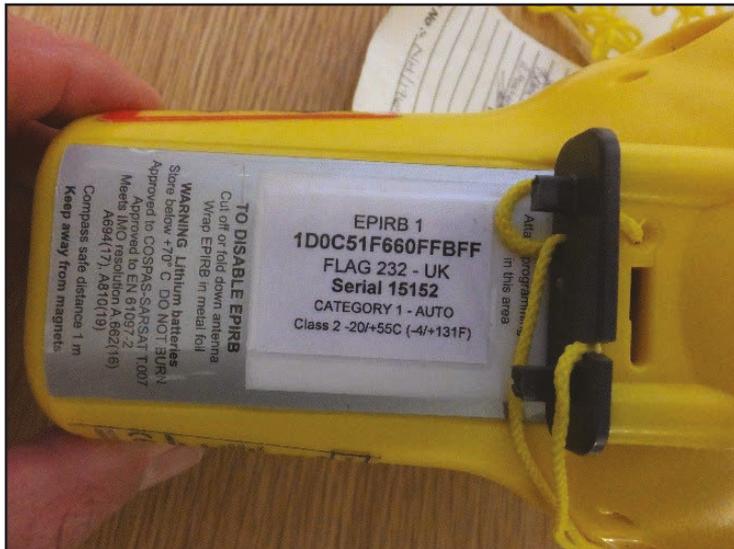
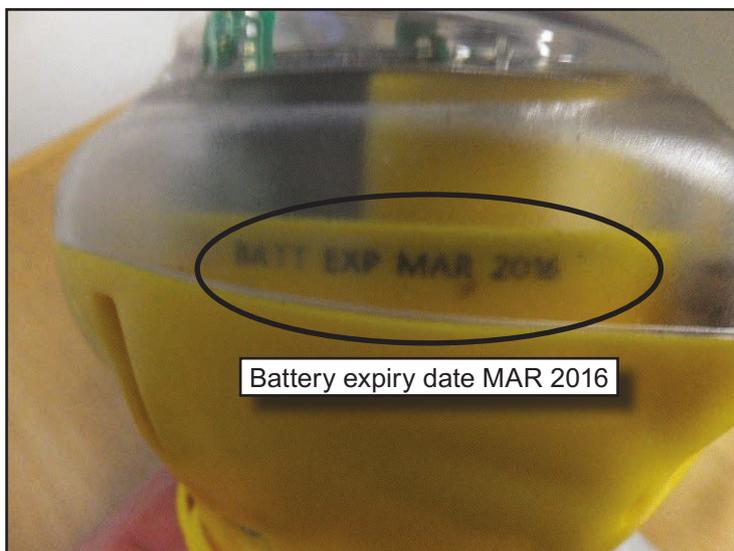
Figure 12: Louisa EPIRB

*Louisa's* EPIRB was manually activated by the crew and functioned correctly despite the battery having an expiry date of March 2016 and, therefore, being overdue for replacement (**Figure 12**).
