Climate Adaptation: Risk Management and Resilience Optimisation for Vulnerable Road Access in Africa

Recommendations for Phase 2

AfCAP Project GEN2014C

December 2016

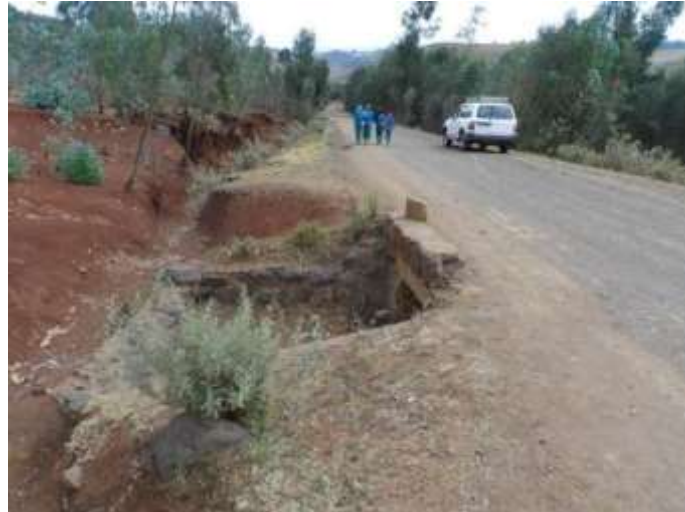
Figure 11: Erosion of shoulders and side drains on steep grade

The local materials available for shoulder construction will be similar to the existing gravel wearing course (crushed weathered basalt or cinder ash), which is highly erodible on steeper grades (Figure 11). The section of road shown in Figure 11, just past the village of Harbuchulule, indicates the erodibility of the local materials and the well-designed cross-drain, the only one on the slope.

It is proposed that this section of road, from just outside the town (38.251692°E, 8.456395°N) to the Wonga River (38.257022°E, 8.450464°N), be constructed as proposed in the current design. However, the shoulders should be constructed using material that complies with Annex G, compacted to 98% MDD heavy compaction and carefully graded to 4% camber, leading into re-shaped side drains. The current road has minimal cross-drainage leading to the extensive erosion of the side drains. It is recommended that cross-draining culverts (single 900 mm pipes) are installed every 40 to 50 m down the hill, with similar culvert inlets to that illustrated in Figure 10.

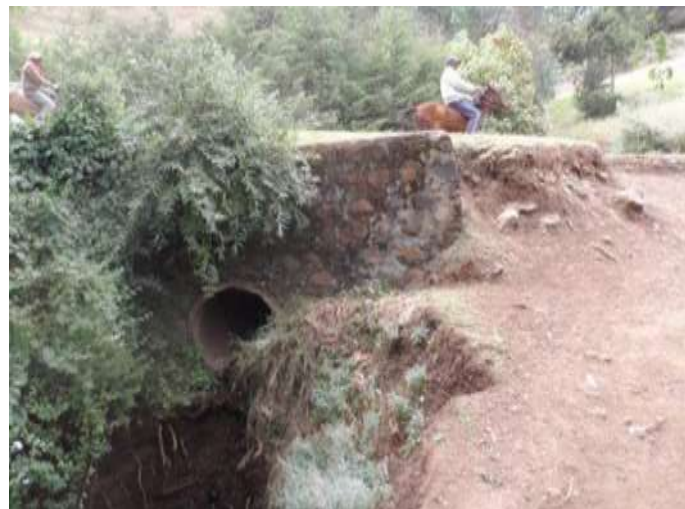
Figure 13: Erosion around, below and adjacent to culvert

The fast flow of water at some drainage structures had resulted in damage to the adjacent fills and head and wing walls. In these cases, (e.g. at about km 46.0) the water flow paths need to be better controlled and the capacity of the structures increased where possible. The flow of water through the culvert, over the road and down an access road adjacent to the culvert at km 46.0 have resulted in significant erosion in the area and damage to the culvert (Figure 13).

In this area, it is proposed that the drains (side and catch-water) on the upslope side of the road be reshaped and graded with some enlargement. The existing pipe needs to be replaced and a second similar one installed next to it (or a cast in situ concrete box culvert of dimension 2 x 2 m may be more economical). The access path/road to the left of the culvert in Figure 13 should be reshaped, grassed and the access moved away from the culvert (it is currently badly eroded and too steep for most forms of transport). Anti-erosion measures need to be installed at the outlet of the culvert – these could be a stilling pod, or a concrete spillway with flow retarding structures.

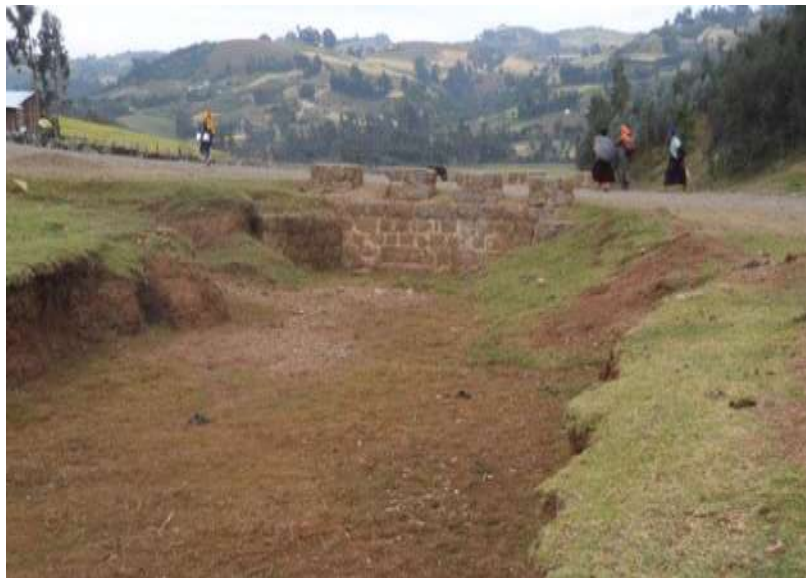
Figure 15: Construction of a river diversion (downstream side view)

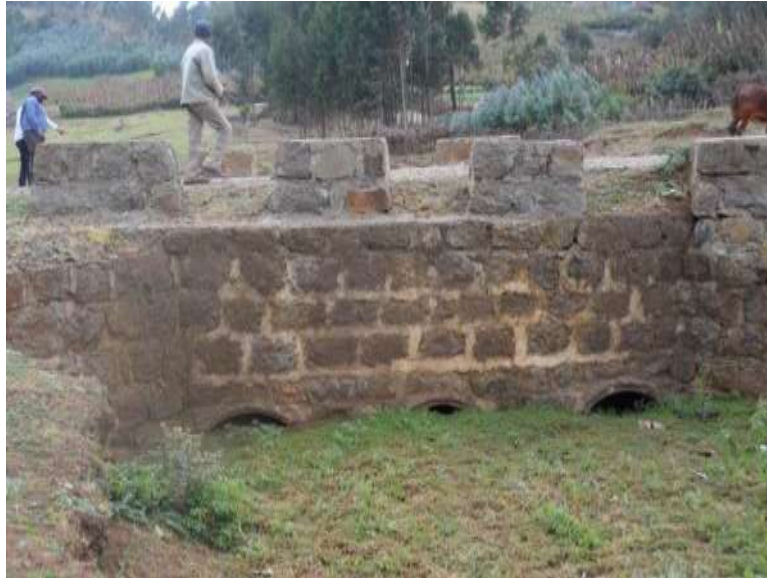
Figure 16: Upstream view of diversion channel

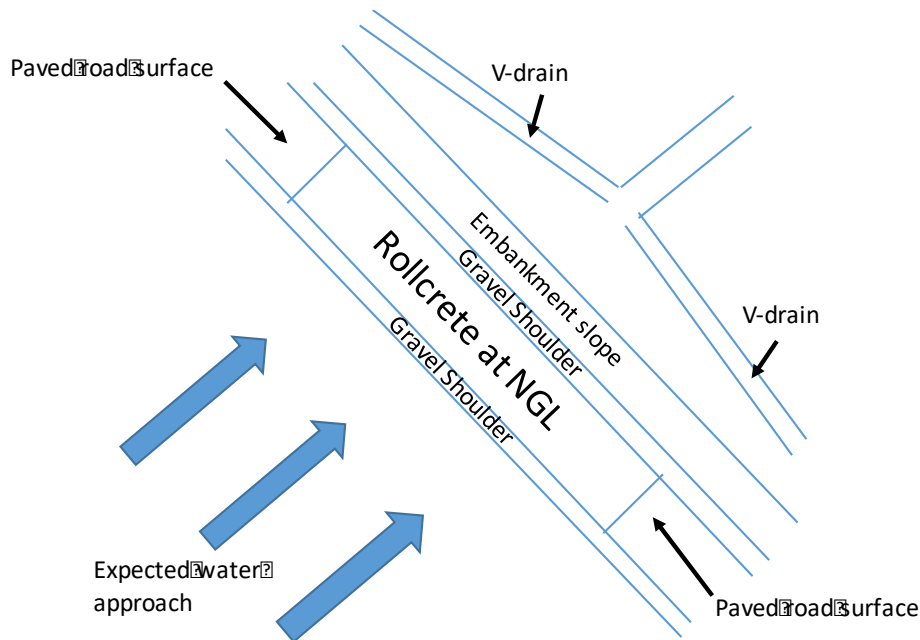
Figure 26: Sketch of proposed road and drain layout

The rollcrete should be the same width as the existing road although the road should be lowered slightly to form a drift at about natural ground level (remove the base course). The existing road shoulders (or preferably material complying with those for a good gravel wearing course as shown in Appendix G) should be ripped and re-compacted (at the lower levels of the drift) to refusal with the heaviest plant available and should lead into a properly shaped V-drain at least 0.6 m deep and on a 1: 2 (V: H) or preferably a 1:3 slope where space allows on the down-stream side of the road. The

drains can be led into the lowest point in the area diverging away from the road towards this point. The purpose of these is to slow down water flows and to act as a stilling pond to reduce erosion as far as possible. It may be necessary to include some mitre drains off the side drain to reduce water flows, but this can only be decided when on site during construction. Unfortunately, it is not possible to indicate these on the GoogleEarth image as the road in this area is beneath the trees. However, a sketch of the layout is shown below.

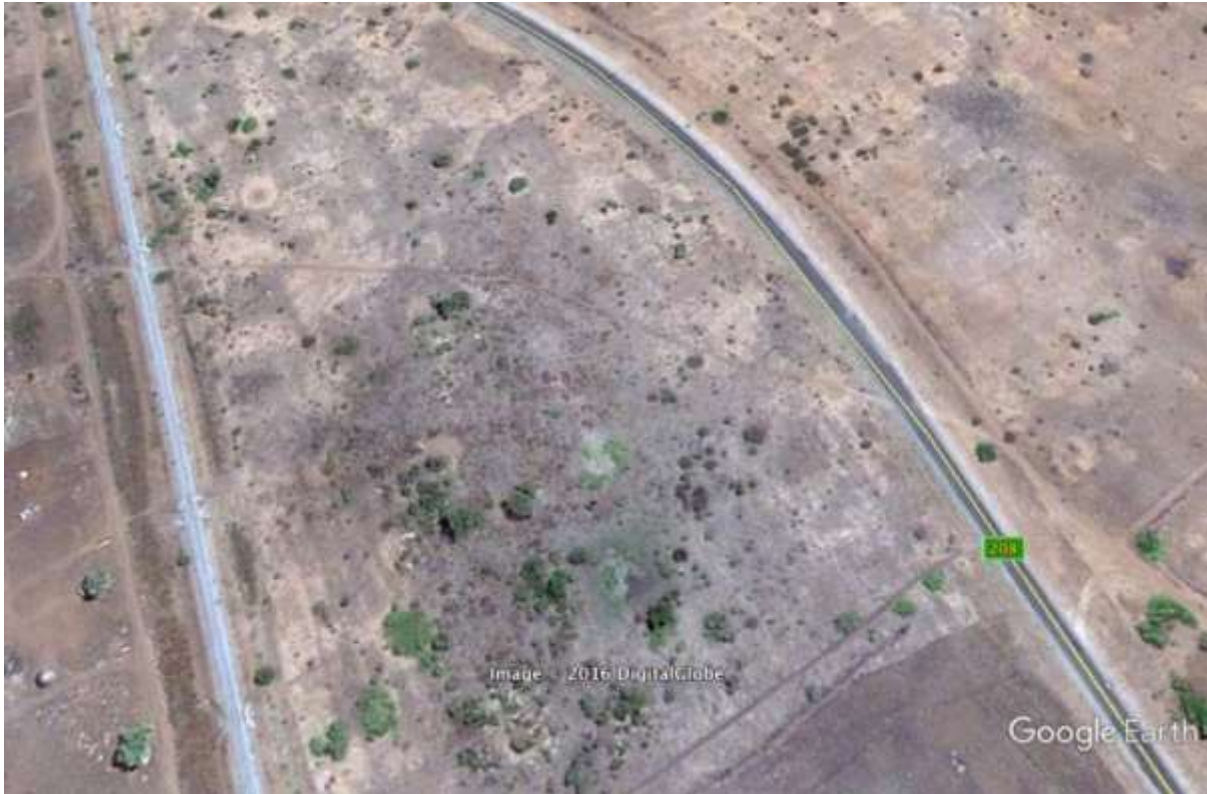
Figure 27: Google Earth image of road and railway line comparing cross-drainage structures

A section of road about 16 km from Chokwe (from coordinates 24.442553°S and 32.857301°E to about 24.43557°S and 32.85446°E) showed several failures in the outer wheel track of the lane going towards Chokwe (apparently the heavier loaded of the two lanes). These areas exhibited significant crocodile cracking, rutting and shear failures. This was attributed to a build-up of water on the upslope side of the formation, which then soaked beneath the formation weakening the subgrade, which failed under heavy loads.

It is significant that the railway line running parallel to and uphill of the road has significantly more (and larger) culverts than the road (Figure 27). The road has only one or two single 600 mm pipe culverts in this section while the railway line has five box culverts each one consisting of 3 x 1m boxes.

The road failures have probably been exacerbated by the poor shape and condition of the shoulders in these areas (lack of maintenance), allowing moisture to accumulate alongside the bituminous surfacing.

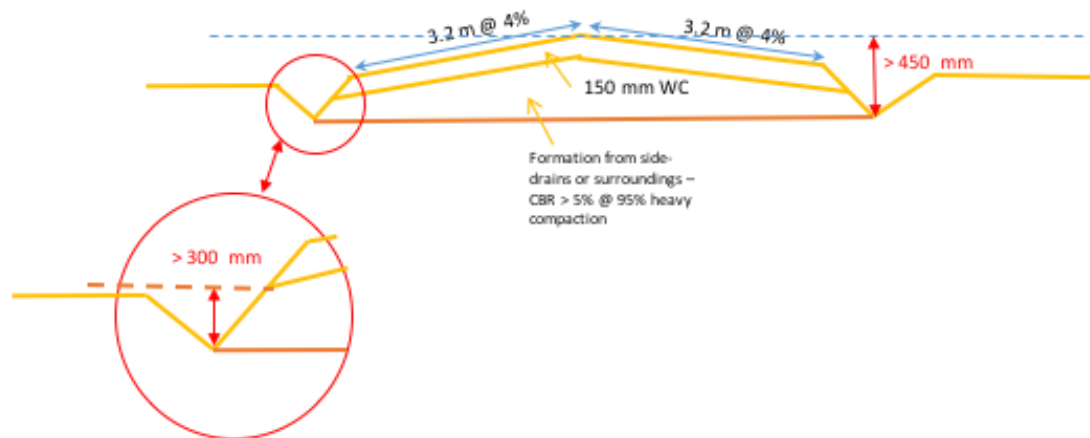
Figure 36: Recommended cross section for unpaved road

In general, the proposed upgrade design follows good engineering practice although the number and heights/capacities of some of the drainage structures may be limited. Observations indicate that the formation should be raised over most of the road length, good side- and mitre-drains should be installed, a good road shape should be implemented and the road should be surfaced with an appropriate gravel (Annex G). A typical cross section should be as illustrated in Figure 36.

At km 7.1 -7.5, the road should be constructed in accordance with the cross section shown in Figure 36. The existing eroded, poorly drained surface with localised laterite outcrops (Figure 37) must be ripped, shaped and compacted (with heavy high amplitude rolling on exposed laterite hardpan areas attempting to induce fractures and avoid perched water tables), raised where necessary to allow adequate and effective side-and mitre-drains to be installed and then surfaced with a selected gravel wearing course. The gravel wearing course must comply fully with the requirements in the Ghana Standard Specifications for Roads Manual, in terms of Grading Coefficient and Shrinkage Product. The laterites seen on site (borrow pit at about km 2.1) and being used locally, although not tested during this investigation, mostly appear visually to comply with these requirements. In addition, construction must be of the highest quality (as indicated in the Standard Specifications or better), particularly the compaction

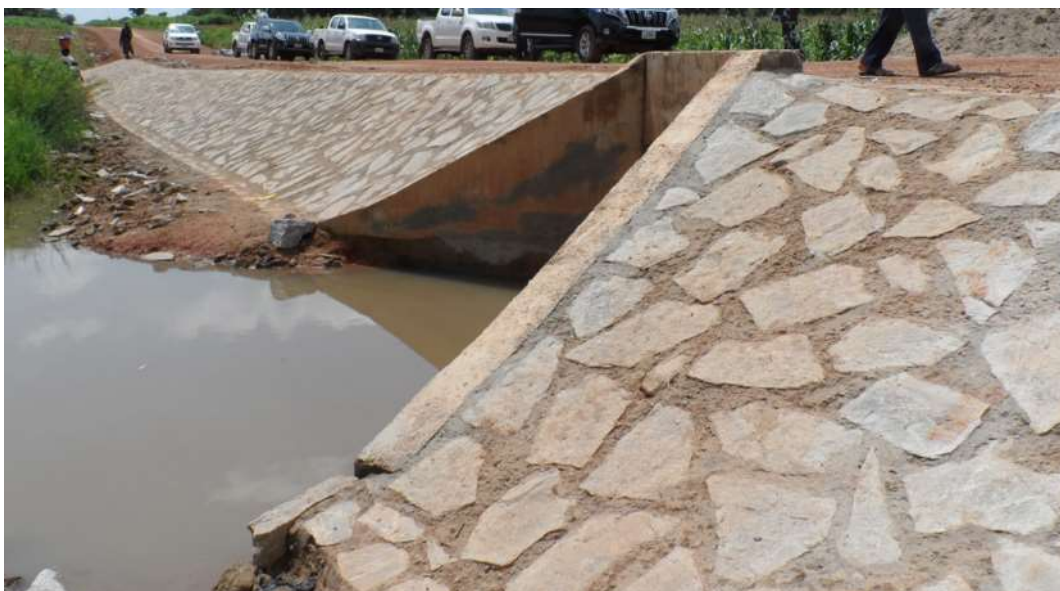
Figure 40: Stone pitching to avoid erosion around culvert wing-walls

Careful attention needs to be paid to the areas around head-walls and behind wing-walls to ensure that water does not flow over or on the road in these areas. This requires good side drains on the approaches to culverts as well as protection using mortared stone pitching or rip-rap.

The mortared stone pitching should be continuous behind the wing-walls (Figure 40) and be blocked in at the top and bottom using concrete strips (Figure 41). If necessary, down-chutes can be constructed in the pitching alongside the wing-walls and at intervals in the stone pitching.

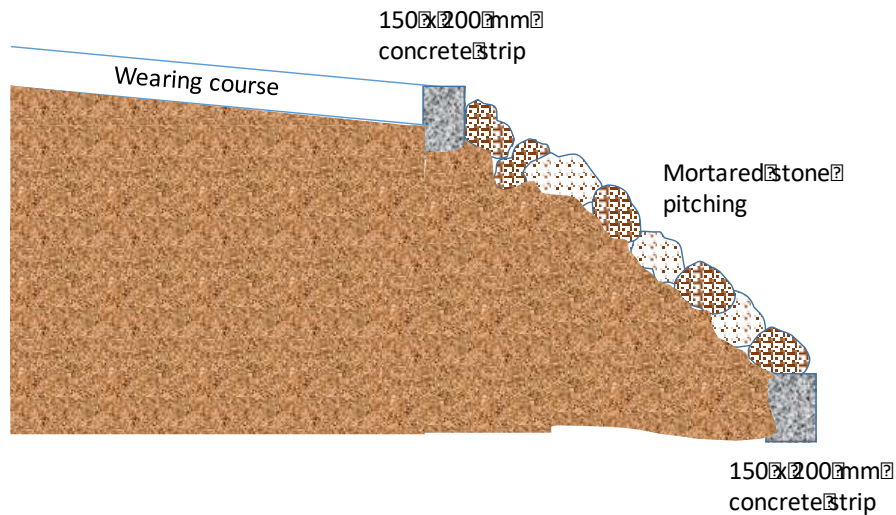
Figure 41: Concrete strips to retain stone pitching

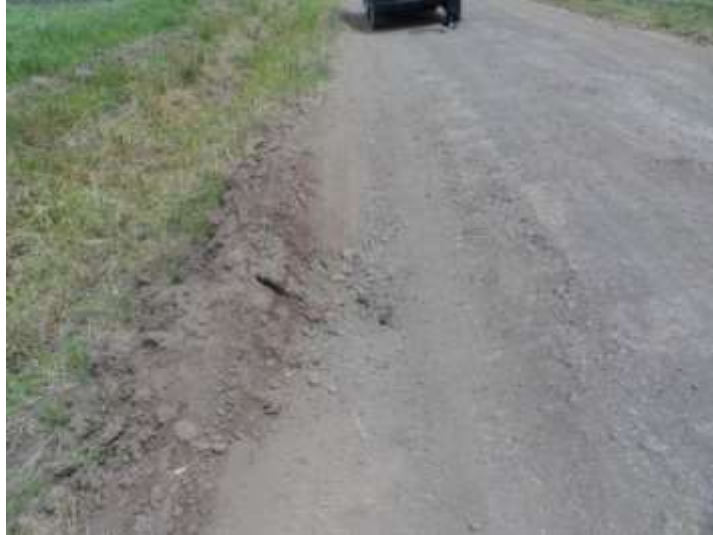
However, where side drainage is impeded and water appears to accumulate, large shear failures are seen (Figure A.6), which are not present over the majority of the road. This is clear evidence that the expansive clay, when unsoaked (or at least at lower moisture contents) is sufficiently strong to support the wearing course without shearing. A CBR strength of 5% has been shown to be adequate for the subgrade of unpaved roads with light traffic. Where the material becomes saturated (the CBR of the clay is about 1%), failure occurs.

Figure A.6: Shear failure of subgrade at point of water accumulation

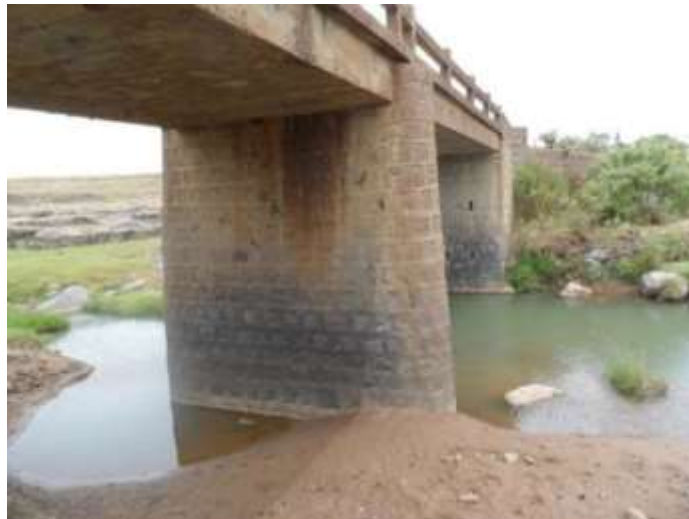
A large and old bridge at km 8.1 (Figure A.7) shows no evidence of deterioration or damage due to flooding. The only damage is the loss of a mortared parapet wall that has probably been knocked into the river by a vehicle.

Figure A.7: Bridge at km 8.1

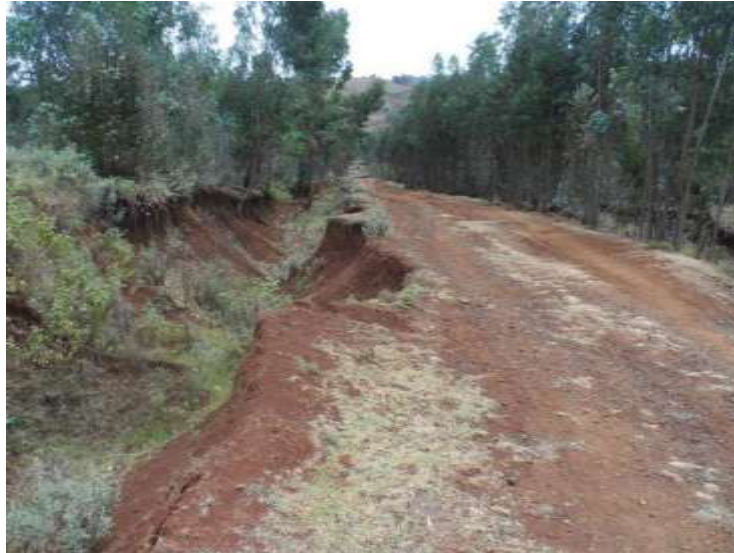
Between km 25.6 and 26, the road descends a steep grade alongside which there is severe erosion (Figure A.8). No cross-drains occur in this section of road and all storm-water on the left side is channelled down the side of the road to the river at the bottom of the hill.

Figure A.8: Erosion alongside the road on a steep grade

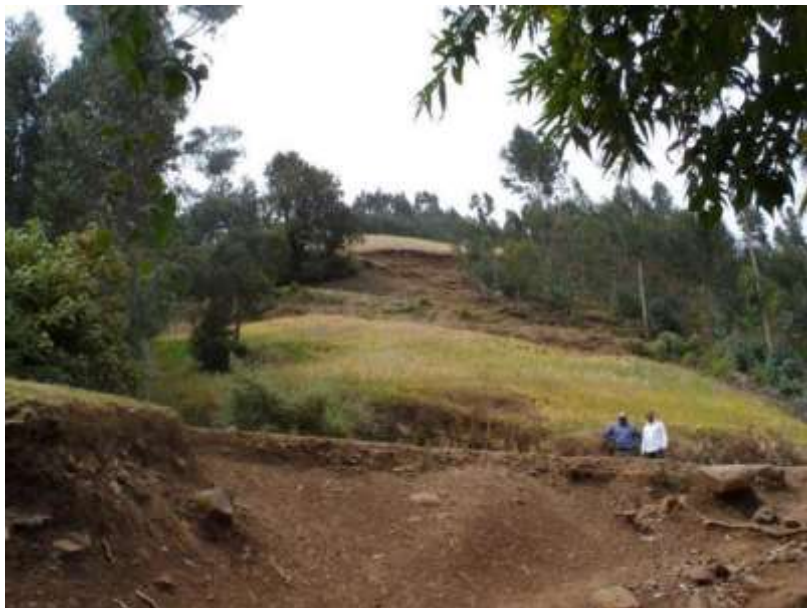
The road then passes into a section of cut slopes with some small fills between km 44.6 and 46.0 km. Some landslides have occurred (Figure A.10) and there are definite signs of other instability issues in the area (Figure A.11). At one of the culverts in a small fill downhill from the landslide in Figure A.12, severe erosion of the side of the fill has occurred, mostly associated with the presence of a track/road leading off to the side. This has undercut a portion of the road and resulted in damage to the adjacent culvert, where the head and wing-walls have moved and deprived the pipe of support, which has resulted in separation of the pipe from the headwall (Figure A.12).

Figure A.11: Landslide scar on hill with erosion of embankment in foreground

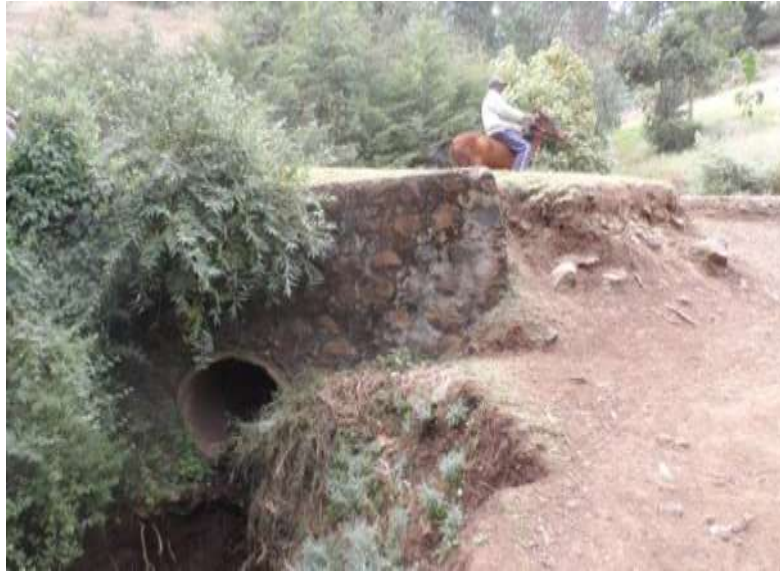
Figure A.12: Damage to head and wing-walls and pipe in culvert caused by adjacent erosion of the embankment

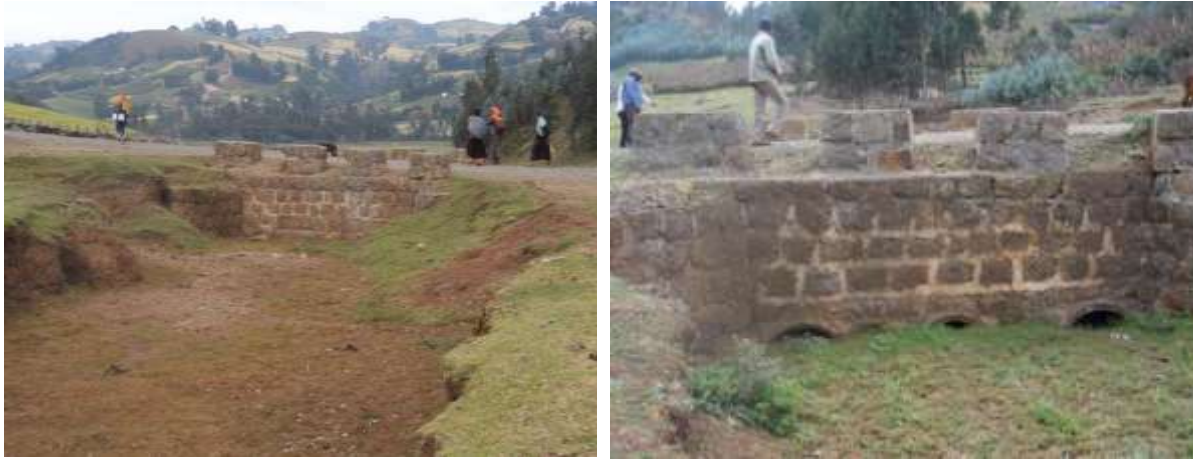
Figure A.14: Diversion channel and culverts

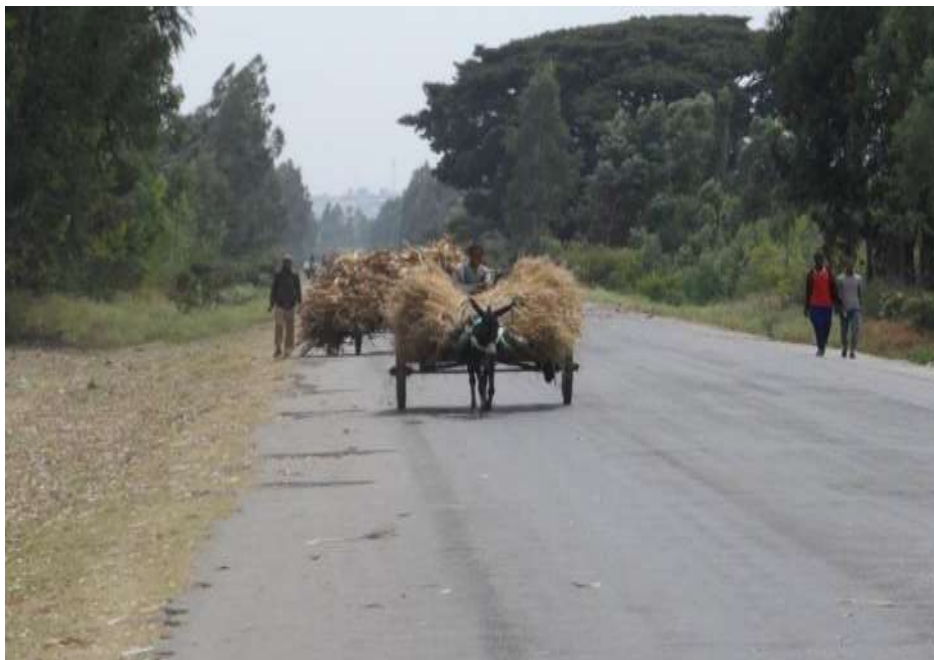
This is a paved road about 51.5 km long which was constructed 7 years ago. As it was described as being susceptible to storm damage, the road was inspected over its full length and in general was performing well, apart from some isolated problems as discussed below. The road was constructed with a cinder subbase and a crushed stone base and surfaced with a double seal (19 and 6.7 mm) on the carriageway and a single seal on the shoulder. The road was generally raised above natural ground level and had effective side drains. Of particular interest was the high number of “donkey carts” with steel wheels (the road described above in section A.2.1 carried almost totally pneumatic-tyred carts), which were heavily loaded with local crops (Figure A.17).

Figure A.17: Heavily loaded donkey cart with steel wheels

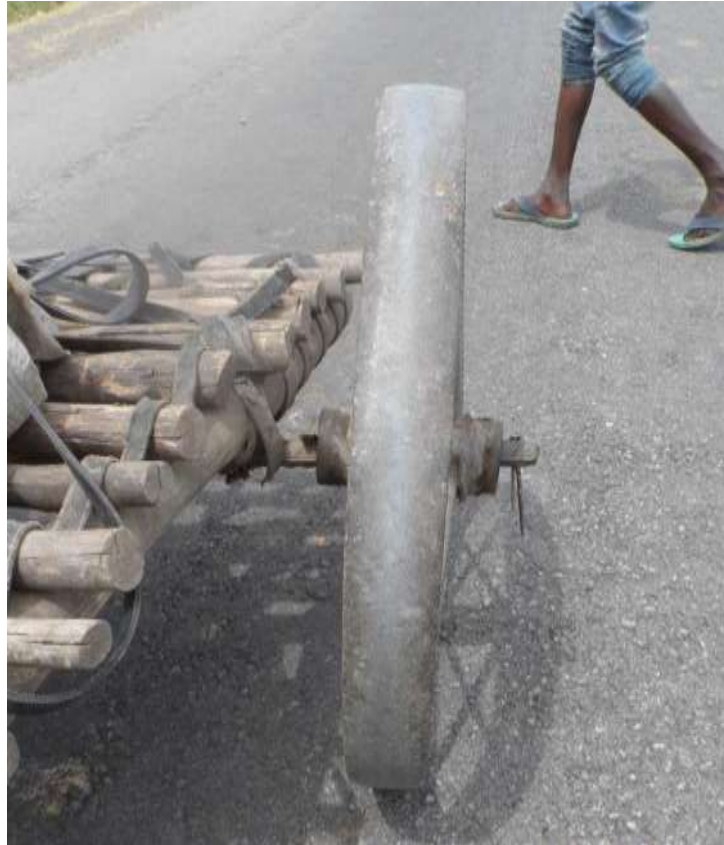
After many observations, the cause of the edge-break was attributed to a combination of vehicle spilling off the road and loosening the single sealed shoulder and then the high stresses of the steel wheels of the donkey-carts (steel marks were visible on many sections of the road) causing breakage of the edges of the edge-break. It was noted that the steel wheels are, in fact, not flat but curved, and only the central 50 per cent or so of the wheel width is in contact with the road, increasing the point loads on the surfacing and edges of failures (Figure A.19).

Figure A.19: Close-up of steel wheel on a donkey cart showing curved profile

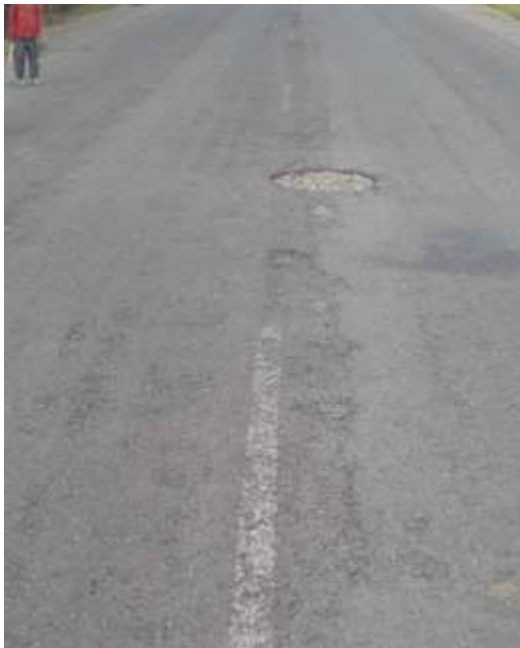
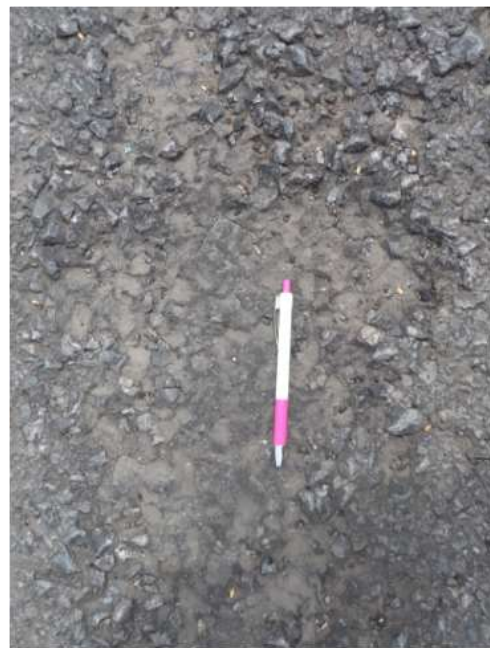
The areas on the road with low binder and stone application rates were prone to the formation of potholes (Figure A.21) and closer inspection of these areas indicated the top of the primed base, with some initial cracking, ultimately leading to the formation of the pothole, under traffic and particularly in wet weather.

Figure A.21: Centre-line pothole and close up of new pothole forming on right (exposed primed base)

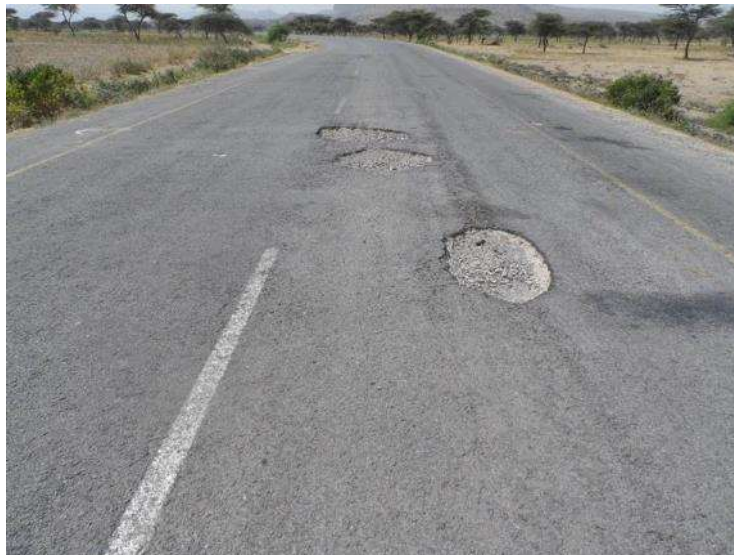
At the bottom of the escarpment the road crosses a flat floodplain on a high embankment. Despite this there are potholes and localised edge-break along the embankment. Many of the large and deep potholes (Figure A.23) could have been avoided by timely maintenance.

Figure A.23: Potholes on embankment over flood-plain

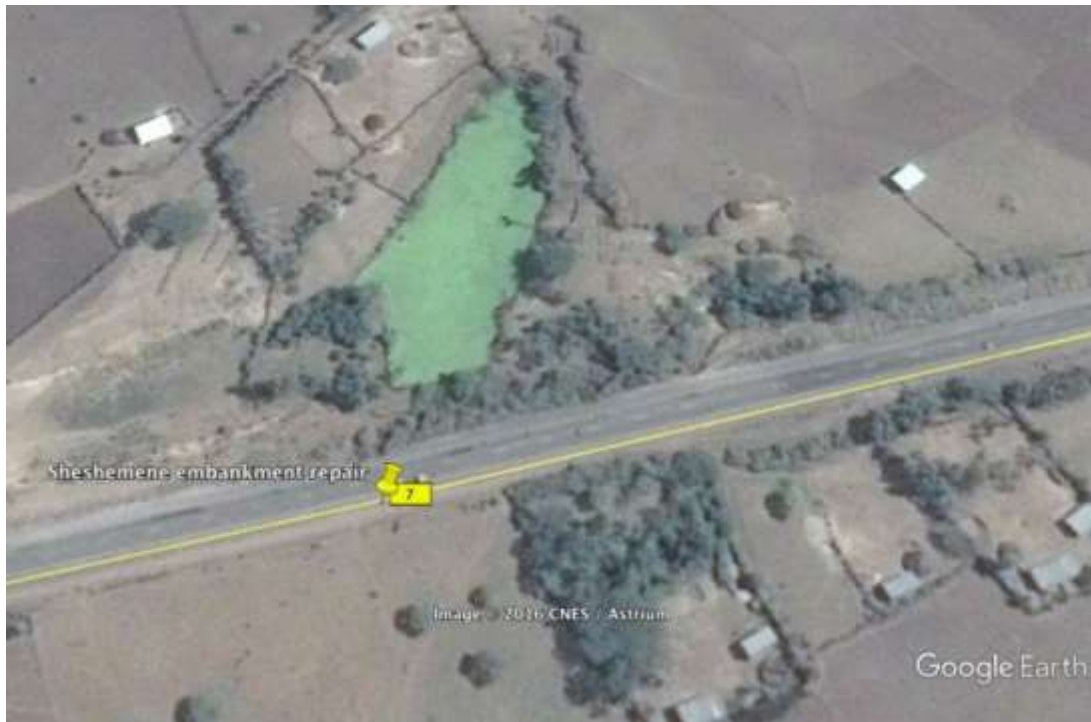
(Figure A.24) shows the presence of a water body, which had been there since at least January 2014 (Figure A.25) but is not clear in poor-quality earlier images (Figure A.26) although there appears to be some water accumulation in the same area.

Figure A.24: Google Earth image of problem area near Sheshemene (23/2/2016)

The road lies in an area of late Tertiary volcanism with the predominant materials being volcanic ash and pumiceous material (tephra). These materials by their mode of formation are highly variable and may range from loose unconsolidated or weakly consolidated materials to highly porous hard rocks, often occurring in layers and channels. Although no detailed investigation was carried out during the visit, it is suspected that the subsidence in the area was caused by storm-water breaking into a channel of weak or unconsolidated tephra, which was easily washed out and led to the formation of deep channels. Once water began flowing and the volume (and velocity) increased, erosion would be fast and severe in the weak ash material.

The large “valley” caused by the erosion has been repaired using about 10 m of cinder aggregate as a rock fill (compacted using vibratory rollers) overlaid with up to 5 m of local soil with a CBR greater than 5%. This has been allowed to consolidate with apparently 60 to 80 cm of settlement occurring (supporting the hypothesis that the material is poorly consolidated ash) and will have the conventional pavement structure placed on top. The stream that caused the initial problem has been diverted into a larger river at the floor of the rift escarpment.

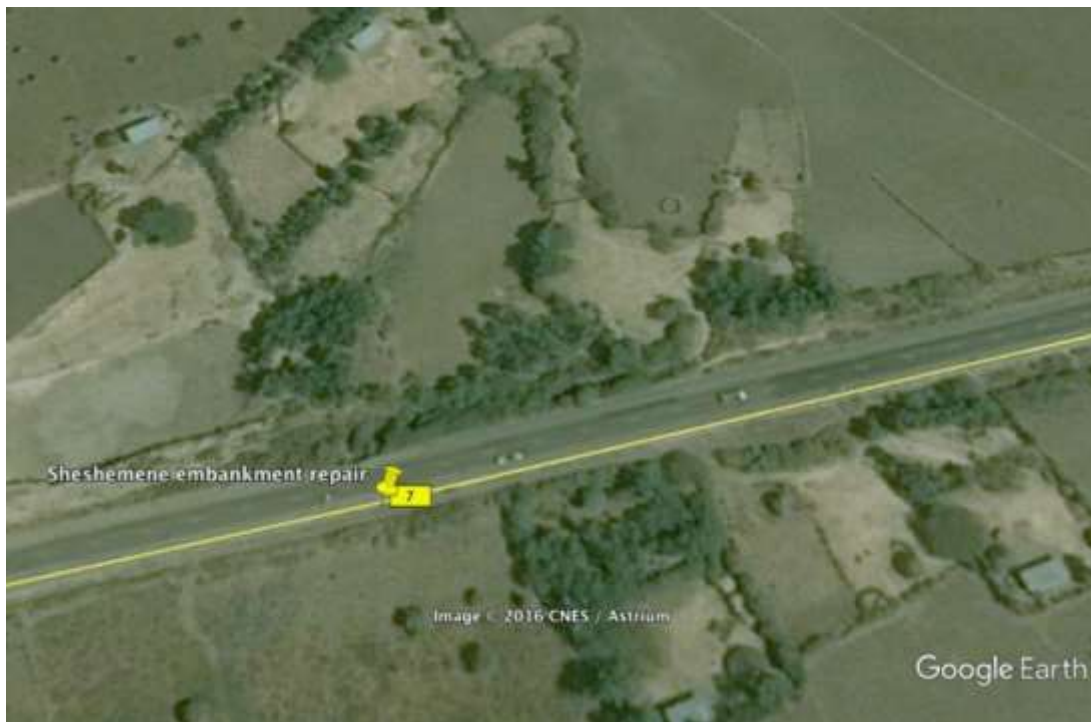
Figure A.25: Google Earth image of problem area near Sheshemene (11/1/2014)

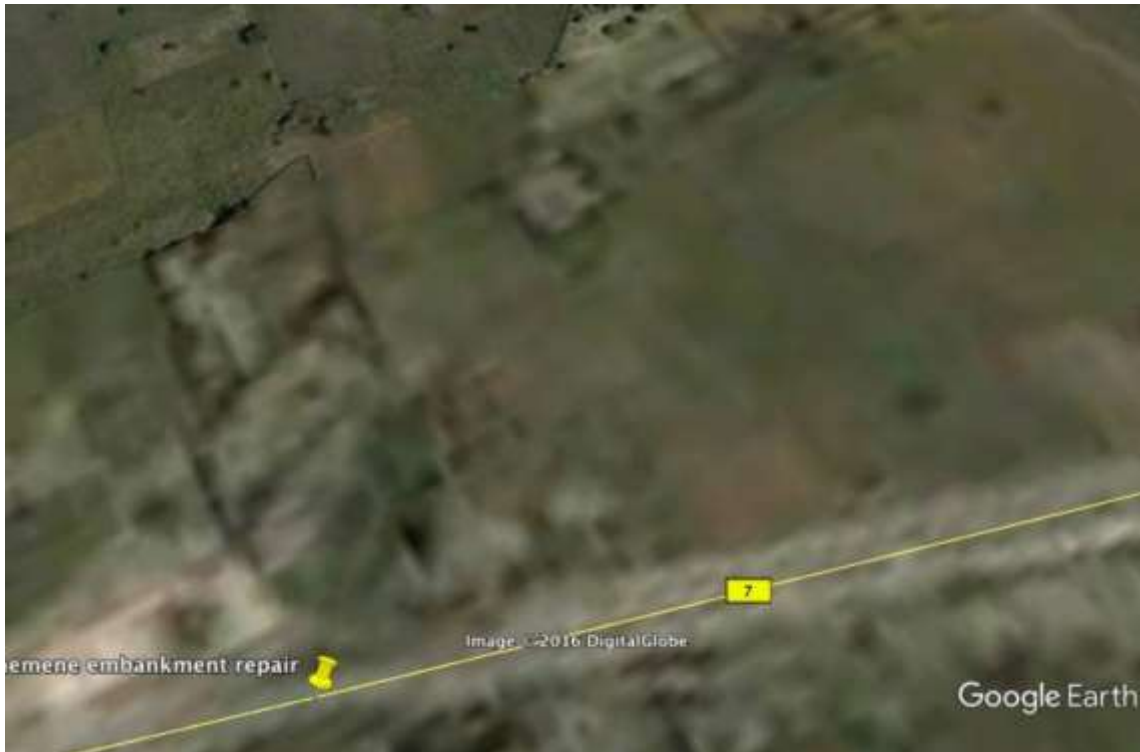
Figure A.26: Google Earth image of problem area near Sheshemene (31/10/2004)

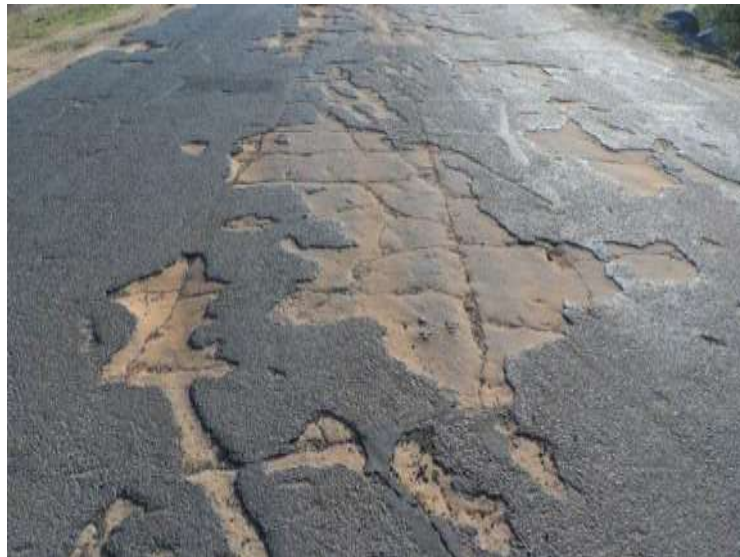
The flooding of 2012 caused significant damage to the road and drainage structures along the road. In some areas, only the surfacing had been badly affected (Figure B.2). In others, the subbase had been eroded during overtopping and the entire road had collapsed (Figure B.3) and various pipe culverts had been washed completely away (Figure B.4). The rainfall at the time of the 2012 flooding was in excess of 300 mm derived from two tropical storms (Dando and Funso) just a week apart.

Figure B.2: loss of surfacing from cement stabilised sand base

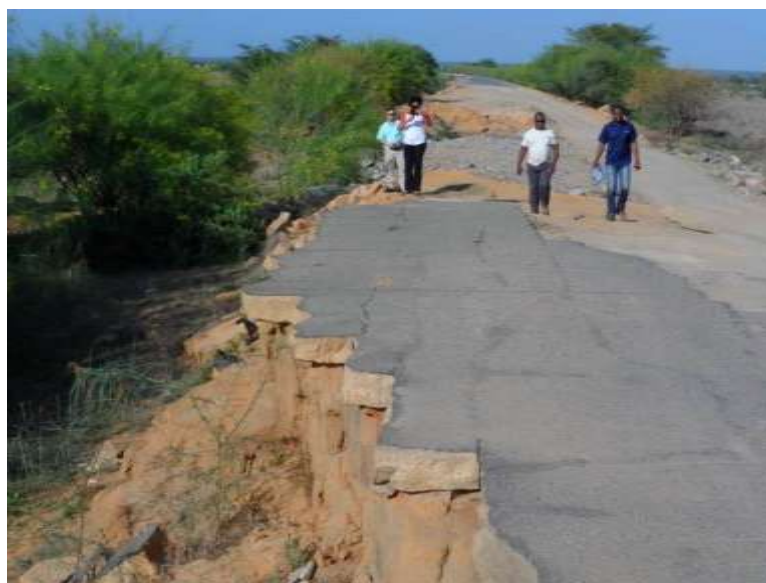
Figure B.3: Undercutting and collapse of pavement due to erosion of embankment during overtopping

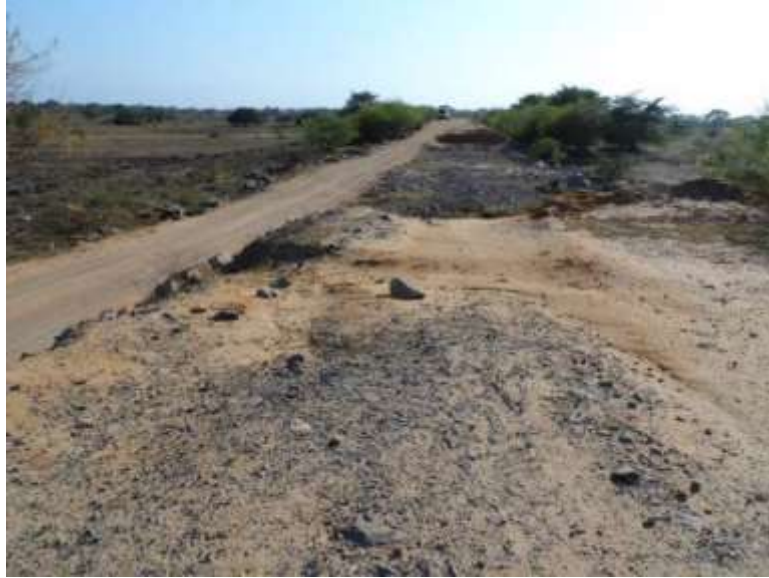
Figure B.4: Site of embankment and culvert removed by flooding with deviation on the left

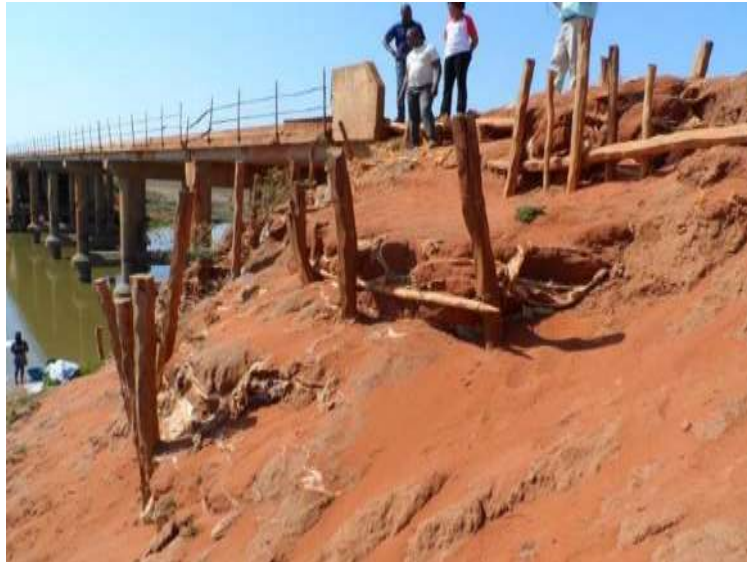
although there was significant settlement at the approaches to many of them, indicating relatively thick alluvial material beneath the approach fills. The bridges seemed to be mainly founded on piles. A number of their approach fills, however, had been badly eroded while being overtopped during the flooding. The Mobeira Bridge in particular had undergone some emergency repairs to the approach fill, using sandbags and wooden stakes.

Figure B.10: Emergency repairs to approach fill on the Mobeira Bridge using sandbags and wooden stakes

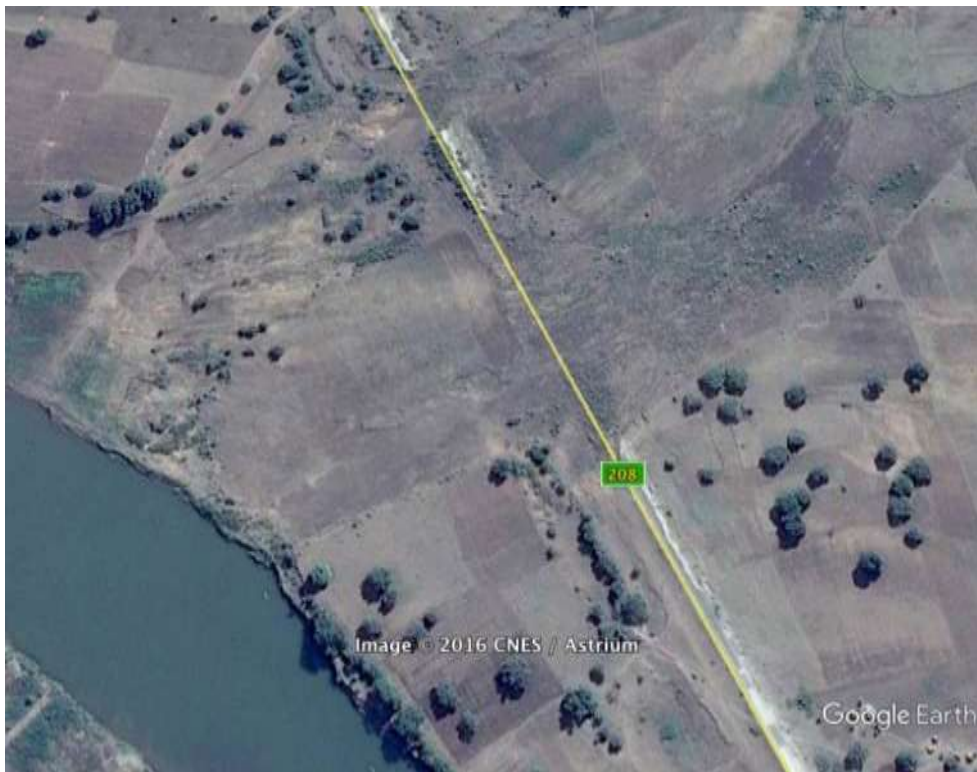
Figure B.13: Google Earth image of the damaged area shown in the previous figures – note complete loss of embankment along part of the road alignment (photographed in 2013)

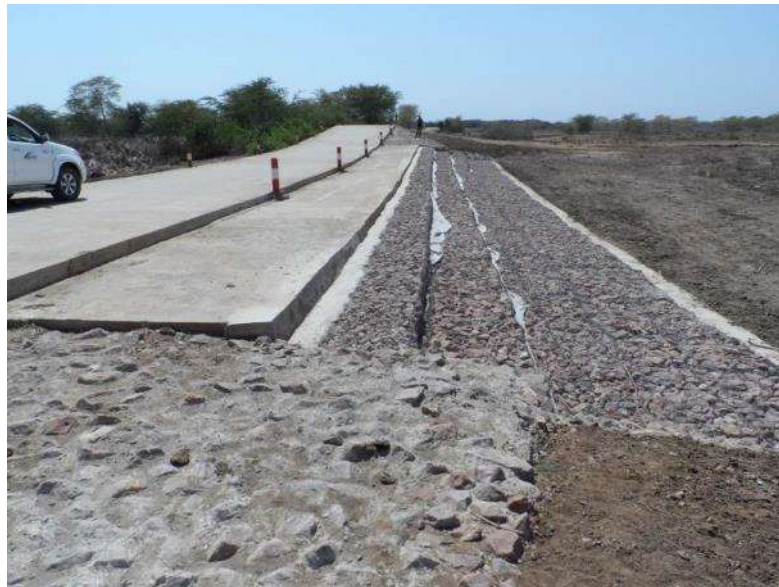
The road was driven over initially from south to north and various points were inspected. These included mostly the emergency concrete drifts, which took various forms. They were all raised above the surrounding natural ground level and most had erosion protection measures on their eastern sides. These varied from “stepped gabion baskets” (Figure B.14) to concrete walls enclosing gabion lined stilling ponds (Figure B.15). In general, they appear to be effective, although relatively costly to construct, especially in view of the lack of aggregate in the area to fill the gabion baskets (aggregate was apparently hauled from Maputo). A suggestion to reduce the costs would be to construct the drifts at natural ground level. This would also reduce likely erosion - it would mean that the road would be closed for a slightly longer duration while the flood water subsides.

Figure B.14: Concrete drift with stepped gabion basket

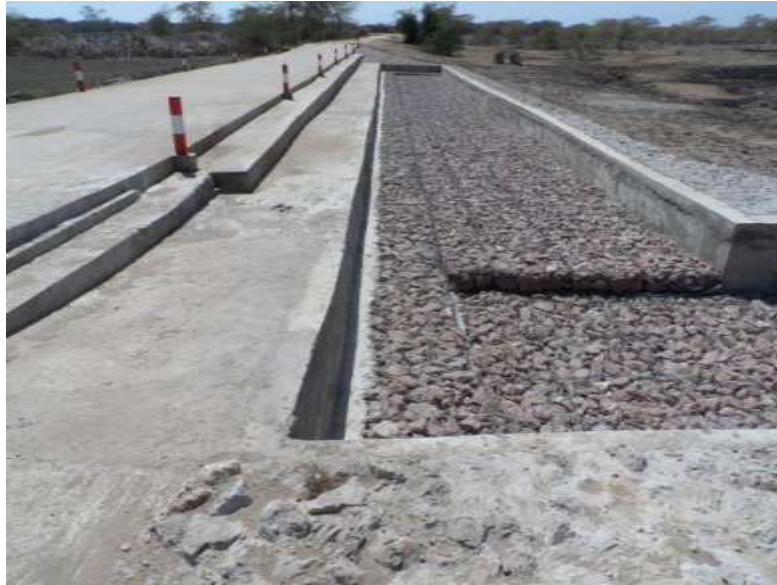
Figure B.15: Concrete drift with gabion lined stilling pond to minimise water velocities and erosion

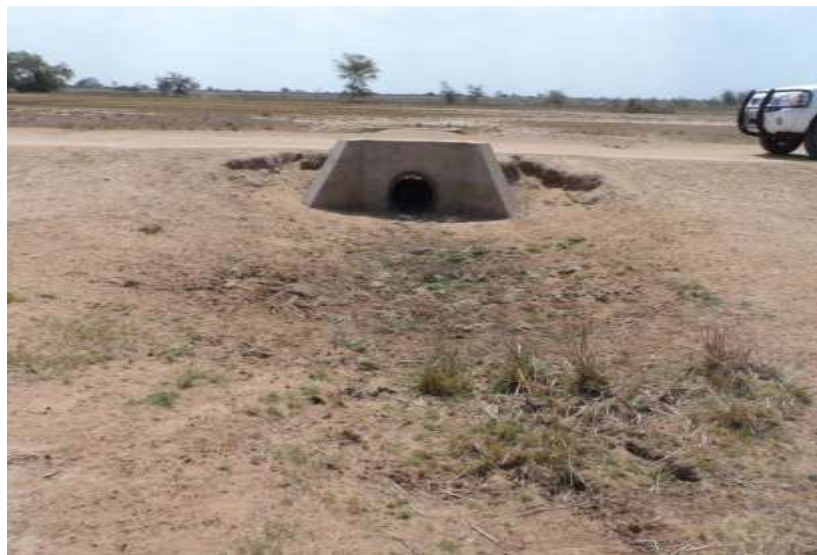
At the northern end of the road, numerous culverts have been constructed as part of the upgrading project. These are spaced at various intervals, but with the flat grades prevailing in the area, many of them appear (visually, although no water was present during the visit) to be unable to actually move the water away from the road effectively (Figure B.16).

Figure B.16: Newly constructed culvert in flat terrain

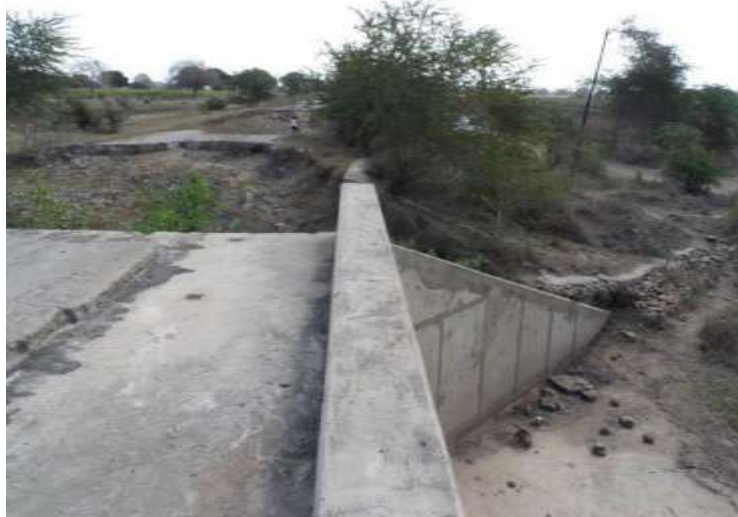
Although not on the list of projects for consideration, a stop was made at one area along this road where the approach fills of three bridges had been washed away during the 2013 floods. In all cases, overtopping of the wing-walls had led to the erosion of the approach fills behind the abutments and damage to the bridges (Figure B.17).

Figure B.17: Loss of approach fills on three consecutive bridges

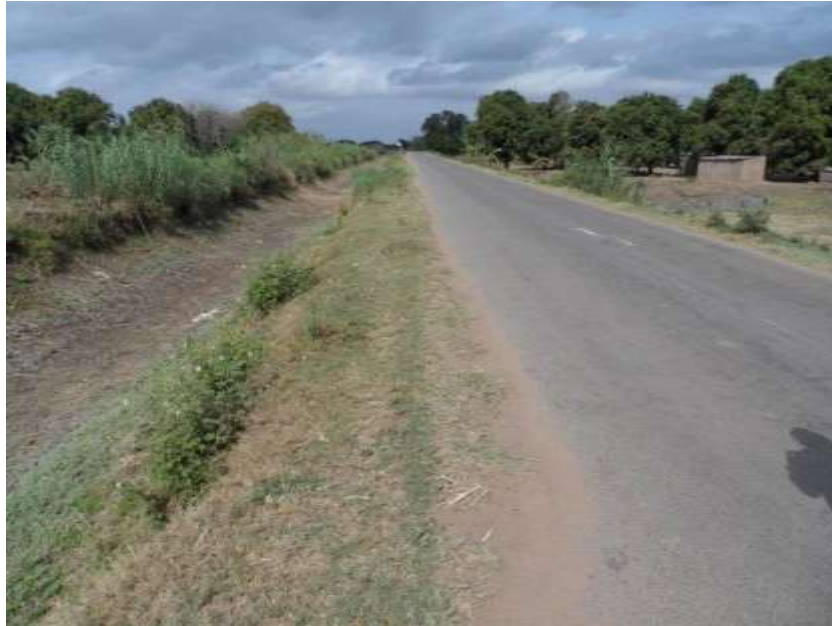
Figure B.18: Good section of Road R859 showing embankment and irrigation canal (empty)

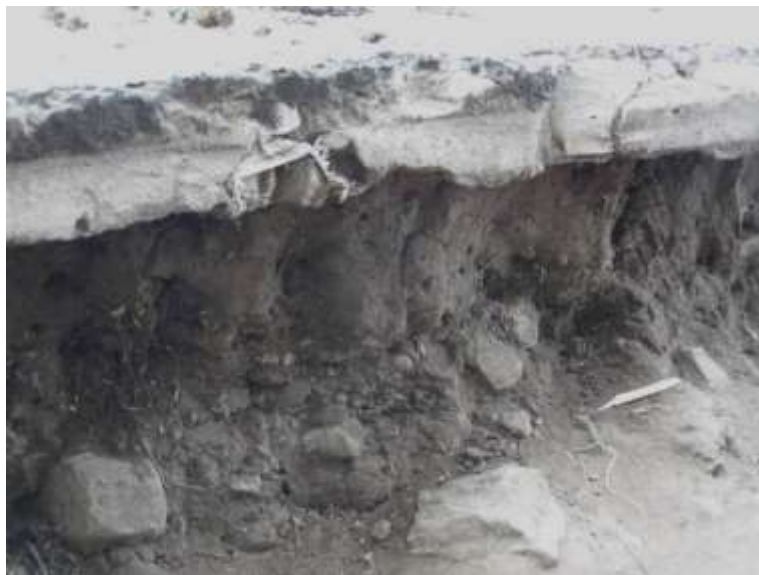
along much of the western portion of the road (Figure B.18). The total thickness of the Geocell was 75-80 mm, resulting in a thin, essentially concrete road (Figure B.19). Although there were localised failures and potholes along the road, the biggest problem was the loss of adhesion between the seal and the “concrete” base (Figure B.20). There was no evidence of a prime having been applied.

Figure B.19: Area of road showing Geocells and in situ material exposed by erosion of embankment next to road

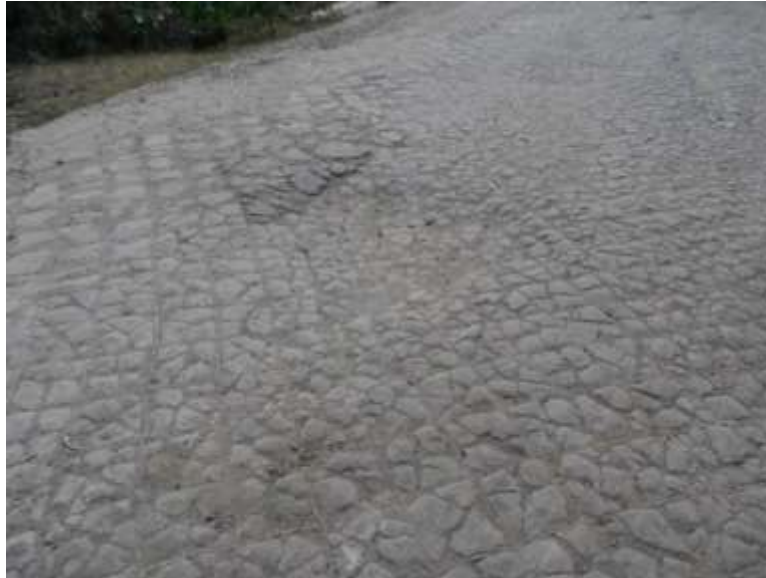
Figure B.20: Area of Geocells with total loss of seal and development of pothole in central part of photograph

This road is currently on the rehabilitation programme with a design and build contract out to tender. The proposed design should be an interesting one as the road, although structurally sound over most of its length, is very thin (shallow structure) and will be difficult to rehabilitate with the Geocells in place. It would probably be best to break them up using an impact roller for use as a new subbase, and then place a cemented sand base over the top.
