Climate Adaptation: Risk Management and Resilience Optimisation for Vulnerable Road Access in Africa

Recommendations for Phase 2

AfCAP Project GEN2014C

December 2016

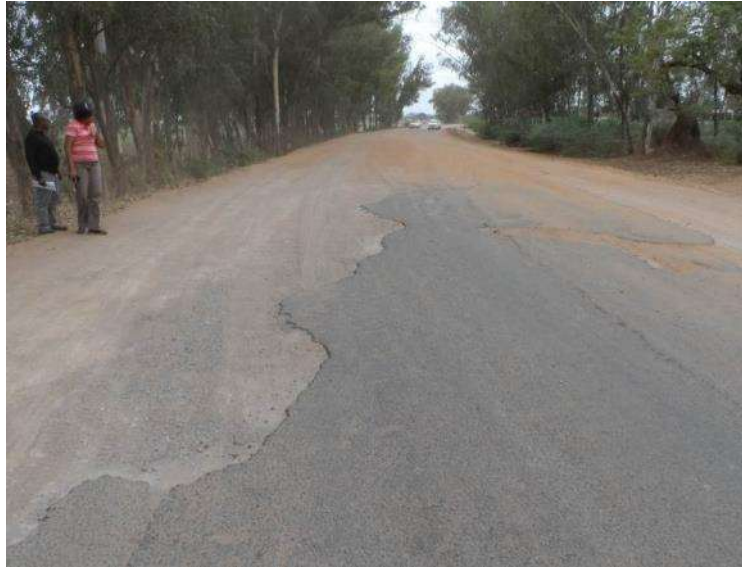
As the road leaves Chokwe (km 3.8 to 4.1, taking the traffic light in town as 0), it shows severe loss of surfacing and damage due to flooding (Figure B.21). This apparently occurred in 2012, when water came from south-west of the road, over the road towards the Limpopo River to the north-east. The damage was repaired with local gravel and the seal has not been replaced. The direction of flooding indicates that it was due to local precipitation and not rising of the level of the Limpopo River. No cross-drainage was evident near this section of road.

Figure B.21: Damage to and loss of surfacing caused by 2012 flooding

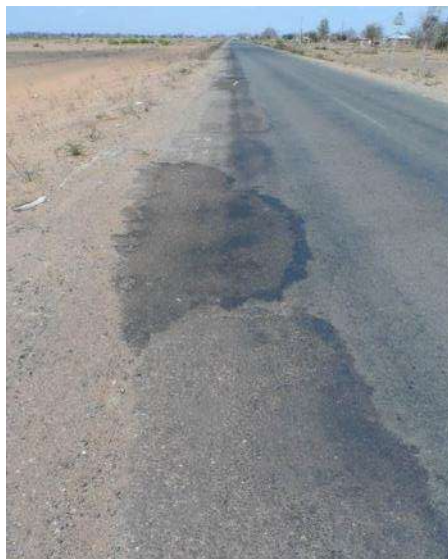
At about km 8.0, there are significant outer wheel path failures in the right hand side lane (Figure B.22), typically indicative of weakening of the structural or support layers due to moisture ingress. It was clear that the shoulders were not well-shaped to move water away from the edge of the carriageway.

Figure B.22: Patches of outer wheel path failures in east-bound lane

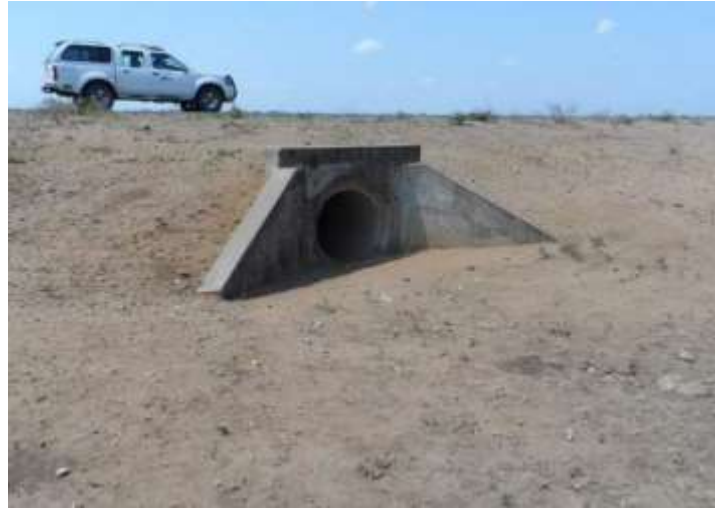
Although there were culverts along the road that were in good condition generally (Figure B.23), they were fairly widely spaced in this area, which appeared to be flatter and more arid. The culverts were nearly all 600 mm diameter pipes, which was surprising as the railway running parallel to the road had culverts in the same locations but these generally consisted of 3 x 1 m square box culverts next to each other.

Figure B.23: Single 600 mm pipe culvert in flat terrain

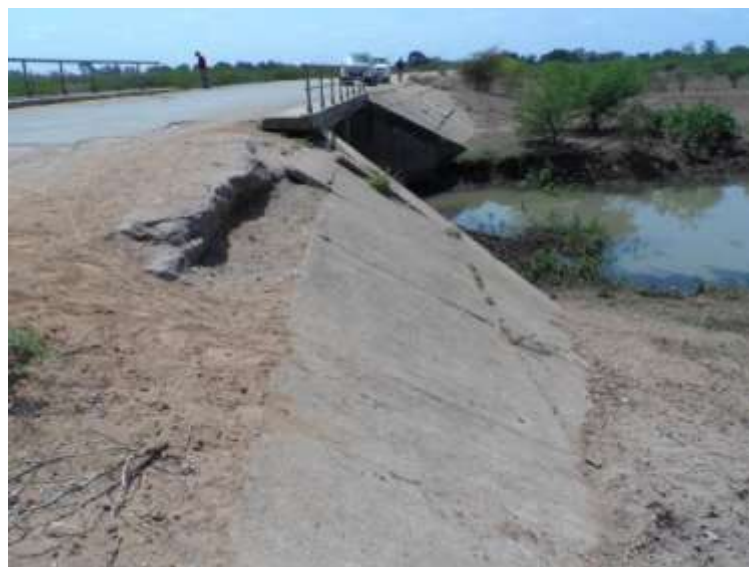
A number of small bridges and one larger one were also inspected. They all showed signs of flood-water damage to varying degrees. This was mostly loss of surfacing near the bridge approaches, damage to erosion protection measures and localised loss of embankment material (Figure B.24).

Figure B.24: Damage to small bridge approach fill, erosion protection and surfacing

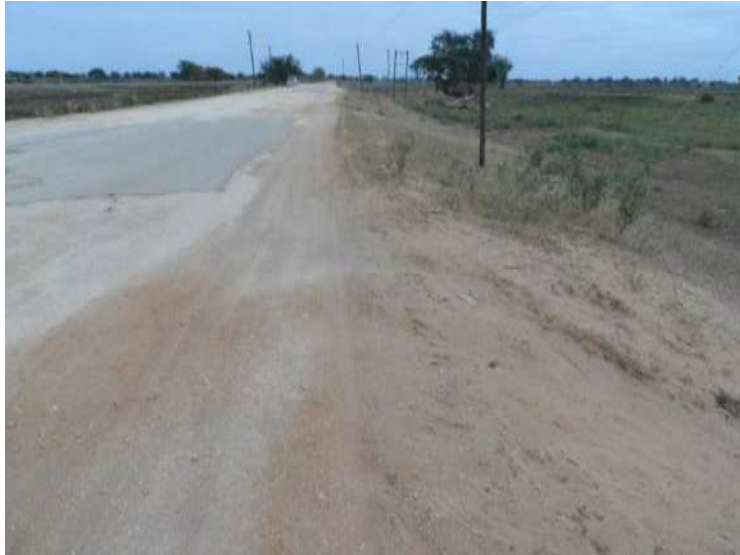
Overtopping and loss of surfacing had occurred at a number of other places along the road, one of the worst areas being at about km 22.3, despite the embankment in this area being about 4 m high (Figure B.25). The overtopping apparently occurred both in 2000 and in 2012. The damage was mostly initiated in 2000 and the road was repaired only with local gravel and not resealed. Damage in 2012 required additional repairs. According to local residents, the flooding was from the north indicating that it was due to local precipitation and not rising of the level of the Limpopo River. Google Earth images of the area in 2000 and 2010 (Figure B.26 and Figure B.27), however, show that the water appears to have approached from the east in 2000, where the Limpopo River is dammed.

Figure B.25: Loss of seal and damage to embankment

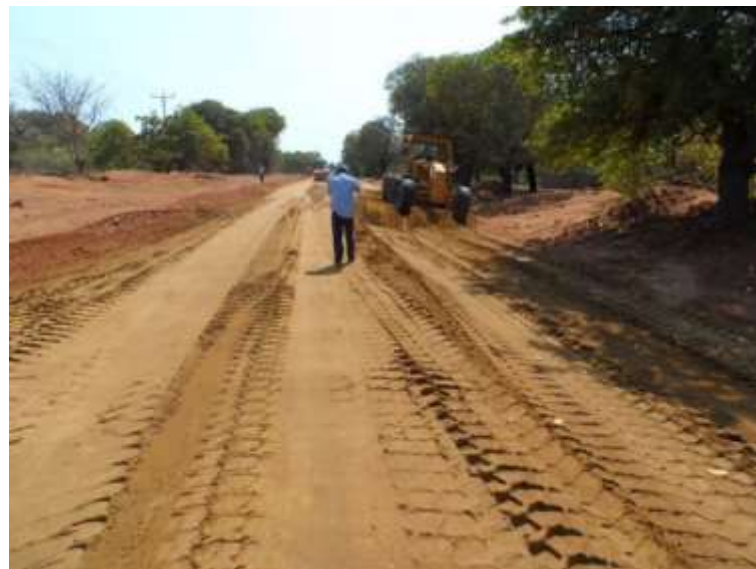
The contractor had new high quality equipment on site and appeared to be doing a good job. The construction of the formation included moving the existing sand on the road (including widening) and importing a yellow brown sand as the formation (Figure B.29). This resulted in large quantities of red sand spoil along the edge of the road that had to be removed before any appropriate drainage measures could be installed – inspection of this material indicated that it would probably have been perfectly adequate for the formation material and only the subbase and base material would need to have been imported from the borrow pit at about km 6.0. This material was a slightly cohesive red sand, typical of those materials that have given good performance as base courses in even untreated states on low volume roads in the SADC region.

Figure B.29: Placement and compaction of subgrade material on Road R443 showing spoil piled at road edges

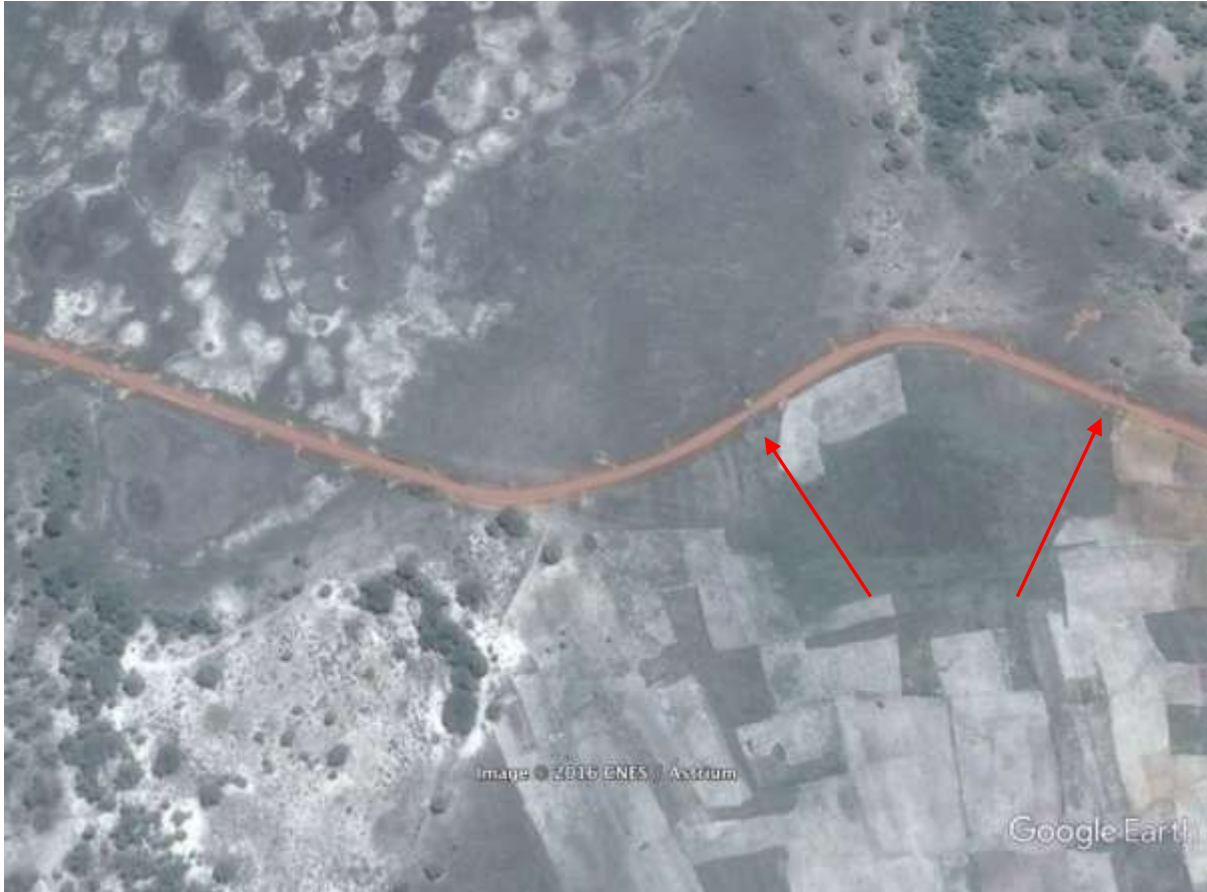
The road was constructed of a red-brown sand that compacted quite well to provide an appropriate surfacing for the standard of road required. However, the road crossed a large flood-plain between two shallow marshy areas (dry during the visit) with cross-drainage provided only by two double-pipe 600 mm culverts (shown in red on Figure B.30).

Figure B.30: Road R451 crossing between two marshy areas with only two culverts. The closely spaced mitre drains on the left have been installed after 2013

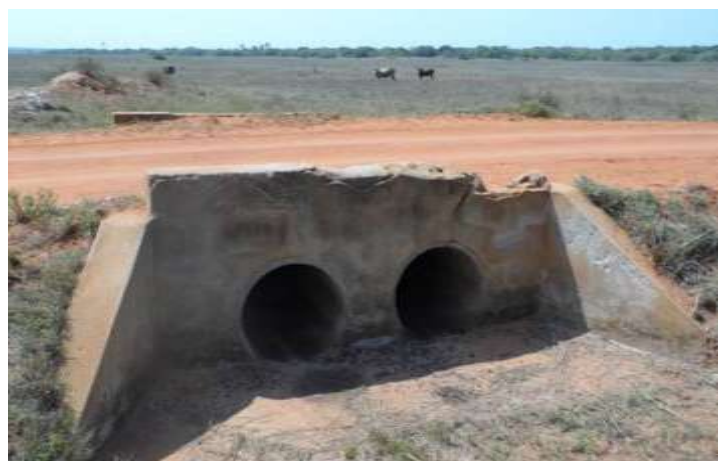
It is interesting to note that there is only 3 m variation in altitude along the road from the left to the right of the image above, over a distance of 800 m. Figure B.31 shows one of the culverts, somewhat damaged, which acts an equalisation pipe between the two sides of the road. This road is apparently never overtopped.

Figure B.31: Typical example of road prior to upgrading

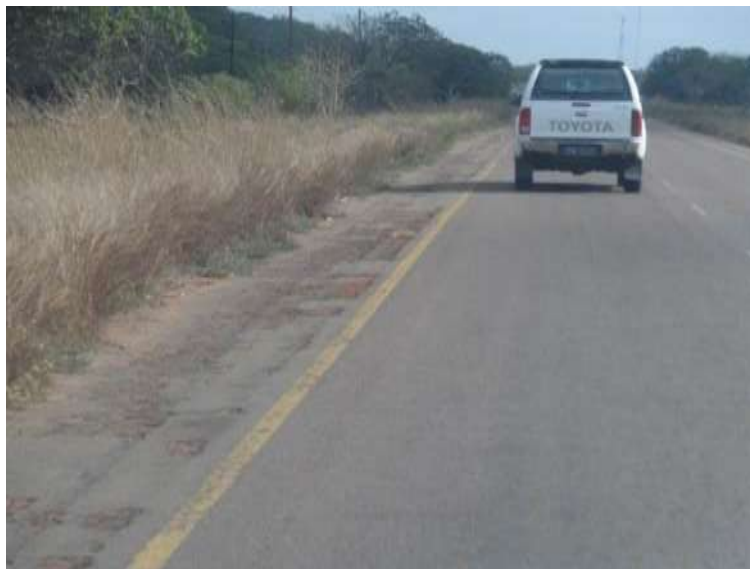
Figure B.33: Example of failure of non-durable single seal on shoulder

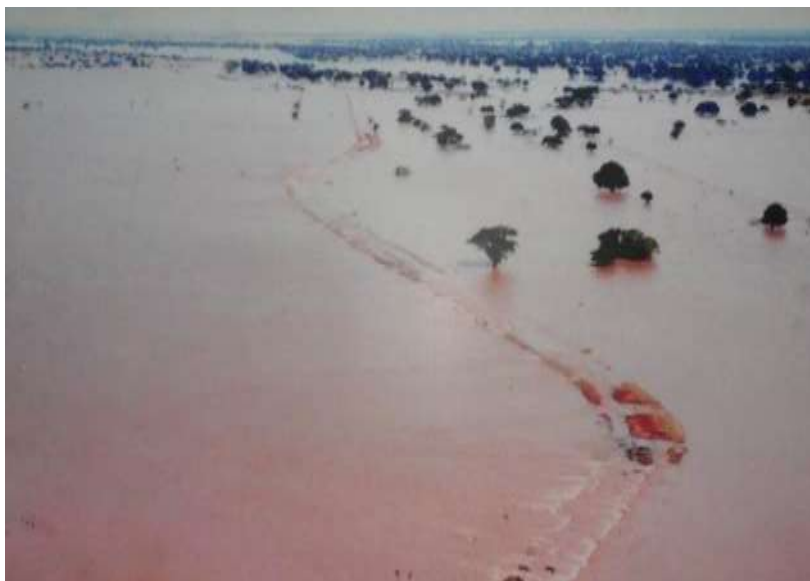
A lot of the damage to the embankments was considered to be due to turbulence caused by concentrations of water flowing across the road at slightly lower points. This is exemplified in Figure B.35 taken during the 2012 flooding where such turbulence is clearly visible along the road. There was also evidence to suggest that the presence of trees and termite nests exacerbates the problem, with trees affecting the laminar flow of water while termite nests initially cause some turbulence and then provide weakness in the embankment (tunnels and voids) leading to erosion and undermining of the road. It is also suggested that the embankment slopes on the downstream side should be flattened to reduce the velocity of water flowing down it and prevent undercutting and erosion.

Figure B.35: Photo of 2012 flooding showing localised turbulent flow at low points in embankment

As the flooding in the areas visited can often come from either side of the road, it is recommended that the embankments on both sides of the road are flattened, covered with a layer (150 mm thick) of suitable clayey material, compacted and then grassed over with a deep-rooting indigenous grass. It is preferable that both rhizomous and bunch-rooted grasses are used to ensure surface strengthening for erosion protection and deeper anchoring to avoid surface sloughing. Flattening should be to a maximum slope of 1 vertical to 3 or 4 horizontal to reduce the velocity of flow of water down the embankment slope, as well as minimising “wave” action on upstream slopes during the approaching flood.

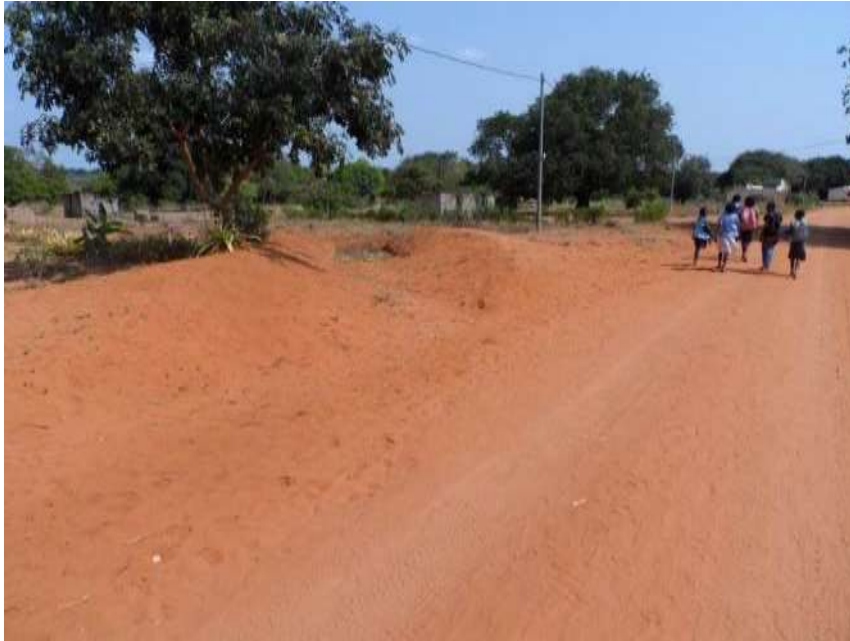
Figure B.37: Short mitre drain built up on both sides and at end during maintenance

It is obviously not possible to design entire lengths of road that will not be overtopped during extraordinary flood events in such flat and low-lying areas. However, for normal rainfall, it is imperative that the side and mitre drains are capable of removing water from the road effectively. On nearly all of the roads inspected, the side drains were usually effective where they existed but most mitre drains were ineffective (Figure B.37). While it is acknowledged that in flat areas, the removal of water from mitre drains is difficult, their general configuration observed made drainage almost impossible. Most of these did not extend more than a few metres away from the road and effectively acted as small sumps. Maintenance usually resulted in the silt and materials from the drains being mounded along the side of the drains and at the end of the drain, reducing their capacity for removing water from the road environment even further. The ends of the mitre drains must be opened up to allow water to flow out of them, even if a larger “sump” is excavated to hold water while it evaporates. Building up of the drain on the downhill side is acceptable, as this will minimise overtopping of water which could then flow back onto the road.

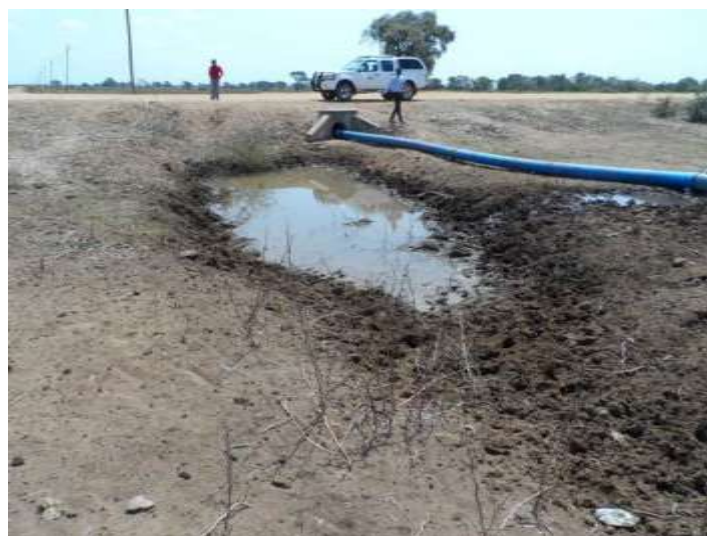
Figure B.38: Photo of 2012 flooding showing localised turbulent flow at low points in embankment

It is essential that cross-drains have the capacity to move water from one side of the road to the other without erosion, excessive siltation or permitting the water to enter the pavement structure. Where the terrain is so flat that removal of the water is almost impossible, the water should be removed as far from the road as practically possible and the allowed to flow into a sump or drain-away areas. It should not be allowed to accumulate close to the road (Figure B.38).

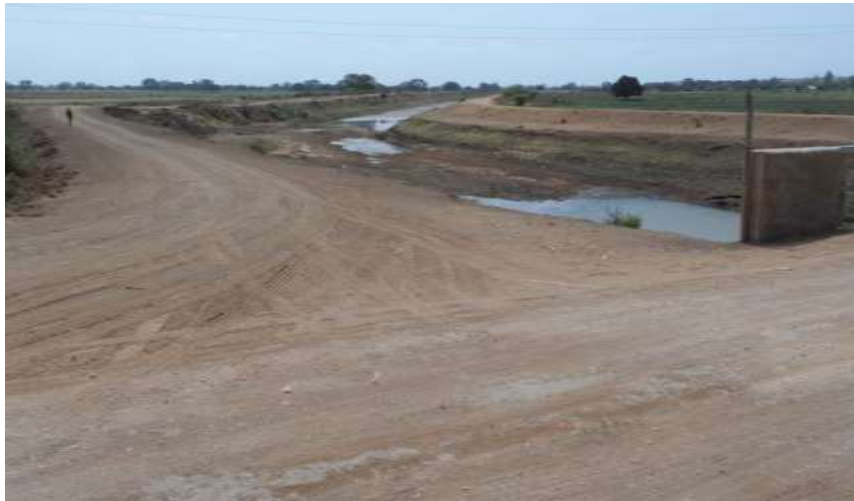
It is also important, certainly for new road developments, to try and remove the impact of flooded rivers attempting to change direction near the structures. Figure B.41 shows a river approaching the bridge at an angle and then being sharply diverted to cross under the bridge perpendicularly. The damage to the approach fill and pavement clearly indicates that the folded river could/did not change direction and overtopped the embankment causing the damage to the approach fill and the road.

Figure B.41: Damaged road and fill caused by change in direction of river

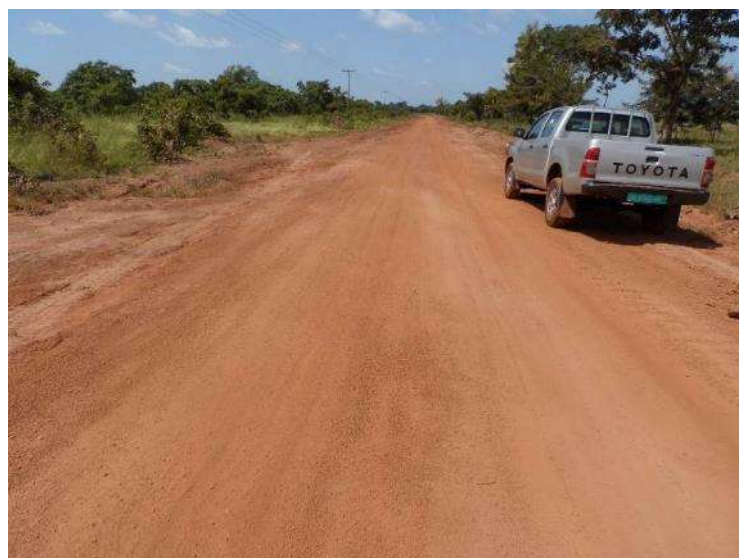
The road starts northwest of Giana with a raised culvert immediately at the beginning where water can pass beneath the upgraded road parallel to the existing R90 road. The road then drops to a low point, which will be raised with imported gravel and then surfaced with a 100 mm thick subbase (wearing course). This will be a local laterite from a nearby borrow pit. The quality of the gravel appears to be good, with a good riding quality over the short initial section using the gravel (Figure C.2). This section still needs to be raised before final gravelling.

Figure C.2: Laterite wearing course with rudimentary drains – section still to be raised

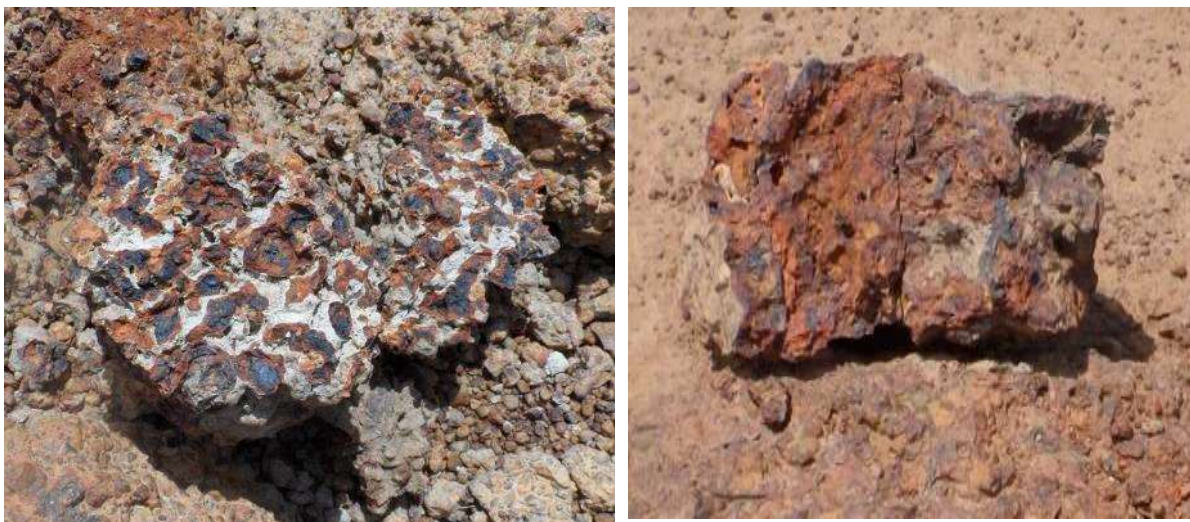
It is interesting that there are two distinctly different laterites in the area. One has strong cemented iron pisoliths in a grey weak clayey matrix, while the second one has the pisoliths strongly cemented by iron oxides (Figure C.9).

Figure C.9: Laterite with clay matrix (grey part on left) and with iron oxide matrix (right)

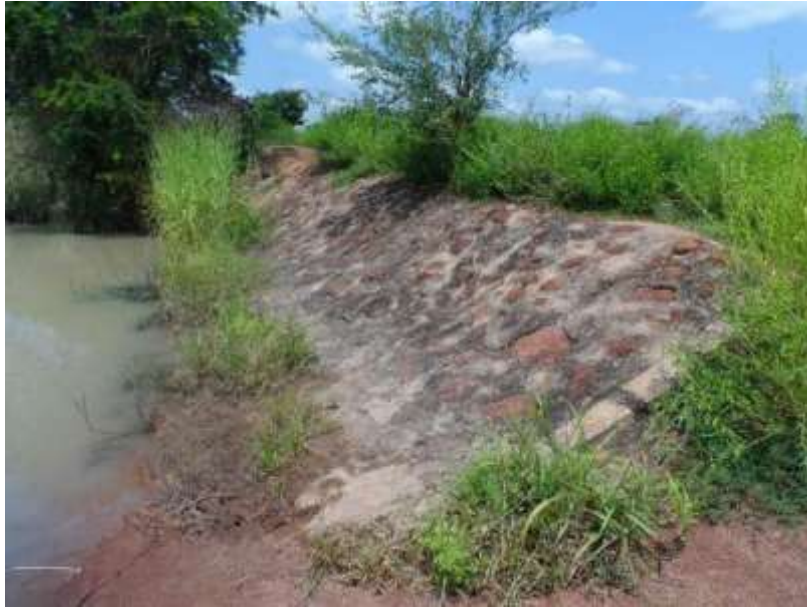
At about km 8.85, a series of box and pipe culverts allow a river to cross the road with standing water occurring on both sides of the road. There was evidence of overtopping of the embankment with some erosion on the downstream side of the fill in places, particularly next to the wing-walls. The embankment was on a 1:1.5 slope but still had evidence of erosion, except where grouted stone-pitching was placed, which was highly successful in protecting the slopes (Figure C.10).

Figure C.10: Grouted stone pitched embankment protection

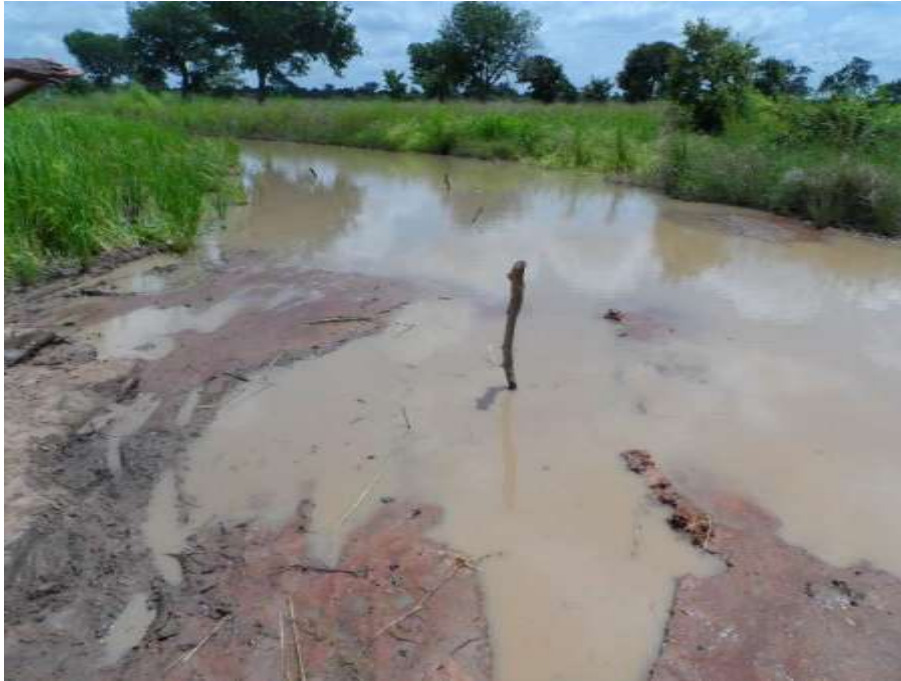
In the area of km 10.4, the road was totally flooded (Figure C.12). Although it was possible to drive through it (four-wheel drive was utilised), the road cannot be considered accessible for all vehicles beyond this point.

Figure C.12: Flooded area at about km 10.5

The proposed design in this area is to install two 2x2m box culverts and two 1200 mm pipe culverts and raise the road onto an appropriate embankment.

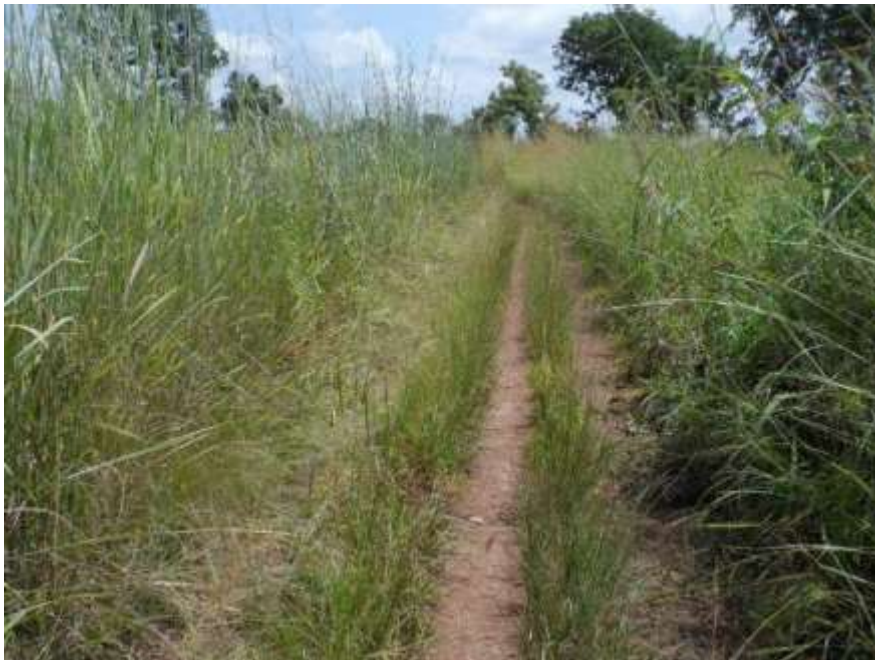
From about km 11.3 onwards the road decreases in width to no more than a track in places (Figure C.13) with localised drainage problems and loose material requiring 4-wheel drive (Figure C.14).

Figure C.13: Road decreases in width to a track in many places

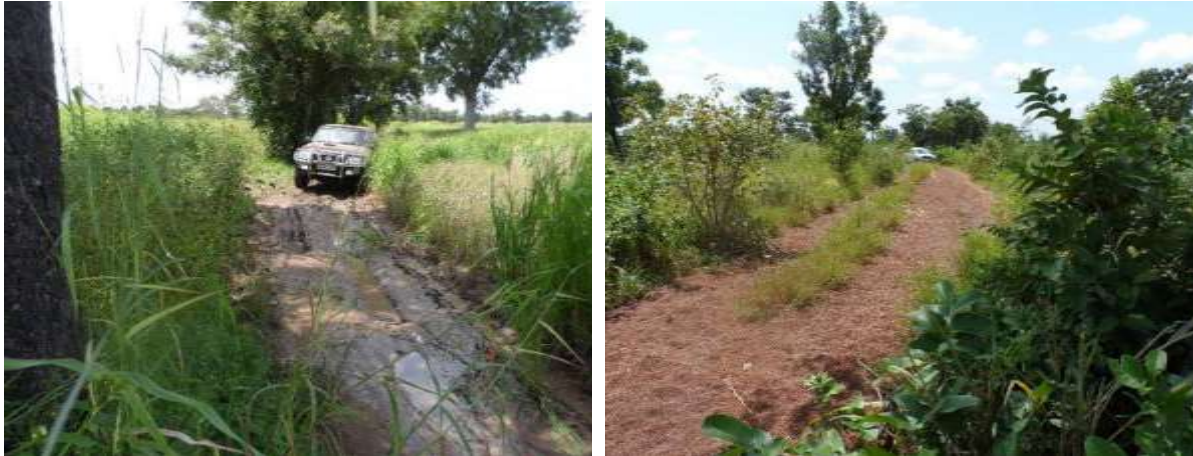
Figure C.14: Localised drainage and passability problems

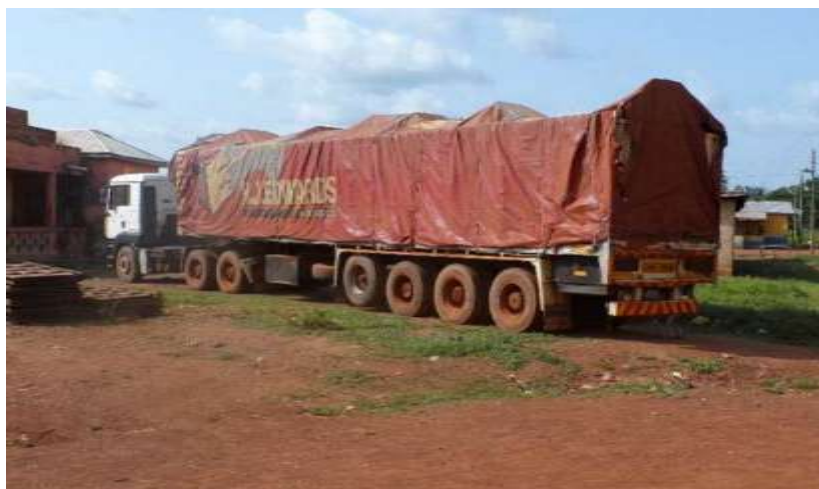
Recent logging activity in the area has led to large vehicles using the road (Figure C.15) and a number of concrete box culverts had collapsed and been repaired using logging off-cuts (Figure C.16).

Figure C.15: Large truck noted alongside road during site visit

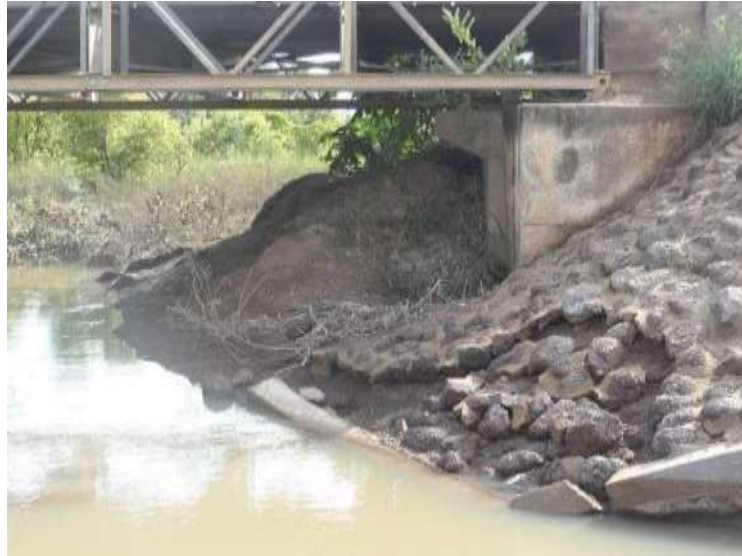
At about km 14.7 there is a Bailey Bridge replacing a concrete one that was washed away some time ago. This is effective but shows some evidence of erosion of the bank protection beneath the bridge (Figure C.18).

Figure C.18: Erosion of bank protection beneath Bailey Bridge

Apart from the bridge that had been replaced by the Bailey bridge, the structures generally coped with the local precipitation. Damage to the structures was mostly traffic related, although erosion of the embankment protection beneath the Bailey bridge should be repaired before additional erosion leads to damage of the abutments and approach fills.

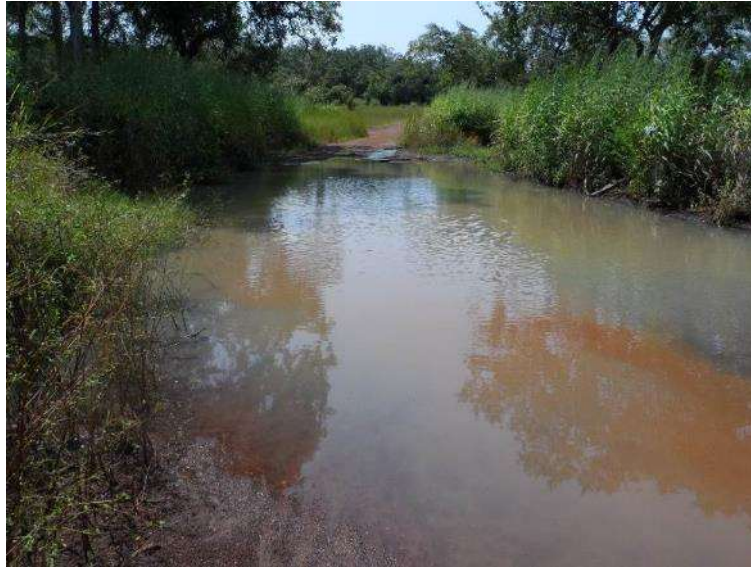
From this area onward the mostly un-engineered earth road with minimal side drainage continues and is of poor quality. At km 63.7, the road was flooded as a result of an earth dam being built by the community adjacent to the road (Figure C.20). Although this was passable at the time of the visit, it is unlikely that it would be passable after severe rains when the dam fills up. The road continues as a more or less 4 x 4 track with numerous other areas where flooding had to be traversed until a local resident suggested that the flooding became too severe for even a 4x4 vehicle and the continuation of the trip along the road was abandoned (Figure C.21).

Figure C.20: Newly constructed culvert in flat terrain

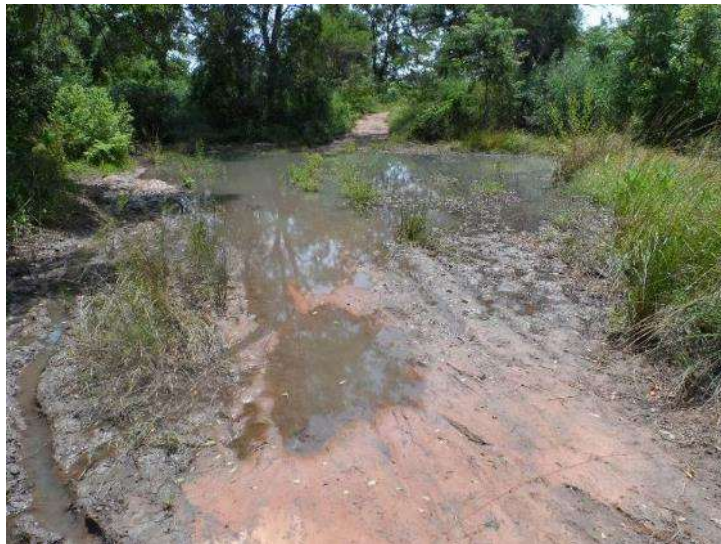
Figure C.21: Flooded road at which point the trip was ended
