Fatal CO poisoning on board motor cruiser *Vasquez* while moored at Cardiff Yacht Club 12 November 2016

SUMMARY

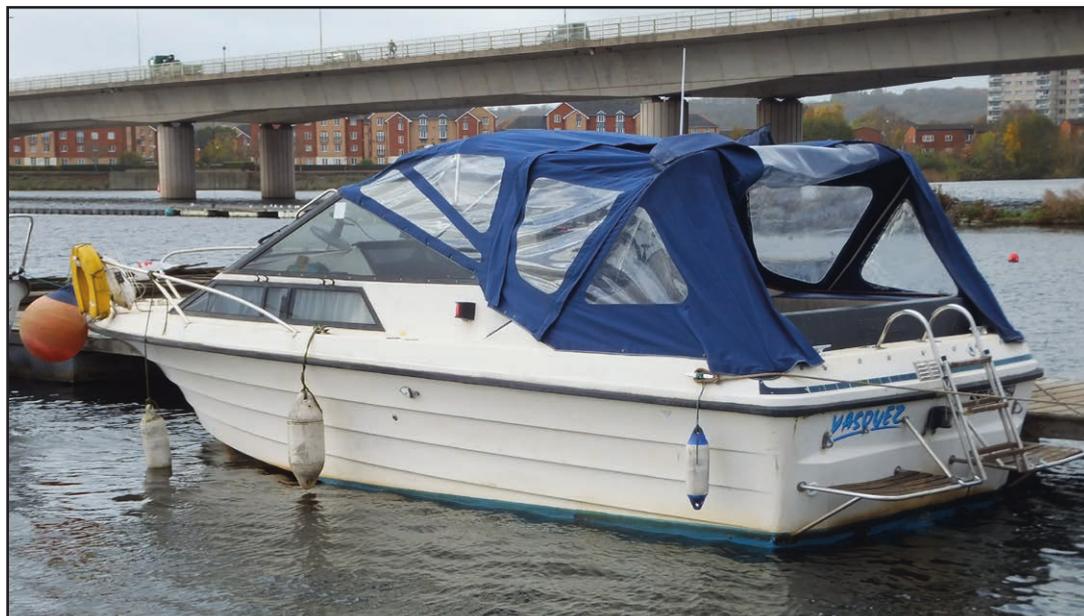
Figure 1: *Vasquez*

During the morning of 12 November 2016, Ray Milton travelled to Cardiff Yacht Club to check on his motor cruiser *Vasquez* (**Figure 1**), which was moored in the marina. Ray regularly visited the club to socialise with other club members, usually on a weekly basis, but on this occasion had not visited for a couple of weeks. He had arranged to meet a friend at the club that morning.

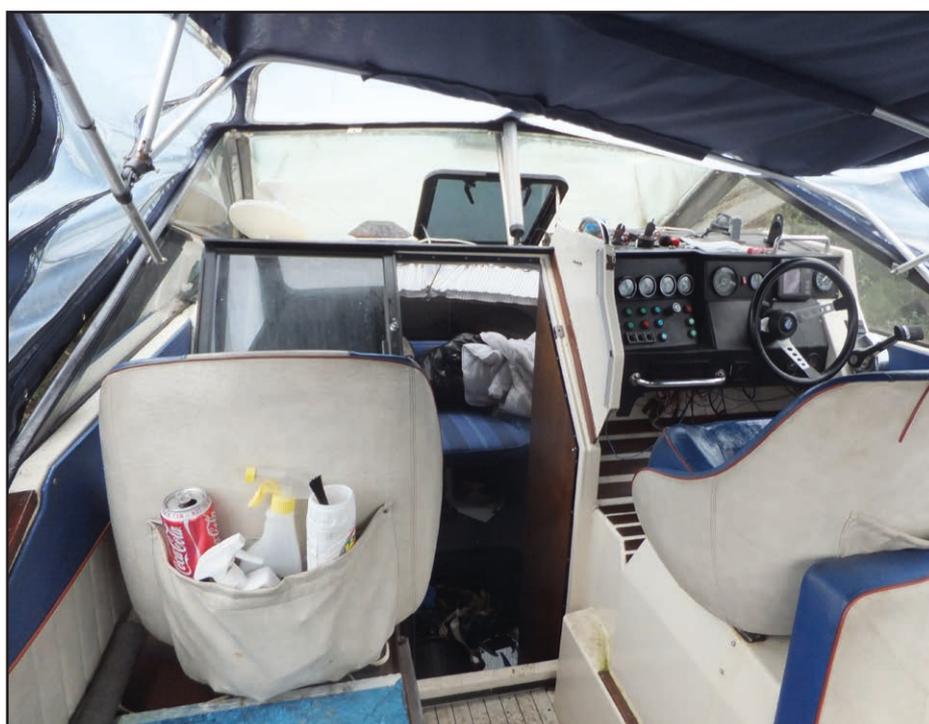
Figure 2: Cockpit with view forward into the cabin

The vessel had a forepeak cabin with seating area, dedicated sleeping berth and toilet compartment. The cockpit, which could be enclosed with a canopy, contained the helm position (**Figure 2**) as well as a small galley and further seating. The engine compartment was situated under the floor of the cockpit at the aft end.
