## ACCIDENT

<b>Aircraft Type and Registration:</b>	Reims Cessna F150M, G-BDZC
<b>No &amp; Type of Engines:</b>	1 Continental Motors Corp O-200-A piston engine
<b>Year of Manufacture:</b>	1976 (Serial no: 1316)
<b>Date &amp; Time (UTC):</b>	17 October 2016 at 1021 hrs
<b>Location:</b>	Bourn Airfield, Cambridgeshire
<b>Type of Flight:</b>	Private
<b>Persons on Board:</b>	Crew - 1                      Passengers - 1
<b>Injuries:</b>	Crew - 1 (Fatal)    Passengers - 1 (Serious)
<b>Nature of Damage:</b>	Aircraft destroyed
<b>Commander's Licence:</b>	Private Pilot's Licence (A)
<b>Commander's Age:</b>	58 years
<b>Commander's Flying Experience:</b>	363 hours (of which 9 were on type) Last 90 days - 7 hours Last 28 days - 2 hours
<b>Information Source:</b>	AAIB Field Investigation

## Synopsis

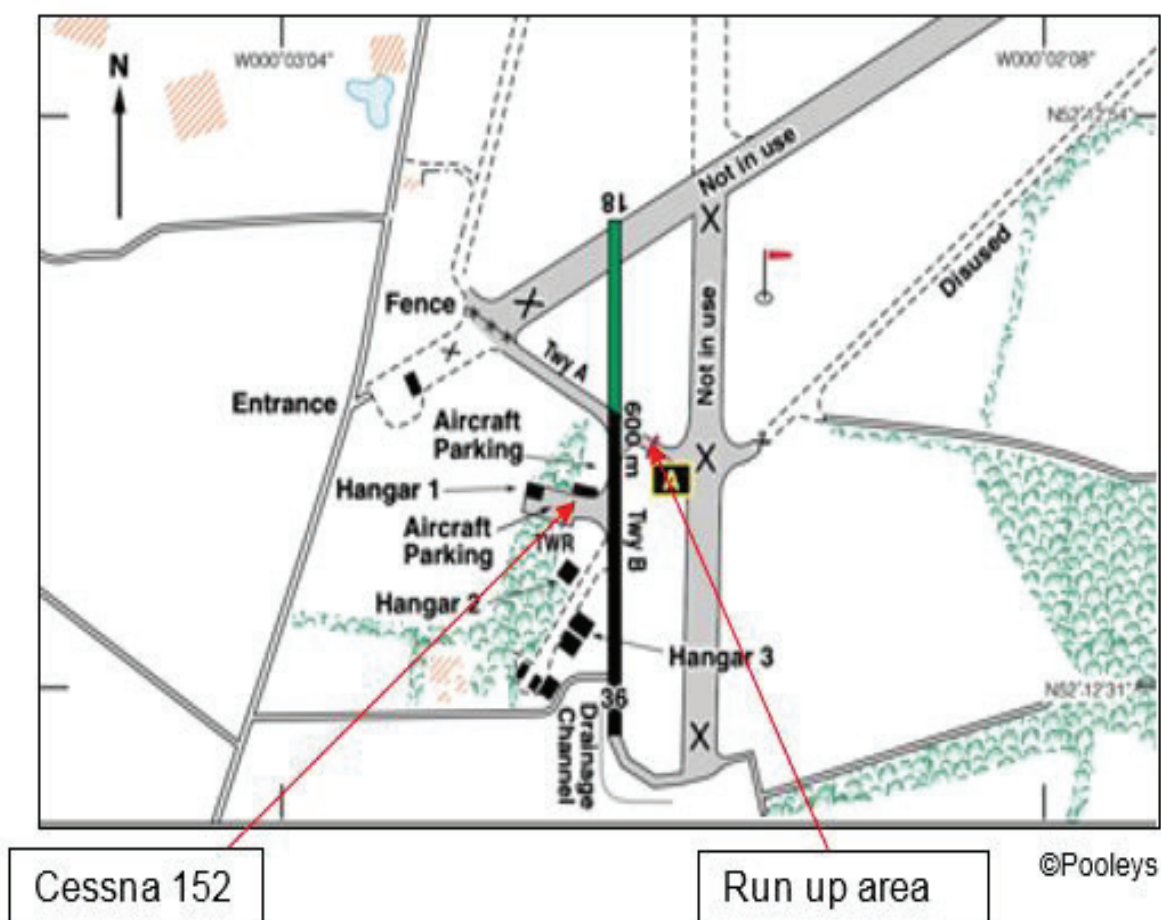
**Figure 1**

The pilot, with his passenger on board, started the engine and taxied from behind the C152 across to the run-up area, located on an old taxiway to the east of Runway 18 (Figure 1). He remained there a short while and then taxied towards the threshold of Runway 18, out of view of the occupants of the C152.

Aircraft parking and run-up areas at Bourn Airfield
