## Inspection and testing of failed tow wire rope from tug *ALP Forward*

### FINAL REPORT

TTI Reference number TTI-IMLR-2016-5284

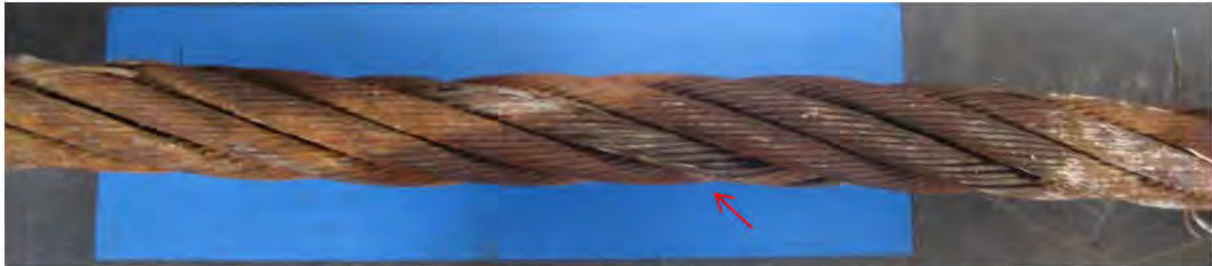
The tug side sample was laid out and measured at 19.2 m overall length. Measuring from the cut end of the sample the first strand failure of the main failure was measured at 10.2 m (Figure 5.3). Over the next lay-length or so this strand pulled into the middle of the wire rope, displacing the IWRC so that it was not obvious that it had failed there.

Figure 5.3: Strand failure noted at 10.6 m from cut end on tug side sample (started at 10.2 m).

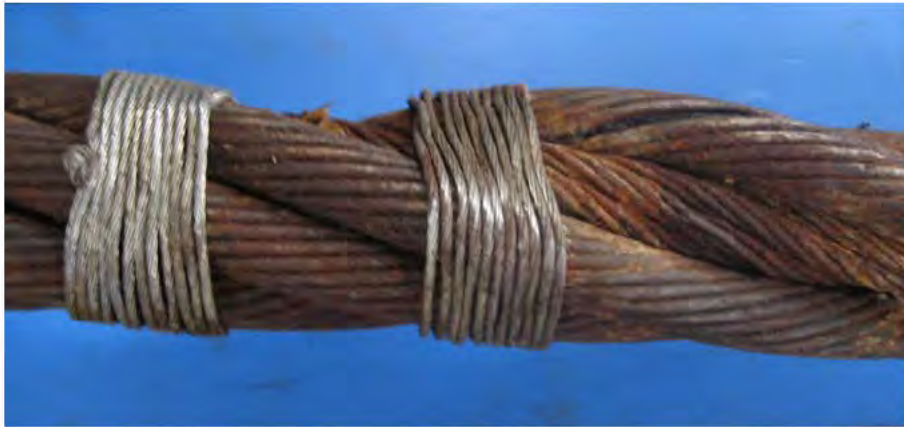
At 12.96 m a pair of servings were noted. It is assumed that these were put in place by personnel removing the failed sample for examination (Figure 5.5).

**Figure 5.5:** Seizing wire on wire rope measured at 12.96 m from cut end on tug side sample.

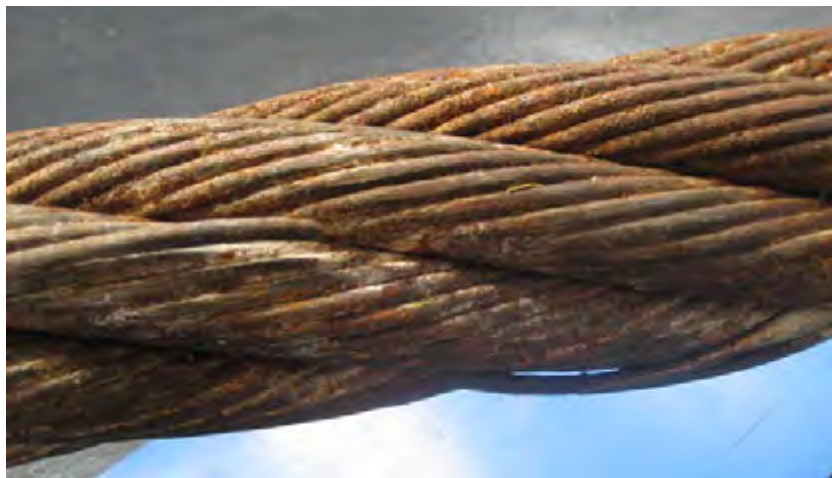
It is immediately noted that the lubricant between the strands is missing, the protective galvanising seems low or lost, and the wires (the outside of the wire rope) are covered in what appears to be superficial corrosion. Wire breaks were noted distributed along the 10 m length, both along and around the wire rope circumference. In all 40 visible breaks were counted (there may well have been more), all of which initiated at the inter-strand contact region of the wire rope and appeared to be shear type in nature. Beyond 10 m from the cut end there were many more wire breaks.

**Figure 5.8:** Two of six outer strand wire breaks measured at 2.0 m from cut end on tug side sample.

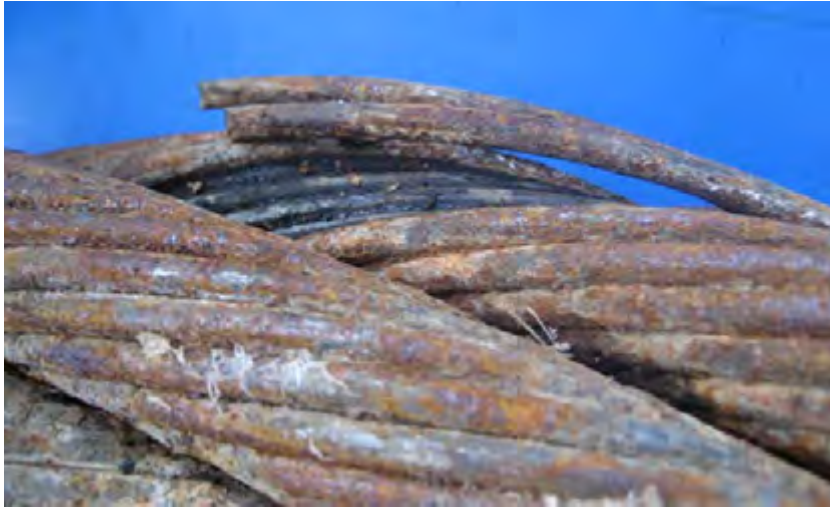
**Figure 5.9:** Two outer strand wire breaks measured at 5.6 m from cut end on tug side sample.

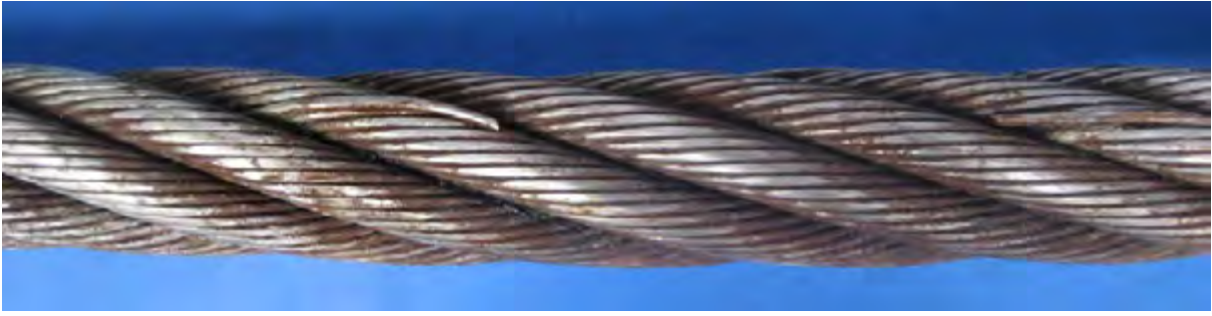
**Figure 5.10:** General condition of the wire rope about 1.1 m from cut end of rig side sample.

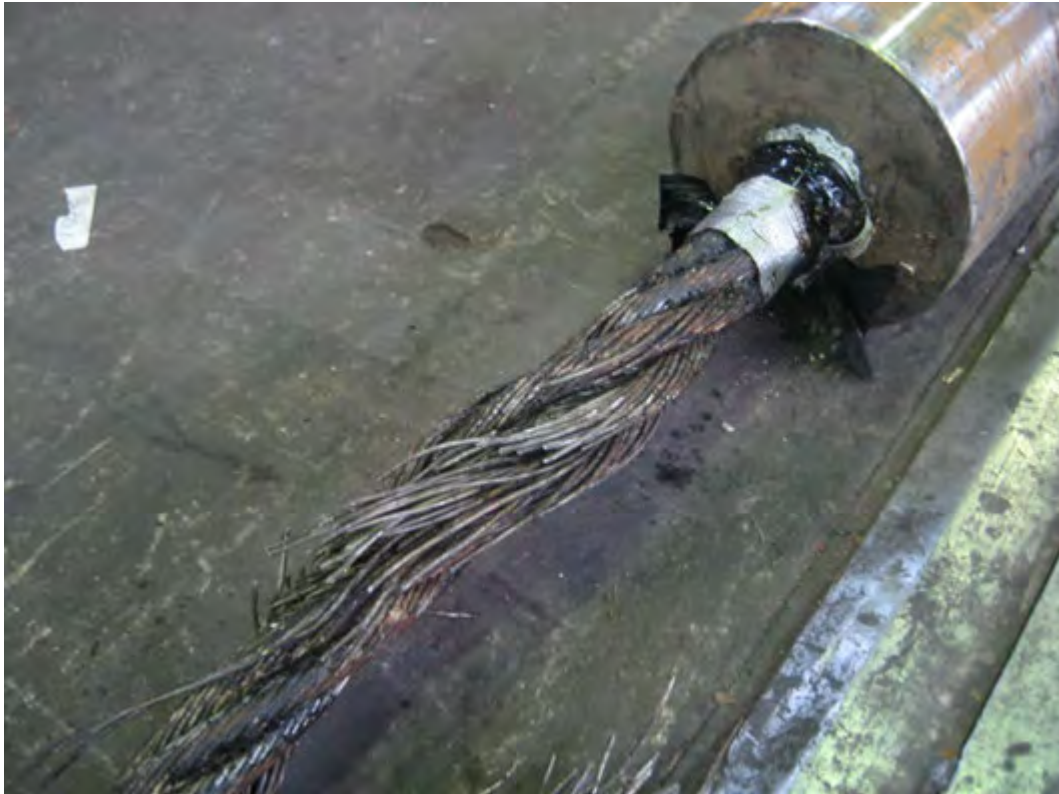
Figures 9.3 - 9.5 show the drum sample following testing. It may be seen that the sample failed clear of the terminations (Figures 9.3 and 9.4). Examination of the failure showed that the majority of the wire failures were from tensile overload (as would be expected), with a few shear type failures (given the helical nature of wire rope, this is also as expected).

**Figure 9.4:** Drum sample failure clear of termination.

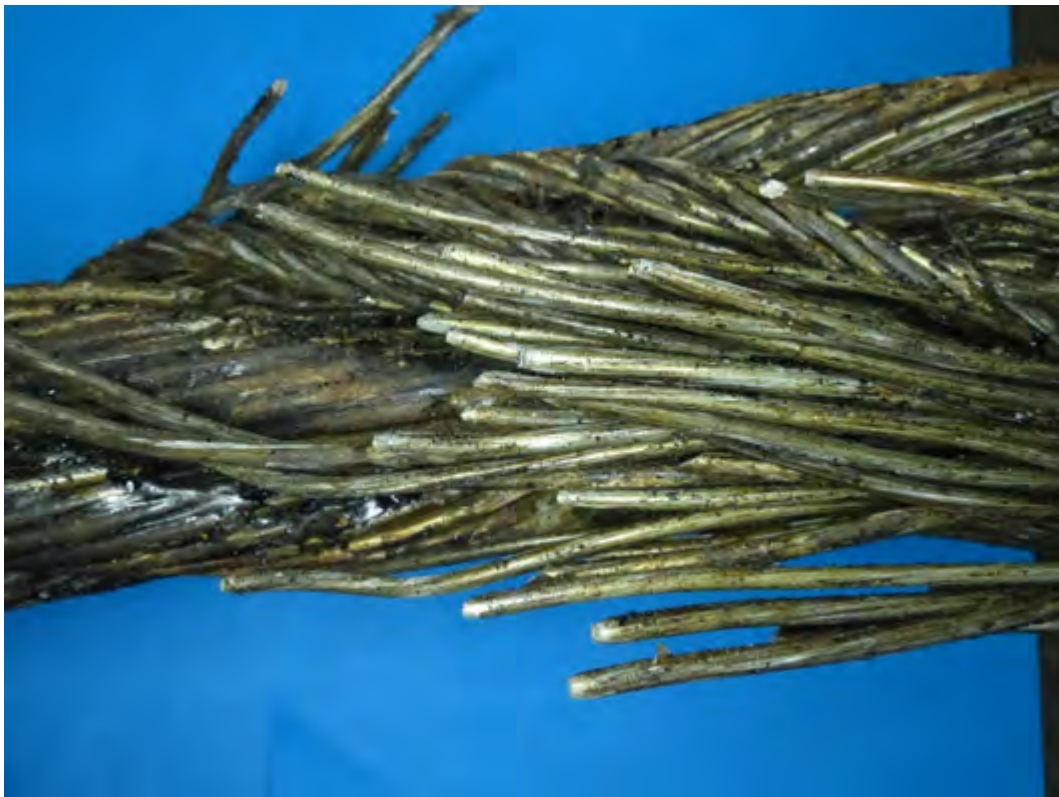
**Figure 9.5:** Drum sample detailed view on failure region.

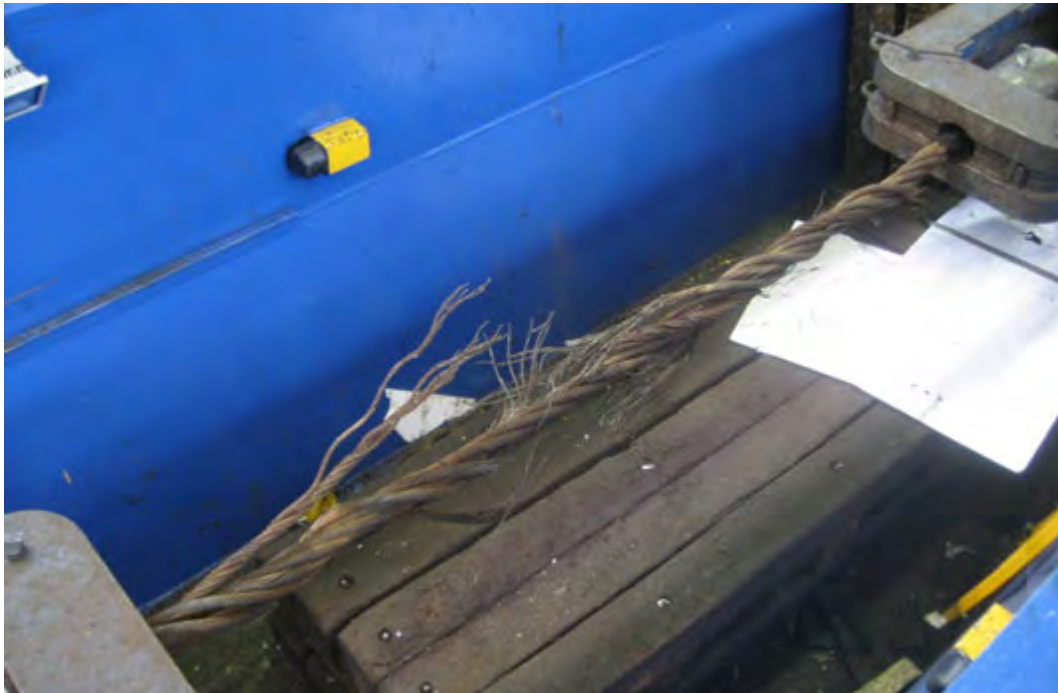
Figure 9.6 shows the broken wires which fell out of the tug side sample when it was terminated for testing. The wires are largely from the IWRC, which as the initial inspection had shown was in fairly poor condition. In addition to the IWRC wires there were also some outer strand outer layer wire breaks. The tug side sample failed mid-length (Figure 9.7).

**Figure 9.7:** Tug side sample after testing, failure mid-length.

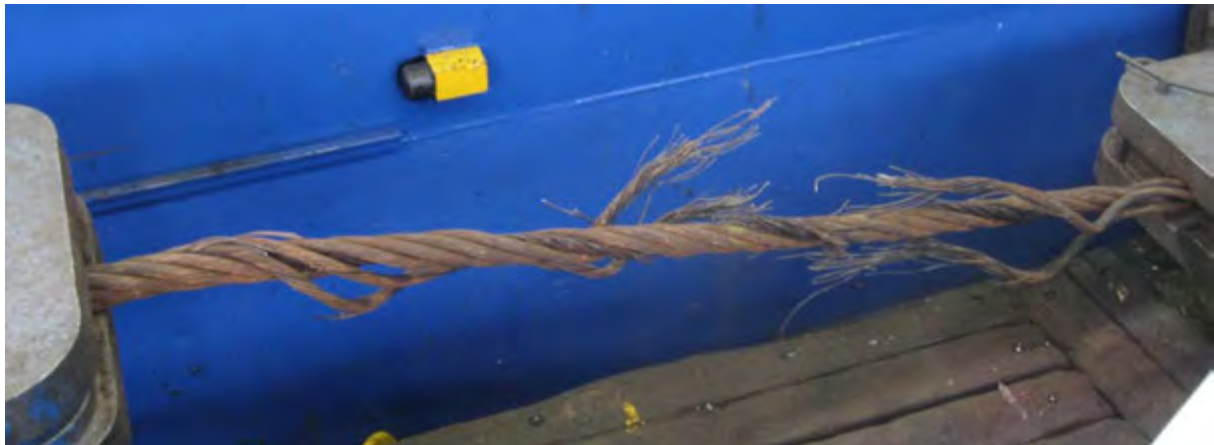
As with the tug side sample, the core of the IWRC was found to be mostly in pieces when the sample was prepared for testing (Figure 9.10). Additionally, there were also breaks in some outer strand outer wires. As with the other samples, the bridle sample failed clear of the terminations (Figure 9.11).

**Figure 9.11:** Bridle sample after testing, failure mid-length.

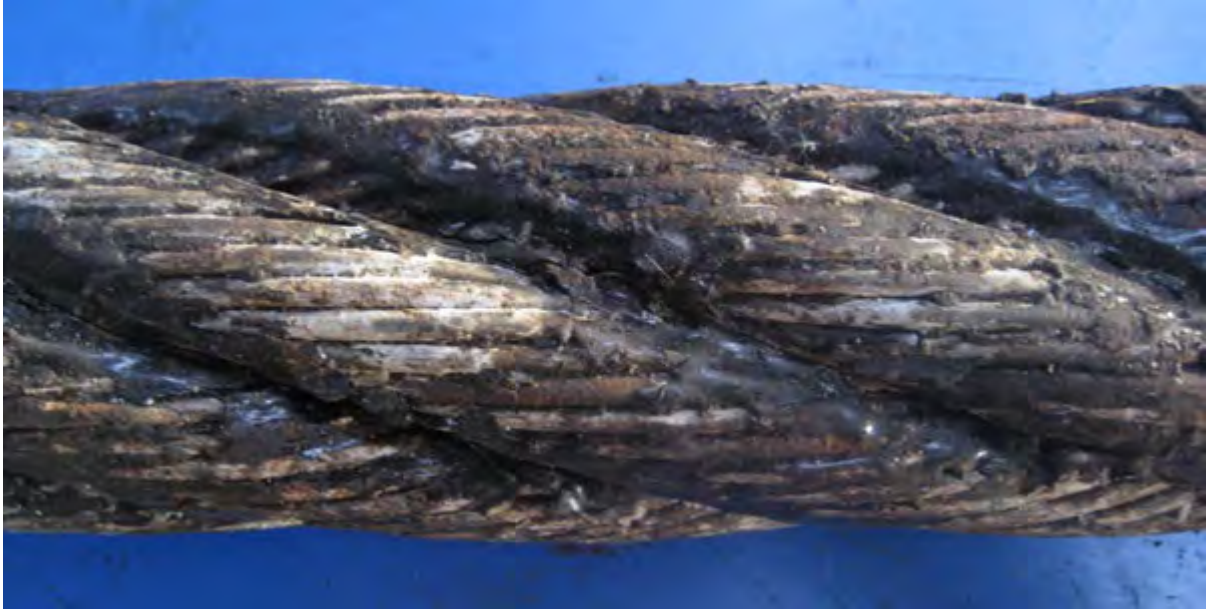
Figure 10.1 shows the general condition of the drum sample. The crown position of the sample was lacking in lubricant, and there were areas of white zinc oxide associated with loss of galvanic protection. In some areas light corrosion was noted (Figure 10.2). There were also patches of what appeared to be mud. It is not known when this was deposited on the wire rope surface.

In the valley positions between strands the lubricant level was very good, but it was hard and glassy in appearance. It is noted that the wire rope inspection certificate states that the lubricant is 'D / bitumin lube', so it is likely that this lubricant is the original as manufactured.

**Figure 10.1:** General condition of the drum sample.

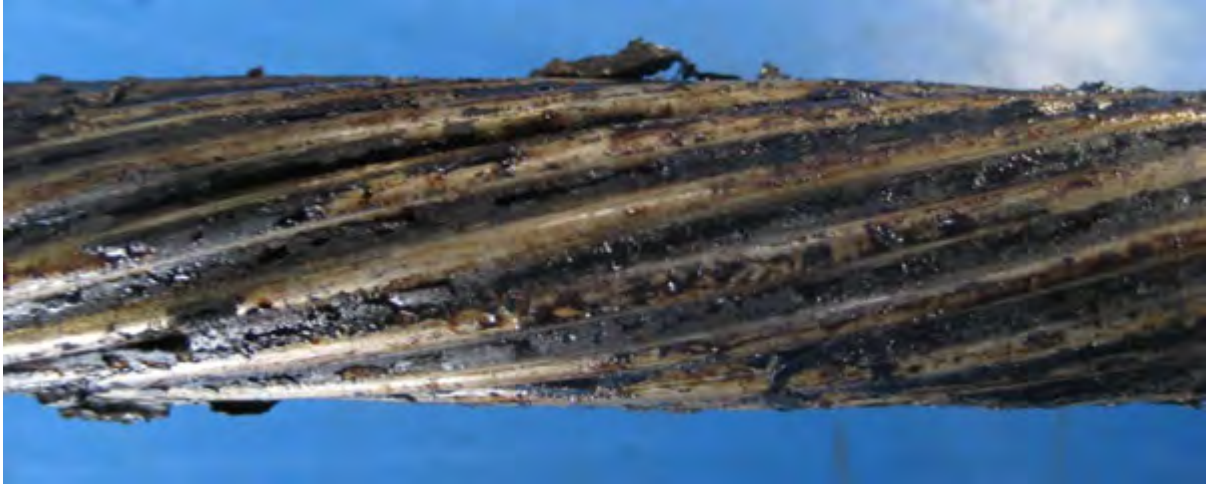
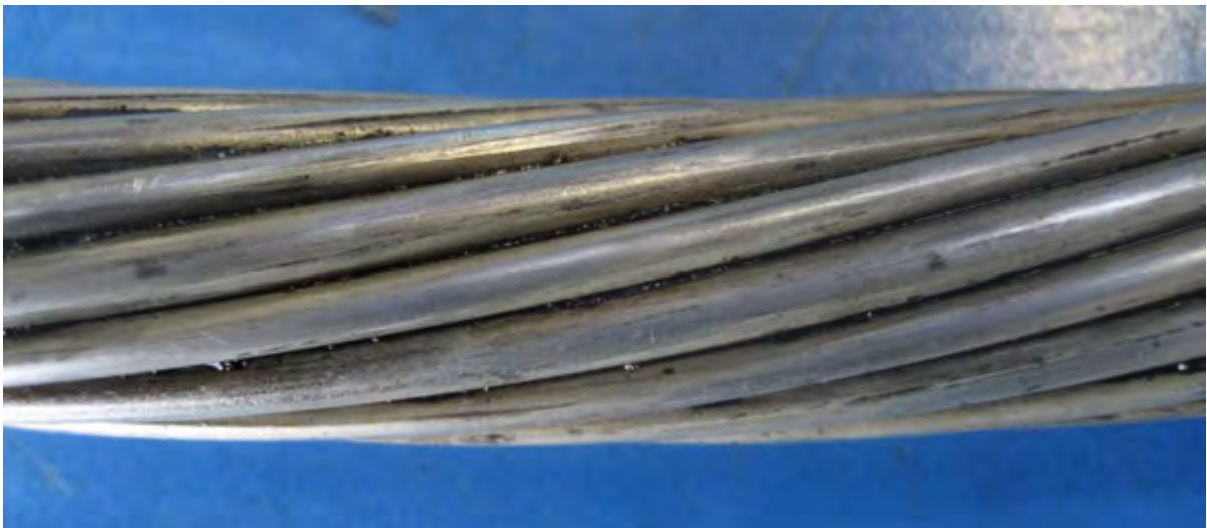
**Figure 10.5:** Drum sample outer strand - second layer of wires.

The outer strand was then stripped down layer by layer to permit assessment of the internal condition. Figures 10.5 - 10.7 show the second and third layers and core wire of the outer strand. It may be seen that the inner layers and core of the outer strand are well lubricated and have retained a good galvanising covering. No signs of degradation or wear were noted.

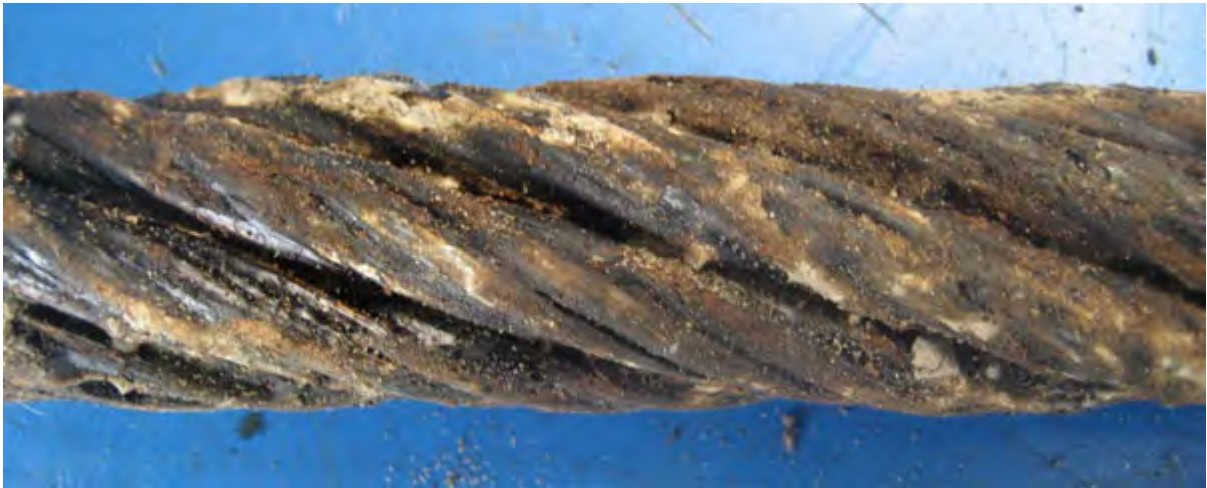
Figure 10.9 shows the drum sample with all the outer strands removed to show the IWRC. As noted above, the lubricant level is low and what is there appears denatured and powdery. An outer strand was removed to permit further examination. Figure 10.10 shows the core strand after cleaning. It may be seen that the residual galvanising is patchy, but there is no corrosion as such on the core strand. Dismantling the core strand shows that the lubricant inside the strands is good and sticky, and that the residual zinc is a little patchy, but overall good (Figure 10.11).

**Figure 10.9:** Drum sample IWRC.

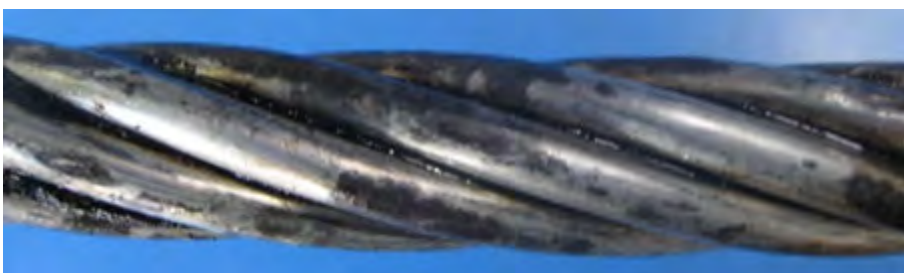
Figure 10.12 shows the IWRC core strand, which is similar in appearance to the IWRC, but with more lubricant. On cleaning the outer surface of the core (Figure 10.13) it may be seen that the residual galvanising is also patchy, but as with the outer strands, there is no corrosion. Figure 10.14 shows the core after dismantling. It may be seen that the lubricant level is good, and appears sticky in nature. The galvanising is a little patchy on the more exposed surfaces.

**Figure 10.13:** Drum sample IWRC core strand cleaned.

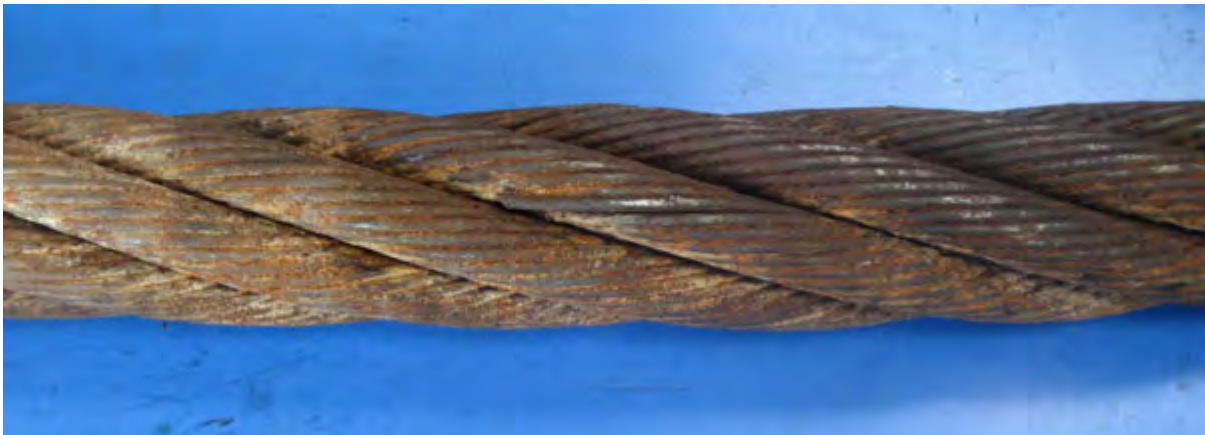
Figure 10.15 shows the general condition of the tug side sample in the 'as received' condition. Its appearance is quite different to that of the drum sample (cf. Figure 10.1). The lubricant level was low to none, and there was a covering of light corrosion along the length. A single wire break was noted in one of the outer strands in the valley position, that is at the position where the outer strands contact one another. Figure 10.16 shows a detailed view on the wire break which had a 45° shear failure fracture surface typical of combined axial and transverse loading (axial load in the wire rope combined with transverse load as two strands press together). Note also that there is very little if any residual galvanising and the corrosion which has just started to roughen the surface of the wires.

**Figure 10.15:** General condition of the tug side sample before cleaning.

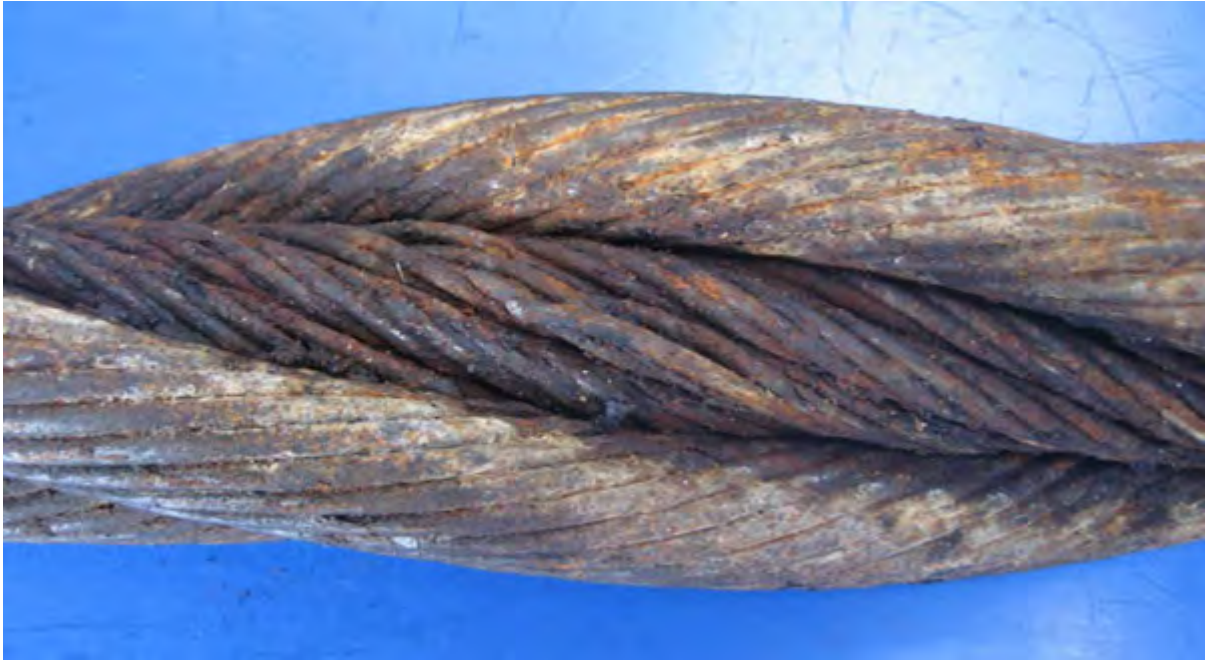
Figure 10.17 shows the tug side sample with two outer strands removed to reveal the IWRC. The lubricant level was generally low (a single large patch was noted in one area (Figure 10.18)). As with the outer strands the residual galvanising was low, and there was corrosion along the length of the core. Many wire breaks were noted in the IWRC outer strands (Figures 10.17 - 10.20). The remaining outer strands were carefully removed to permit full inspection of the core (Figure 10.18).

**Figure 10.17:** Tug side sample with two outer strands removed to reveal IWRC.

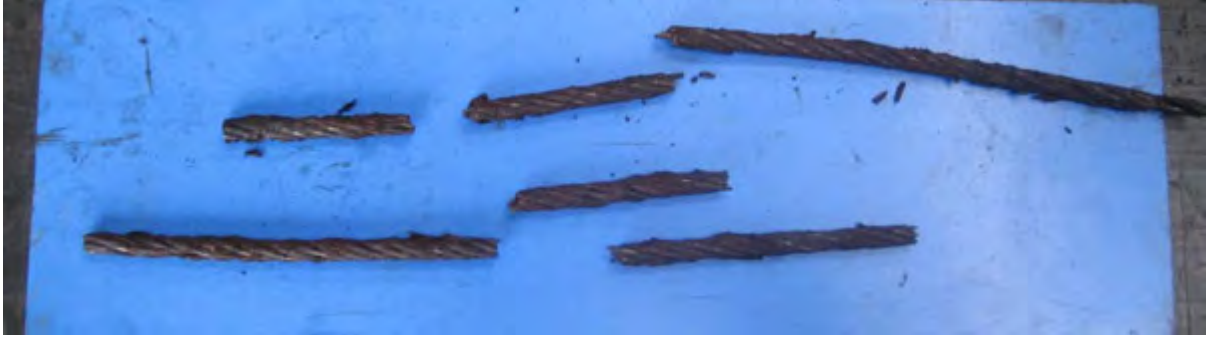
Figure 10.21 shows the IWRC with two strands removed to show the core. The lubricant level was much better than on the outer strands, but it was dry and flaky (Figure 10.22). There did not appear to be much corrosion - the main feature noted was that the whole core strand was broken through in several places. Once the outer strands were all removed it could be seen that the core strand was broken through completely in five places (Figure 10.23), as well as having other wire breaks along its length.

**Figure 10.23:** Tug side sample IWRC core - broken through in five places (6 pieces) over 1 m length.

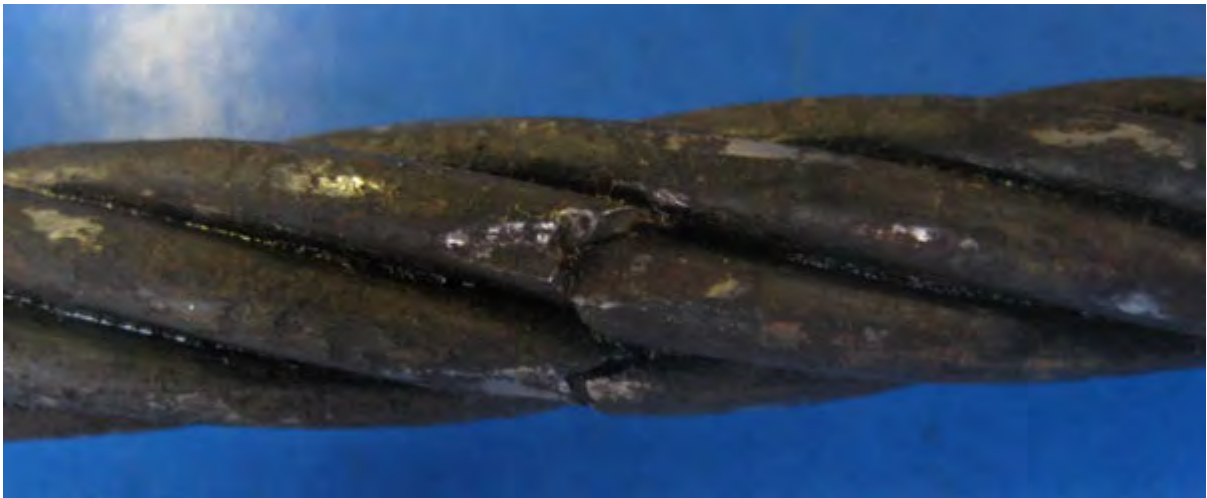
Figures 10.24 and 10.25 show sections of the IWRC core and an outer strand after cleaning. The IWRC core has some residual galvanising present, whilst the core strand has very little if any. The corroded appearance noted above (Figure 10.21) has cleaned off. The wire failures in both the strand and the core are the shear type, which are to be expected as the IWRC experiences high transverse loads as it supports the main outer strands in the wire rope.

**Figure 10.24:** Tug side sample IWRC core strand after cleaning.

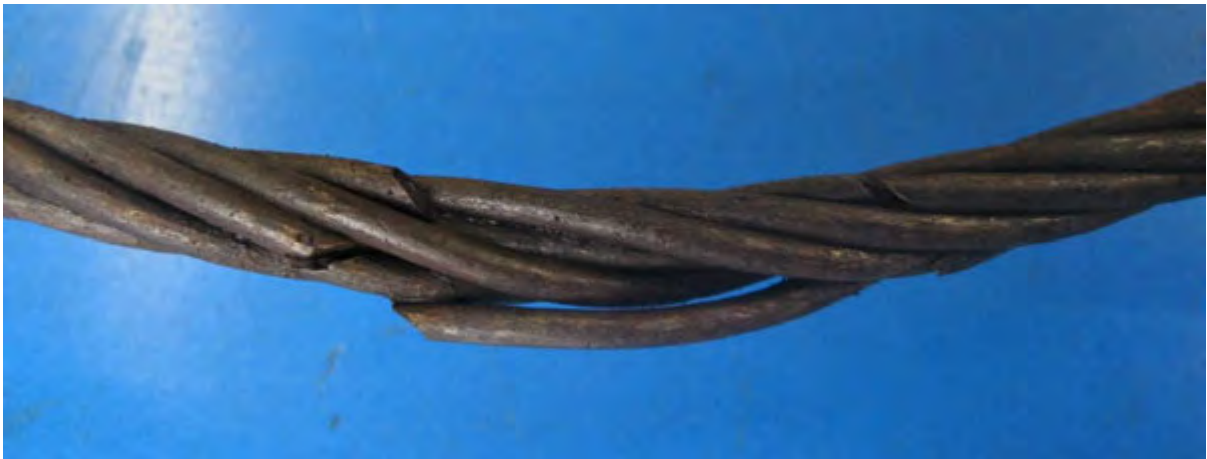
**Figure 10.25:** Tug side sample IWRC outer strand after cleaning.

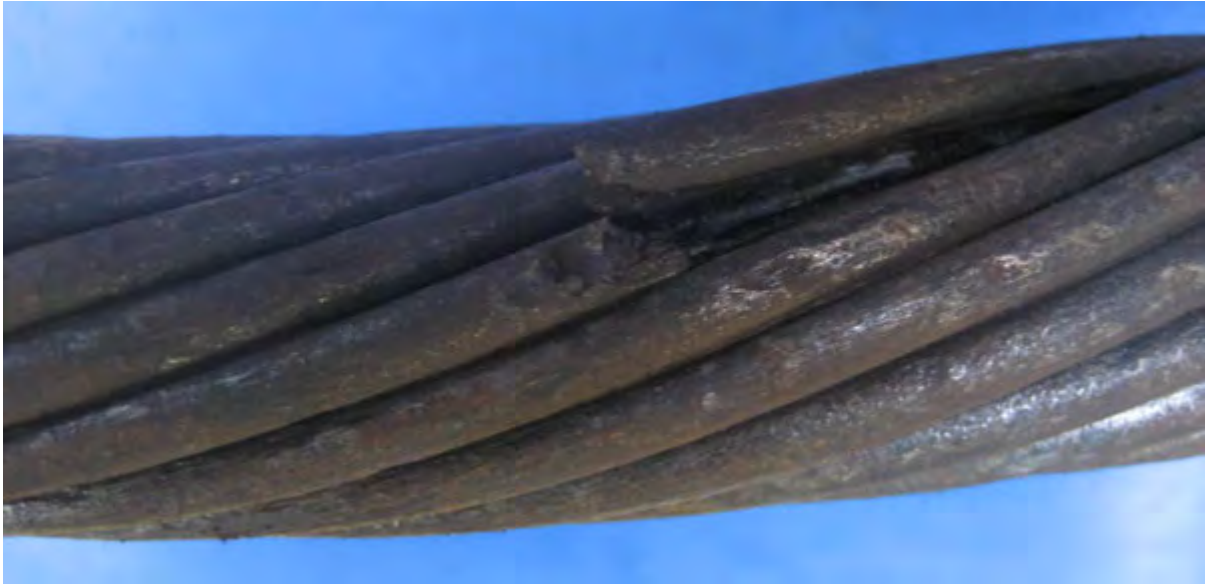
Figure 10.26 shows one of the main outer strands after cleaning. The wire break was located in the valley position in the wire rope and was not detected until the strands were removed to inspect the core. (In all four outer strand outer wire breaks were found in the 1 m sample - only one of which was found before the wire rope was dismantled.) The break has initiated at the wear patch on the surface of the wire, and failed in a mixture of shear and fatigue. The 'beach' marks characteristic of fatigue may be seen on the right hand edge of the fracture surface. It is also noted that there is very little residual galvanising left on the surface of the strand.

**Figure 10.26:** Tug side sample main outer strand after cleaning.

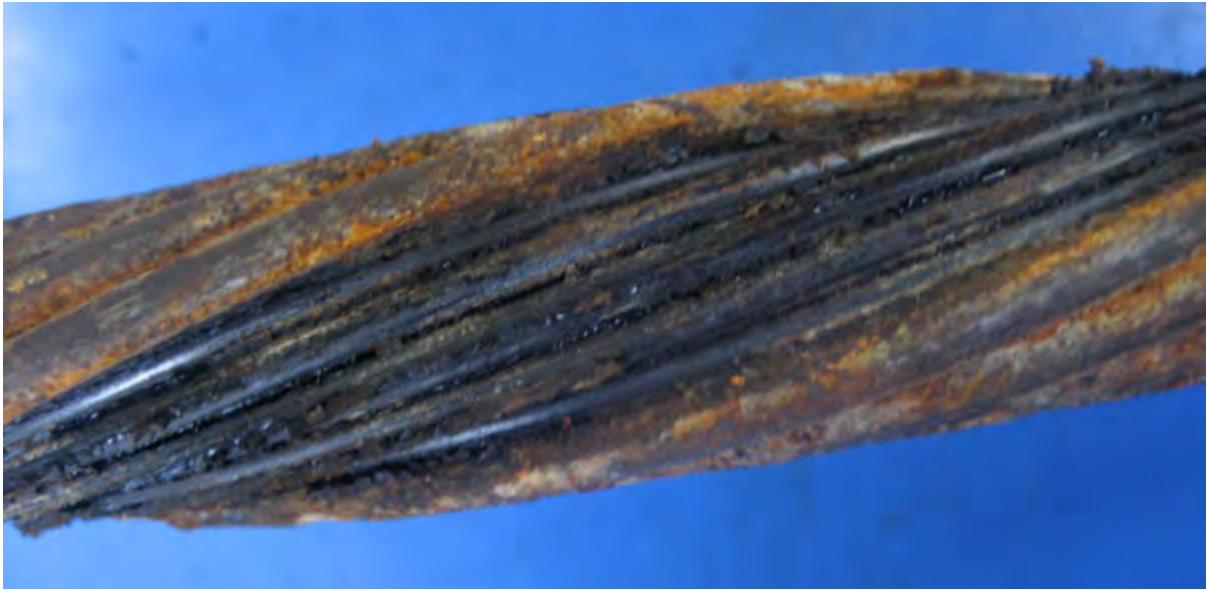
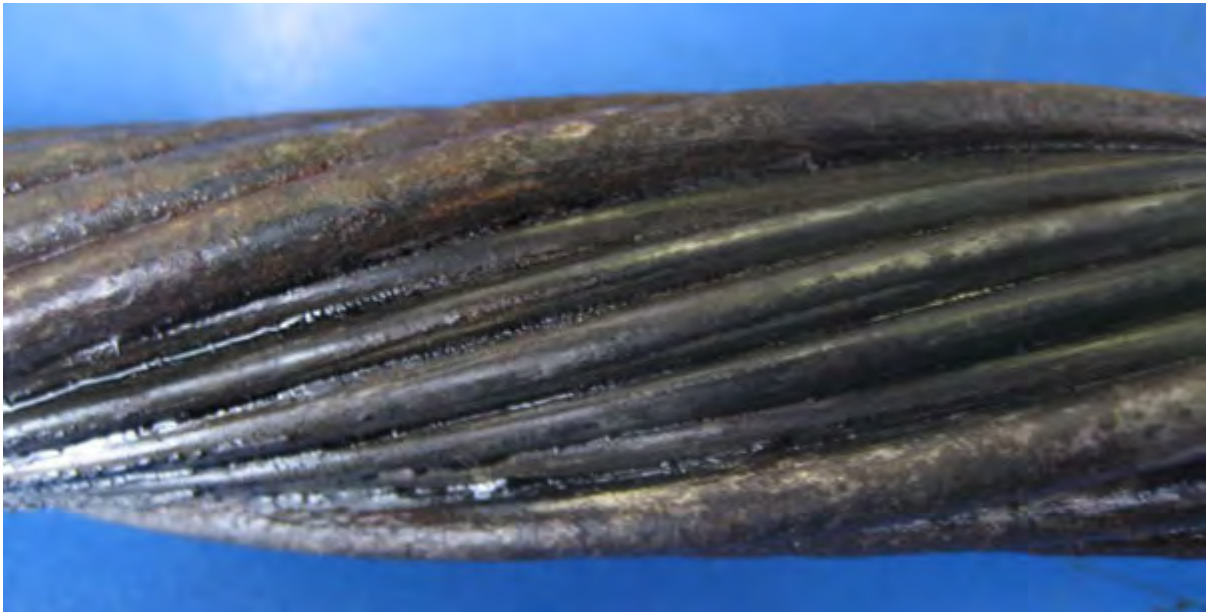
Figure 10.27 shows an outer strand with four outer wires removed to reveal the second layer. The contrast between the outer layer and second layer is quite marked: the level of lubricant in the second layer is better, and although still low, the residual galvanising seems better. Figure 10.28 shows the third layer of wires in the main strand before and after cleaning. This 'far' into the strand the lubricant is much better both in level and nature and the residual galvanising is also higher. Similarly the strand core wire had very good lubricant and high residual galvanising levels. No corrosion was noted in any of the inner layers of the outer strand inspected.

**Figure 10.27:** Tug side sample, main outer strand with four outer layer wires removed to expose the second layer.

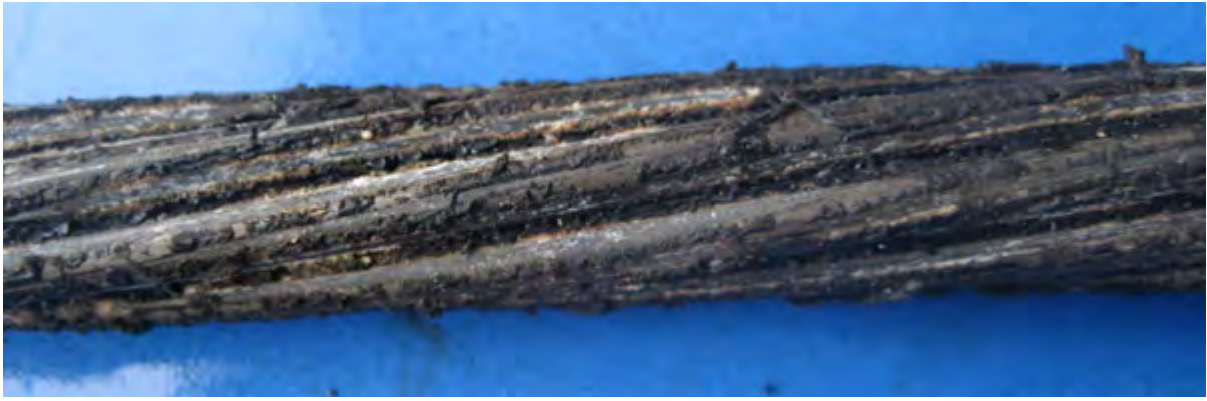
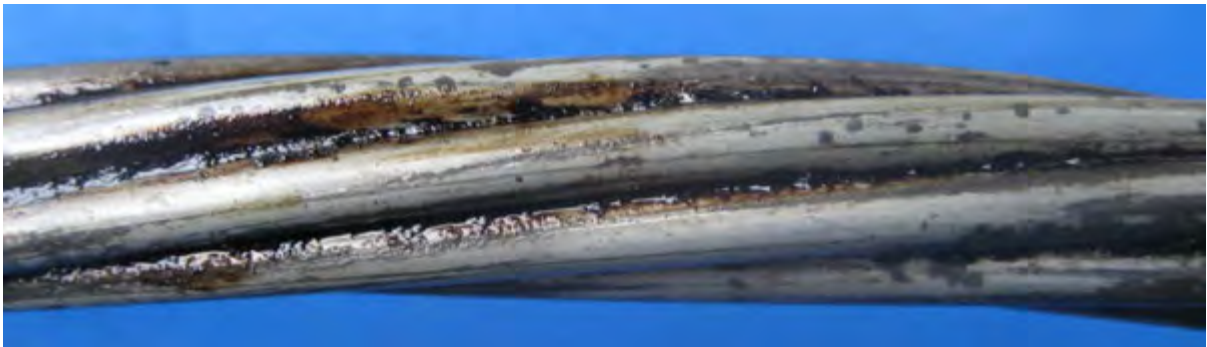
**Figure 10.28:** Tug side sample, main outer strand third layer of wires.

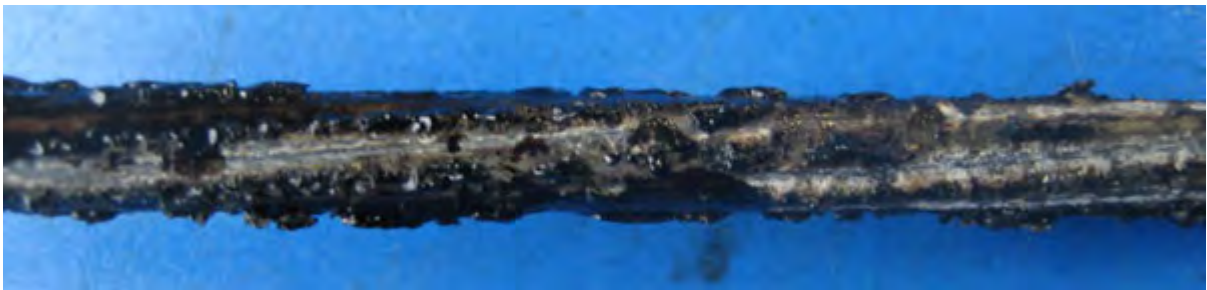
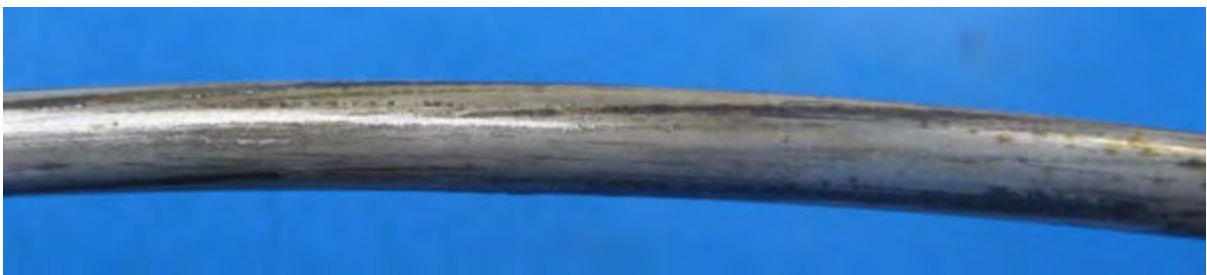
**Figure 10.29:** Tug side sample, main outer strand core wire.

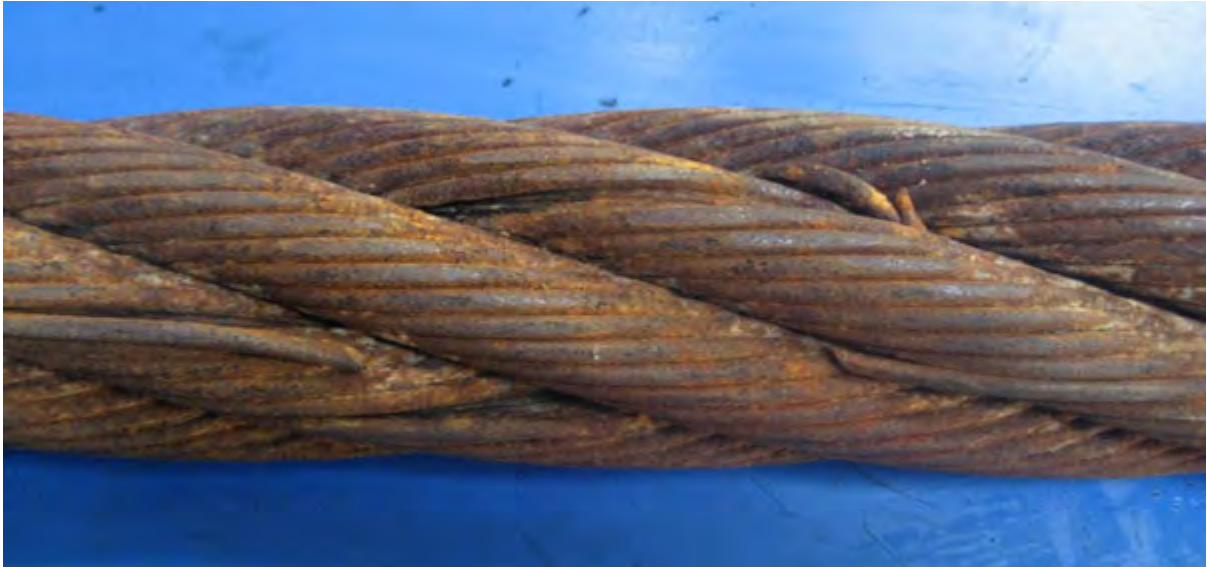
Figure 10.30 shows a general view of the bridle sample. It is fairly similar in appearance to the tug side sample: the external lubricant has gone and the surface of the wire rope is covered with a light corrosion which has just started to cause a roughening of the wire surface (Figure 10.31). Seven outer strand outer wire breaks were counted along the length (four of which may be seen in Figure 10.30). All wire breaks were in the valley positions and shear type in appearance.

**Figure 10.30:** General view on bridle sample.

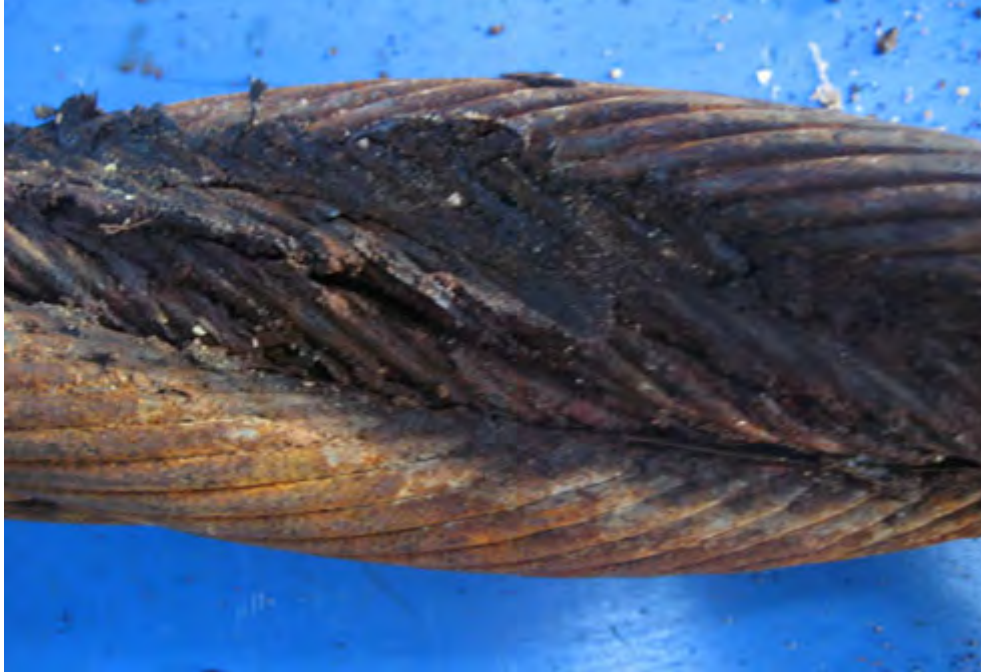
Figures 10.32 and 10.33 show the bridle sample with two outer strands removed to expose the IWRC. It may be seen that in some areas the lubricant was a quite a high level, if somewhat denatured (Figure 10.32), whilst in other places along the core the level was low (Figure 10.33).

**Figure 10.32:** Bridle sample with two outer strands removed - area of good lubrication on IWRC.

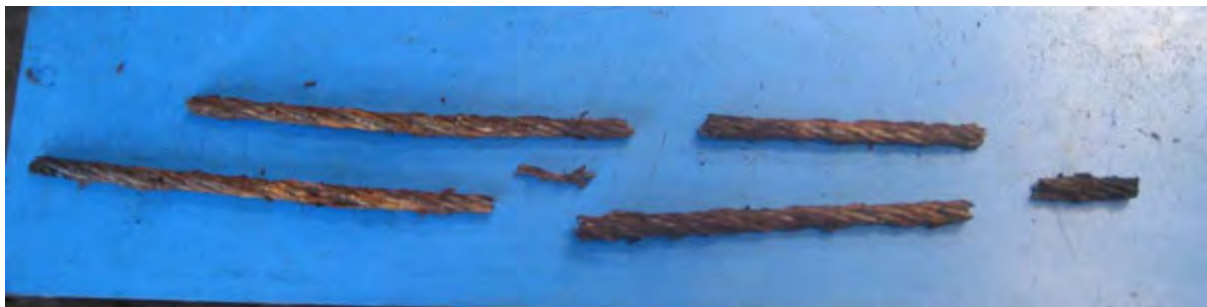
Figure 10.35 shows the IWRC with three outer strands removed. The condition is very similar to the tug side sample. The lubricant is at a reasonable level, if a little dry. As with the tug side sample the core strand was broken through in several (in this case four) places (Figure 10.36).

**Figure 10.36:** Bridle sample IWRC with three outer strands removed to show the core (all core strand wires broken).

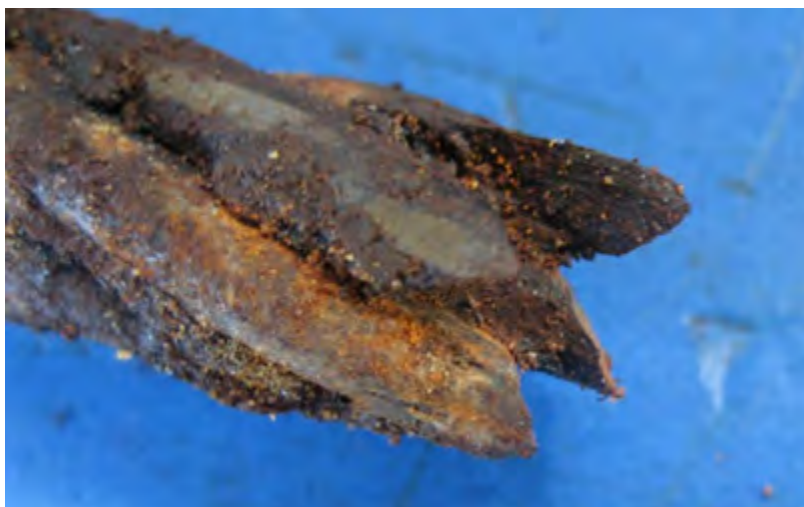
The wire failures in the core strand were typically shear type with the characteristic 45° fracture surface (Figure 10.37). Figure 10.38 shows a dismantled section of core strand before and after cleaning. It can be seen that the residual galvanising level on the wires is very low, with only a few small patches observed, however the wires do not appear to be corroded.

**Figure 10.37:** Bridle sample IWRC core showing typical shear type wire failures.

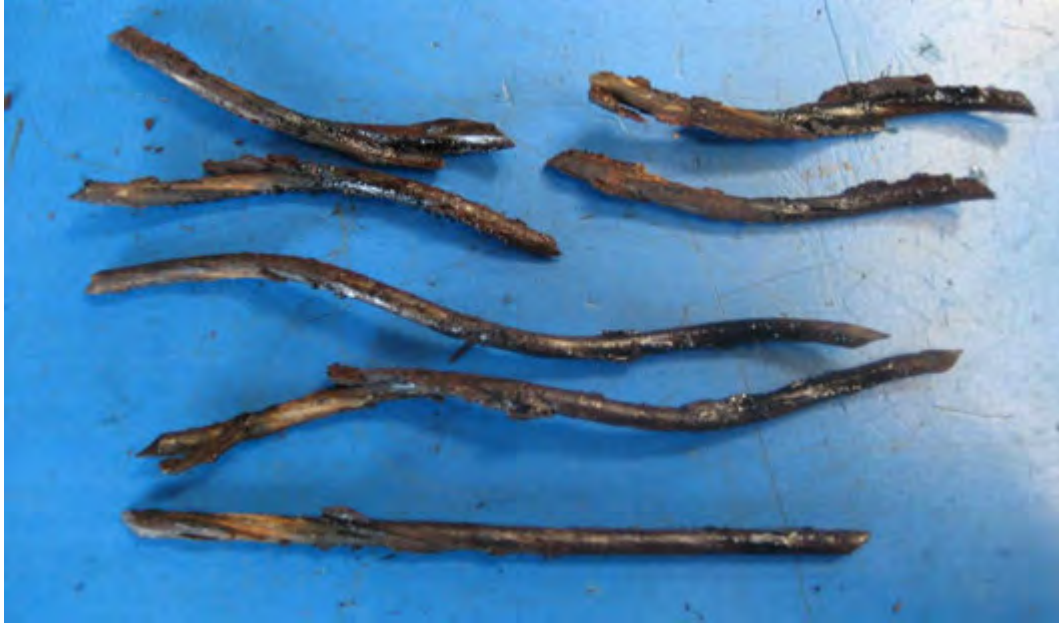
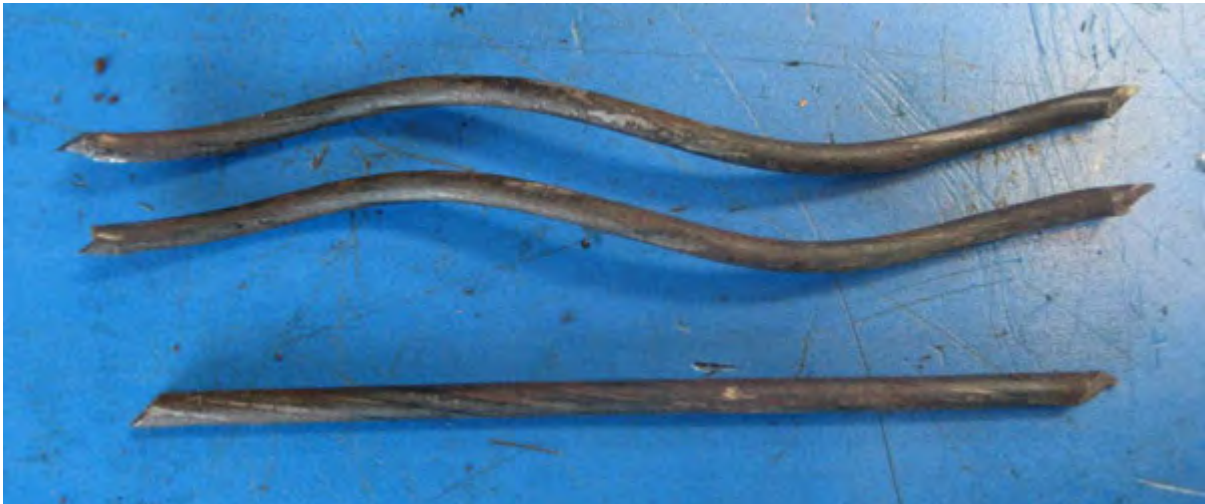
**Figure 10.38:** Bridle sample IWRC core, (some) outer wires and core wire (bottom).

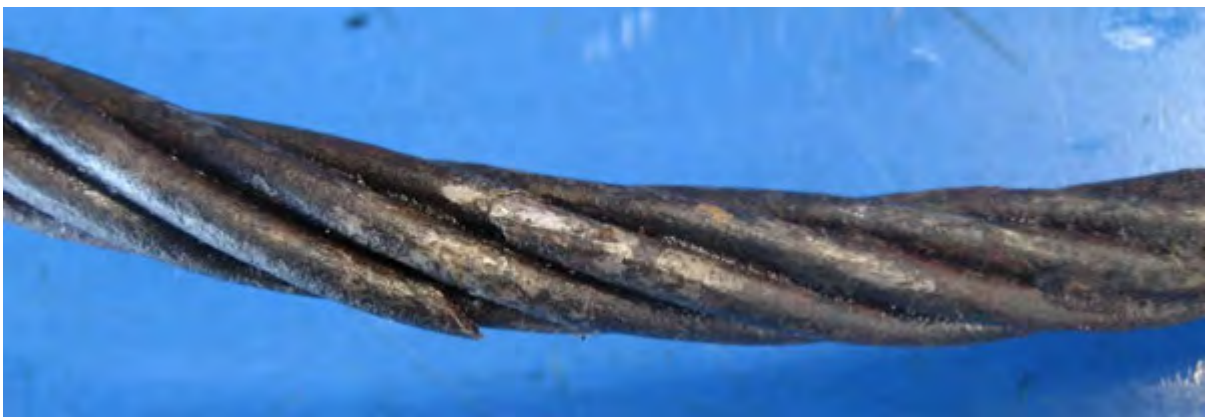
Figure 10.39 shows a IWRC strand after removal from the core and cleaning. The wire breaks are typical of those found in the core strands. As with the tug side sample, all strands and the core were stripped down to count the number of breaks. In the IWRC outer strands 69 wire breaks were counted and in the core 48 (total 117 breaks in 1 m of IWRC).

**Figure 10.39:** Bridle sample IWRC outer strand (after cleaning).

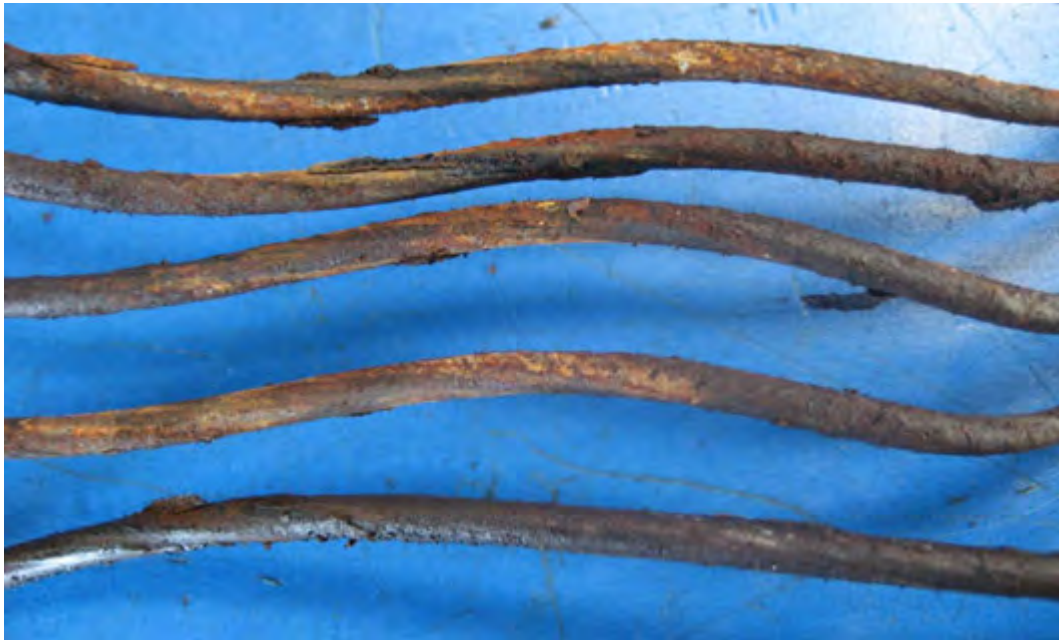
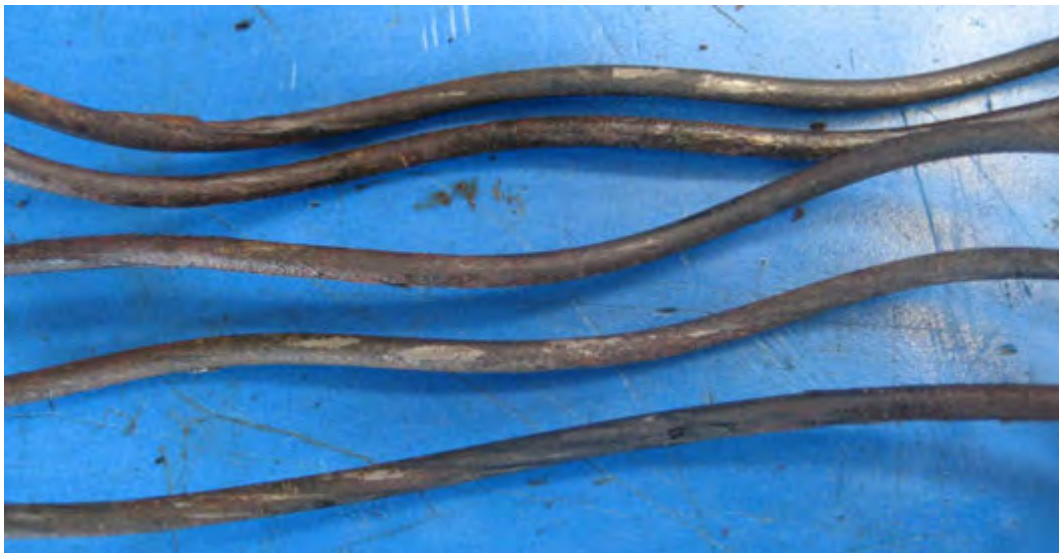
Figure 10.40 shows a section of dismantled IWRC strand before and after cleaning. As with the core strand the residual galvanising is very low. Additionally, some areas of the wire surface show a roughening from the start of corrosion.

**Figure 10.40:** Bridle sample IWRC strand, (some) outer wires and core wire (bottom).
