## Inspection and testing of failed tow wire rope from tug *ALP Forward*

### FINAL REPORT

TTI Reference number TTI-IMLR-2016-5284

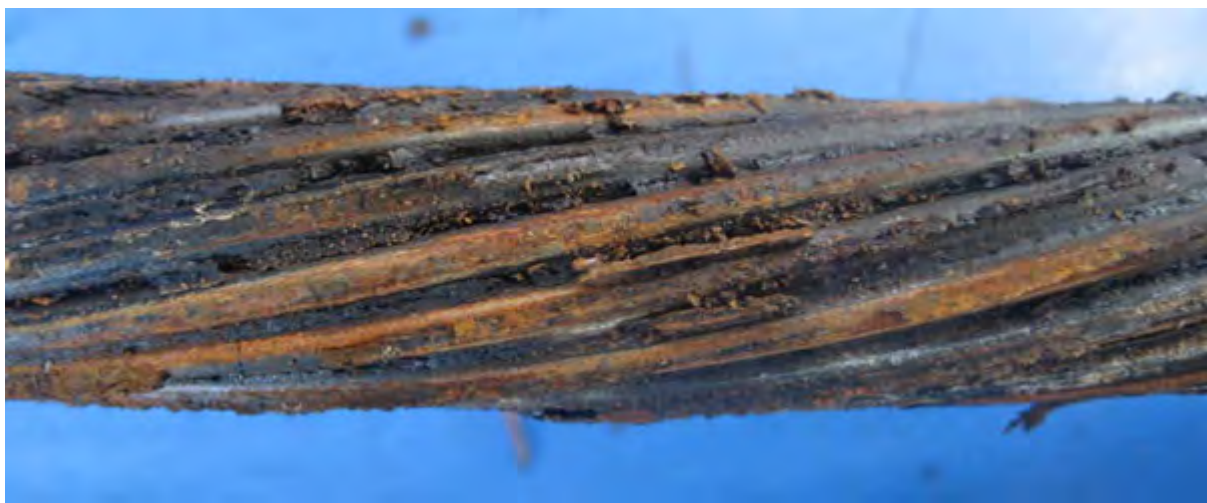
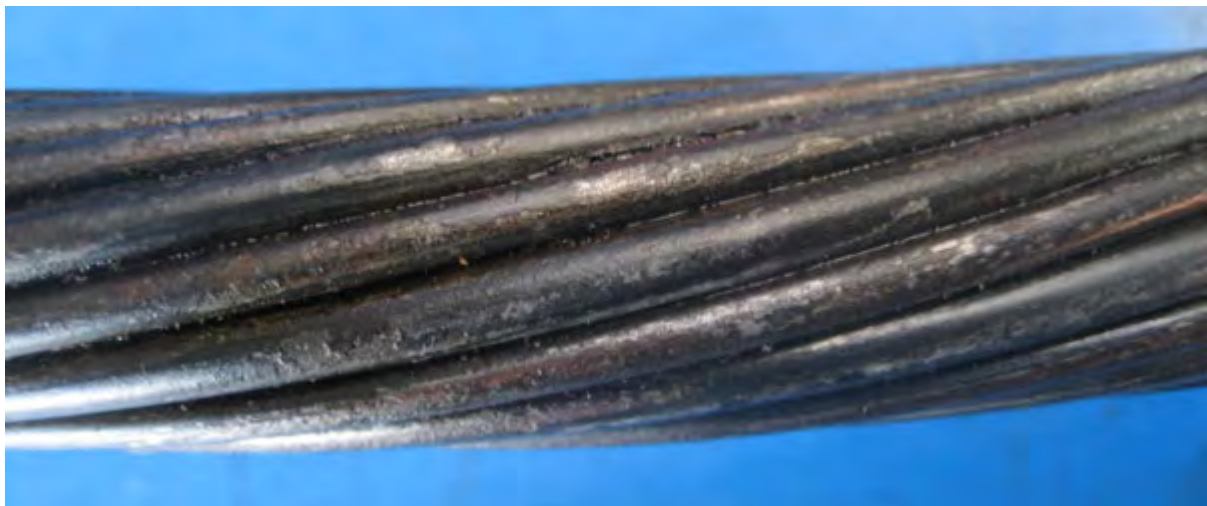
Figure 10.43 shows the second layer of the main strand before and after cleaning. The level of lubricant is already much better than on the outer layer of wires, although somewhat flaky and denatured. The cleaned wires show very little residual galvanising, and a slight roughening of the surface indicates the onset of corrosion.

**Figure 10.43:** Bridle sample main strand second layer of wires.

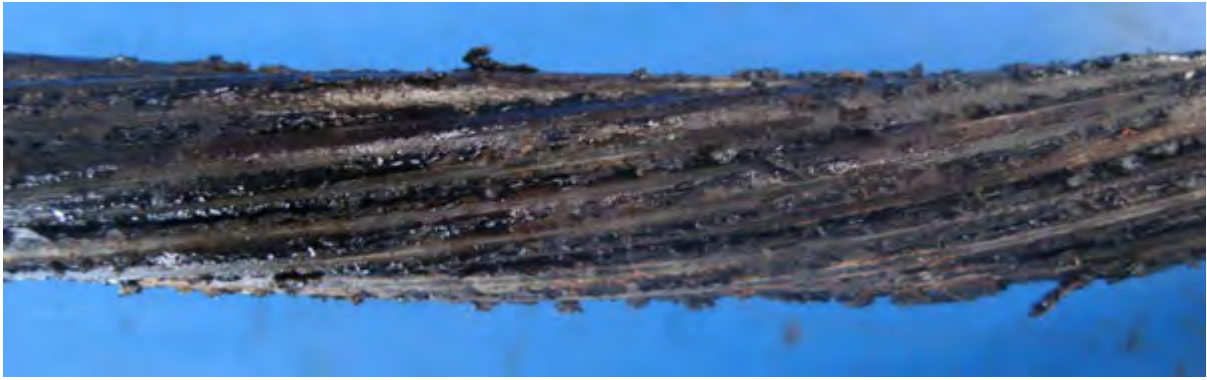
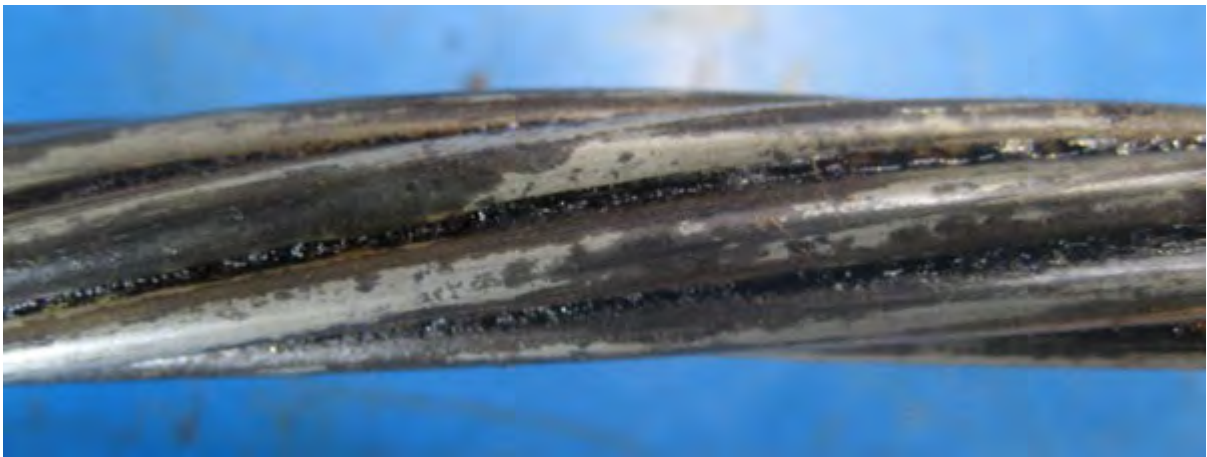
As with the tug side sample, further 'into' the strand the nature of the lubricant and level was better, and the wires had retained more of their galvanic protection (Figures 10.44 and 10.45). No corrosion was noted in the third and core layers.

**Figure 10.44:** Bridle sample main strand third layer of wires.

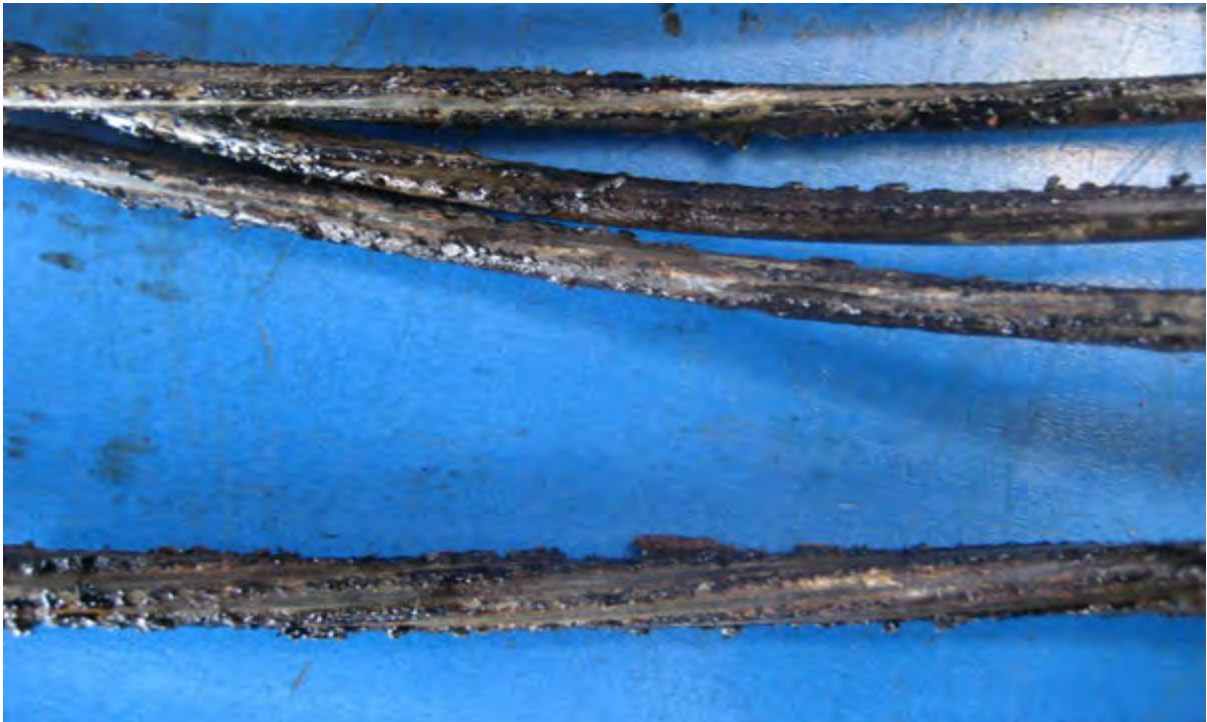
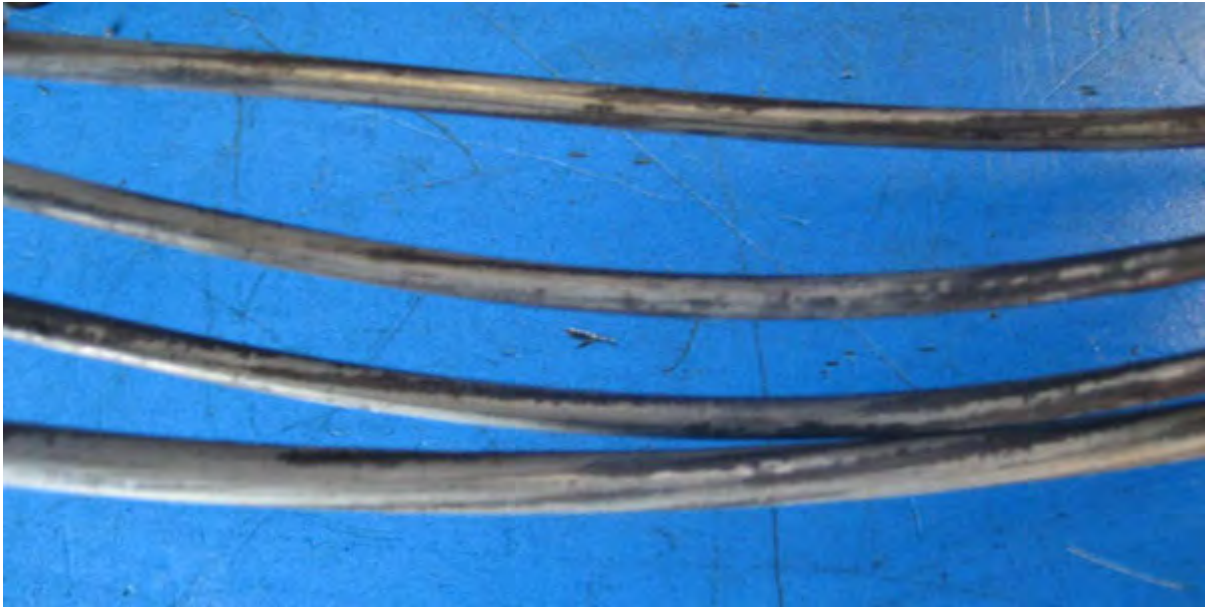
**Figure 10.45:** Bridle sample main strand (some of) the third layer of wires and core wire (bottom).

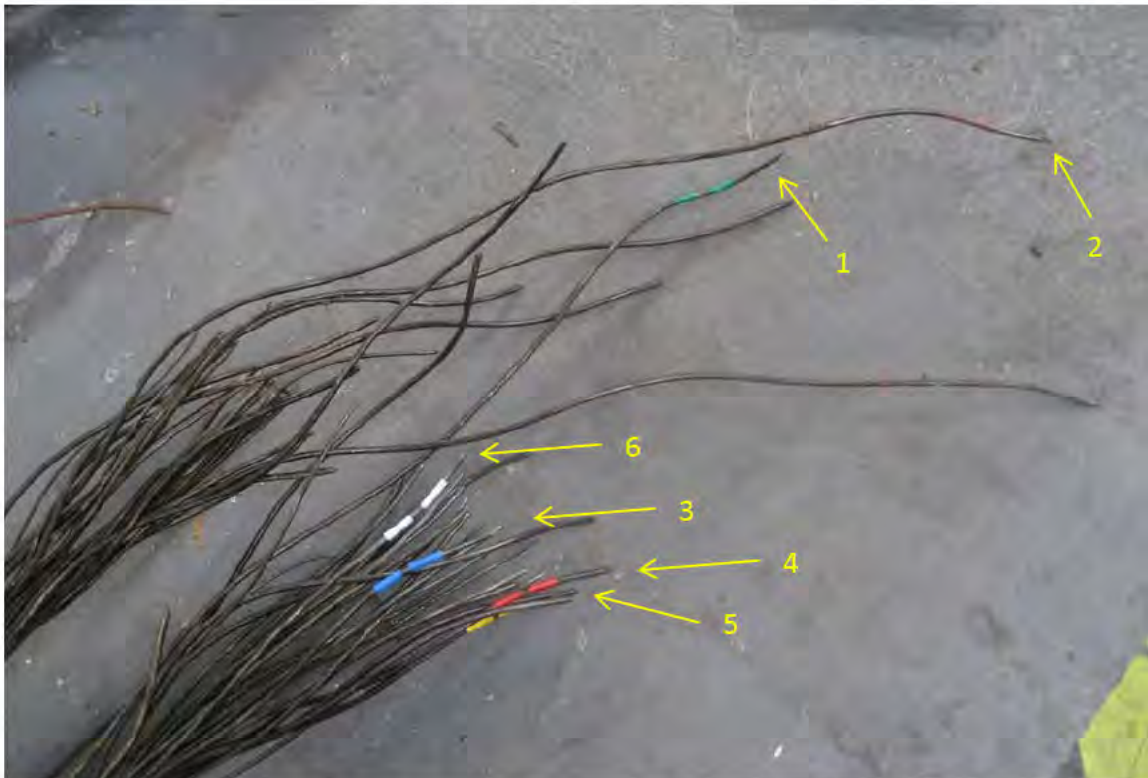
Figures 11.1 and 11.2 show the main failure of two of the strands. It may be seen that the failure position is generally at the same axial location, but with some longer wires which were probably already broken and pulled away from the construction (e.g. Figure 11.3). As with the break load samples (§9 tug side and bridle), the tendency was for the main strand inner wires to break with cup and cone type fractures (Figure 11.4), and the outer strand outer wires to break with predominantly shear failures (Figure 11.2, Figure 11.5).

The nature and distribution of the wire breaks on the main failure point towards failure primarily from tensile overload on a sample weakened by wire failures caused before or during the storm.

**Figure 11.1:** Tug side sample main failure Locations and ID numbers of wire fracture surfaces taken for further examination.

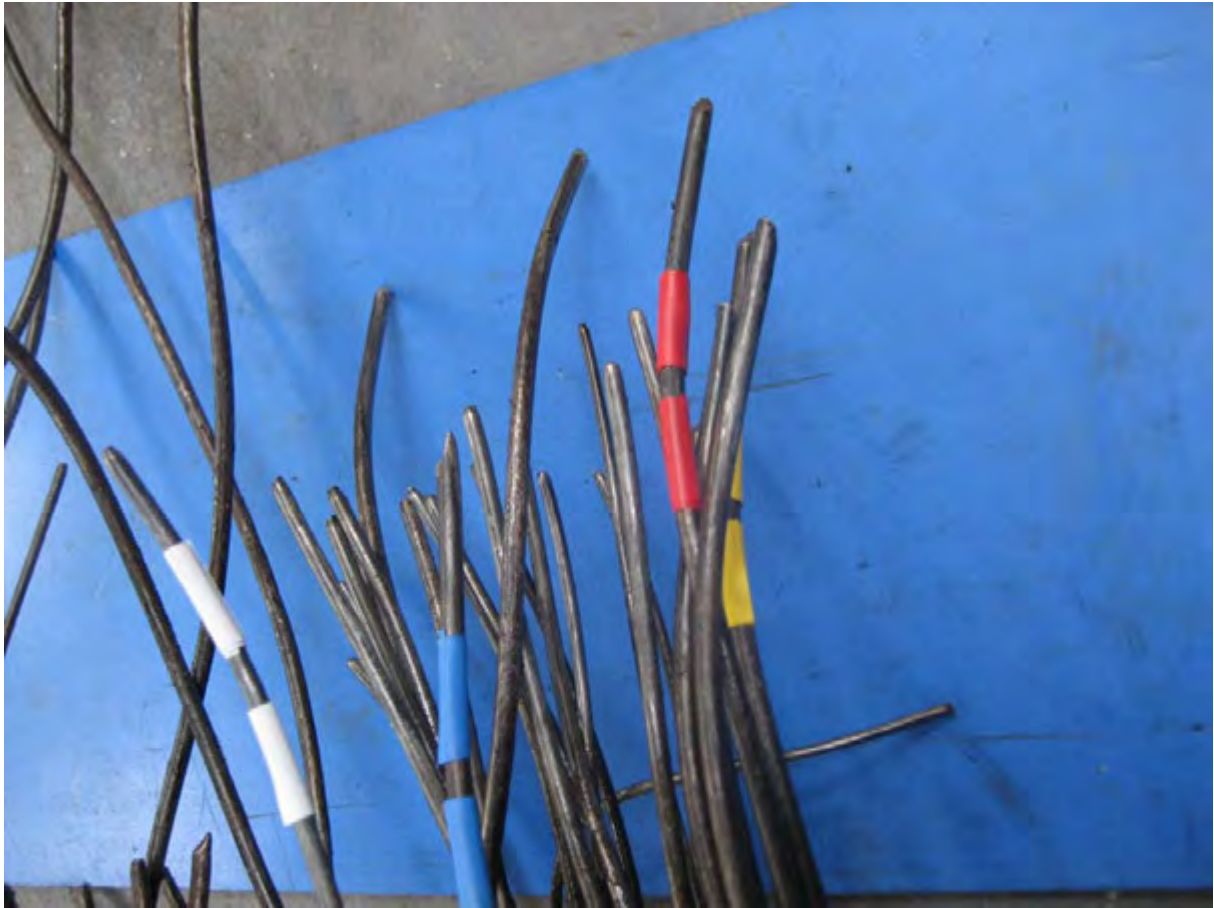
**Figure 11.2:** Tug side sample main failure, detailed view on one strand.

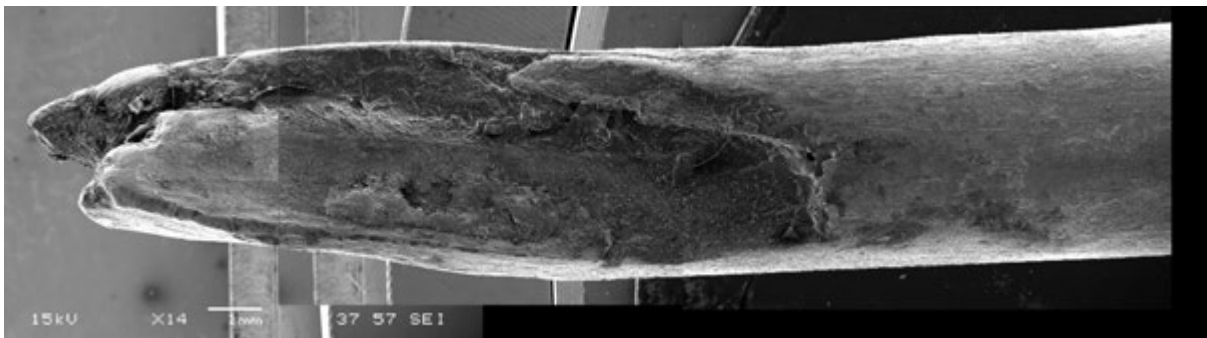
**Figure 11.3:** Composite SEM image of Wire 2 showing non tensile type failure.

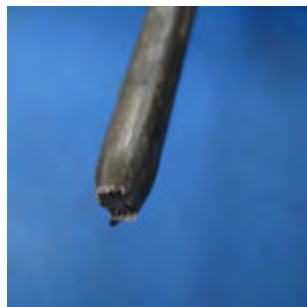
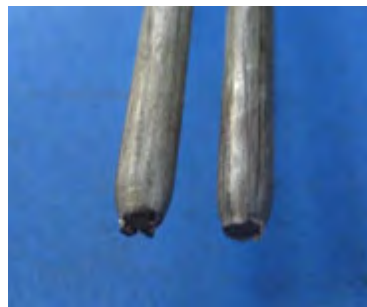
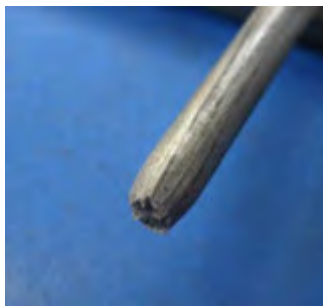
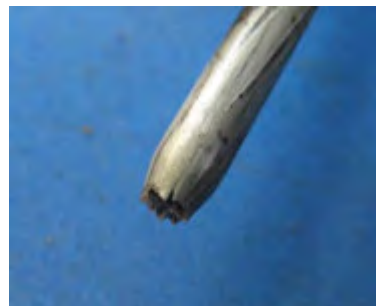
- The results of the tensile tests were very consistent, and very good. With the exception of one wire (at 99%) all wires were in the range of 101% - 109% of the average wire grade stated on the manufacturer's certificate (see Table 2.2 and Appendix A). Wire breaks were typical cup and cone type failures, which was as expected (Figure 14.1).

**Figure 14.1:** Typical appearance of wire failures in tensile tests on wires from the drum sample.

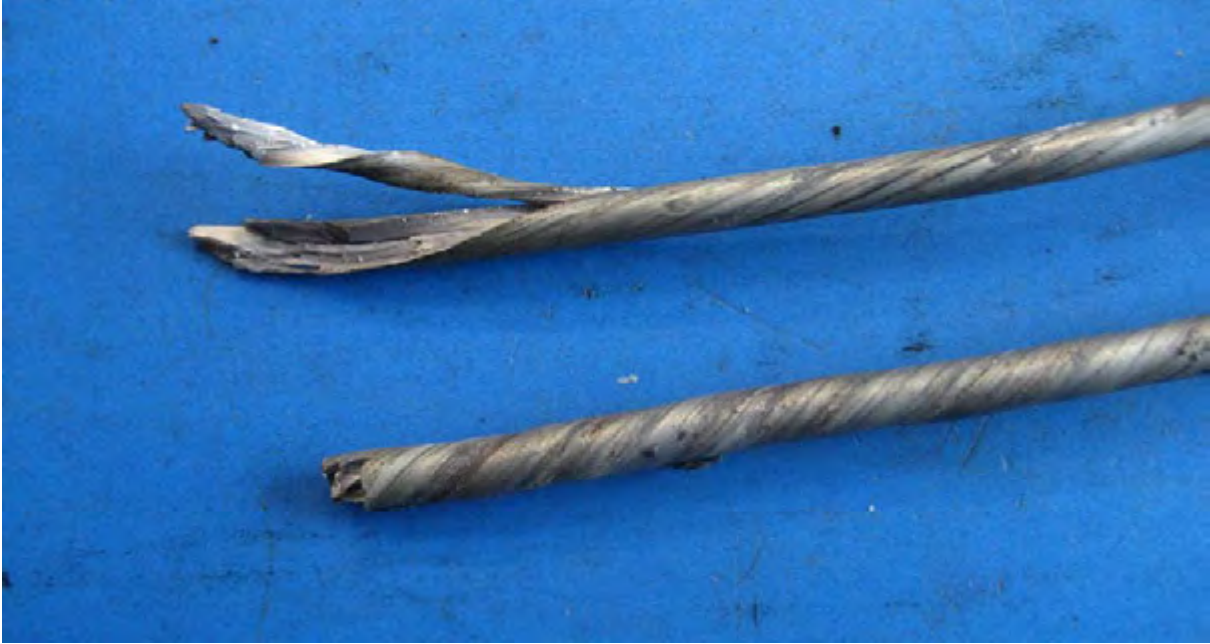
- The results of the torsion tests were a little more varied. The wires either passed by some margin or failed rapidly (Figure 14.2). The torsion test is very sensitive to surface condition, and it maybe that surface of the outer wires on some of the outer strands was damaged leading to premature failure. The results of the tests on the wires from the inside of the main strands were generally very consistent and good. The tests undertaken on the IWRC wires were generally low. It is thought that the reason for this may be the effort put into straightening the wires for testing. It is easy to damage a wire despite taking great care in sample preparation. In contrast the core wire which required no straightening performed well.

**Figure 14.2:** Appearance of wire failures in torsion tests on wires from the drum sample. (Top OS OW1 (7 turns/100d<sub>w</sub>), bottom OS CW (27 turns/100d<sub>w</sub>)).

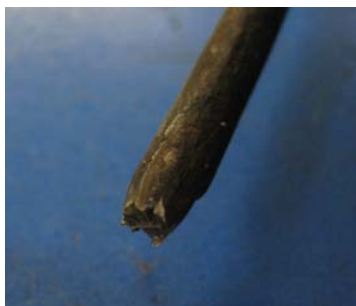
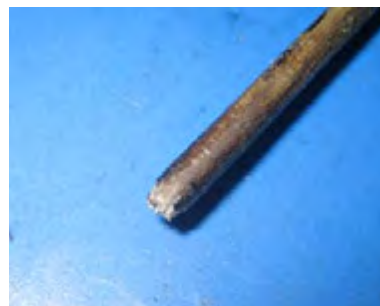
- The results of the tensile tests on the outer strand outer wires were consistently all a bit low (one at 83%, others at 92% to 99%), (Figure 14.3). The results of the tests on the main strand inner wires were all very good (100% to 109%). The IWRC wires were in the range 97% to 104% of the assumed original grade.

**Figure 14.3:** Typical appearance of wire failures in tensile tests on wires from the tug side sample.

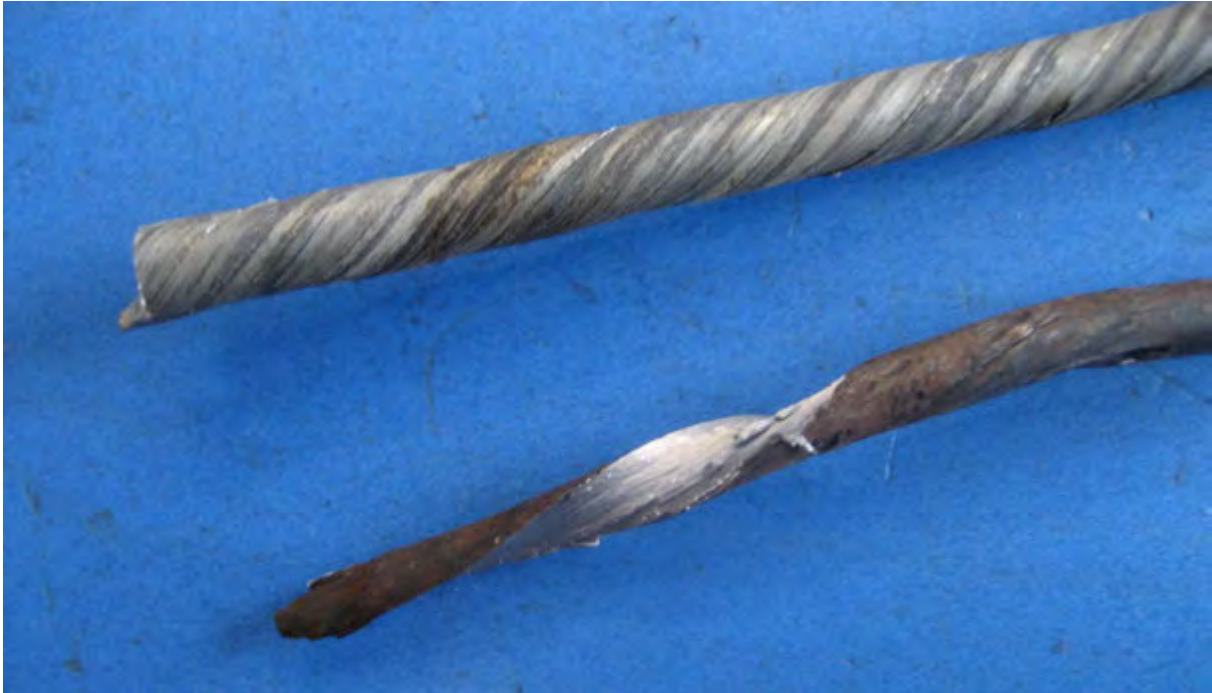
- The results of the torsion tests on the outer strand outer wires were all very low, typically about 10% - 30% of the standard minimum requirement. The results of these tests were significantly affected by the surface damage (wear) and corrosion noted on the sample during the inspection (Figure 14.4). In contrast, all the wires on the inside of the main strands performed well. These wires had not experienced surface damage and were not corroded. The IWRC wires were very poor, but this is to be expected given the state of the IWRC (two wire sizes could not be tested as a sufficiently long sample could not be obtained!).

**Figure 14.4:** Appearance of wire failures in torsion tests on wires from the tug side sample. (Bottom OS OW1 (3 turns/100d<sub>w</sub>), top OS CW (27 turns/100d<sub>w</sub>)).

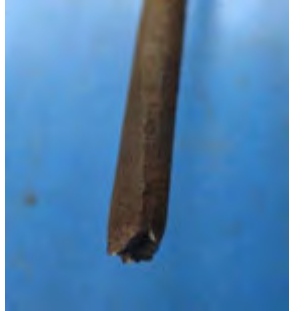
- The initial inspection had shown that the condition of the bridle sample was similar to that of the tug side sample. If anything the results were a little lower for the bridle sample. The outer strand outer wires were affected by surface abrasion (Figure 14.5), leading to results of 73% - 90% of the original strength. The wire rope wires from inside the outer strands which were not affected by abrasion all performed well (100% to 108%) as did the IWRC wires (100% to 104%).

OS2 OW3 - note surface abrasion

**Figure 14.5:** Typical appearance of wire failures in tensile tests on wires from the bridle sample.

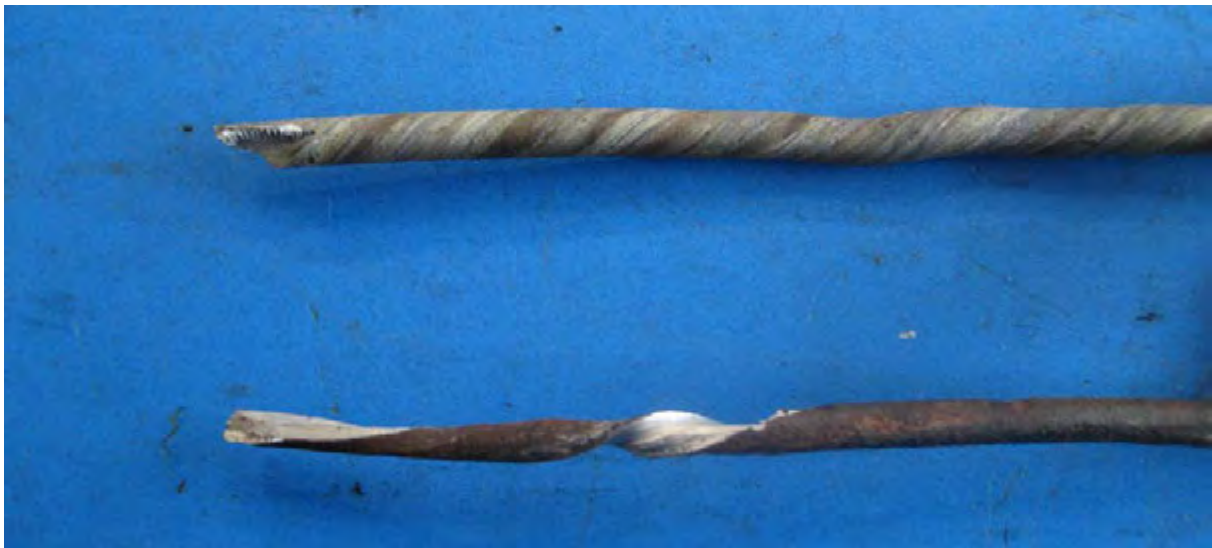
- The results of the torsion tests followed the familiar pattern - the outer strand outer wires were low, typically 10% - 30% of the standard minimum requirement. The outer strand inner layers of wires were comfortably in excess of the minimum, whilst the IWRC wires (where available) performed poorly.

**Figure 14.6:** Appearance of wire failures in torsion tests on wires from the bridle sample. (Bottom OS1 OW3 (3 turns/100d<sub>w</sub>), top OS1 CW (30 turns/100d<sub>w</sub>)).

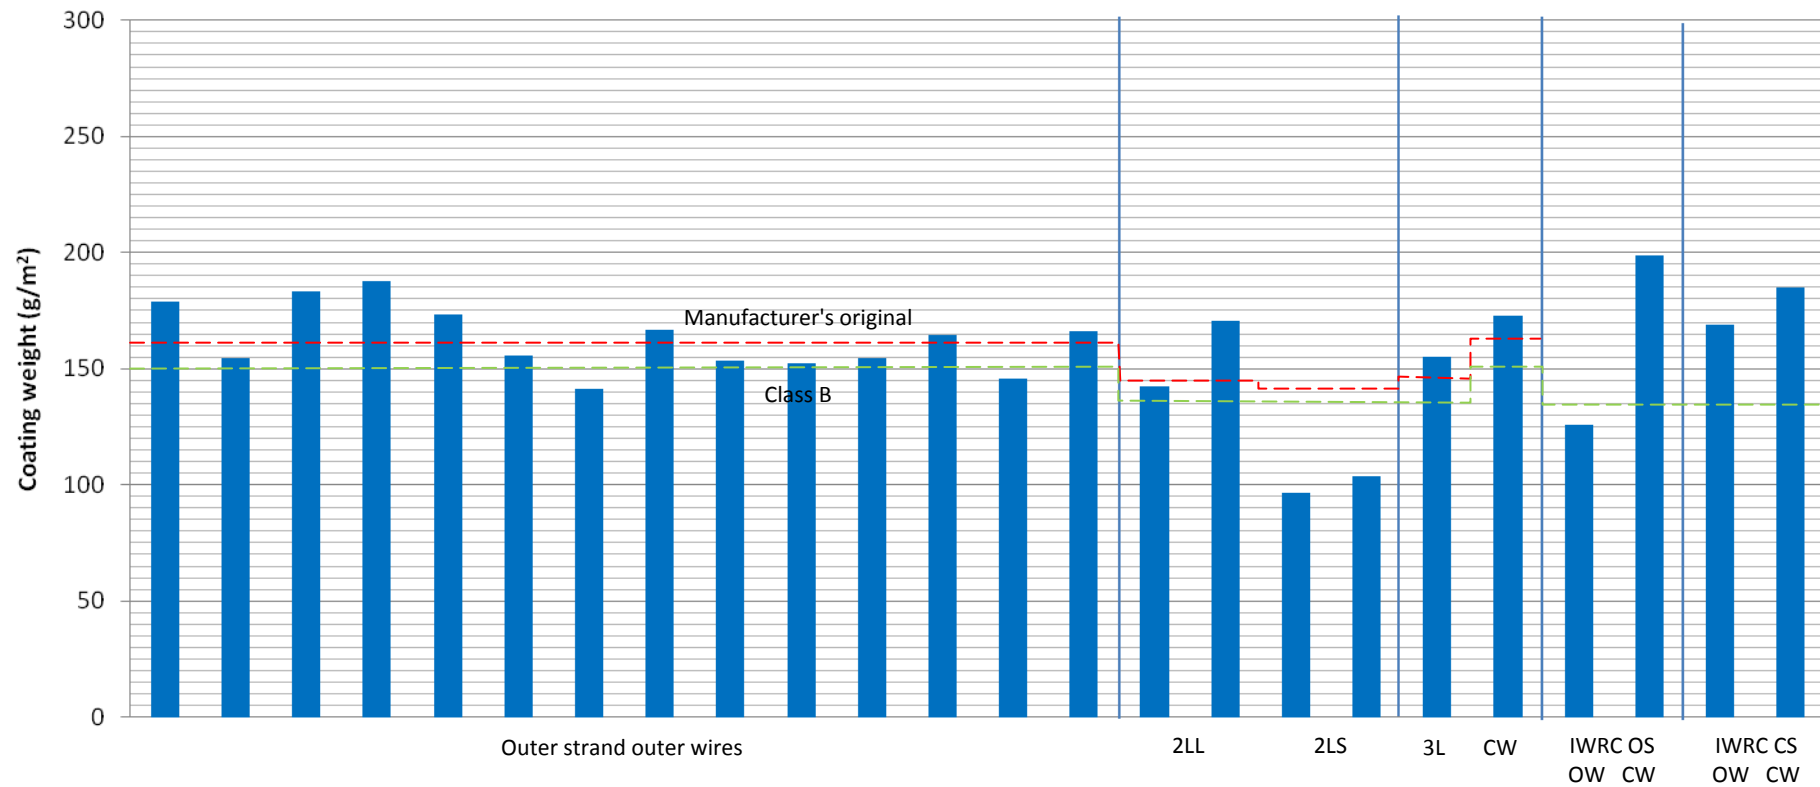
**Figure 15.1:** Measured average residual galvanising on wires from various positions in the wire rope construction on the drum sample.

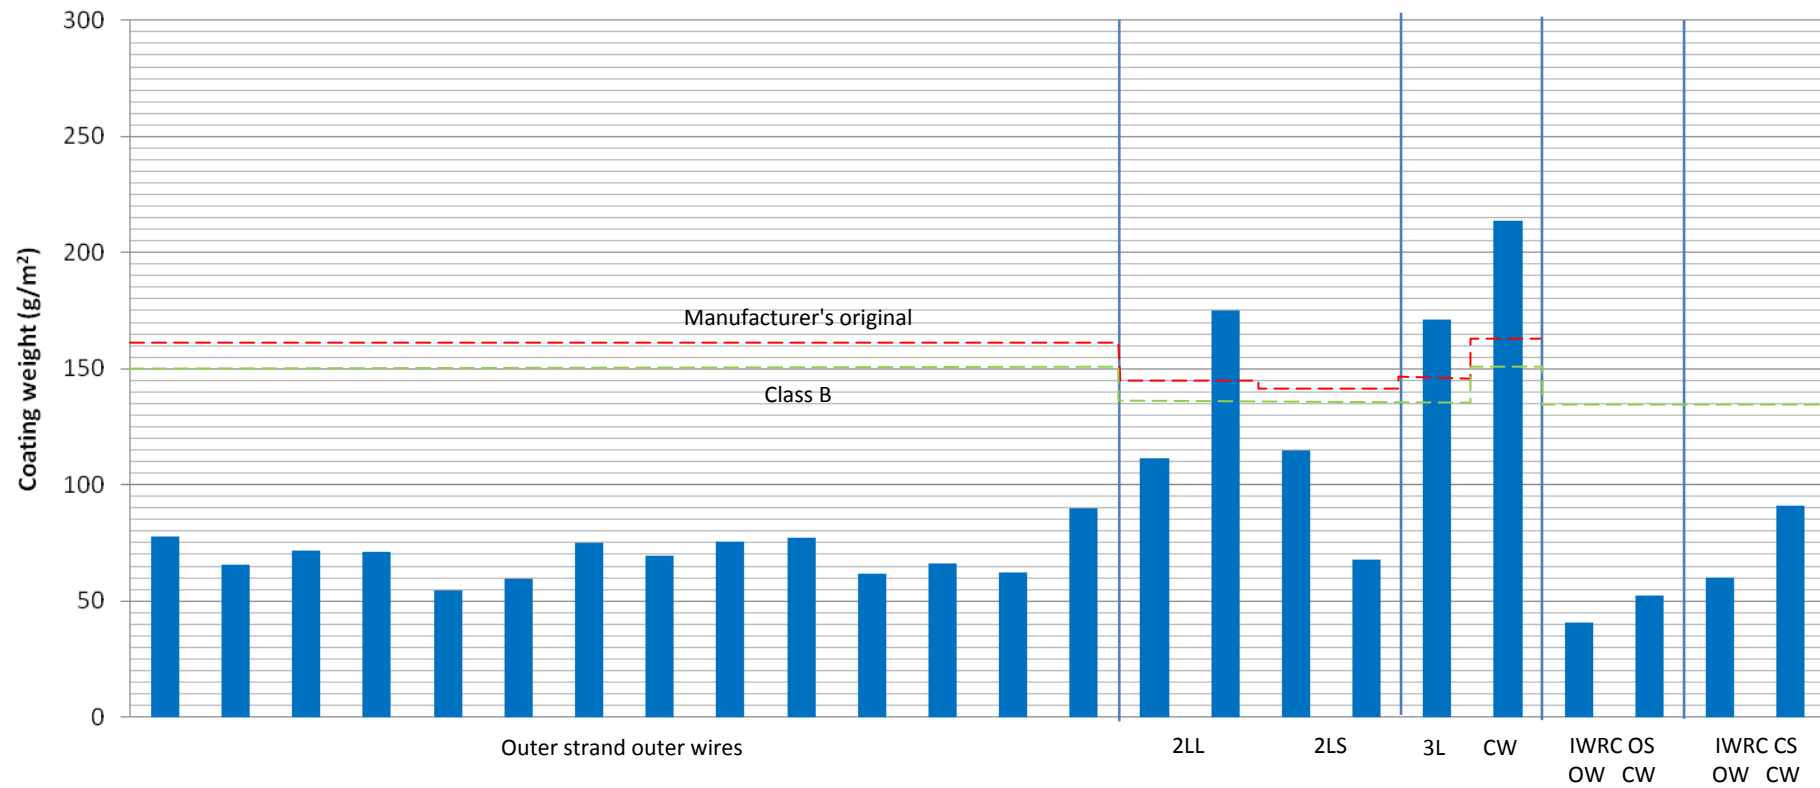
The outer wires of the outer strands of both the tug side and bridle samples are both well down. Remember that the coat weight measurement is an average figure, and does not distinguish any distribution - so a wire may be corroding on an exposed section and protected on the section towards the inside of the wire rope.

**Figure 15.2:** Measured average residual galvanising on wires from various positions in the wire rope construction on the tug side sample.

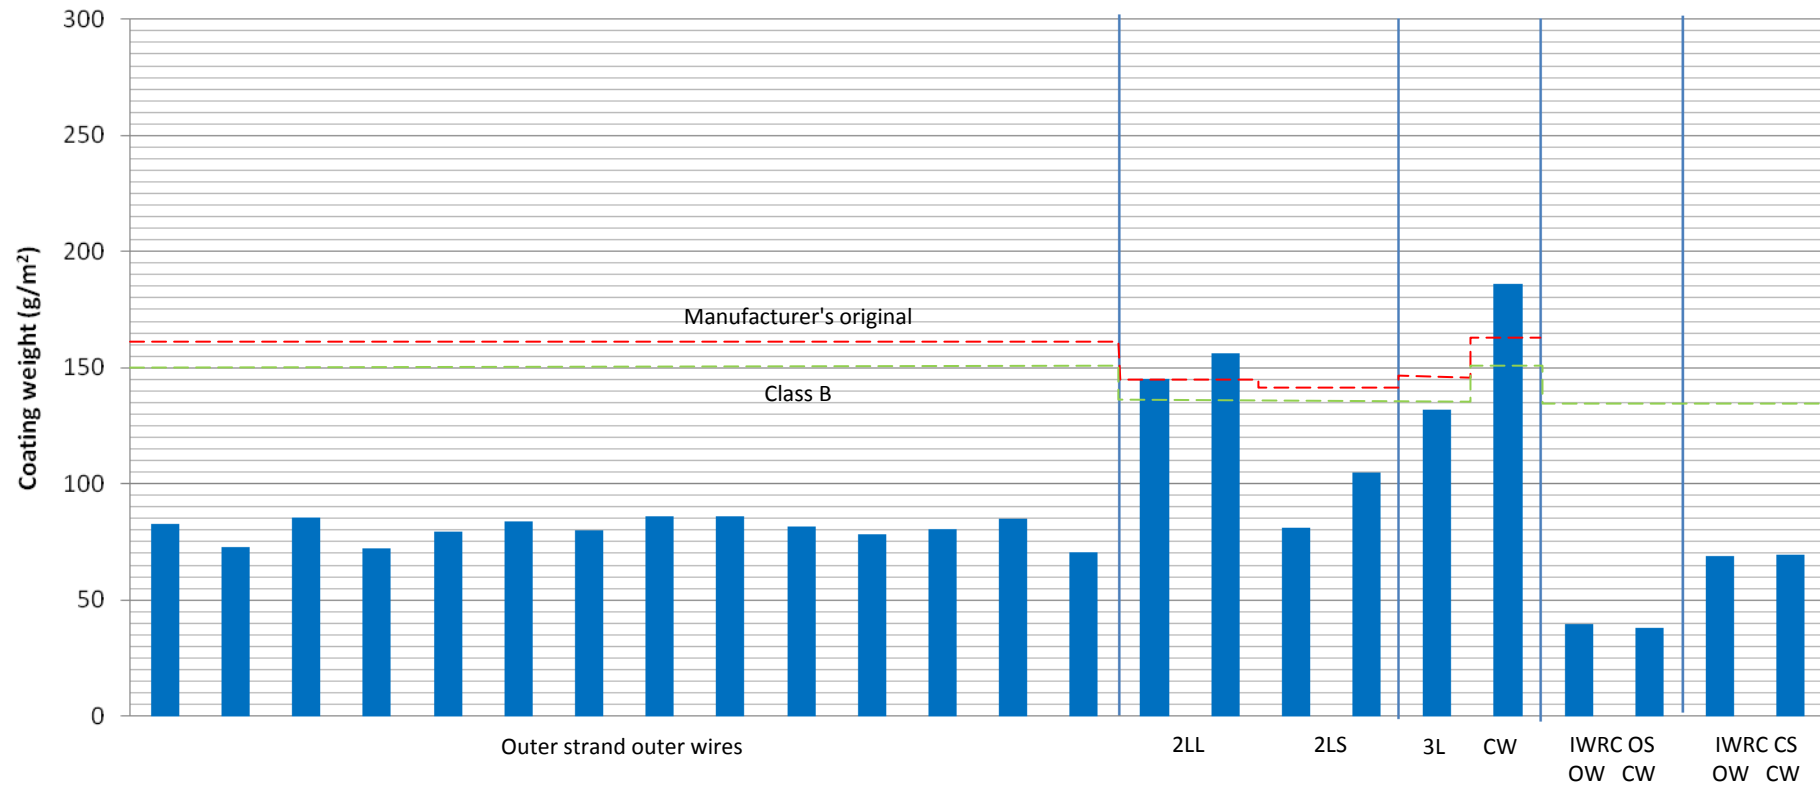
**Figure 15.3:** Measured average residual galvanising on wires from various positions in the wire rope construction on the bridle sample.

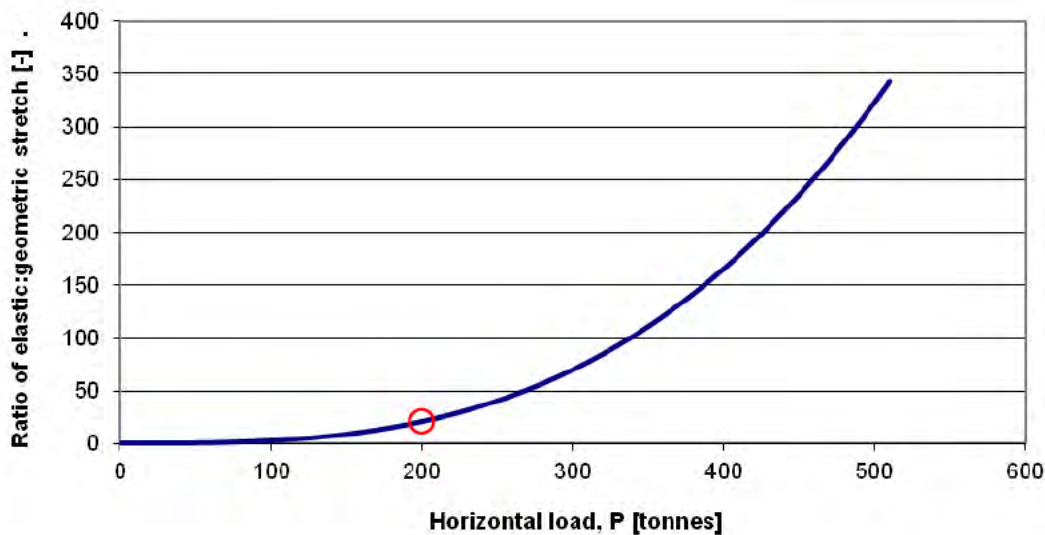
Figure 16.4 shows the ratio of the contribution of these two elements to the elasticity of the system (the inverse of stiffness) over the range of loads. As an example, at 200 tonnes (the mean load just at the time of failure [3], the ratio is 20.7:1, so the stretch accommodates 20.7 times as much of the elongation as the change in catenary shape. It can clearly be seen; that for the towing application, especially at the loads we are interested in, the dominant factor is the elastic stretch of the line.

**Figure 16.4:** Ratio of the contributions of elastic : geometric stretch for a range of loads. The red circle shows the point for 200 tonnes horizontal load, where curve shows that the ratio is 20.7:1.

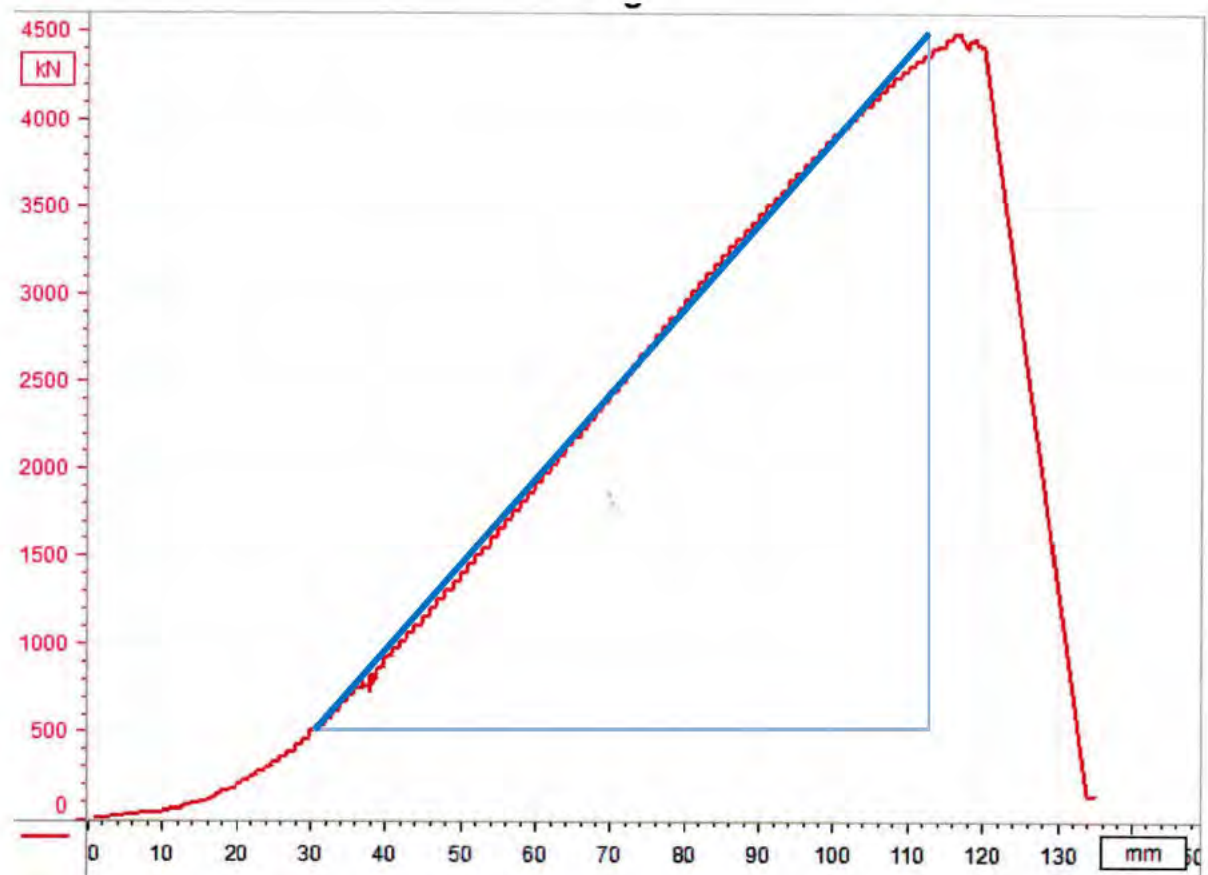
**Figure 16.5:** Load-extension measurements for the drum sample (77 mm 6×37 + IWRC RHO) during the breaking load test (3190 mm long).

In this equation the term  $\Delta F / \Delta \ell$  is the slope on the graph (shown by the blue line in Figure 16.5). The slope of the blue line in Figure 16.5 is 49.8 kN/mm and the length  $\ell$  is 3190 mm, which gives a value of **EA of 159 MN**.

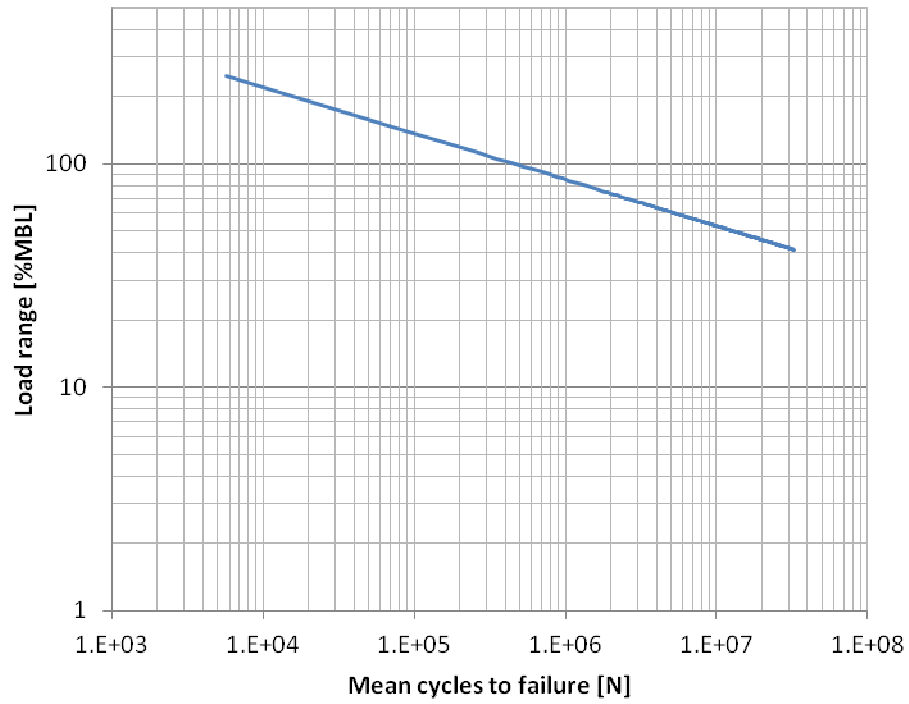
Figure 16.7 shows the predicted number of cycles to failure for a rope loaded from zero to peak tension (the load range) for varying load ranges. By way of example, it may be seen that for a peak tension of 240 tonnes, the predicted number of cycles to failure would be 5,745 cycles. At a period of 14 s, failure would occur after about 22 hours.

**Figure 16.7:** Mean cycles to failure as a function of load range based on API RP 2SK [13].

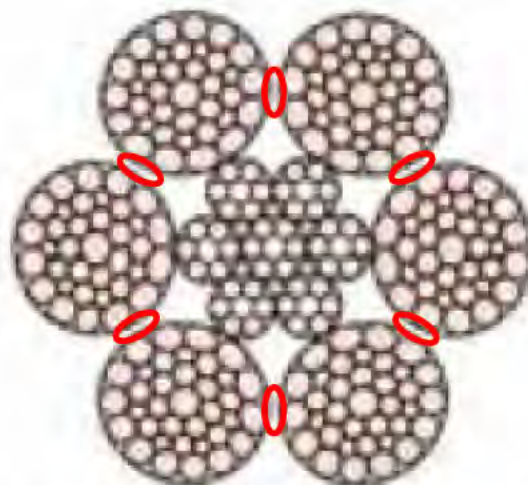
The loss of strength due to the core disintegration was one issue, but another problem is that the damaged core was unable to provide proper support to the outer strands. As the core collapsed, so the outer strands contacted one another leading to a series of breaks in the strand valley positions (see Figures 9.10, 10.42 and 17.1). It is noted that the outer strand outer wires represent about 44% of the metallic sectional area in the wire rope (so each wire is roughly 0.5% of the total area).

**Figure 17.1:** Wire rope (6 × 37 + IWRC 'Super Titan') cross-section showing inter strand contact positions exacerbated by an incorrect size (small) or damaged/worn core.
