Report on the investigation of the loss of control and
grounding of ro-ro passenger ferry

Hebrides

Lochmaddy, North Uist

25 September 2016

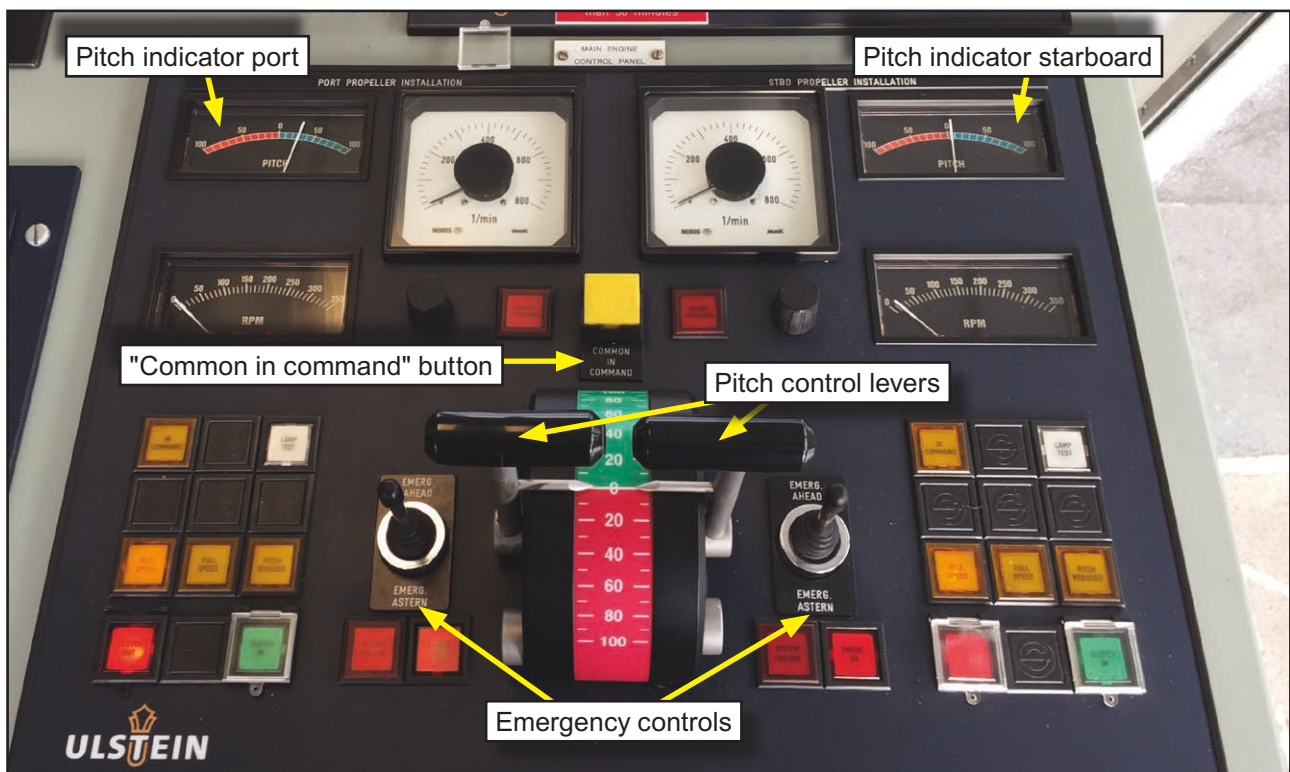
Figure 4: Propulsion control panel (starboard console)

The third officer prompted the master to de-clutch the port shaft. The master depressed the port shaft 'clutch-out' button on the starboard wing console (Figure 4) several times, accidentally breaking the button's protective cover as he did so. However, the port shaft remained clutched in. The master was not aware that the ECR had taken control of the port CPP or that the chief engineer had set the port

If the primary control system failed a secondary system could be selected by pressing the 'emergency control' button on any of the three bridge panels (**Figure 4**). The pitch and direction set on the CPPs was then adjusted by joy sticks. A warning indicator lamp illuminated on the bridge panel in control and on the ECR panel when the emergency control had been selected.

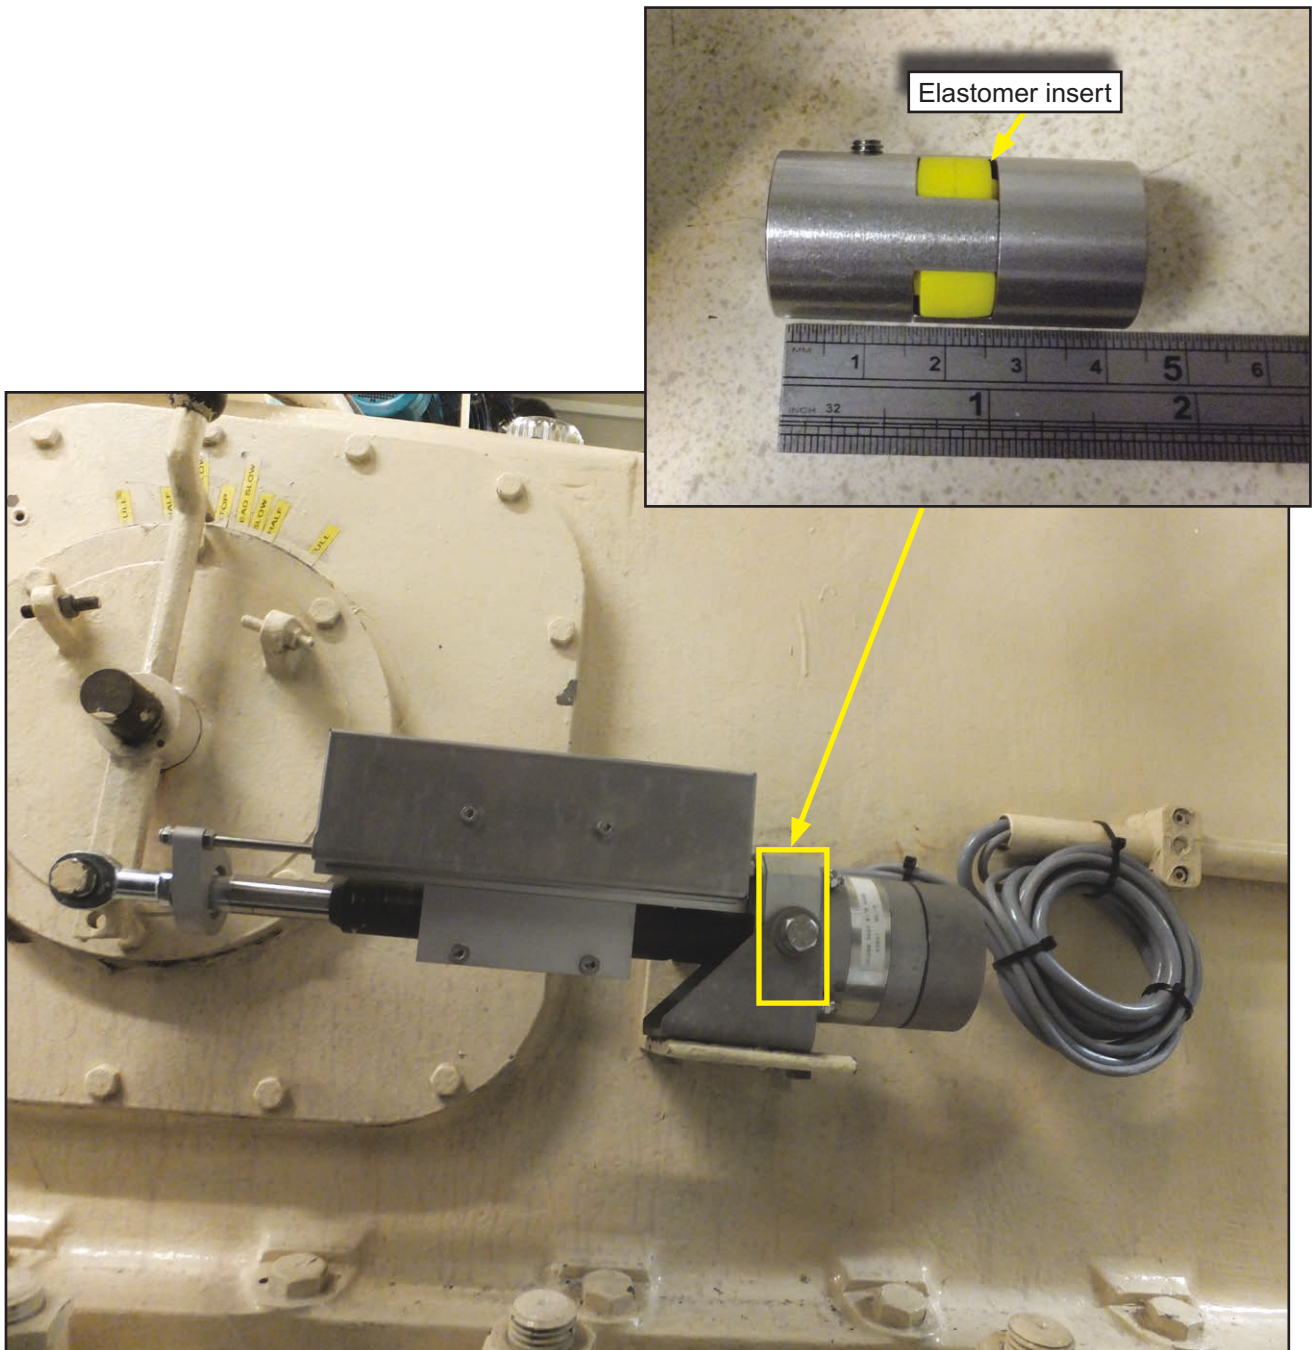
Figure 15: Linear servomotor actuator (with jaw coupling)

The linear servomotor actuator on the port gearbox (**Figure 6**) was supplied by Scana Mar EL (Scana) to RR Marine as a complete unit. It comprised a stepper motor and ball screw unit connected by a flexible jaw coupling. The jaw coupling comprised two halves, each with two protruding spigots that interlocked when the two halves of the coupling were engaged (**Figure 15**). The interlocked spigots were kept spaced evenly apart by an elastomer insert known as a spider, which absorbed torsional vibration and prevented backlash.

The job description for the inspection of the actuator, written by Scana, is at **Annex C**. The instructions recommended annual inspection of the jaw coupling to check for, among other things, the security of the setscrew and wear or damage to the elastomer spider. The instructions also indicated that thread locking fluid was to be used to secure the coupling setscrew. The suggested service life of the actuator was 15000 hours in operation (subject to the replacement of worn parts).

The service instructions for the actuator were not included in the system's engineering manuals carried on board *Hebrides* that had been provided by RR Marine. Furthermore, RR Marine had not issued any information regarding the maintenance or inspection of the actuator.
