TECHNICAL REPORT

Discipline or report series#10 E&T Materials- Failure Investigation	Document number#12 DNS206728	Report number#52 DNS206728	Issue#13 2
Title#15 Investigation into the functional failure of a propulsion propeller pitch-control actuator of MV Hebrides, operated by Caledonian MacBrayne. Pitch control was delivered as part of the propulsion system by RR Marine.			
Authors#20 [REDACTED]		Telephone: [REDACTED]	Date#40 30/03/2017

Summary#60 The MV Hebrides ferry operated by Caledonian MacBrayne ran aground in Lochmaddy Marina in North Uist Sep 25, 2016 at 1105 a.m. LT while approaching the berth. It was reported that the grounding was caused by a technical failure of the port pitch control system. The pitch is set by a stepper motor which depends on a grub-screw for transfer of torque between the motor and the actuator via a three part coupling. The preliminary investigation carried out by the Marine Accident Investigation Board (MAIB) determined that the failure of the pitch control was caused by the grub-screw unscrewing from its intended position. In addition to the three parts of the coupling, the grub-screw and the motor shaft, the investigation also examined a new

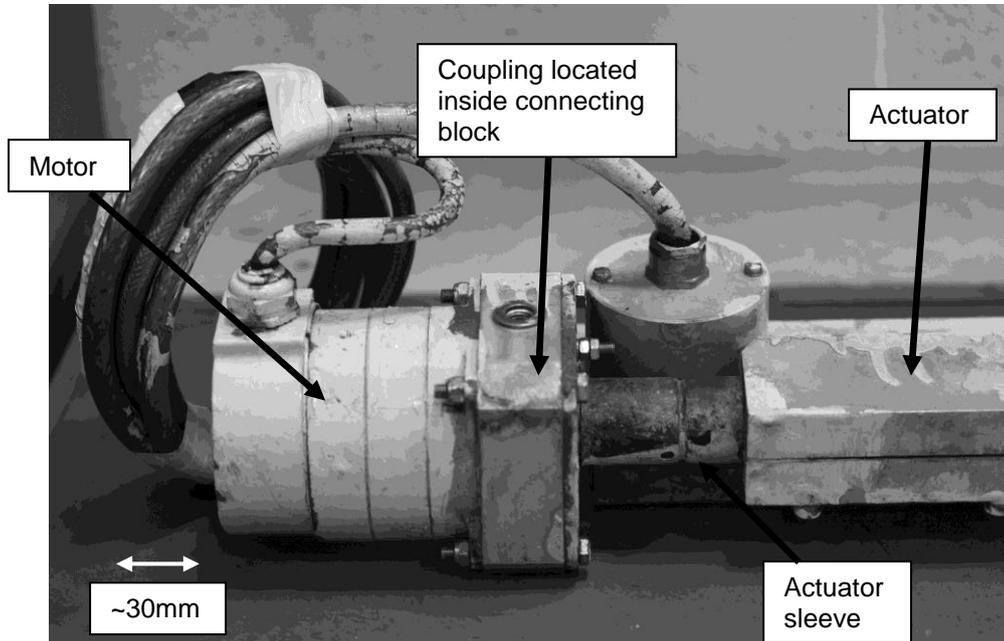
Figure 1. The image shows the pitch control assembly with the motor to the left and the actuator to the right. The coupling with the grub-screw is located inside the block at the centre of the assembly.

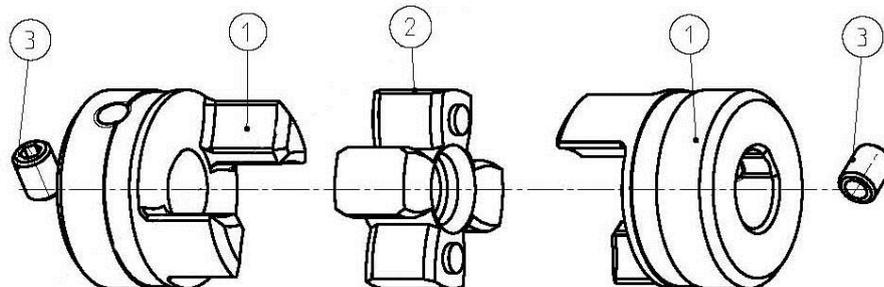
The preliminary investigation also found that the motor coupling had been machined to fit the motor shaft.

Figure 2. The transfer of torque from the motor to the actuator is via a three part coupling. The three parts of the coupling are the two coupling halves (no.1) and a polymer “spider” (no.2). The prongs of the polymer spider located between the two halves prevents metal to metal contact. The motor coupling half is secured to the motor D-shaft by a grub-screw (no.3). The sketch above shows a slightly different coupling. The actual coupling investigated had straight sided cylindrical outer diameters and was supplied with key and keyway for the actuator half rather than a grub-screw.
