ACCIDENT

| Aircraft Type and Registration: | North American P-51D Mustang, G-MSTG |
| Date & Time (UTC): | 2 October 2016 at 1434 hrs |
| Location: | Topcroft Farm Airstrip, near Hardwick Airfield, Norfolk |

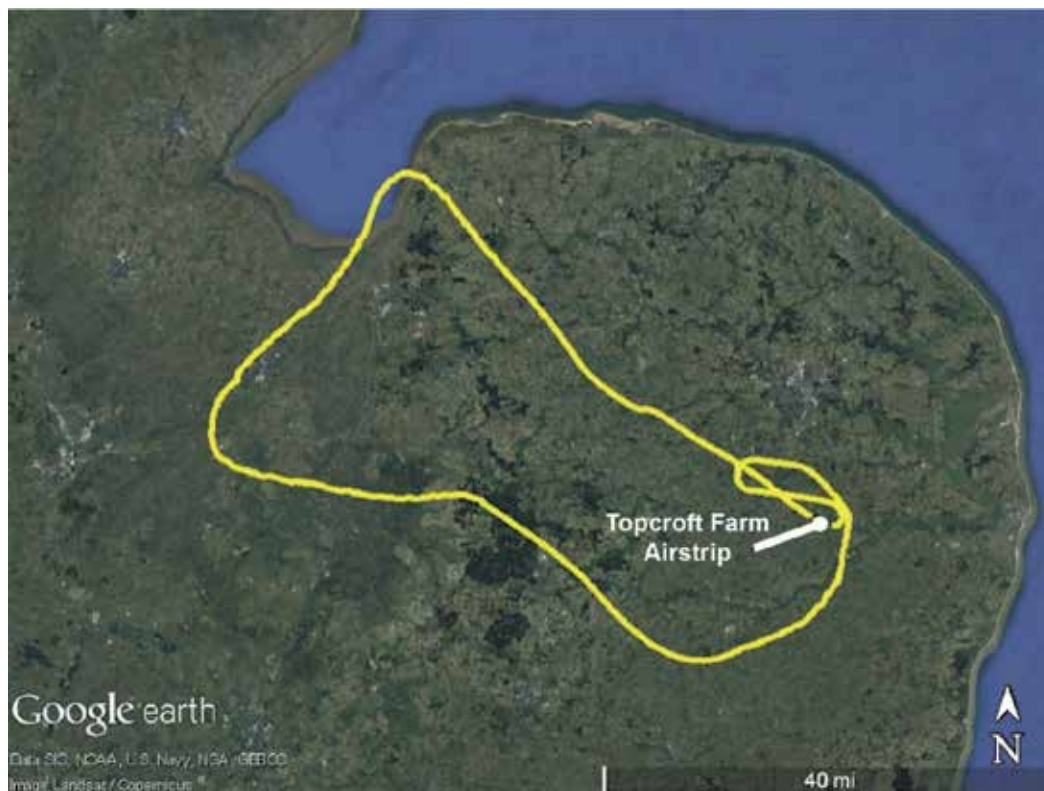
Figure 1

The aircraft took off from Runway 28 at approximately 1348 hrs and flew north-west towards The Wash. It then flew inland to turn onto a south-easterly track near March, turning west of Eye towards Bungay and then back towards Hardwick (Figure 1).

Radar track of G-MSTG

Radar coverage in the area did not extend to ground level in the area of the airstrip, however, radar recordings provided an overview of the flight (Figure 1).

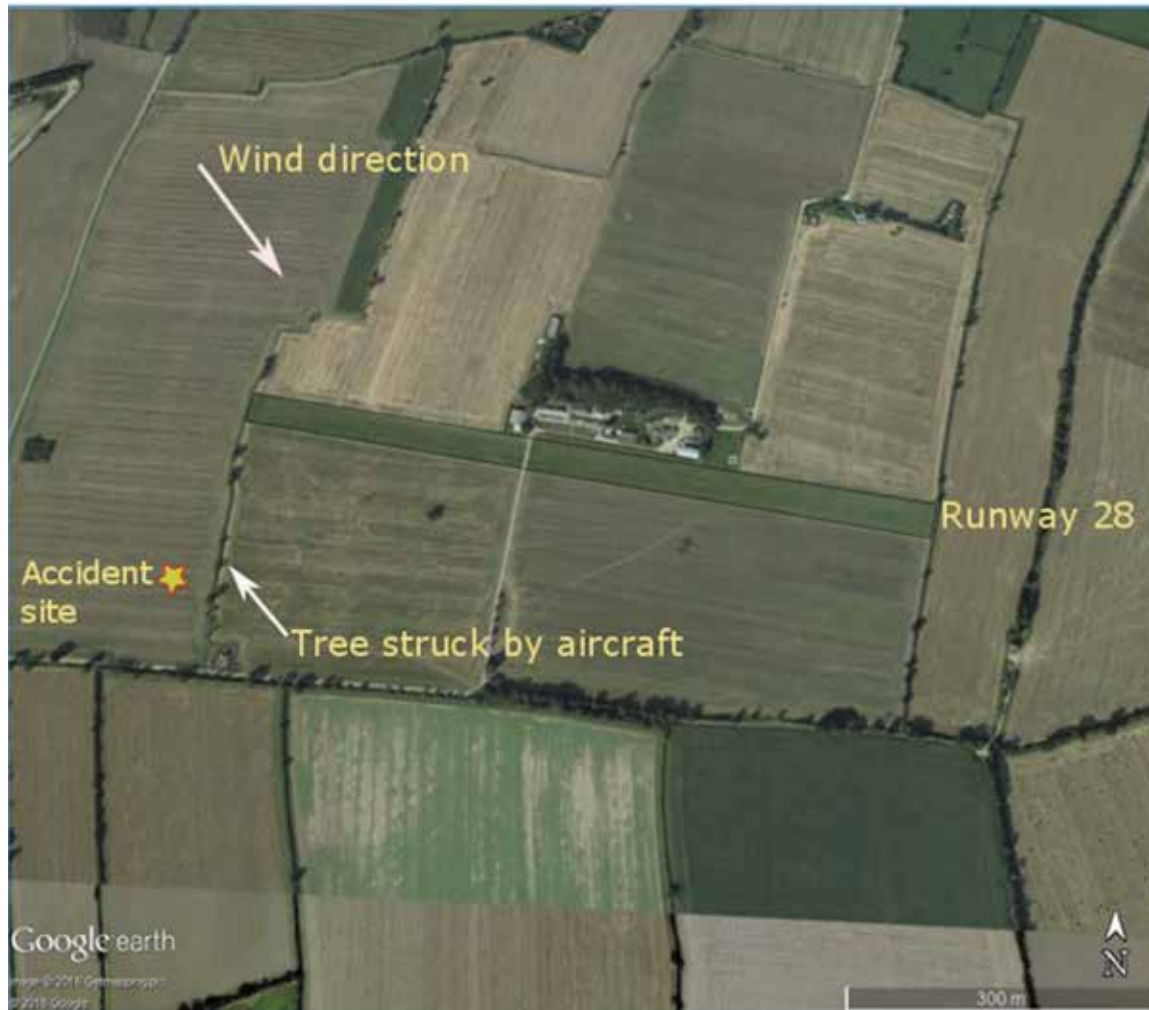
The video showed the aircraft achieve a three-point touch down and bounce back into the air. The aircraft appeared to be approximately aligned with the runway and to drift left

towards the runway edge. At the same time there was a small amount of left roll which was corrected with ailerons. The aircraft then touched down again and bounced a second time; an engine rpm increase being heard on the video shortly after this touchdown. Again, the aircraft appeared to remain approximately aligned with the runway when touching down but, when airborne again, continued to drift towards the runway edge and also yawed to the left.

Figure 2
Topcroft Farm Airstrip

The aircraft was seen to fly increasingly to the left of the runway, narrowly missing a tree standing in the adjacent field to the south of the airstrip. It remained at low level until it collided with a tree at the boundary of the field causing the aircraft to impact the ground. The emergency services were called and arrived on site shortly afterwards. The pilot was seriously injured and the passenger received fatal injuries.

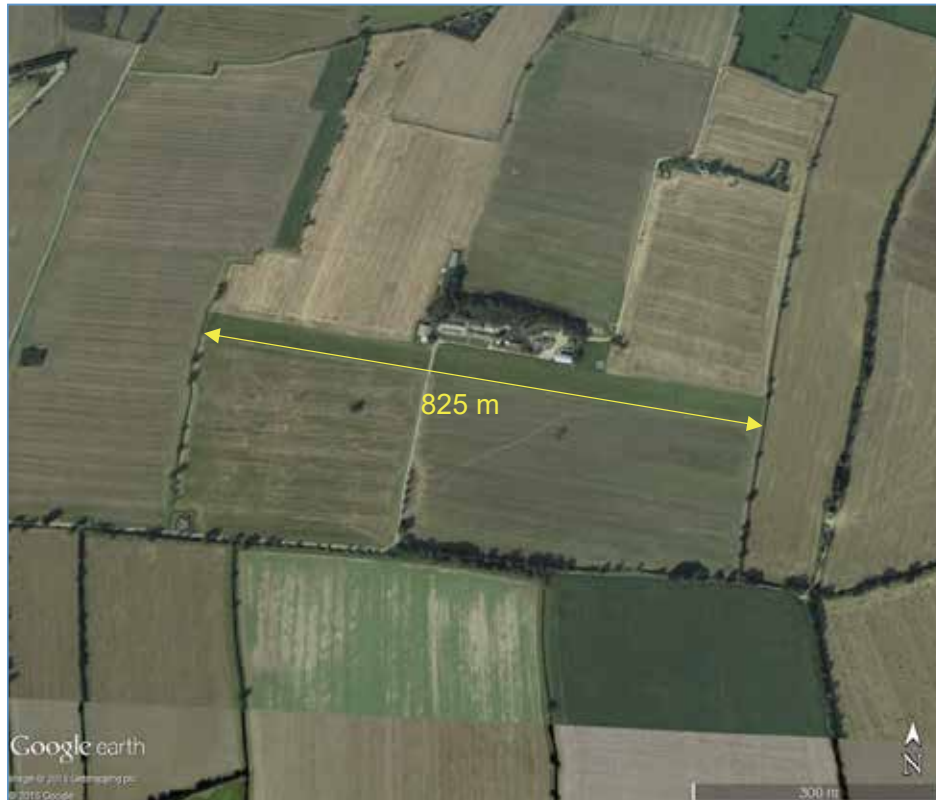
The private farm strip used by the aircraft owner consisted of a grass runway, orientated 10/28, 825 m long and which varied in width between 37 m at its middle and 45 m at either end. There was a low hedge running across either end of the strip. On the day of the accident the runway was firm, dry and in good condition with grass cut to approximately 6 cm in length.

There was a windsock situated on the northern side of the strip next to some farm buildings and an aircraft hangar. The field to the south of the strip had been ploughed up to a concrete track which ran perpendicular to the runway about 500 m from the threshold of Runway 28. Beyond the track the field had been cultivated presenting a soil surface with small regular grooves approximately two to three cm in depth. Figure 9 shows an aerial view of the airfield and the surrounding area.

Figure 9
Topcroft Farm Airstrip
