ACCIDENT

Aircraft Type and Registration:	Boeing 737-4Q8, OE-IAG
No & Type of Engines:	2 CFM56-3C1 turbofan engines
Year of Manufacture:	1992 (s/n 25168)
Date & Time (UTC):	4 October 2016 at 0455 hrs
Location:	Runway 25, Belfast International (Aldergrove) Airport
Type of Flight:	Commercial Air Transport (Cargo)
Persons on Board:	Crew - 2 Passengers - None
Injuries:	Crew - None Passengers - N/A
Nature of Damage:	Fractured lower torsion link on right main gear leg
Commander's Licence:	Airline Transport Pilot's Licence
Commander's Age:	45 years
Commander's Flying Experience:	5,900 hours (of which 900 were on type) Last 90 days - n/k hours Last 28 days - n/k hours
Information Source:	AAIB Field Investigation

Synopsis

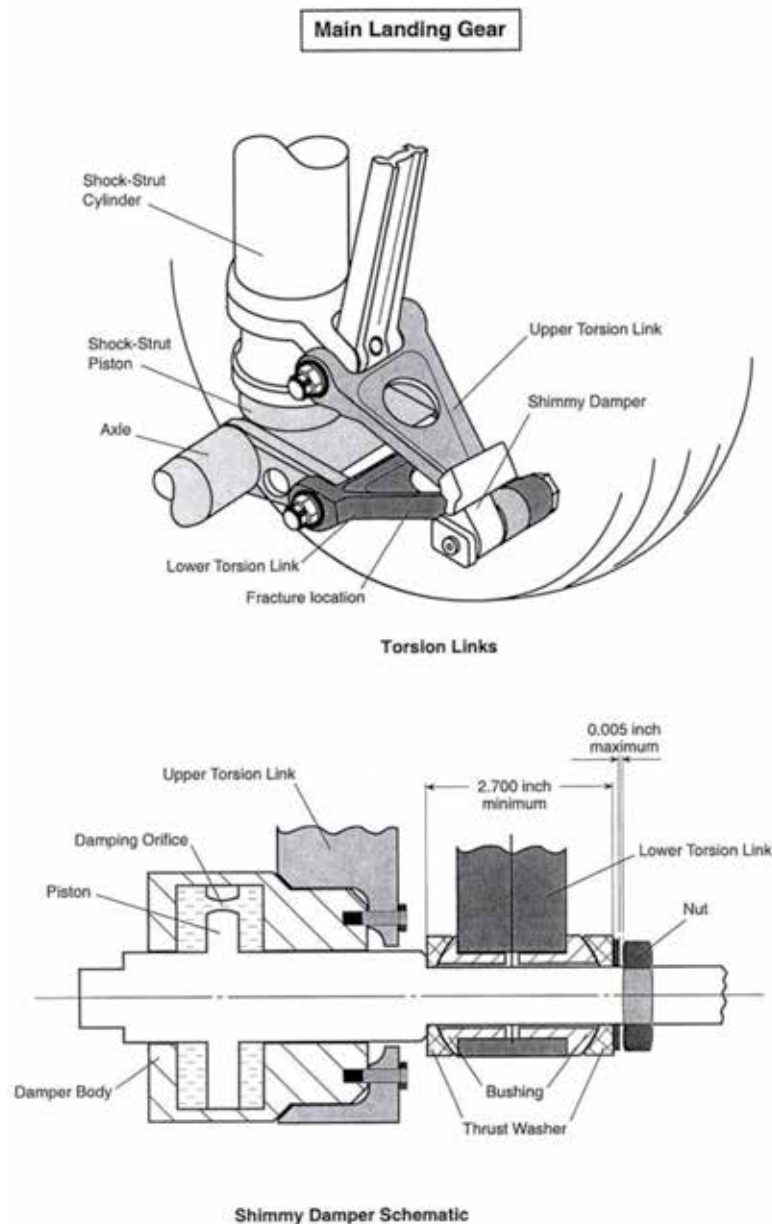
Figure 7
Schematic of MLG and shimmy damper

A scissor linkage, made up of an upper and lower torsion link, is intended to prevent rotation of the inner piston relative to the outer cylinder, while allowing axial movement to provide shock absorption (Figure 7). The upper torsion link is attached to the outer cylinder via a horizontal pivot joint and the lower torsion link is similarly attached at the inner piston.

A shimmy damper is connected between the apexes of the upper and lower torsion links in order to control the rotary oscillation of the shock-strut inner piston relative to the outer cylinder and thereby prevent excessive MLG vibration (shimmy) during high-speed taxi and under heavy braking. The apex of the upper torsion link is bolted to the damper body and the apex of the lower torsion link is connected to the damper piston rod via a bearing assembly. This consists of spherical bushes sandwiched between two thrust washers and is clamped against a shoulder on the rod by an end nut. The torsion links can pivot relative to each other but horizontal displacement between their apexes is controlled by the damper action (Figure 7).
