ACCIDENT

Aircraft Type and Registration:	Europa, G-NDOL	
No & Type of Engines:	1 Rotax 912ULS engine	
Year of Manufacture:	1995 (Serial no: PFA 247-12594)	
Date & Time (UTC):	28 May 2017 at 1200 hrs	
Location:	Apperknowle, Derbyshire	
Type of Flight:	Private	
Persons on Board:	Crew - 1	Passengers - None
Injuries:	Crew - 1 (Fatal)	Passengers - N/A
Nature of Damage:	Aircraft destroyed	
Commander's Licence:	Light Aircraft Pilot's Licence	
Commander's Age:	79 years	
Commander's Flying Experience:	1,146 hours (of which 880 were on type) Last 90 days - 7 hours Last 28 days - 1 hour	
Information Source:	AAIB Field investigation

Synopsis

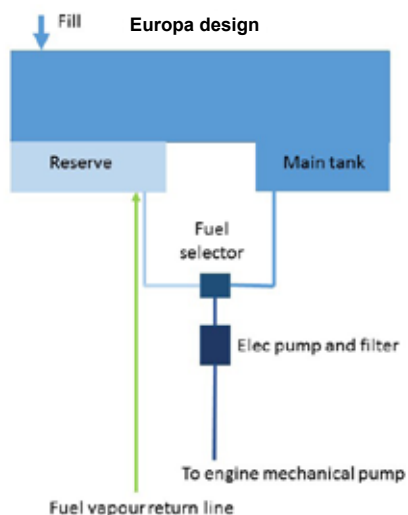
Figure 3

The fuel system on the aircraft was found to be in good condition and its installation was similar to the manufacturer's recommended design configuration but with some notable differences (Figures 3 and 4).

No coarse fuel filters were found on the tank outlet fittings.
