Report on the investigation of the  
grounding of the ultra-large container vessel

***CMA CGM Vasco de Gama***

Thorn Channel, Southampton, England

22 August 2016

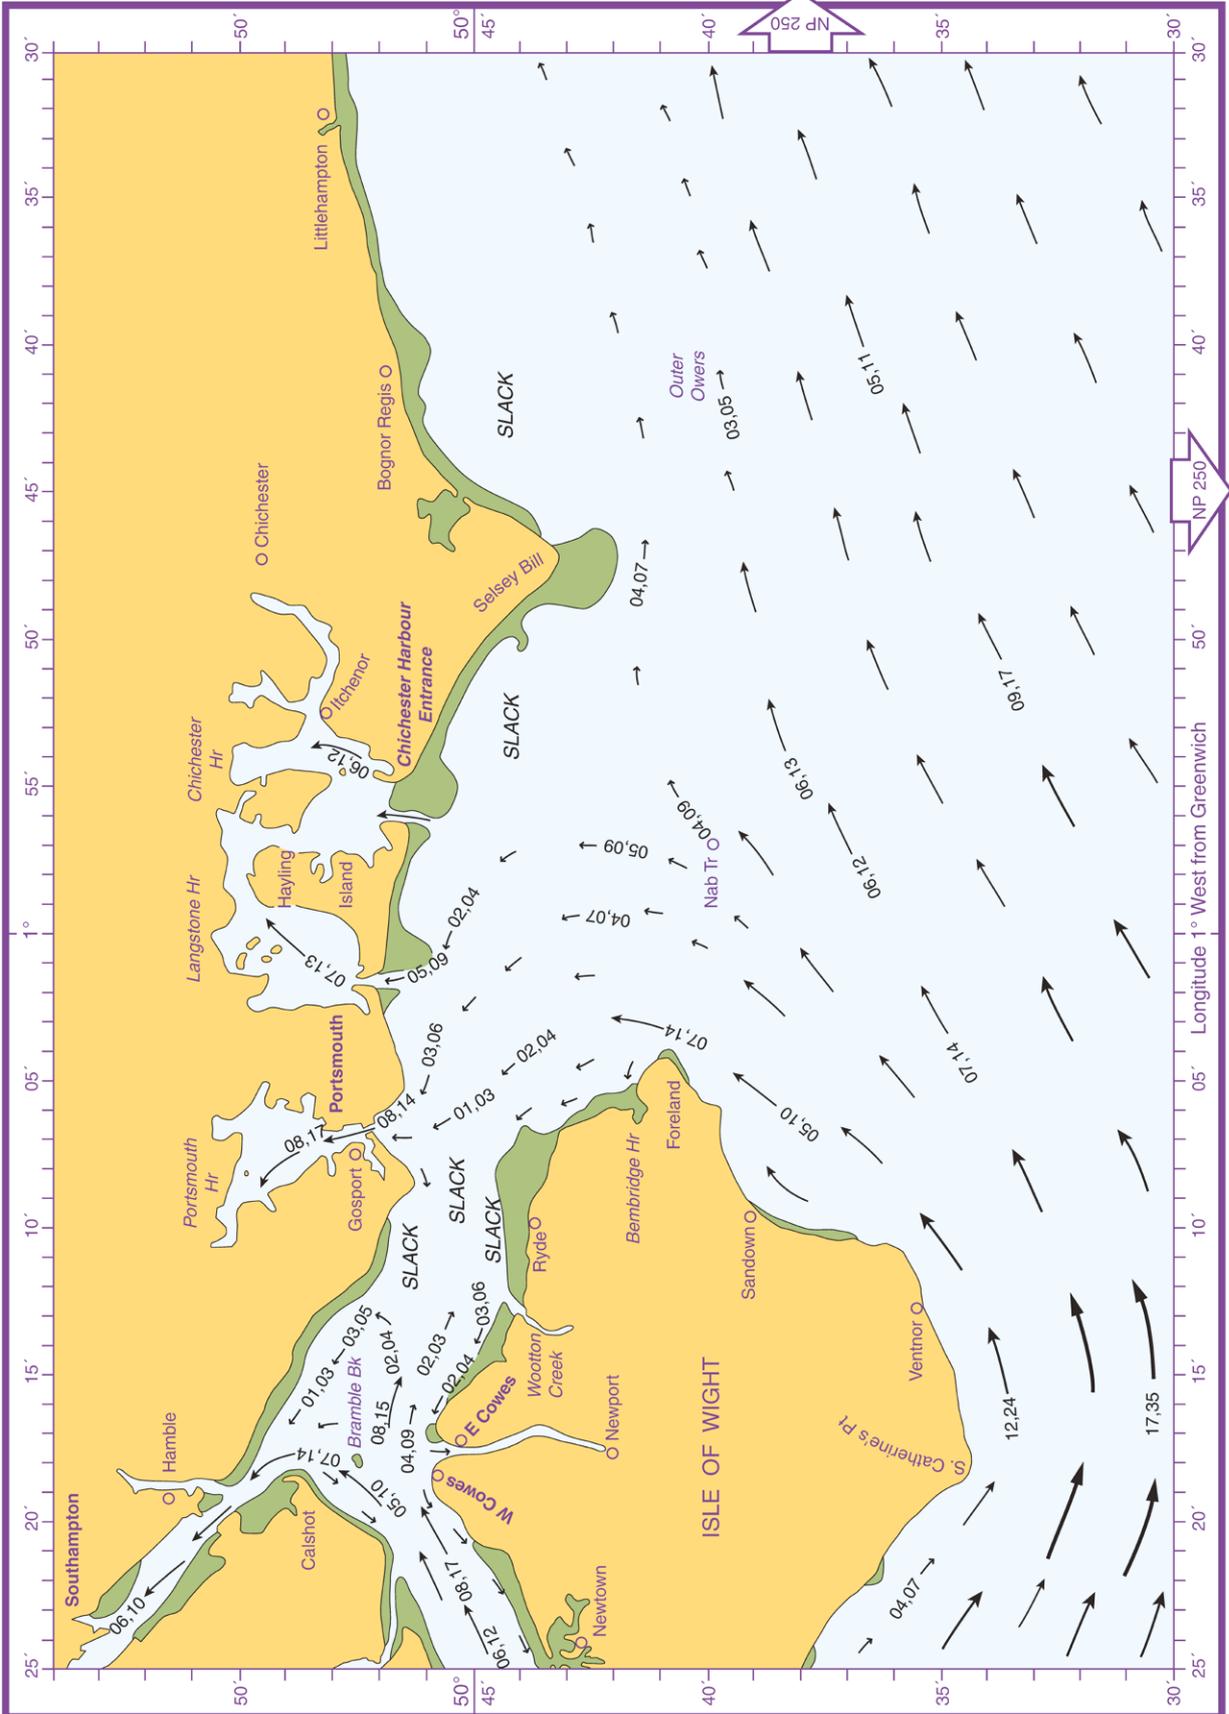
Figure 12: Tidal streams 2 hours before high water Portsmouth

For most of its passage through the Solent, *CMA CGM Vasco de Gama* was pushing into the tide until it commenced the turn within the Precautionary Area, about 2 hours before high water at Portsmouth (**Figure 12**).

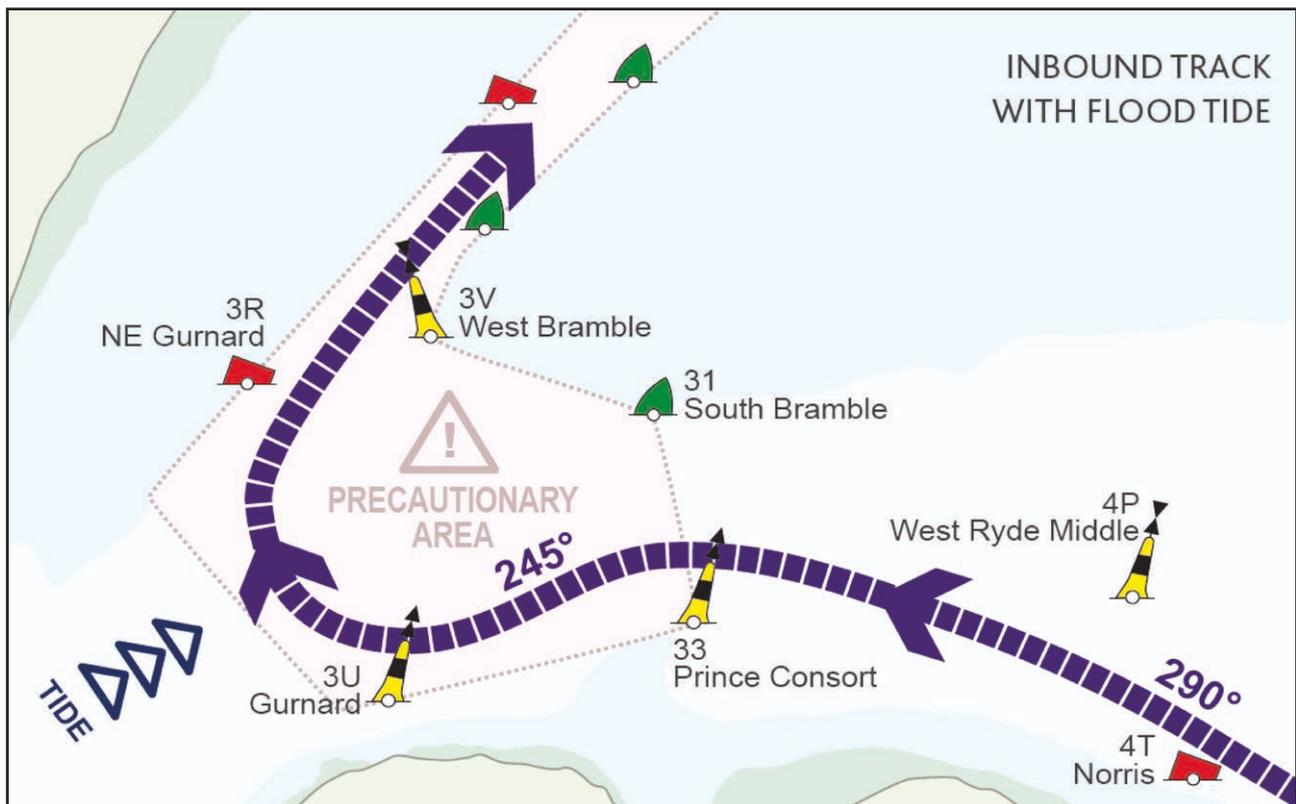
**Figure 14:** Execution of the Bramble Bank turn

The turn around Bramble Bank into the Thorn Channel was known to be difficult for large vessels, particularly when inbound. It involves two substantial course alterations: one to port abeam of the Prince Consort buoy of up to 40° and one to starboard, close to the Gurnard buoy, of about 140° (**Figure 14**). The prevailing winds in the Solent are typically south-westerly and there is a significant tidal stream direction and rate change at the southern end of the Thorn Channel Precautionary Area. For ultra-large container vessels, the turn was typically undertaken at a speed of between 10 and 12kts.

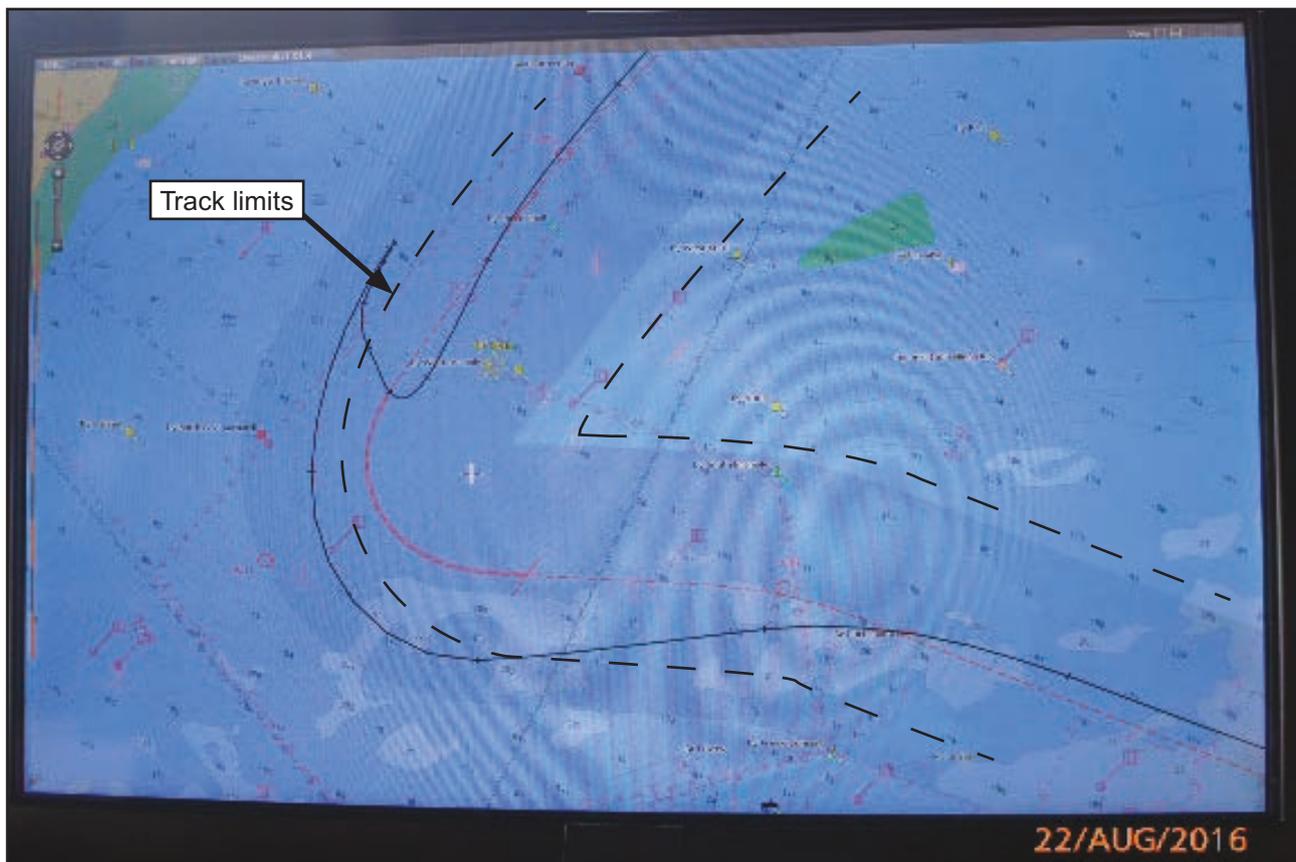
Figure 19: ECDIS track limit settings

A *preparation for arrival* checklist (**Annex J**) was completed by CMA CGM Vasco de Gama's 8 to 12 OOW and countersigned by the master prior to the vessel's arrival at Southampton. The checklist indicated that all mandatory alarms had been set in ECDIS, the parallel index had been set on the radar and the cross-track error had been set to 0.5nm. The track limits were not adjusted for each leg of the pilotage section of the passage. When the vessel grounded, it had not gone outside the set permissible track limits (**Figure 19**) and no ECDIS alarms sounded.

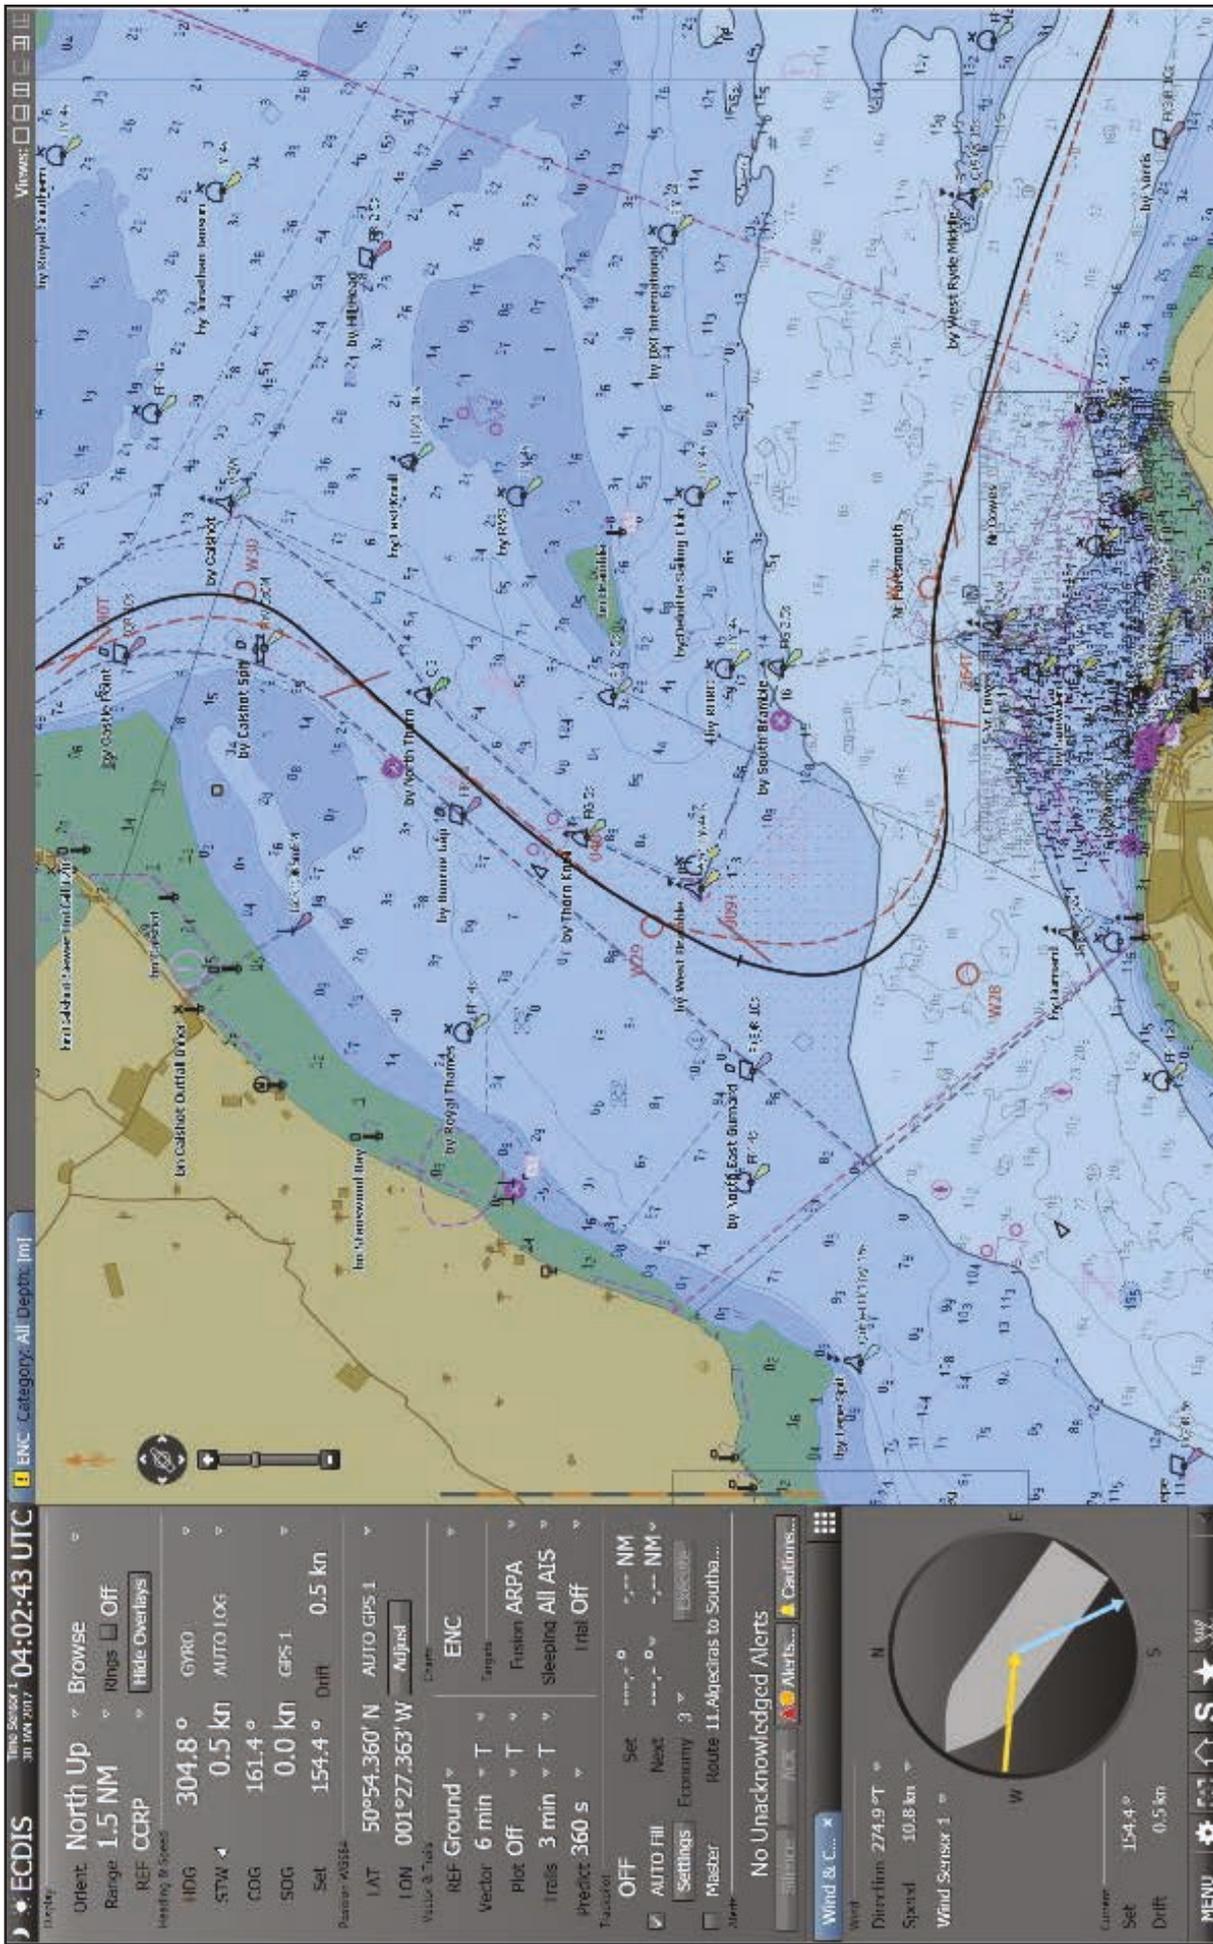
Figure 22: Example of ECDIS display screen with safety contour adjusted and in four colour mode

No ECDIS alarms sounded prior to or after the grounding and the display screen, which had been set to the full mode, was overly cluttered (**Figure 17**) and was therefore difficult to use for effective navigation in restricted waters. Had the safety contour depth been adjusted and the screen set to display four colours instead of two, this would have resulted in the identification and clearer definition of safe waters. Furthermore, the displayed picture would have been a lot easier to view (**Figure 22**).
