Report on the investigation of the collision between  
the high-speed passenger catamaran

***Typhoon Clipper***

***Alison***

adjacent to Tower Millennium Pier, River Thames, London

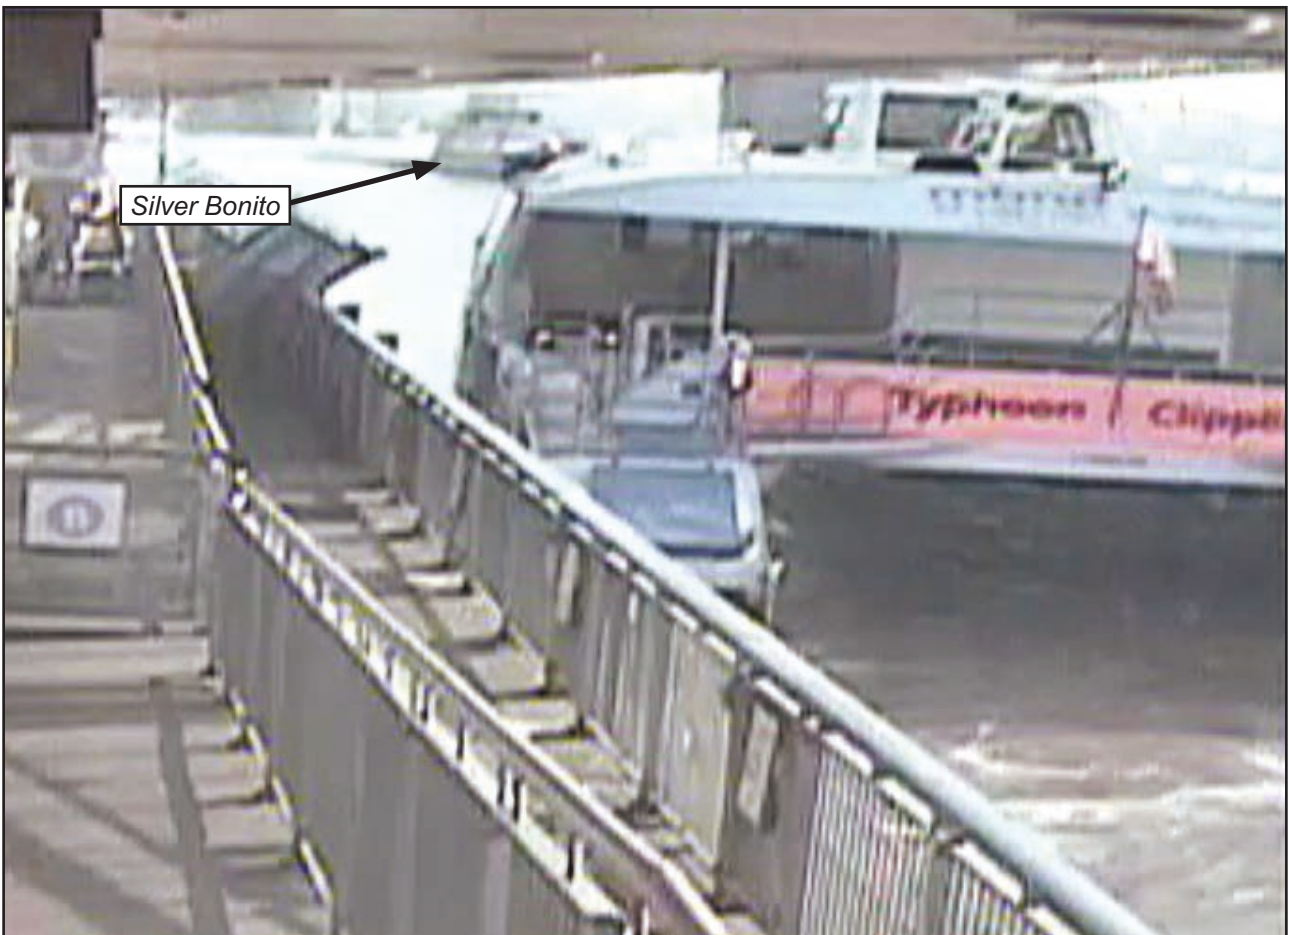
**Figure 3:** *Typhoon Clipper* adjacent to the pier waiting for *Silver Bonito* to pass

Once passengers had embarked, the crew of *Typhoon Clipper* unberthed the vessel and the master decided to wait for *Silver Bonito* to pass clear before proceeding ahead. *Typhoon Clipper* was stationary with the bow away from the pier and the port quarter close to, or touching, the pier (**Figure 3**). At the same time, *Alison* was unberthed by its crew and driven close by the end of the pier (**Figure 4**) then headed into the river with the intention of passing ahead of *Typhoon Clipper* before turning to starboard behind *Silver Bonito*.

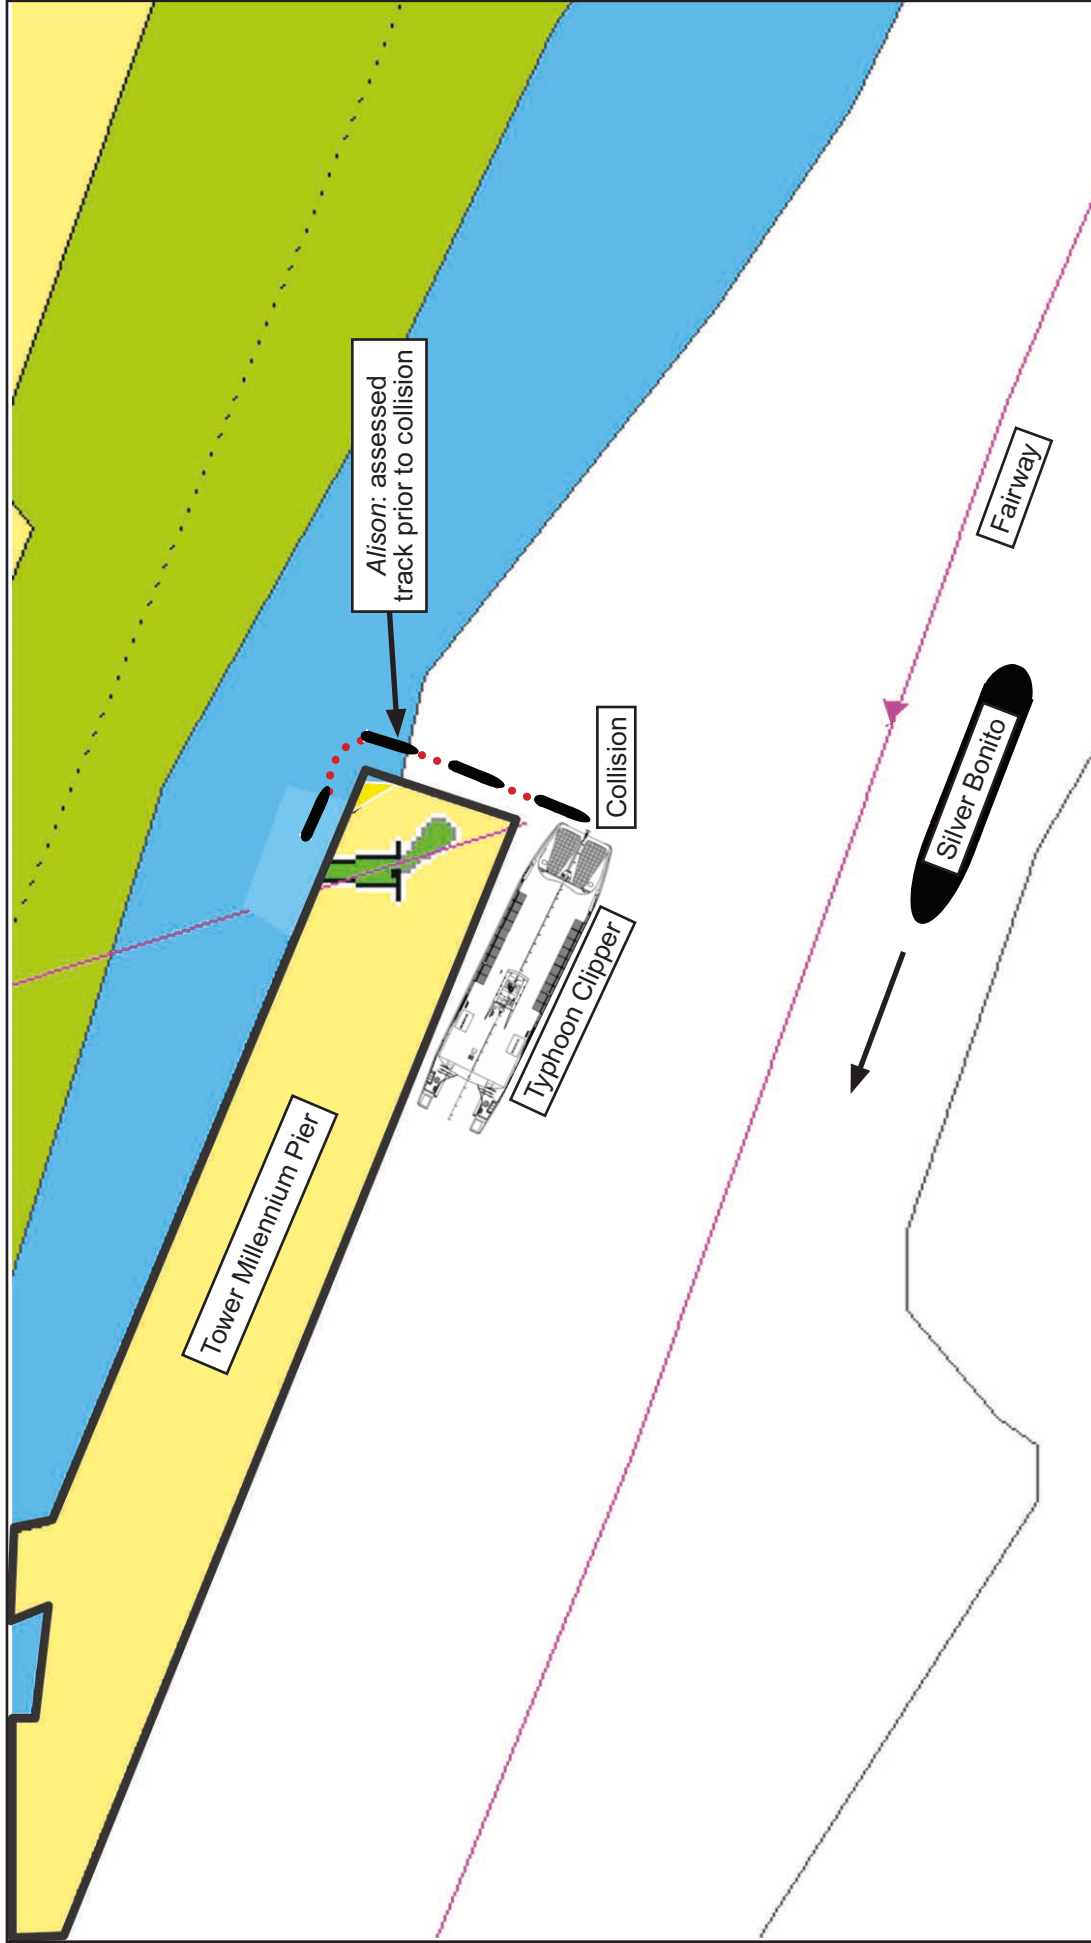
**Figure 5:** Chart showing the movement of Typhoon Clipper, Silver Bonito and Alison

At 1107:57 and with *Silver Bonito* passing clear to starboard, *Typhoon Clipper's* master applied ahead power and starboard rudder to head back downriver. Both of *Alison's* crewmen were alerted to *Typhoon Clipper's* acceleration by the sound of its engines increasing power. *Alison's* helmsman immediately applied full astern in an attempt to back out of the way as *Typhoon Clipper* moved rapidly closer (**Figures 5 and 6**).

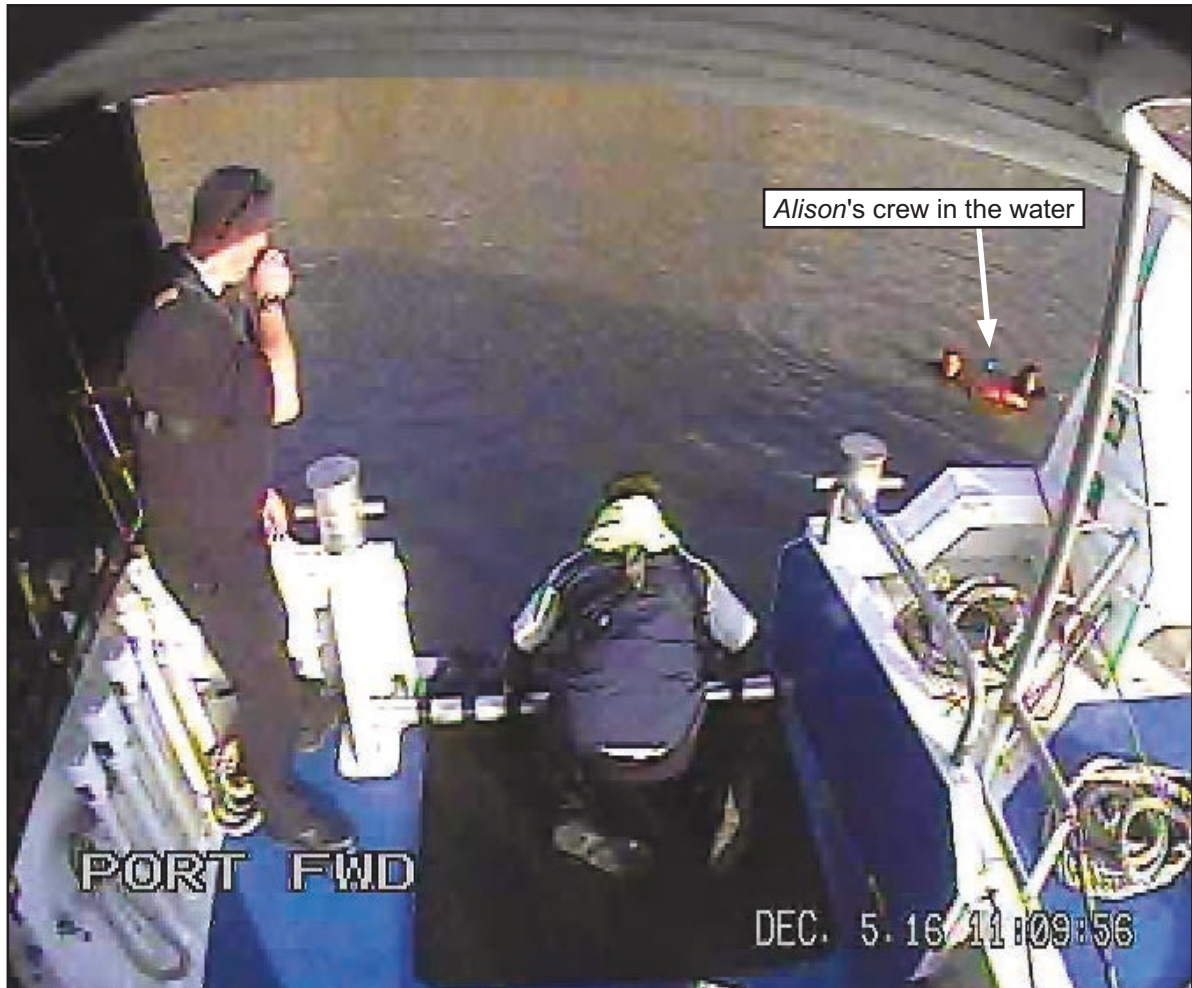
**Figure 8:** *Typhoon Clipper's* port forward embarkation area just prior to the rescue with *Alison's* crewmen in the water

When the mate heard the DCSA's man overboard report, he went to the port side forward embarkation area, where he used a hand-held radio to inform the master of the situation. Meanwhile, the DCSA threw a second lifebuoy, then rigged the port side scrambling net and fetched the boat hook in preparation for rescuing *Alison's* crew (**Figure 8**).

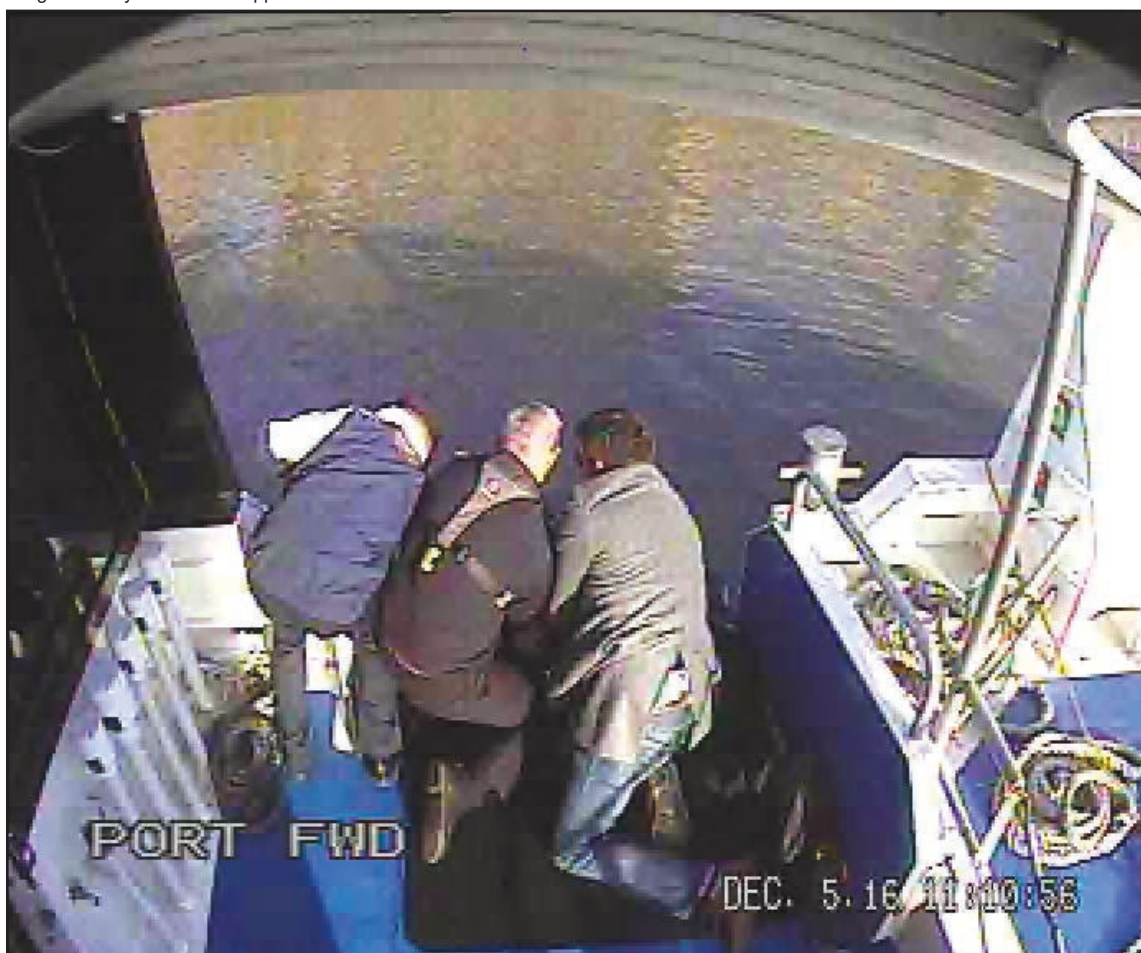
**Figure 9:** *Alison*'s second crewman being rescued out of the water by *Typhoon Clipper*'s mate, the DCSA, an off-duty DCSA and a passenger

*Typhoon Clipper's* master manoeuvred the vessel close to *Alison's* crewmen, who were able to cling onto the scrambling net but were unable to climb out of the water unaided. With the assistance of a passenger and another member of Thames Clippers' staff<sup>2</sup>, the mate and DCSA hauled *Alison's* crewmen out of the water, one at a time. The second crewman from *Alison* was lifted out of the water 3 minutes and 30 seconds after the collision (**Figure 9**).

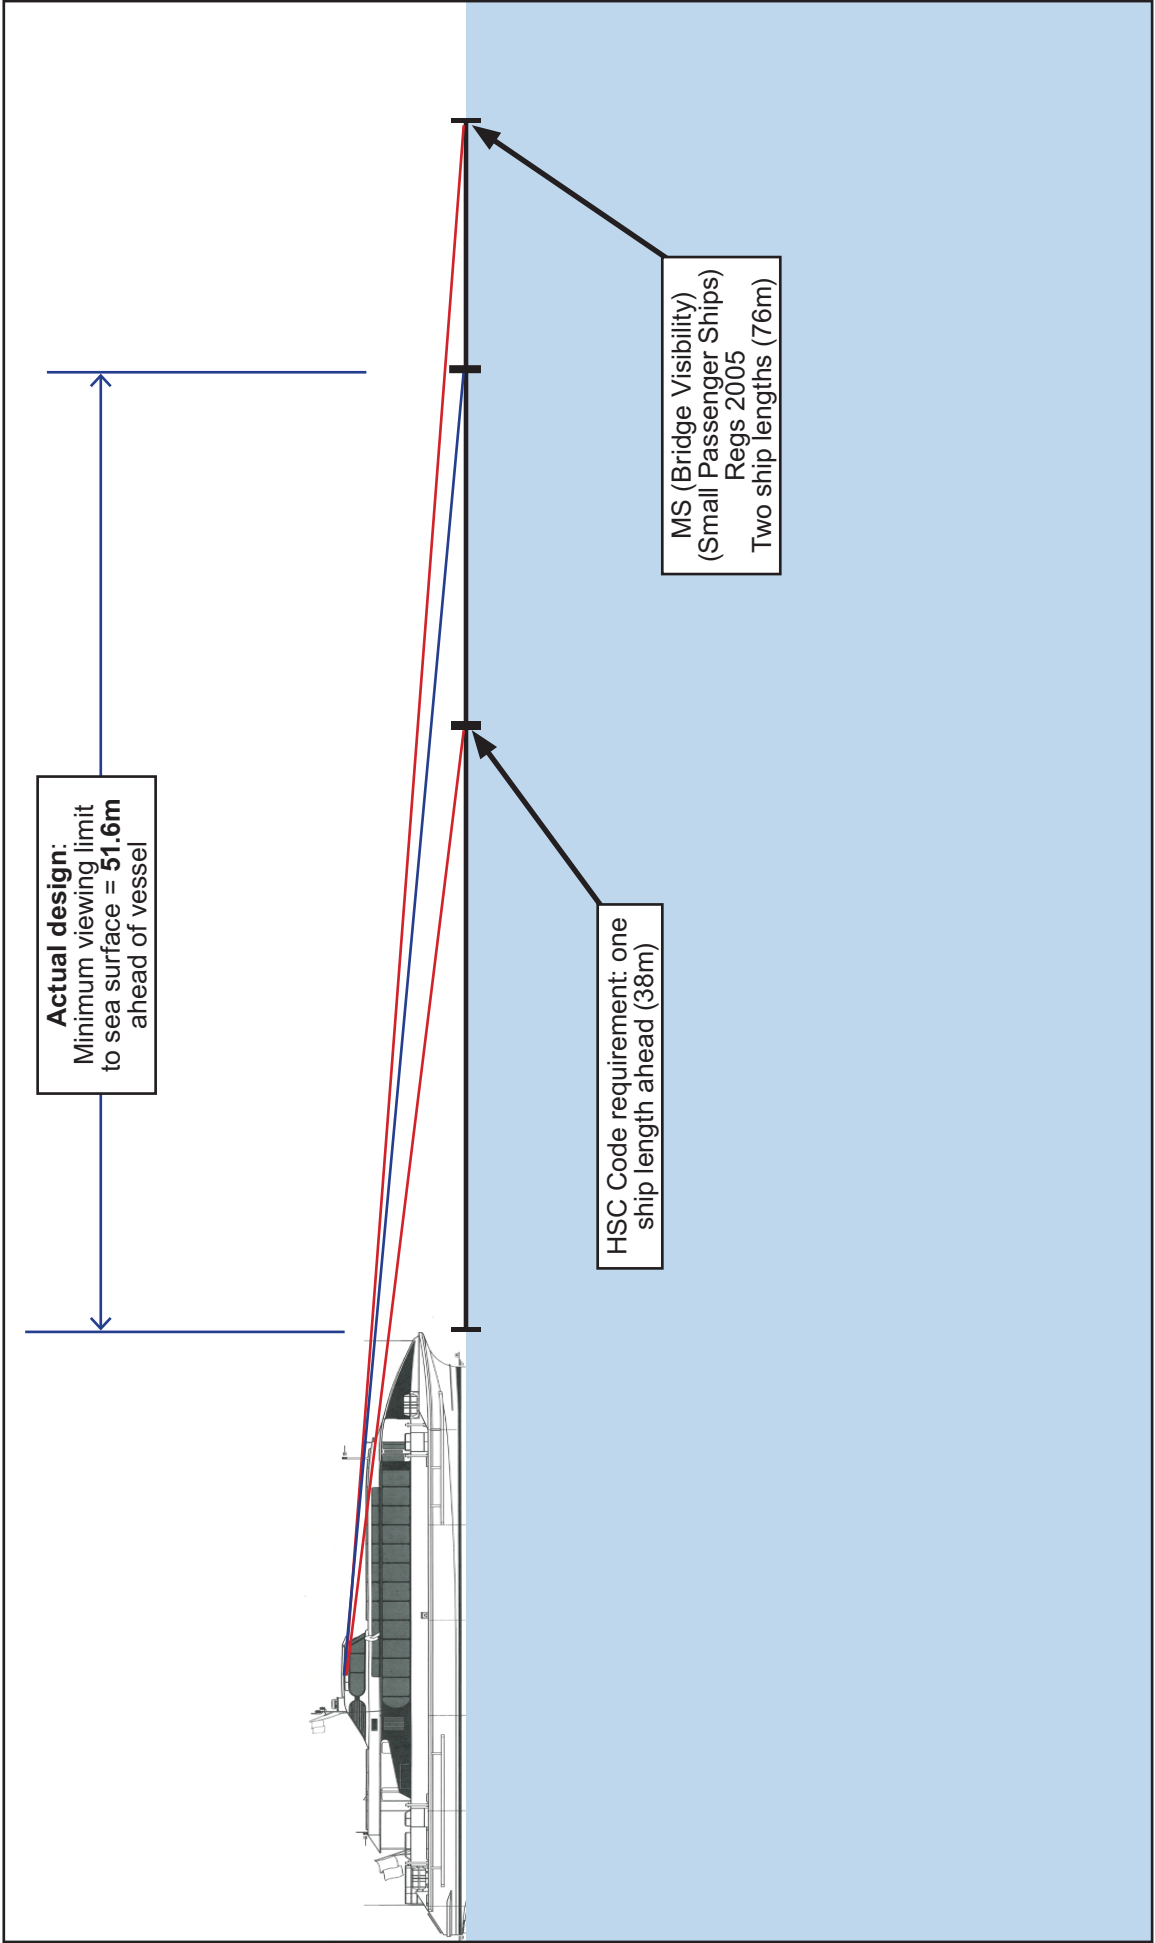
**Figure 12:** Diagram showing regulation and designed sight lines ahead of *Typhoon Clipper*

From a normal seated position in the wheelhouse, the master of *Typhoon Clipper* had sight of the sea surface 51.6m ahead of the vessel (**Figure 12**). Given that this was less than two ship lengths it complied with the UK Merchant Shipping (Bridge Visibility) (Small Passenger Ship) Regulations, 2005, minimum ahead visibility requirements applicable when the vessel was designed and built.

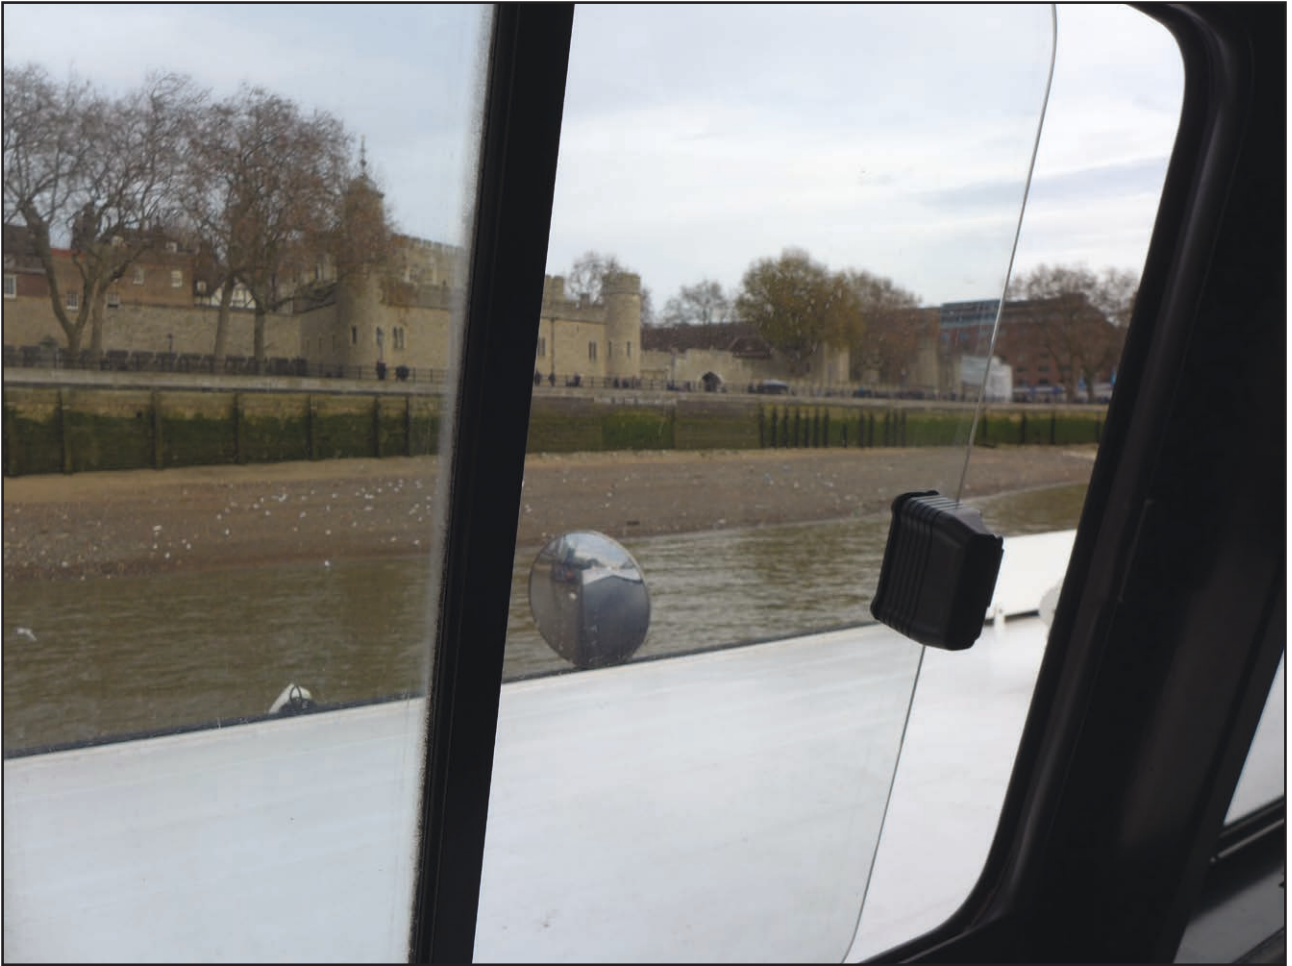
Figure 13: *Typhoon Clipper's* rear-view mirrors

To improve visibility astern during berthing and unberthing, *Typhoon Clipper* had been fitted with rear-view mirrors either side of the wheelhouse (**Figure 13**).

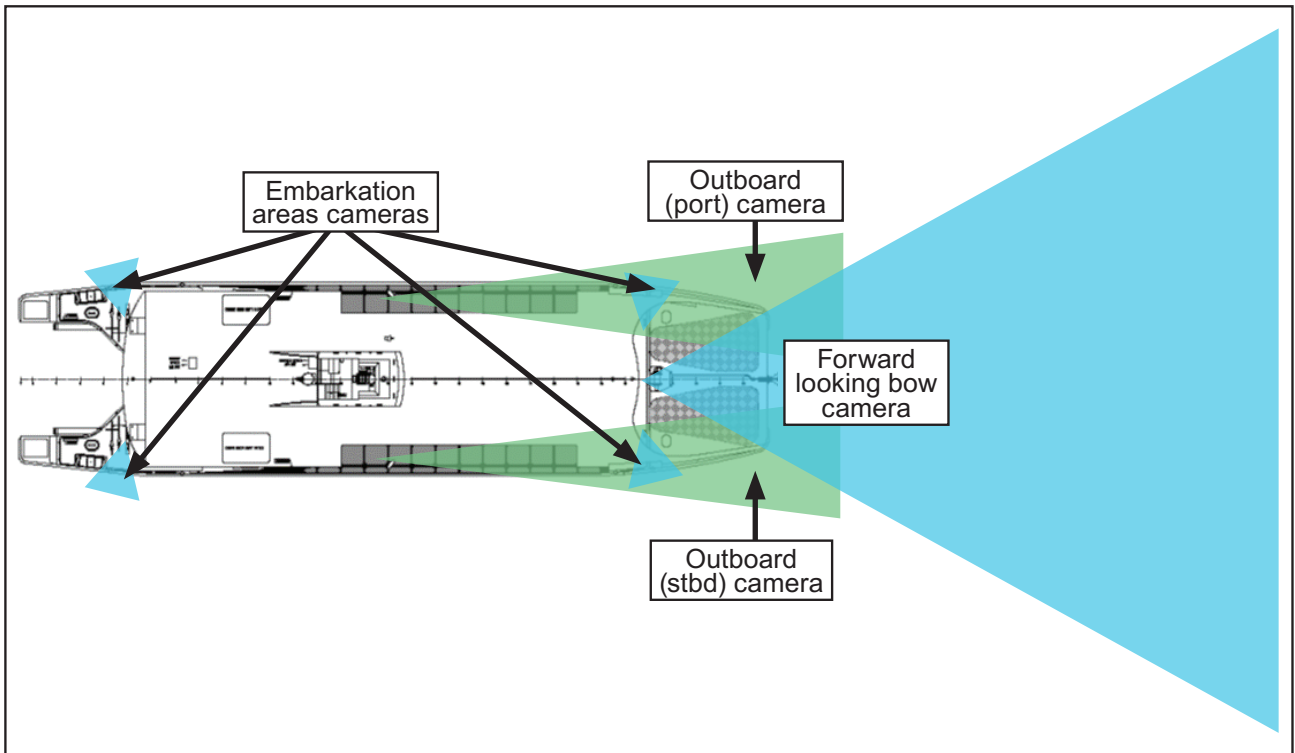
Figure 14: Diagram showing approximate arcs of coverage of *Typhoon Clipper's* external CCTV cameras

*Typhoon Clipper* was fitted with a closed-circuit television (CCTV) system. There were seven external cameras providing a view of each of the four gangway positions, a bow camera looking ahead and a camera mounted outboard on either side also looking ahead (**Figure 14**). The internal cameras viewed the wheelhouse, passenger cabin and both engine rooms; there was also an audio recorder in the wheelhouse. All the CCTV camera imagery and wheelhouse audio data was continuously recorded.

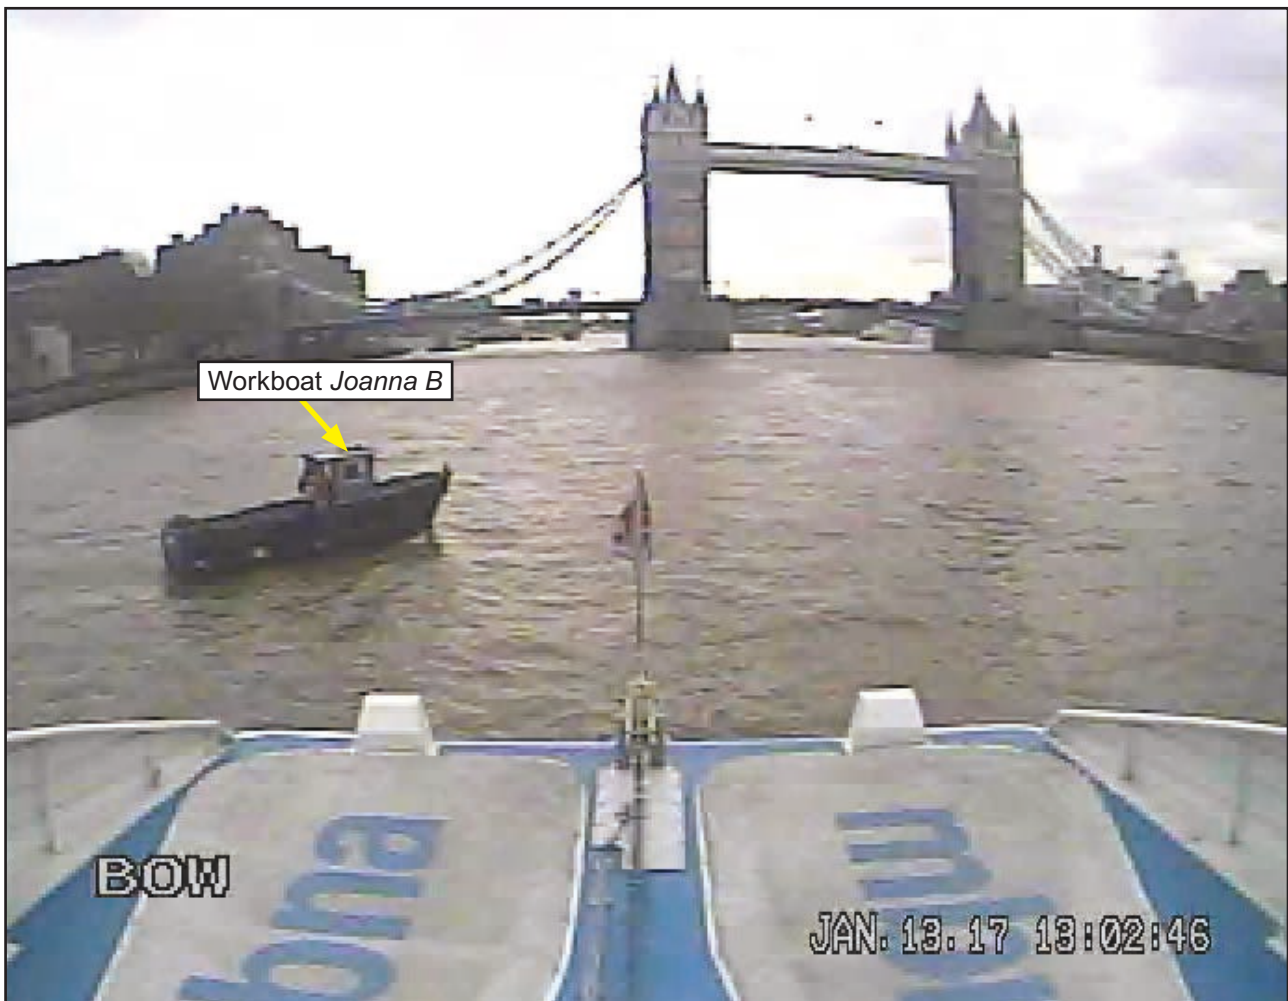
**Figure 20:** Accident reconstruction - *Typhoon Clipper* bow camera view showing the workboat *Joanna B*

At each stage of the trial, both *Joanna B's* fixed horn and the hand-held horn were clearly audible in *Typhoon Clipper's* wheelhouse and, following the reconstruction, could also be heard on the playback of the recording of *Typhoon Clipper's* wheelhouse audio.

The accident reconstruction demonstrated that, had *Alison's* horn been sounded at any point between departure from the pier and the collision, it would have been audible on the recording of *Typhoon Clipper's* wheelhouse audio.
