Rail Accident Investigation Branch

Rail Accident Report

Freight train derailment at East Somerset Junction 20 March 2017

Report 19/2017
December 2017

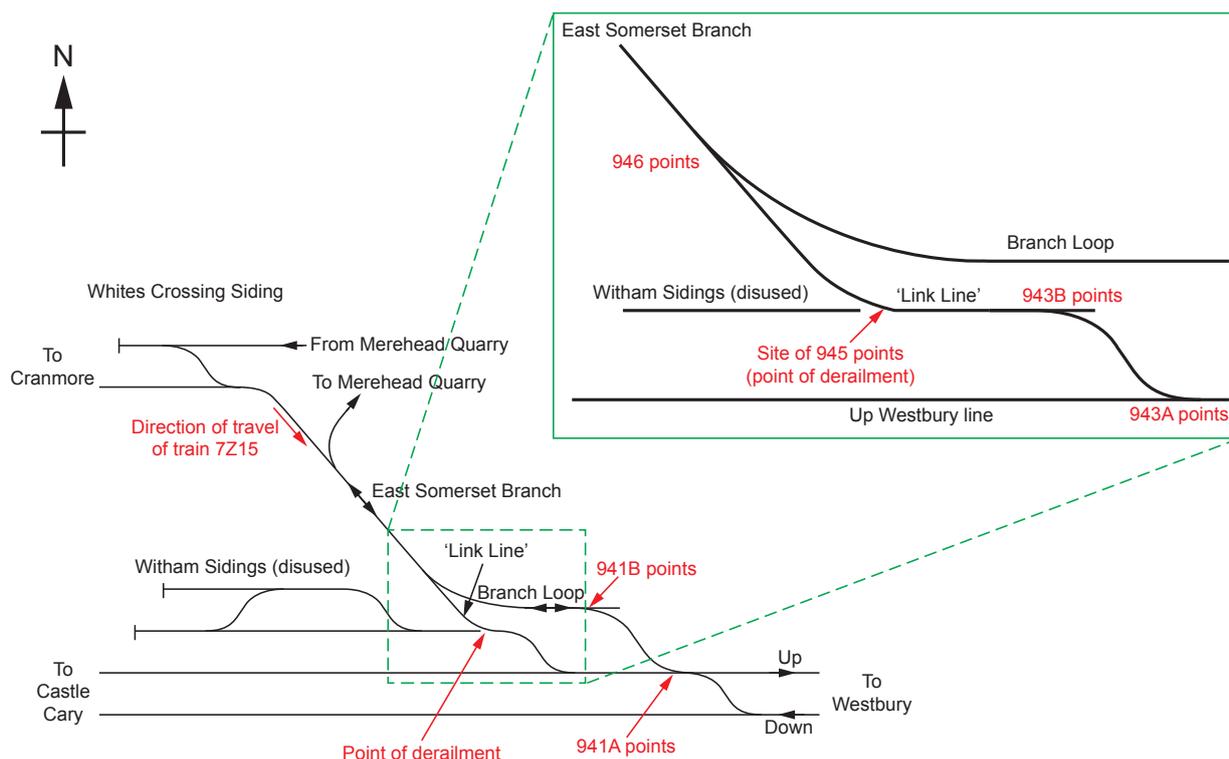
Figure 3: East Somerset Junction schematic layout of track

- 8 The East Somerset Branch line (also known as the Merehead Single line) diverges from the Up Westbury line at 943A *points* (figure 3). The branch line has an ELR (*engineer's line reference*) of 'ESB', while the ELR for the Up and Down Westbury lines is 'WEY'. A set of *trap points*, 943B, protects the junction; this was the site of a previous derailment on 10 November 2008 ([RAIB report number 28/2009](#)). The derailment on 20 March 2017 occurred at the site of the former 945 points, which used to connect Witham Sidings to the branch line; these had been *plain-lined* in 2010 (see paragraph 32).

- 9 A second route is available for trains running onto or off the East Somerset Branch. Network Rail's *Sectional Appendix* refers to this as the Up/Down Goods Loop, although it is commonly called the Branch Loop. This line runs from 941A points, at the connection with the Up Westbury line, and merges with the East Somerset Branch at 946 points. It is approximately 760 metres long, which is sufficient to accommodate a 'jumbo train'². The former Witham station lay between the present sites of 941A and 943A points.

- 10 The 'Link Line' is the section of the East Somerset Branch lying between 943A points and 946 points; it is approximately 260 metres long, too short to accommodate a 'jumbo train'. Both the Branch Loop and the Link Line are bi-directional, and trains running to or from Merehead Quarry may be routed along either line.

- 21 The person holding the position of TME (acting) from March 2015 to May 2016 had worked in the industry since 1987. He was assistant TME at Westbury from March 2012 until March 2015, when he became TME (acting).

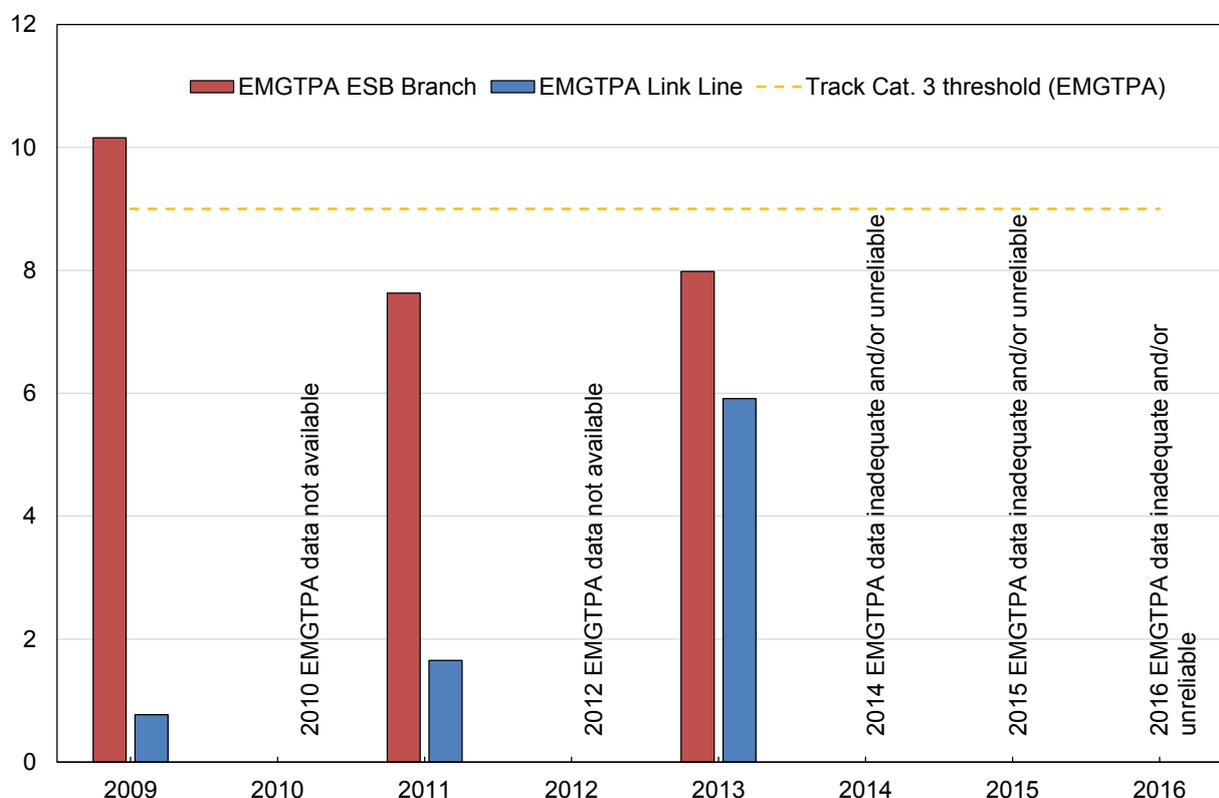
Figure 13a: Equivalent million gross tonnes per annum (Network Rail data)

78 Increasing freight traffic added to the track maintenance workload at Westbury due to the wear and tear on the track. Witnesses report that track damage in the Westbury area is principally caused by loaded stone trains travelling on the Up line.

79 The RAM team publishes figures that enable each section of track to be categorised for inspection purposes, based on the tonnage carried (expressed as equivalent gross tonnes per annum (EMGTPA)). At the time of the derailment on 20 March 2017, no EMGTPA figures had been published for the Western Route since 2013 (figure 13a). Data from Mendip Rail show the tonnage carried from Merehead Quarry in 2016 was 38% higher than in 2013 (figure 13b). Although there is no direct correlation between the Mendip Rail data and EMGTPA, the increase in traffic would probably have raised the inspection category of the East Somerset Branch from Cat. 4 to 3. The increased tonnages would also probably have resulted in the track categories for both the Link Line and the Branch Loop being Cat. 4 (at the time of the derailment they were Cat. 4 and Cat. 6). These changes in category would not have made any practical difference to the required inspection frequencies for the East Somerset Branch, although they might have drawn attention to the associated increase in the wear and tear on the track.

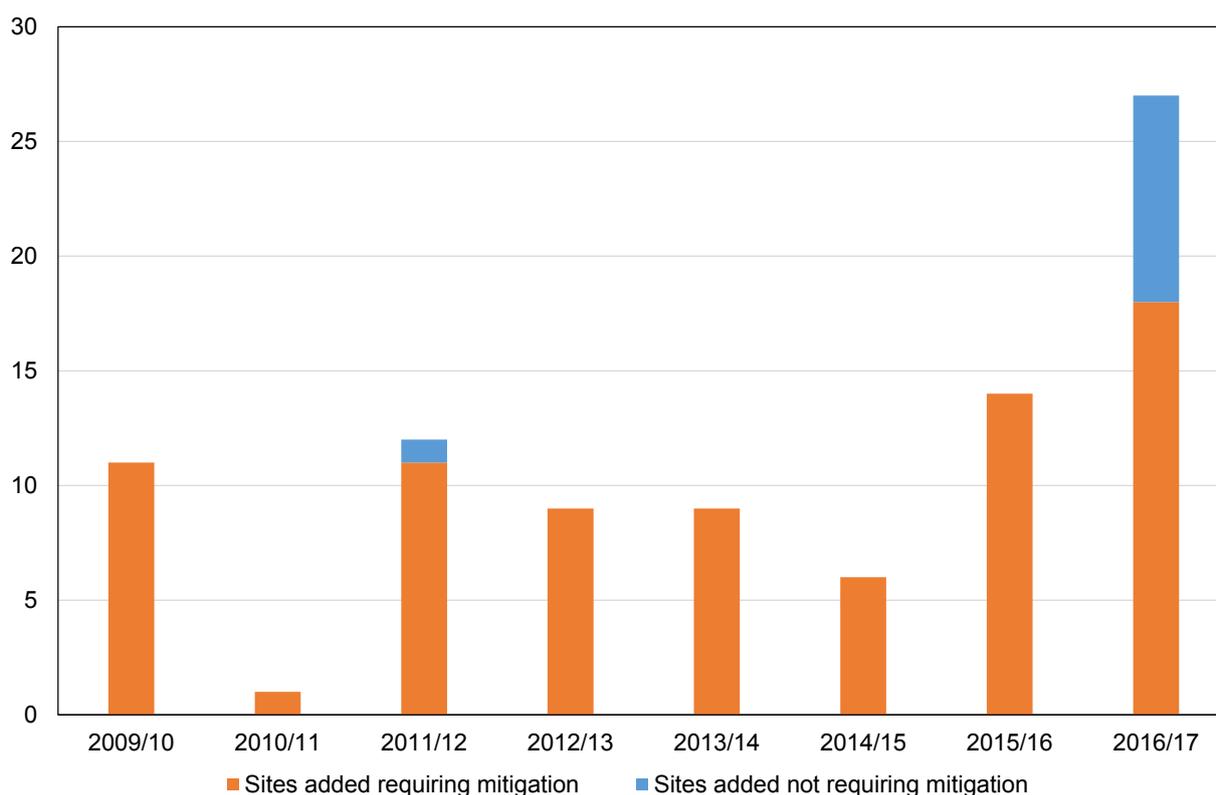
Figure 14: Additional deferred renewal sites, Westbury track maintenance depot

- Work associated with *deferred renewals*. Such work may include the need to carry out ‘mitigations’ (interim refurbishment of assets such as points)¹², as well as managing the poorer reliability of life-extended assets. Although Network Rail has been unable to provide data on trends in the overall number of deferred renewal sites in the Westbury area, it has provided data on the rate of numbers of sites added each year (figure 14); this increased in 2015/16 and again in 2016/17. This data does not include renewals that have been identified as being necessary but which have not been given a planned delivery date (Network Rail does not regard these as ‘deferred renewals’ even though the TME may have indicated when they should be delivered).

- The Swindon works delivery unit was unable to deliver some minor works, such as deferred renewal mitigations, effectively. As a result, it had been restricted to delivery of simple, plain line, mitigation works and led to some jobs being carried out by track maintenance staff.

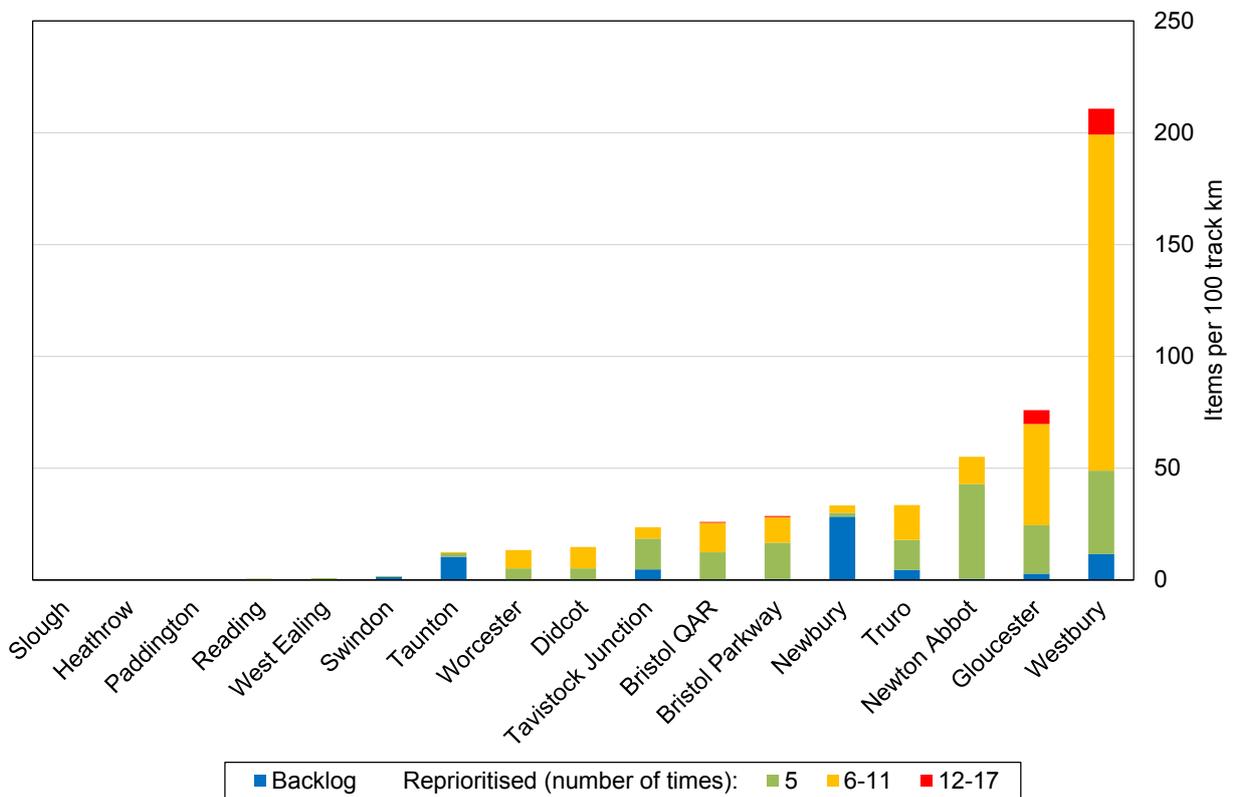
Figure 15: Reprioritised and backlog items in Ellipse by track maintenance depot (Western Route) as at 9 July 2017

- 82 The numbers of Ellipse items that are overdue (in 'backlog') are tracked daily. However, there is less visibility of items that have been reprioritised and given a new completion date. These are controlled by the TSM in accordance with NR/L3/MTC/MG0176/11, 'Prioritisations, reprioritisations and cancellations', and must be approved by the TME on every sixth occasion. Westbury has the highest number of Ellipse work items that have been repeatedly reprioritised for any track maintenance depot on Western Route (normalised by track km, figure 15; this includes backlog items). This is an indication that staff at Westbury track maintenance depot may have been struggling with the volume of work. Had this not been the case, it is possible that depot management would have identified that track geometry of the Link Line was not being measured.

- 83 Following the derailment, and in recognition that Westbury track maintenance depot faced some specific challenges (paragraph 80), the Swindon infrastructure maintenance delivery manager has established a special track asset stewardship review meeting, with the intention that this would meet on a six-weekly basis. This is intended to 'support an improving and sustainable asset condition in the Westbury TME area'.

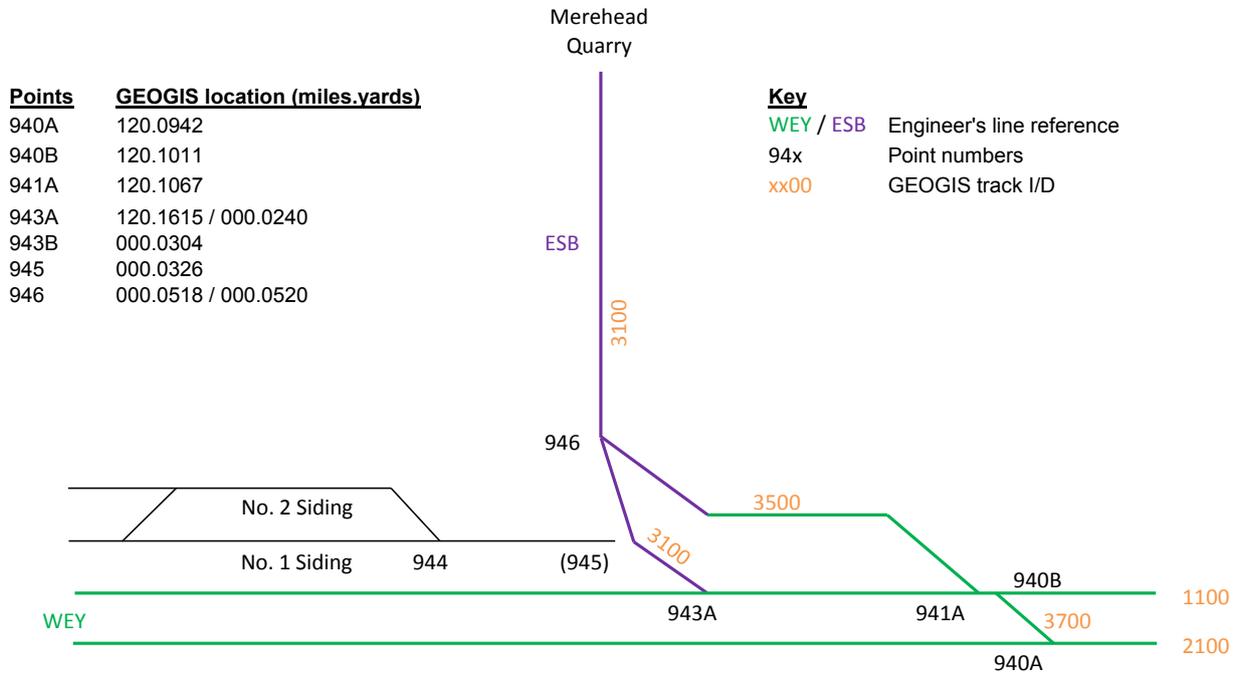
Figure 16: Track identification

D1 Figure 16 is a schematic representation of East Somerset Junction. The ELR for both the Link Line and the Branch Loop changes from 'WEY' to 'ESB' in line with 943A points. The Link Line has the same *GEOGIS* track I/D as the rest of the East Somerset Branch (3100), whereas the Branch Loop has a unique I/D (3500).
