**ACCIDENT**

<b>Aircraft Type and Registration:</b>	Yak-52, G-YAKB	
<b>No &amp; Type of Engines:</b>	1 Ivchenko Vedeneyev M-14P radial piston engine	
<b>Year of Manufacture:</b>	1992 (Serial no: 9211517)	
<b>Date &amp; Time (UTC):</b>	8 July 2016 at 0934 hrs	
<b>Location:</b>	1 nm north of Dinton, Wiltshire	
<b>Type of Flight:</b>	Aerial work	
<b>Persons on Board:</b>	Crew - 2	Passengers - None
<b>Injuries:</b>	Crew - 1 (Fatal) 1 (Serious)	Passengers - N/A
<b>Nature of Damage:</b>	Aircraft destroyed	
<b>Commander's Licence:</b>	Commercial Pilot's Licence	
<b>Commander's Age:</b>	60 years	
<b>Commander's Flying Experience:</b>	2,953 hours (of which 446 were on type) Last 90 days - 18 hours Last 28 days - 15 hours	
<b>Information Source:</b>	AAIB Field Investigation

**Synopsis**

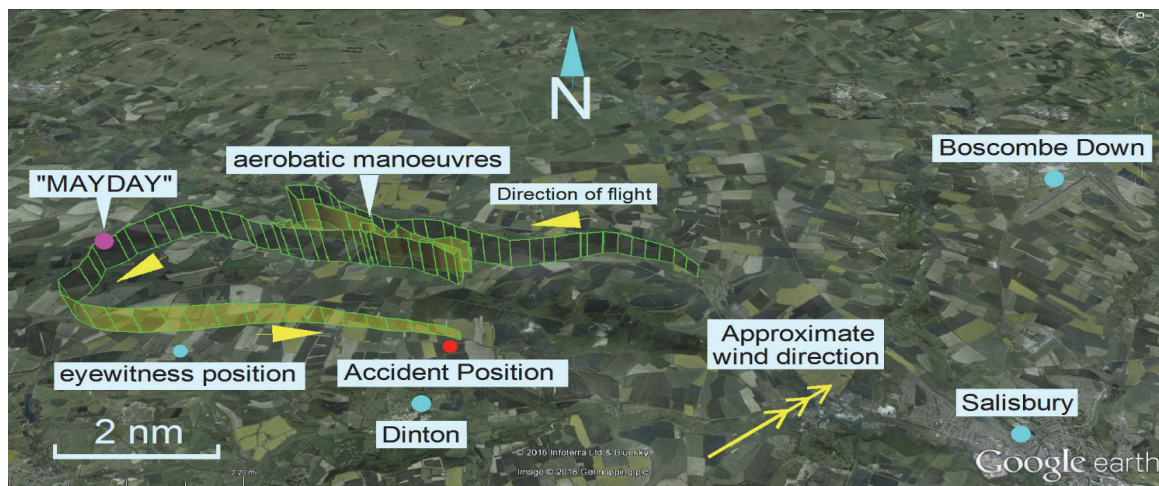
**Figure 1**

The commander stated that at this point he had elected to continue towards BD, in case the engine recovered, while the FSP continued to pump the primer handle. The aircraft continued to descend throughout this time. Shortly thereafter, ATC informed the crew that the aircraft’s range was 9 nm. Realising that the aircraft would not be able to reach BD, at 0933:29 hrs, at an altitude of 1,475 ft amsl (approximately 1,100 ft agl), the FSP transmitted “GOLF KILO BRAVO IS MAY [SIC] PFL’ING TO A FIELD JUST TO THE WEST OF BOSCOMBE [SLIGHT PAUSE] ER WILL PHONE YOU ON THE GROUND.” This was the last transmission received by ATC. Figure 1 shows the radar track of the flight.

Radar plot of the flight (Clee Hill radar data)

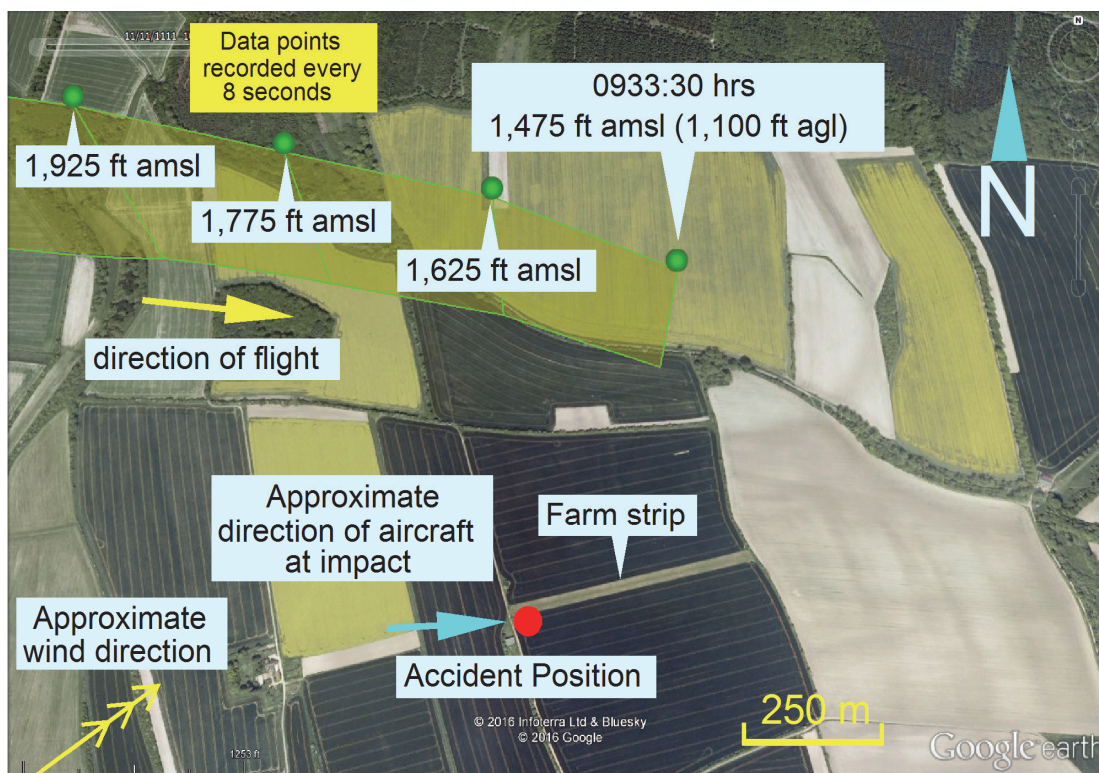
**Figure 2**

decision to try to land on the strip as opposed to the chosen field. Figure 2 shows the relative positions of the final radar points and the accident site.

Final radar points (Clee Hill radar data)

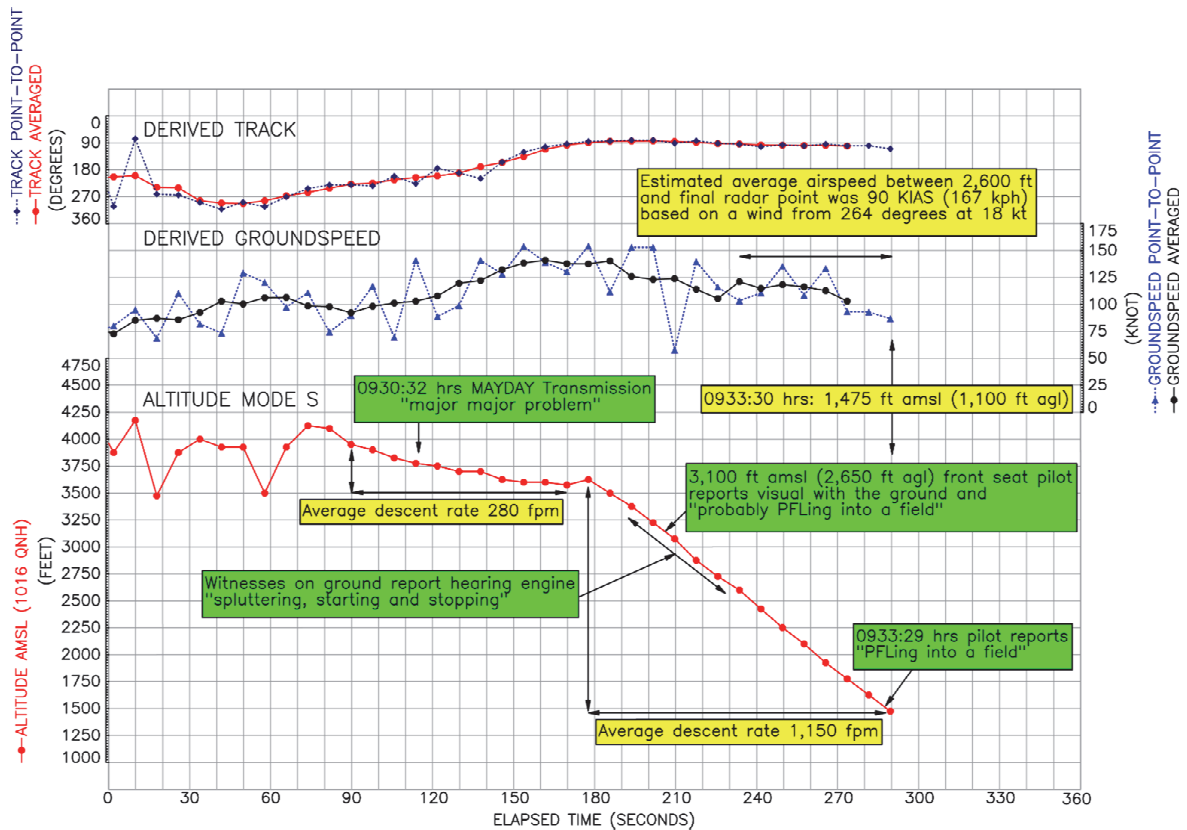
**Figure 5**

Radar data for the accident flight was recorded by various radar stations. The final secondary radar return, recorded at 0933:30 hrs by the Clee Hill radar (Figure 5), placed the aircraft on a bearing of about  $025^\circ$  from the accident site. At this point the aircraft was at 1,475 ft amsl<sup>7</sup> (1,100 ft agl) and approximately 0.32 nm (590 m) from the accident location. The last RT transmission was almost coincident with the final radar point. For the segment between 2,600 ft amsl and the final radar point, the average ground speed was 108 kt and the estimated average airspeed of the aircraft was 90 kt (167 km/hr), based on a wind from  $264^\circ$  at 18 kt<sup>8</sup>.

Accident flight radar data from the Cleve Hill radar

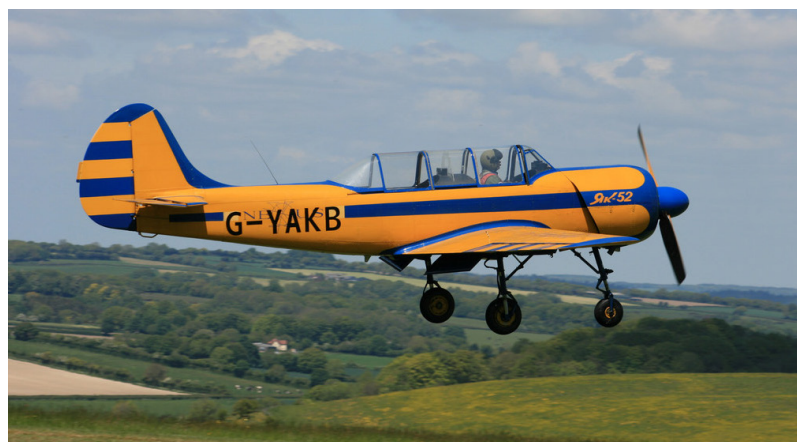
**Figure 6**

The accident aircraft G-YAKB

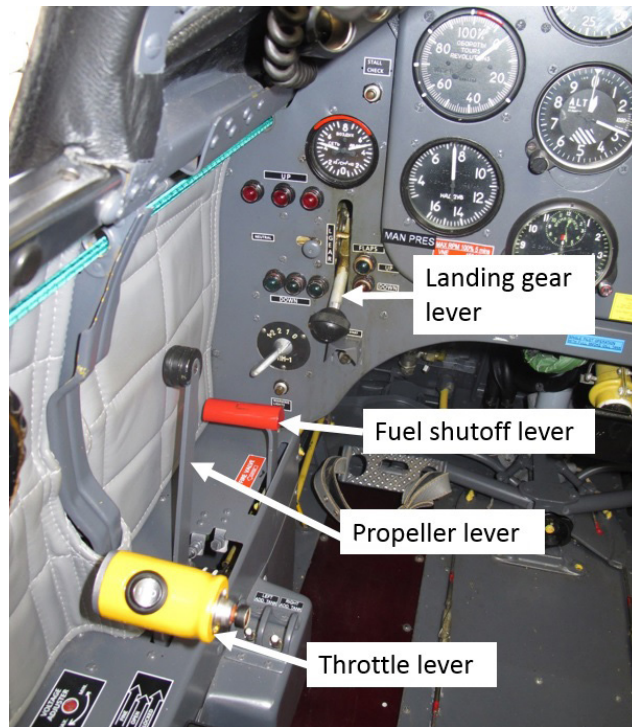
**Figure 7**

On the left side of the front cockpit is a yellow throttle lever, alongside a propeller speed control lever (Figure 7). In front of these levers is a black fuel shutoff lever (shown red in Figure 7). The fuel shutoff lever is pulled aft to shut off the fuel in an emergency, and normally remains in the full forward position (as shown) at the end of a flight. These three control levers are replicated on the left side of the rear cockpit and each is mechanically connected to its counterpart in the front cockpit, so that the front and rear levers move in unison. The landing gear lever is on the left side of the instrument panel and has three positions: UP, NEUTRAL and DOWN. There is a manually-selected sliding safety gate on the selector to prevent the gear being selected up inadvertently on the ground. To select the landing gear down, the gear lever is pushed in and moved from UP to DOWN and the safety gate is slid to the right. The rear cockpit landing gear lever is normally left in the central NEUTRAL position, which gives priority to the front lever. The pneumatically operated landing gear can take up to 15 seconds to move to the fully locked down position. The flap lever is located aft of the throttle lever and has two positions, FORWARD and AFT to select flaps up or full down. The rear cockpit flap lever in G-YAKB was gated to render it inoperable.

Front cockpit controls (left side) from a different Yak-52. Fuel shutoff lever shown in the forward 'fuel on' position. On G-YAKB the fuel shutoff lever handle was black

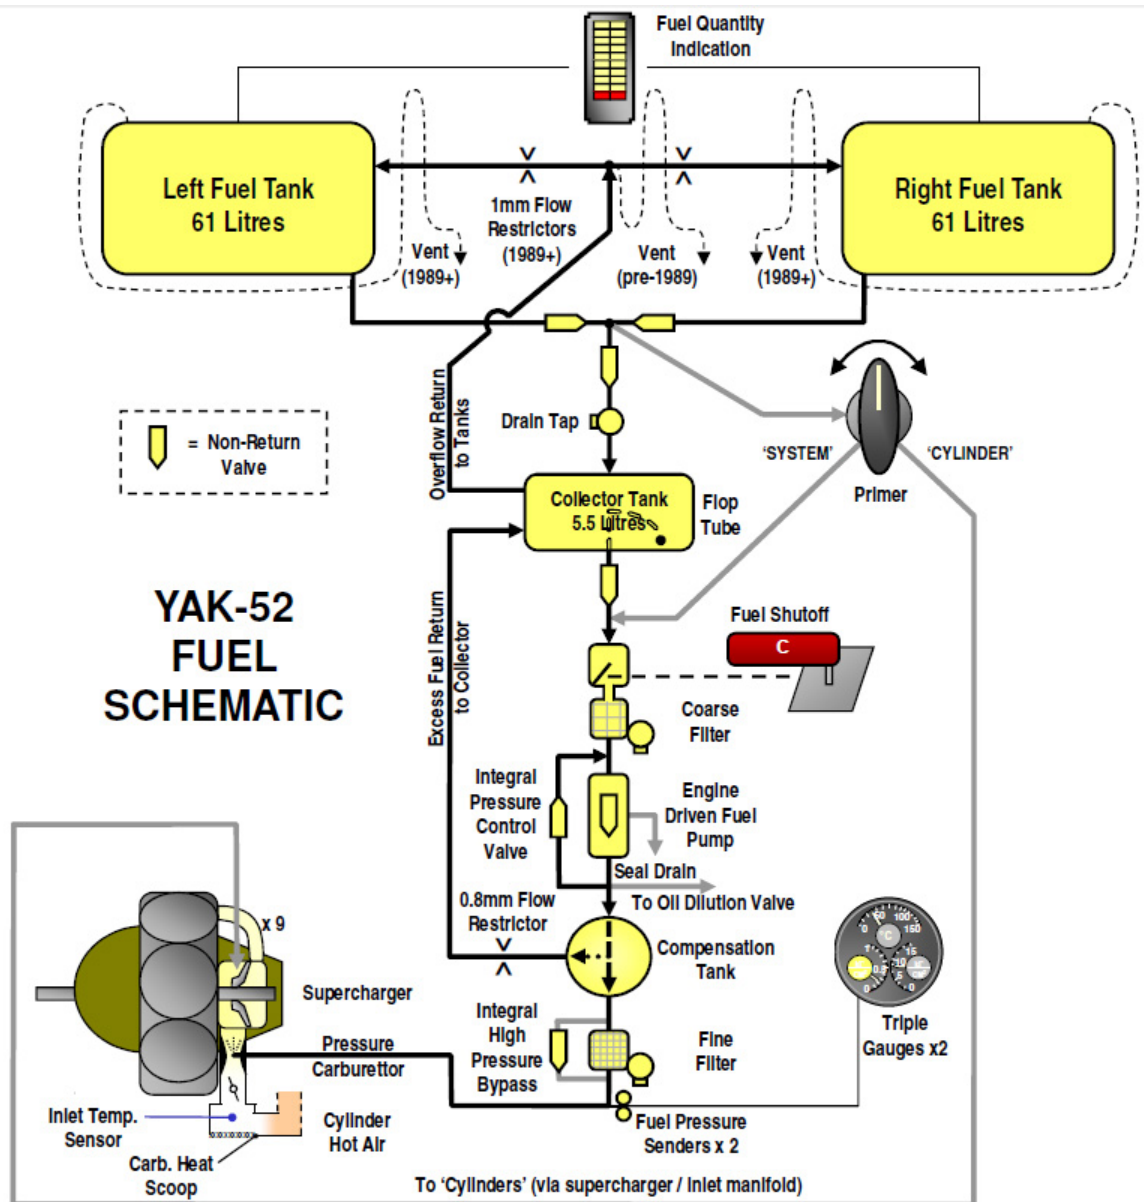
Figure 9

The fuel system includes two wing tanks, each of 61 litres capacity, which gravity-feed a 5.5 litre collector tank in the lower centre section of the aircraft (Figure 9). The engine-driven fuel pump draws its fuel supply from the collector tank which provides a short-term supply of fuel for inverted flight (up to 2 minutes is permitted). There is no left/right fuel tank selector, so both tanks feed the collector tank continuously via non-return ('flapper') valves. The first pair of non-return valves prevent fuel from passing from one tank to the other. The third non-return valve prevents fuel from flowing from the collector tank back to the main tanks. A rubber flop-tube inside the collector tank is connected to the fuel outlet. The flop-tube is weighted at its end so that it rests at the bottom of the tank during normal flight and rests at the top of the tank during inverted or negative-g flight; this ensures that the outlet can always draw the fuel in the tank.

pushed in, the plunger in the handle draws fuel from a position upstream of the collector tank, as shown in Figure 9, and pumps it into a position between the collector tank and fuel shutoff valve. This primes the fuel lines, fuel pump and carburettor for engine start. When the primer handle is turned to the right 'Cylinder' position and pumped, fuel is drawn from the same location but is pumped into the supercharger compressor. This provides some vapourised fuel ready to be drawn into the cylinders as soon as the engine is turned over.

Yak-52 fuel system diagram (© Robert A. Rowe)
