AAIB Bulletin: 2/2018	G-GARB	EW/C2016/09/01	
ACCIDENT			
Aircraft Type and Registration:	EV-97 Teameurostar UK (Eurostar), G-GARB		
No & Type of Engines:	1 Rotax 912-UL piston engine		
Year of Manufacture:	2013 (Serial no: 2013-4104)		
Date & Time (UTC):	18 September 2016 at 1058 hrs		
Location:	Near Builth Wells, Powys		
Type of Flight:	Private		
Persons on Board:	Crew - 1	Passengers - 1	
Injuries:	Crew - 1 (Fatal)	Passengers - 1 (Fatal)	
Nature of Damage:	Destroyed		
Commander's Licence:	National Private Pilot's Licence (Microlight)		
Commander's Age:	55 years		
Commander's Flying Experience:	316 hours (of which 316 were on type) Last 90 days - 58 hours Last 28 days - 22 hours		
Information Source:	AAIB Field Investigation

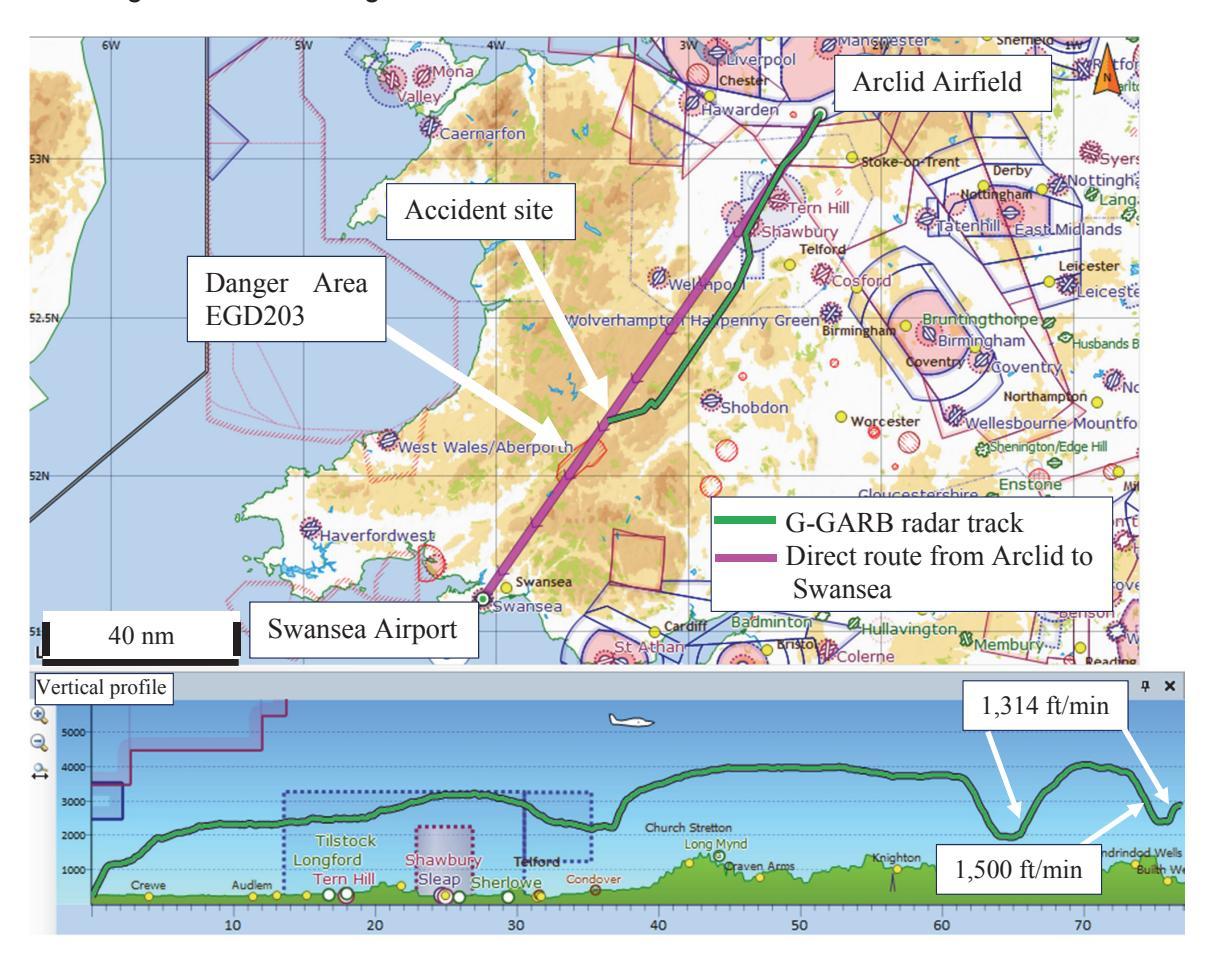
Figure 1

G-GARB recorded radar track with derived vertical speeds (Chart produced by SkyDemon and used with permission)

Vertical speed was calculated by examining the altitude change over the 8 second recording period. This showed two climbs of +1,314 ft/min (+175 ft over 8 seconds) and a descent of 1,500 ft/min (-200 ft over 8 seconds (Figure 1)).

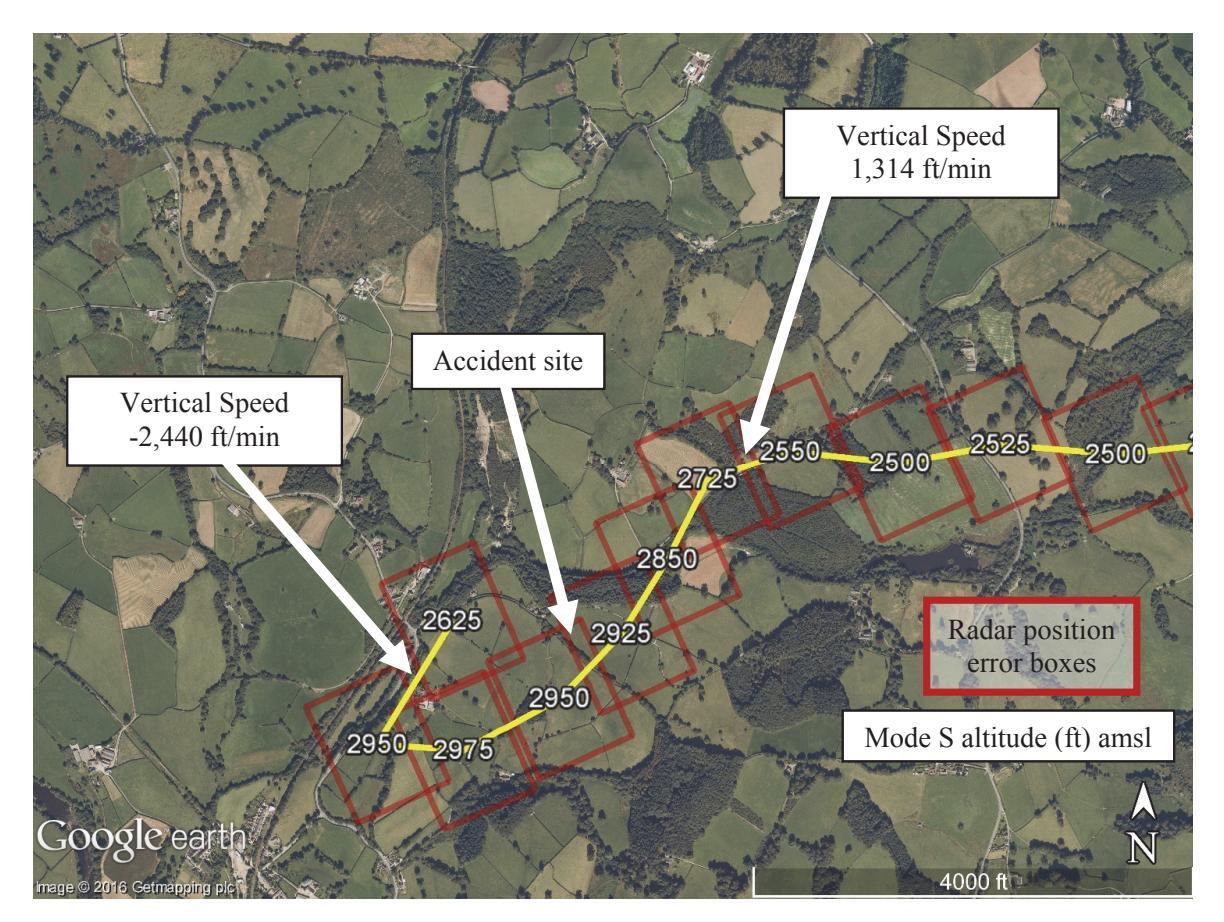
Figure 4

The final stage of the flight is illustrated in Figure 4, which includes 'error boxes', in red, denoting the limited accuracy of the radar position data. A minute and a half prior to the end of the radar recording, the aircraft started to fly at approximately level altitude and constant heading for 40 seconds. Calculated groundspeed for this period was 87 mph ±18 mph (depending on radar error). Considering the aircraft's approximate heading and a reported wind of 240°/ 10 kt, this equates to an airspeed of 97 mph ±18 mph. At 1055:27 hrs, the aircraft commenced a climb from 2,550 ft to 2,975 ft over 40 seconds. The maximum derived vertical speed during this climb was 1,314 ft/min with an average of 638 ft/min. Between the penultimate and final recorded radar returns, the aircraft descended 325 ft over 8 seconds; a descent rate of 2,440 ft/min. The final recorded radar return was at 1056:23 hrs with the aircraft at 2,625 ft (2,100 ft agl), almost overhead the accident site.

G-GARB recorded radar data showing altitude amsl and position error boxes in red
