## CONTENTS

### COMMERCIAL AIR TRANSPORT

**(ALL TIMES IN THIS BULLETIN ARE UTC)**

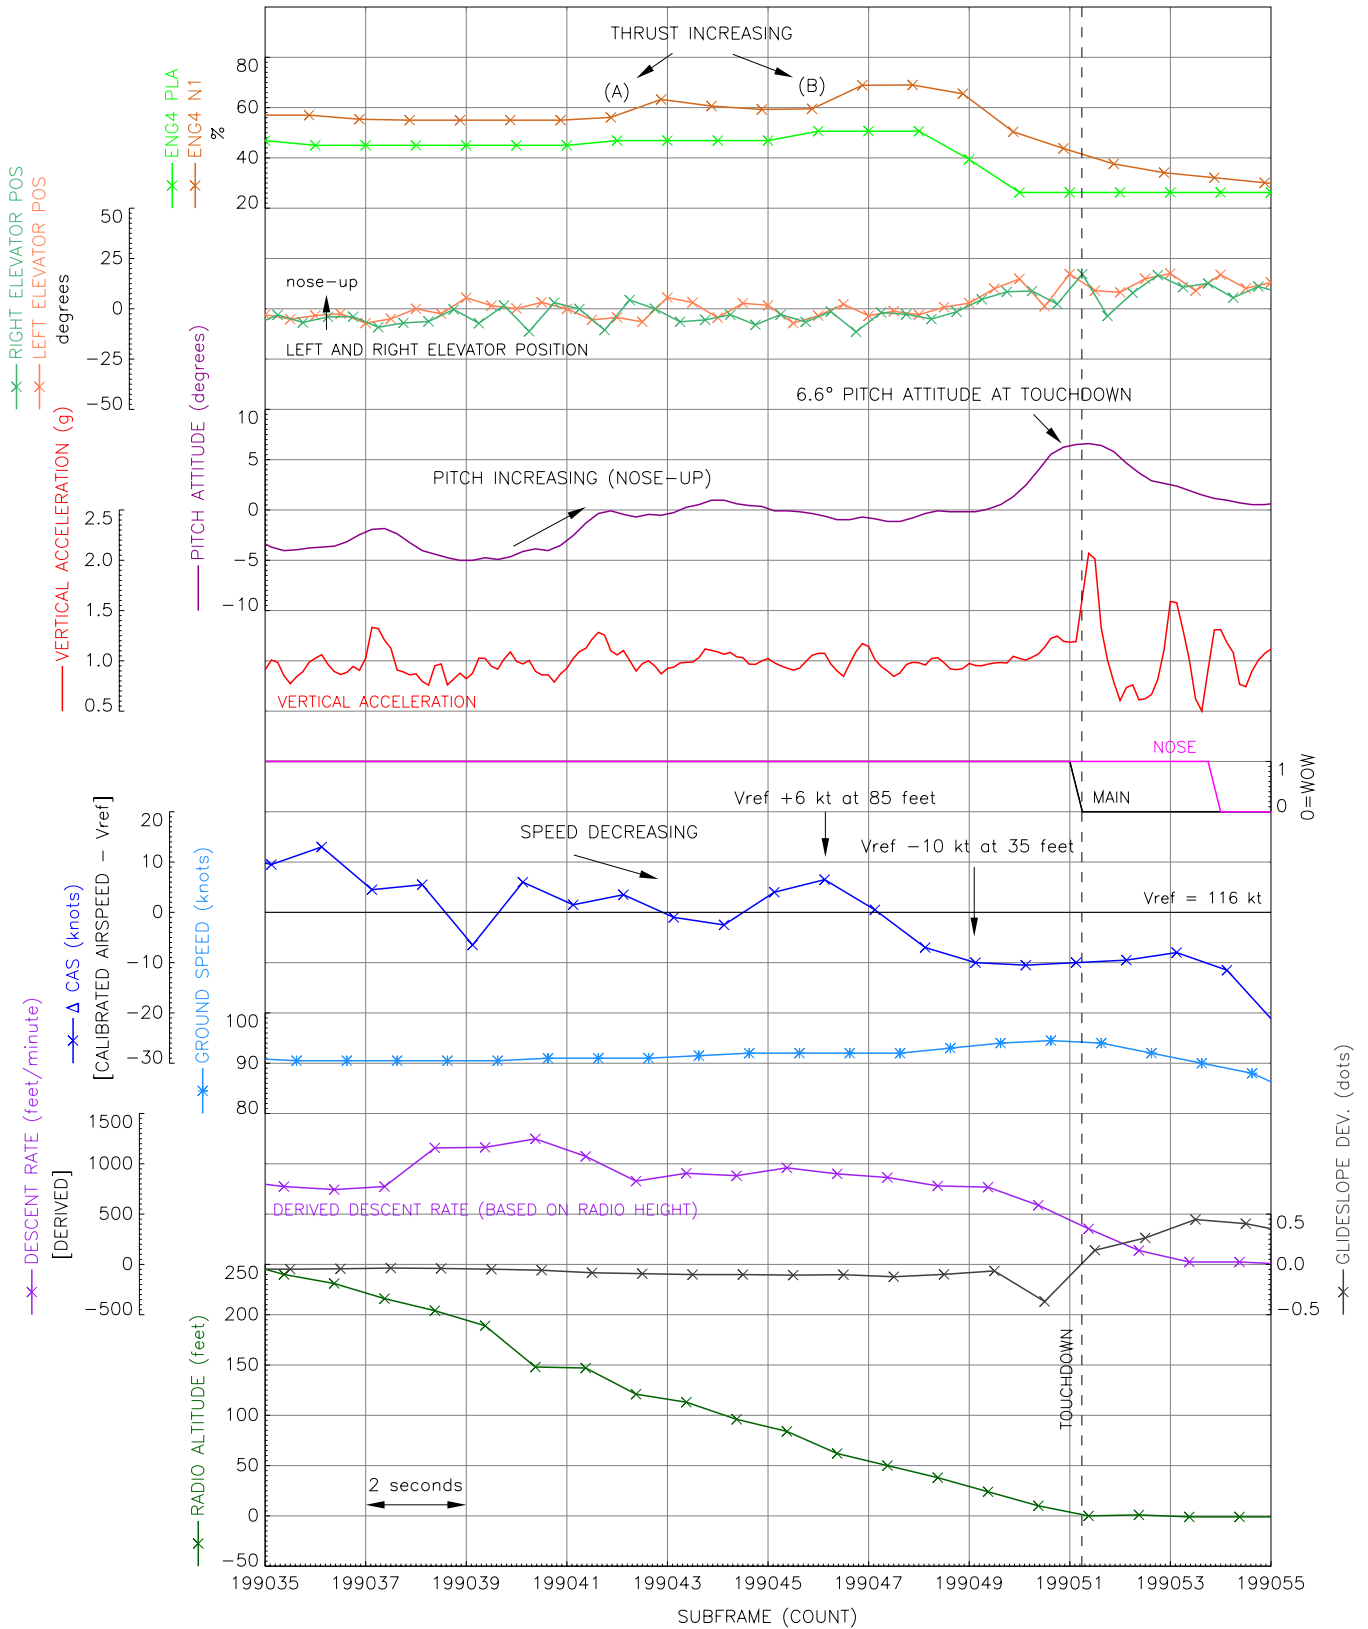
**Figure 1**  
 Salient FDR Parameters  
 (Incident to G-CFAA on 7 January 2005)

As the aircraft approached, at about 85 ft, the commander increased thrust from 60% to 69% N1 and decreased the pitch attitude slightly. Both of these actions should, in still air, have resulted in an increase in airspeed. However, the airspeed decreased by 16 kt over 3 seconds, although the ground speed increased slightly. By 35 ft, the speed was 10 kt below  $V_{\text{ref}}$  making a normal touchdown difficult to achieve, with any attempt to flare the aircraft for touchdown causing a further reduction in speed. During the flare, the pitch attitude increased to 6.6° nose up and the tail contacted the runway. This evidence is consistent with an encounter with significant negative windshear immediately prior to touchdown.

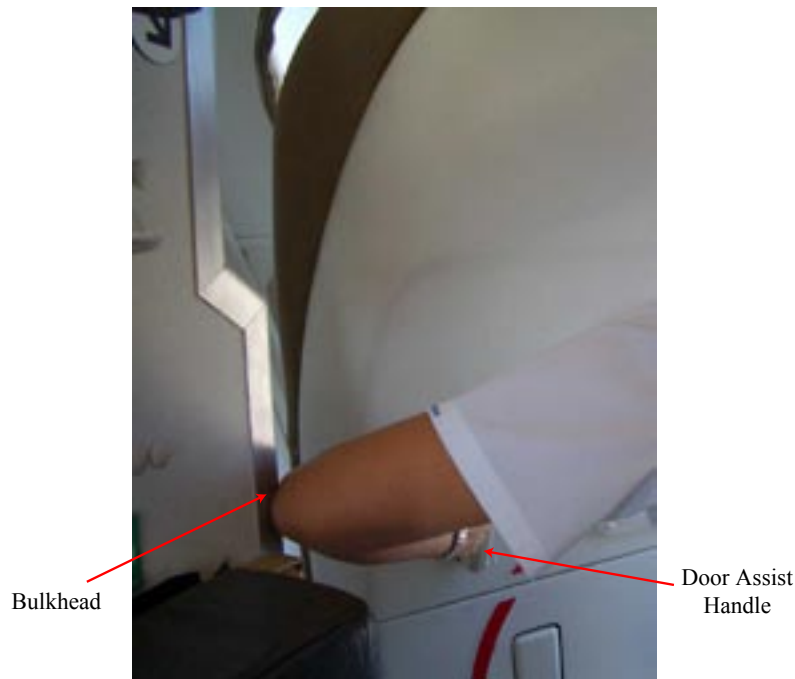
**Figure 1**

Reconstruction of a cabin crew member’s arm trapped between bulkhead and door assist handle

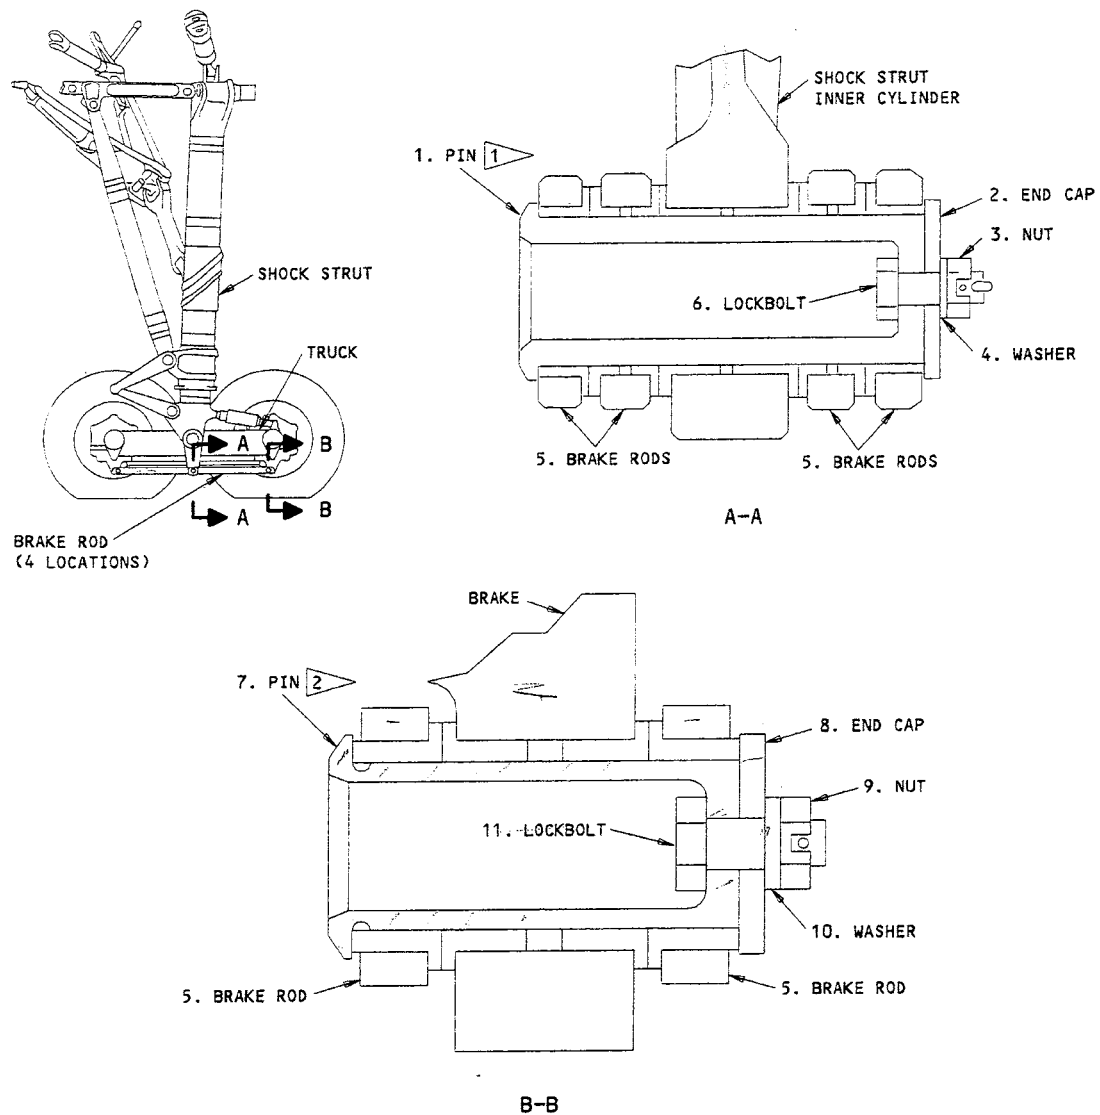
Main Landing Gear Brake Rod Installation  
Figure 401

- 1 INSTALL THE PIN WITH THE HEAD INBOARD
- 2 INSTALL THE PIN WITH THE HEAD ON THE TRUCK SIDE (PREFERRED)  
INSTALL THE PIN WITH THE HEAD ON THE BRAKE SIDE (OPTIONAL)

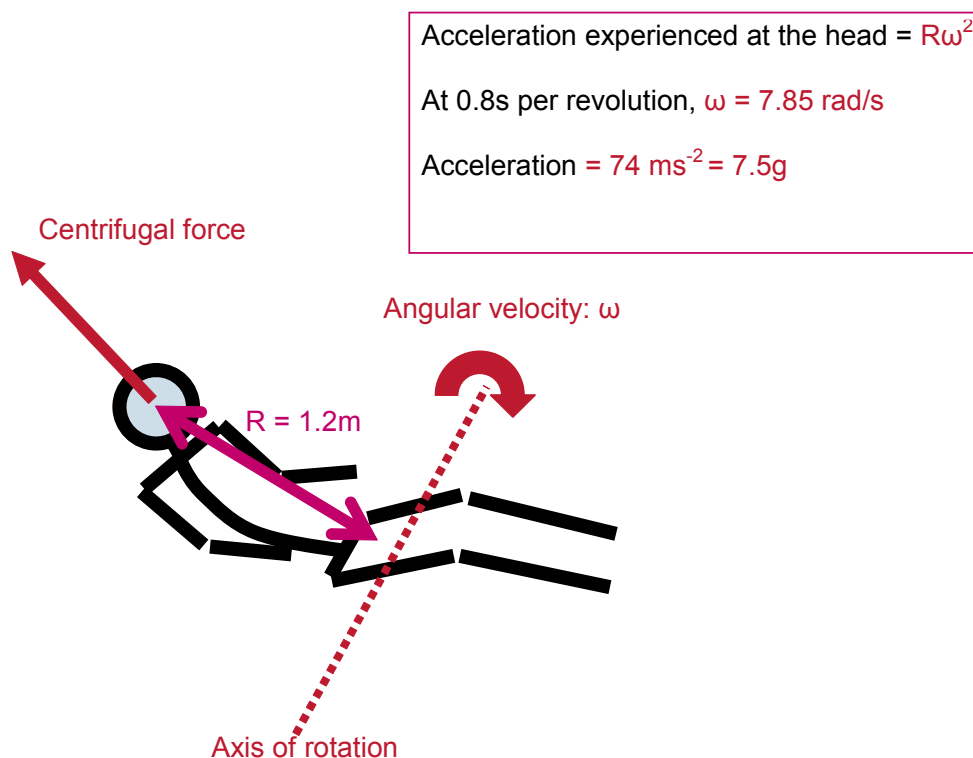
**Figure 3**

After his previous attempt, the pilot had been advised to increase the rate of rotation in the knife-edge spin. The rotation rate he achieved on his third attempt is estimated at about one turn in less than a second. The pilot's head was about 1.2 m from the axis of rotation, which passed through or close to his body. At 1 second per rotation, the acceleration at his head would have been minus 4.8g.

At 0.8 seconds per rotation, his head would have been subjected to a negative acceleration of 7.5g whilst his feet would have been close to the axis of rotation; see Figure 3 below:
