CONTENTS

Summary of:	Aircraft Accident Report No: 5/2008	49
	Report on the accident to Boeing 737-300, OO-TND at Nottingham East Midlands Airport on 15 June 2006

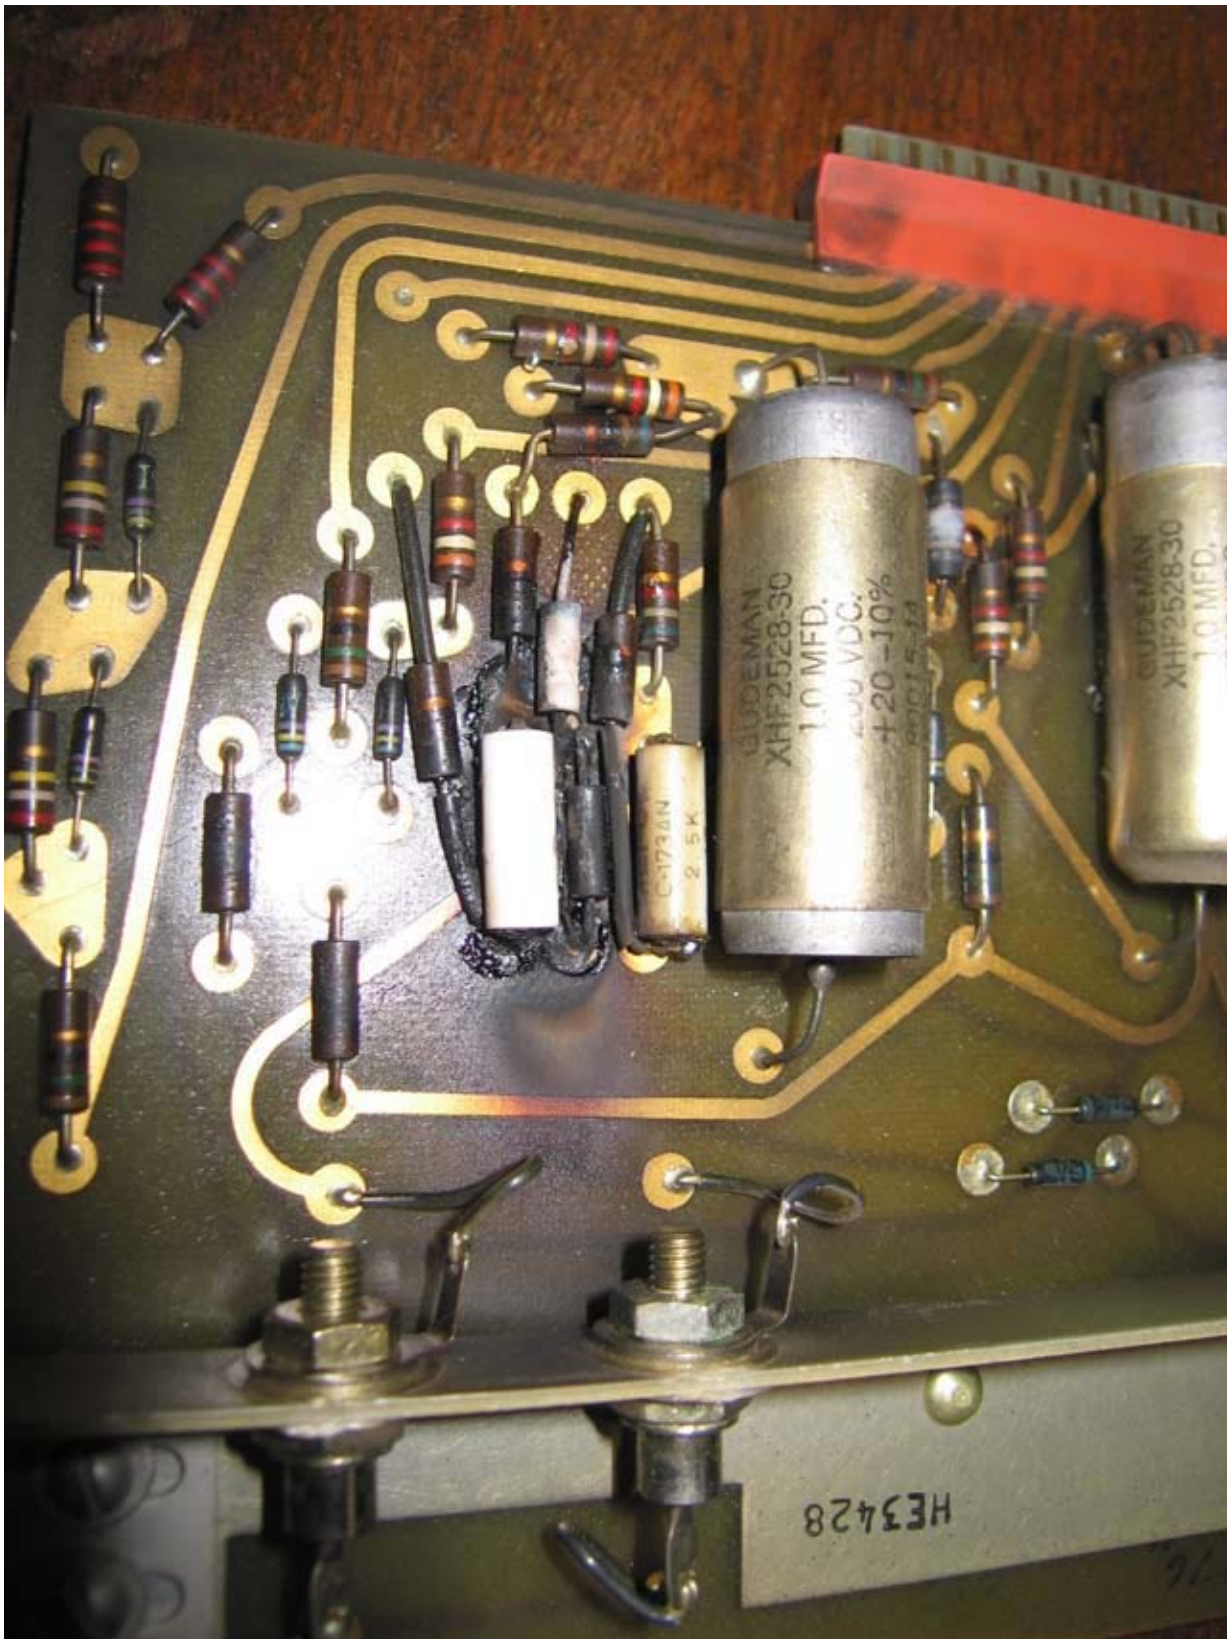
Figure 1

boards, a double synchrophaser board, a saw-tooth synchrophaser board, a speed derivative board and a power supply board. Examination of these circuit boards showed that several components within the power supply board had overheated, with one area showing localised burning of the board (see Figure 1). X-ray examination confirmed that several of the resistors had suffered a breakdown of their internal construction and that a resistor connector had melted and ‘shorted’ across several other connections within the board (see Figure 2). A review of the maintenance records for the component confirmed that the unit had recently been removed from G-FIZU due to the No 4 engine failing to follow the master engine. The unit had been inspected and the defect rectified prior to being returned to the operator in January 2007. The overhaul agency confirmed that the unit passed the post-rectification tests with no abnormalities and that no work was carried out on the power supply circuit board. Discussions with the National Transportation Safety Board of the USA and the engine and airframe manufacturers revealed that this type of unit had also been fitted to the Lockheed P3 Orion and early variants of the Lockheed C130 and L100 (the civil variant of the C130) but had been replaced in the 1980s by a solid state unit. It was confirmed that G-FIZU was the only remaining L188 Electra fitted with this type of synchrophaser unit. Due to the age and low number of these units remaining in operation, only one approved test facility existed worldwide and the damage to the circuits prevented testing of the unit to identify how the failures within the circuit board would have affected the functioning of the unit. The scale of the engine rpm gauges is such that relatively small variations in rpm would produce large movements of the gauge needle, as observed by the crew.

The cause of the incident was a failure within the power supply circuit board in the propeller synchrophaser unit. This caused significant power and rpm fluctuations on all four engines giving the flight crew difficulty in handling the aircraft. The No 2 engine exceeded its maximum governed speed which resulted in the fuel flow to the engine being cut back by its governor; this led the crew to believe that the engine had begun to run down and they shut that engine down. The remaining engines continued to fluctuate and, on final approach, the No 1 and 3 engines also appeared to run down, probably due to fuel being cut back after overspeeding.

that in the event of an identified failure within the synchrophaser unit, the system could be electrically isolated by pulling the circuit breaker on the 'BUS A' panel and the engines would then revert to basic mechanical engine governing.

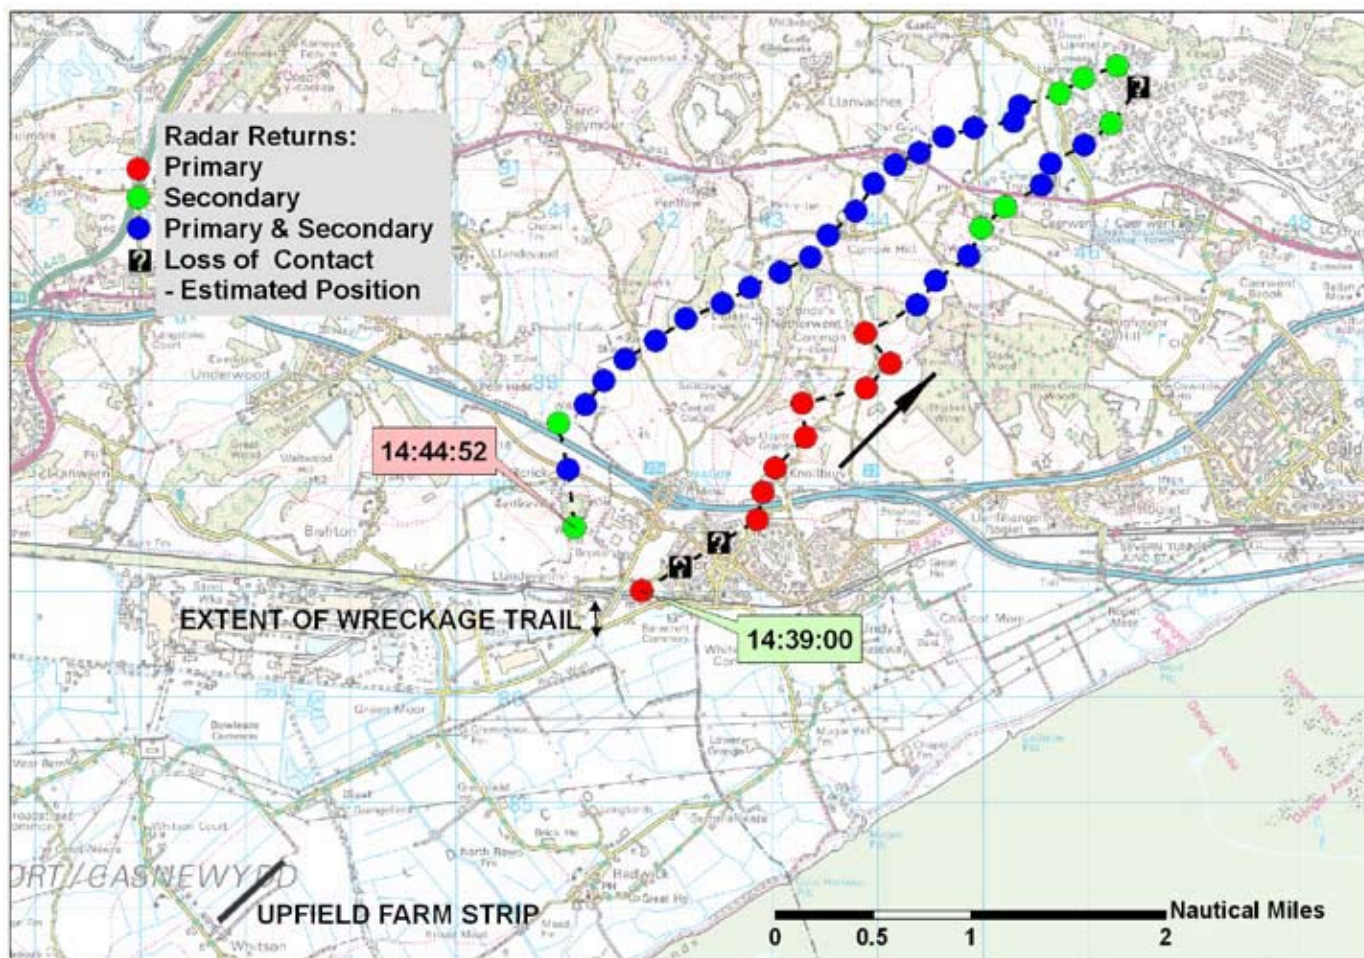
Figure 1

Radar data obtained from the Cardiff radar site recorded the aircraft track and ground speed. No Mode C (altitude) information was received and therefore no height information was available. The aircraft track is shown at Figure 1. From this information the aircraft flew north-east, away from Uckfield Farm and then made a sharp left turn onto a south-westerly heading. No reason for this turn was identified.

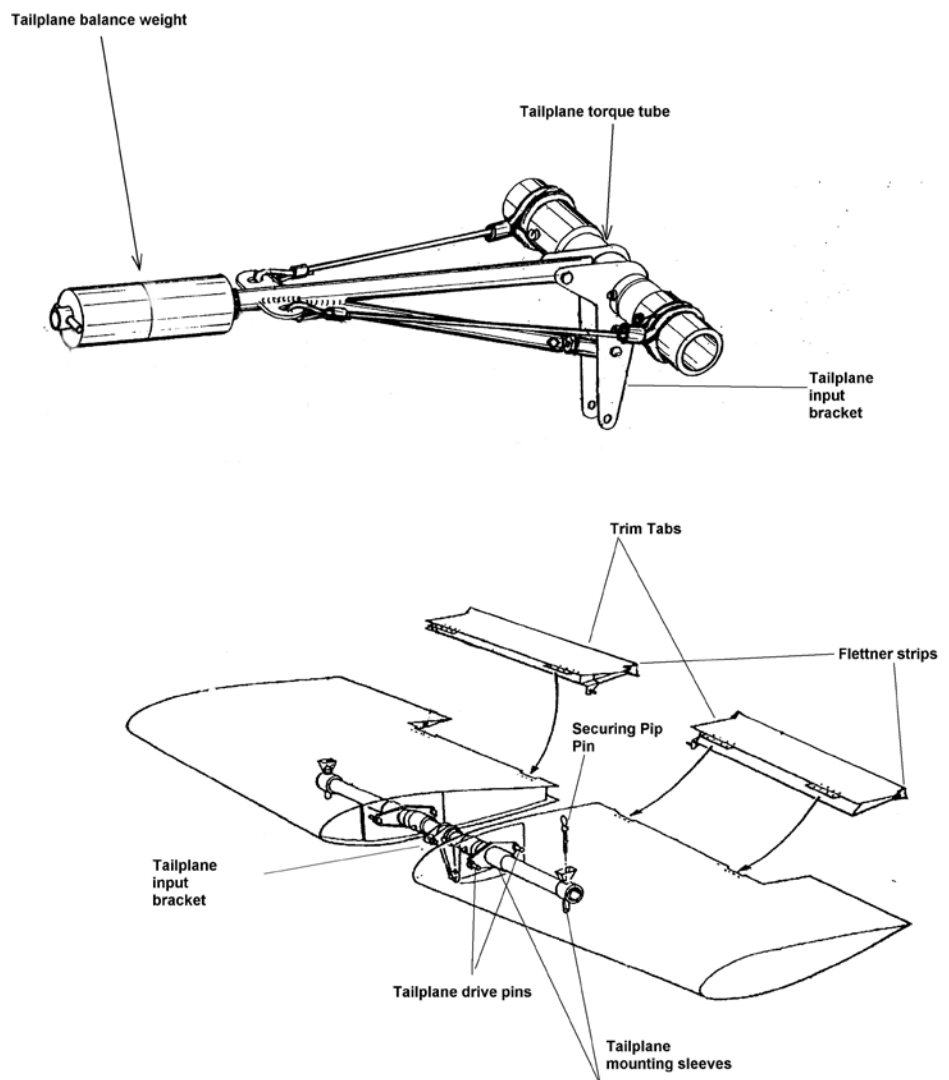
Figure 4

All four of the tailplane locating sleeves (see Figure 4) which had been bonded within the tailplanes, remained on the torque tube; the outer sleeve on each side was secured by its pip pin. Examination of the holes drilled into the outboard sleeves and the tailplane torque tube showed distortion and folding of the fore and aft edges of the holes which confirmed the application of a torque load between the sleeve and the torque tube. Discussions with both the Light Aircraft Association (previously the PFA) and Europa confirmed that the purpose of the outer sleeve and pip pin was to prevent the outboard movement of the tailplane and had not been designed to carry tailplane torque loads. Damage to the tailplanes confirmed that a failure had occurred in the bonding of the outboard sleeves. This had allowed both tailplanes to migrate outboard, disengaging both the tailplane drive pins and the trim tab drive pin and pulling the pip pins through the foam infill. Examination of the pip pin recesses in both tailplanes showed that they did not appear to have been constructed in accordance with the Europa Aircraft Build Manual, see Figure 5. The recesses in G-HOFC's tailplanes were significantly smaller than those shown in the manual; they consisted of a hole, and possibly an insert, of only slightly greater diameter than the pip pin whereas the build manual showed a significantly larger recess which made use of several layers of glass fibre cloth bonded to the sleeve. No abnormalities or inconsistencies which may have initiated the failure of the bond were found. Given that the bonded joint of the outboard sleeve had not been designed to carry torque loads even had it been constructed in the manner shown in the Build Manual, it is probable that it would also have failed due to the application of loads which it had not been designed to withstand.

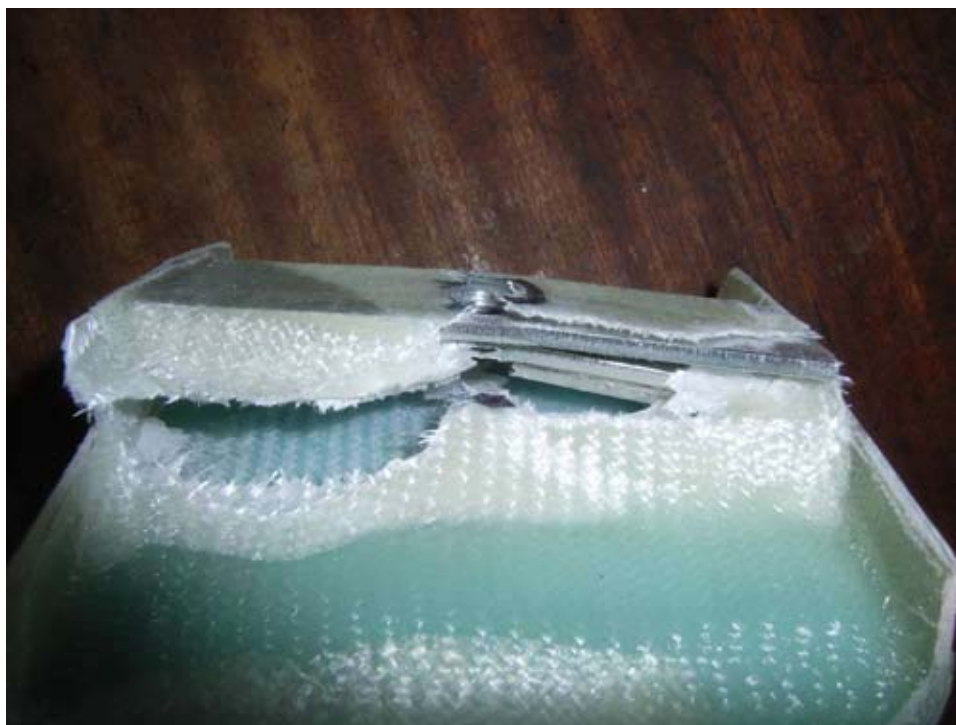
Figure 7

In order to determine the load-carrying capability of the incorrectly built joint, a tensile load test was carried out using two test specimens, one replicating the construction of G-HOFC's right drag pin mount, and one constructed in accordance with the build manual. Due to the limitations of the test equipment the full range of loads experienced by the drag pin could not be reproduced and the tests were limited to the determination of the ultimate tensile strength of the specimens. The results from the test confirmed that both test specimens were capable of holding the unfactored tensile design limit load of 10.03 kN without failure. The test was then repeated and both specimens loaded until they failed. Examination of the specimen replicating G-HOFC's right rear pin mount showed that the innermost (closest to the rib) plate had pulled away from the GRP surface of the specimen, bending under the load, which had disrupted the bond with the next plate, see Figure 7. This showed that the inner plate of the test specimen had carried a significant load prior to disbonding. The damage observed to G-HOFC's right

rear lift pin mounting suggested that it had not been subject to a similar load. Therefore measurements were taken of G-HOFC's rear right lift pin and lift pin mount. These measurements showed that the lift pin was dimensionally correct (12 mm diameter) and that the thread had been cut to the required depth of 2 mm through all of the lamination plates. The diameter of the hole in the outer plate of the mount met the requirements of the Europa Build Manual. Measurement of the second plate confirmed that the partially complete hole within it had been 10 mm in diameter. However, there was some distortion and 'opening' of its circumference where the hole breached the edge of the plate. The partial holes through the innermost plate and the flap plate had become distorted and were found to have a diameter of 11.62 mm. The magnitude of this distortion would have significantly reduced their ability to carry loads from the drag pin and allowed a degree of movement of the pin within the mounting. This, together with the distortion to the second plate, would have meant that the majority of the tensile loads within G-HOFC's right drag pin mounting would have been carried by the outermost plate alone, whereas the undistorted holes in the test specimen allowed load to be carried by all the plates.
