Rail Accident Investigation Branch

Rail Accident Report

Derailment near Waterside, East Ayrshire 21 January 2006

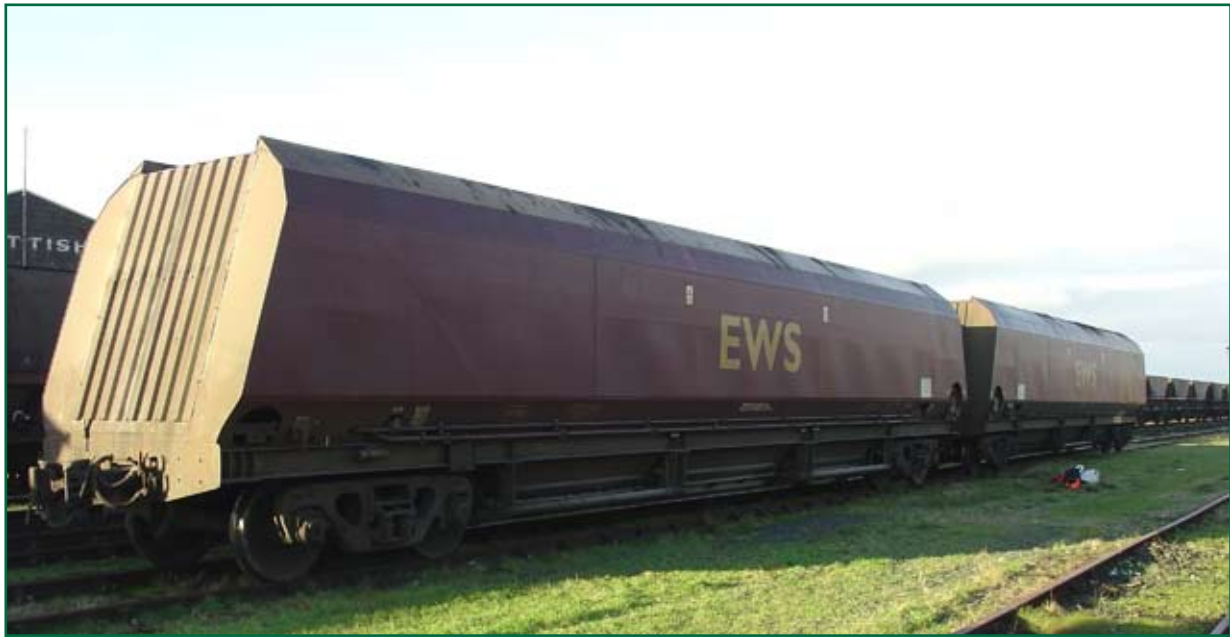
Figure 4: HTA wagons 310724 and 310711 at Falkland Yard, Ayr, following recovery.

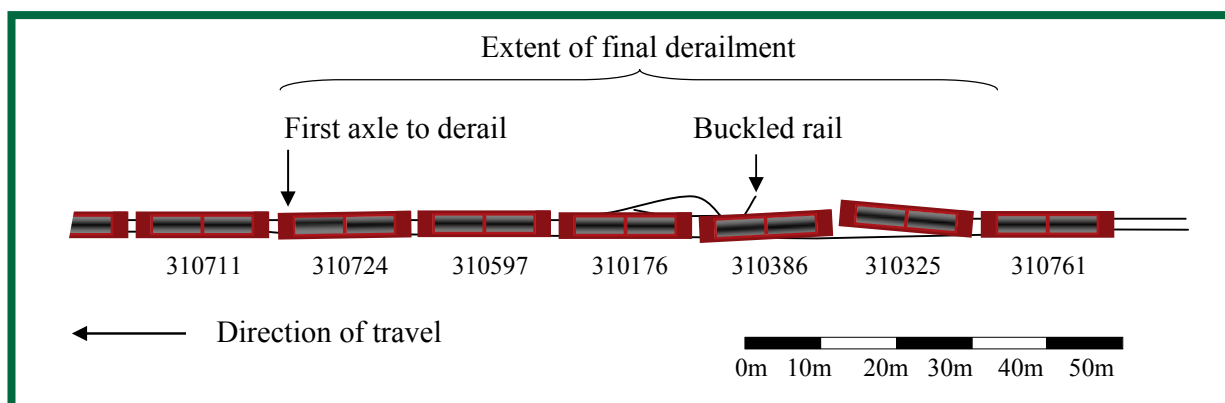
Figure 10: Sketch indicating the final position of last seven HTA wagons in train formation. Wagon 310711 (front) and the trailing bogie of wagon 310761 (rear) were not derailed.
