## CONTENTS

**(ALL TIMES IN THIS BULLETIN ARE UTC)**

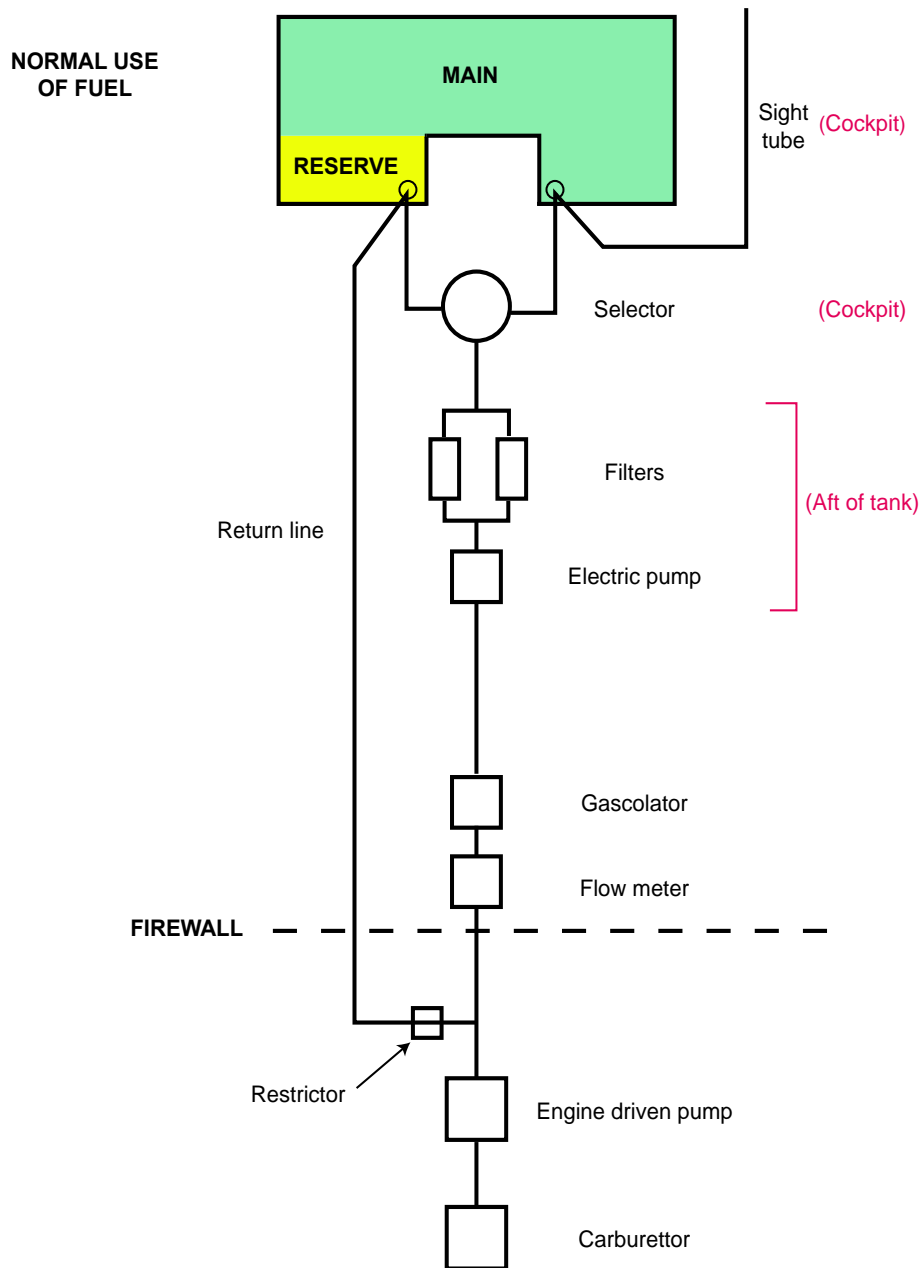
**Figure 1**

fuel supply. A schematic of the fuel system is provided in Figure 1. According to the engine manufacturer the fuel consumption of this engine type at 75% power is 26 litres per hour, with the caveat that: ‘actual consumption will vary depending on installation, propeller and power settings’.

G-BYFG fuel system schematic
