## CONTENTS

**(ALL TIMES IN THIS BULLETIN ARE UTC)**

<b>Aircraft Type and Registration:</b>	Boeing 747-436, G-CIVB	
<b>No &amp; Type of Engines:</b>	4 Rolls-Royce RB211-524G2-T-19 turbofan engines	
<b>Year of Manufacture:</b>	1993	
<b>Date &amp; Time (UTC):</b>	11 July 2009 at 0310 hrs	
<b>Location:</b>	Phoenix, Arizona, USA	
<b>Type of Flight:</b>	Commercial Air Transport (Passenger)	
<b>Persons on Board:</b>	Crew - 18	Passengers - 300
<b>Injuries:</b>	Crew - 1 (Minor)	Passengers - some (Minor)
<b>Nature of Damage:</b>	None	
<b>Commander's Licence:</b>	Airline Transport Pilot's Licence	
<b>Commander's Age:</b>	55 years	
<b>Commander's Flying Experience:</b>	18,235 hours (of which 6,529 were on type) Last 90 days - 215 hours Last 28 days - 63 hours	
<b>Information Source:</b>	AAIB Field Investigation and operator's internal investigation

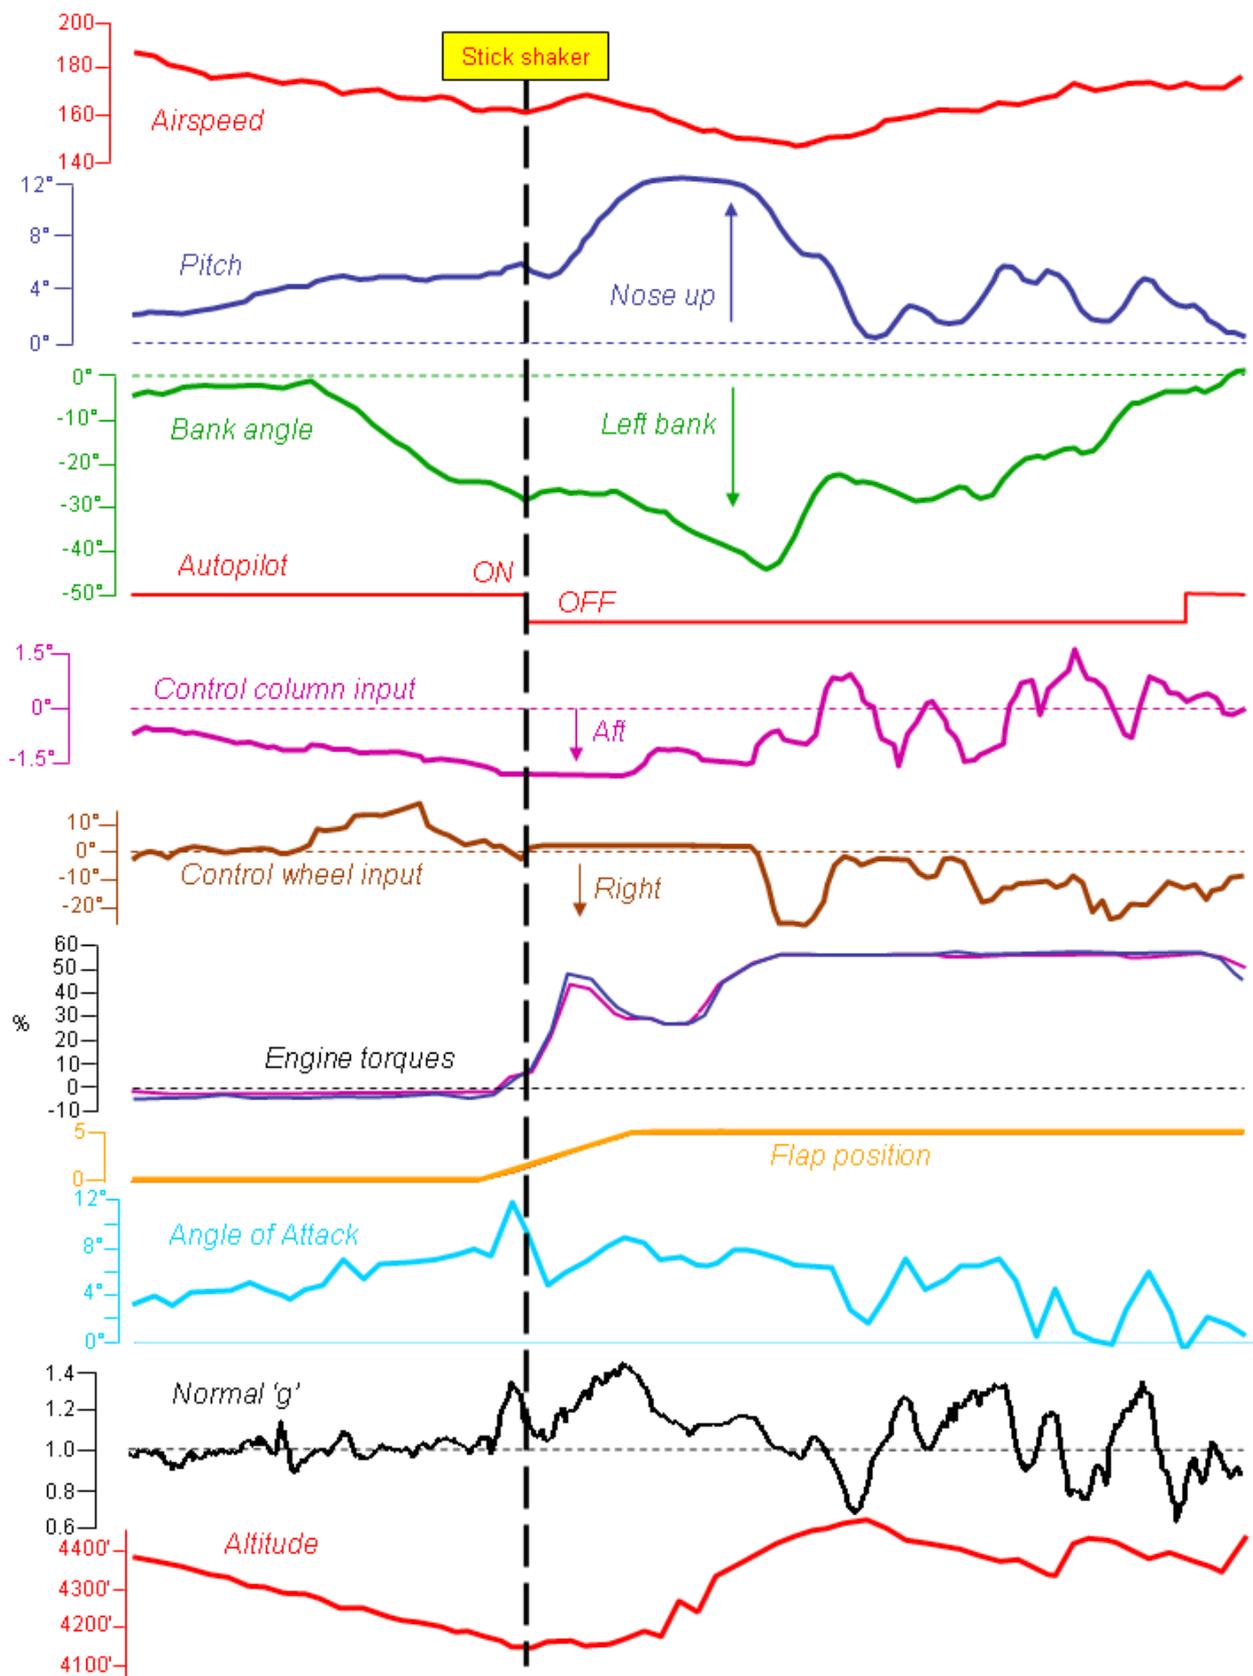
FDR information for the whole flight had been downloaded by the aircraft operator and was available for analysis. Figure 1 shows relevant flight data from the time of the incident.

Relevant FDR parameters over a 65 second period surrounding the stick shaker event (simplified)

As the pitch approached its maximum value, about four seconds after autopilot disengagement, there was a small forward movement of the control column, which was soon removed, with no wheel displacement. Only when the bank angle increased beyond 40° was a large lateral control wheel input made, which corrected the overbanked condition. This was about 13 seconds after autopilot disengagement.

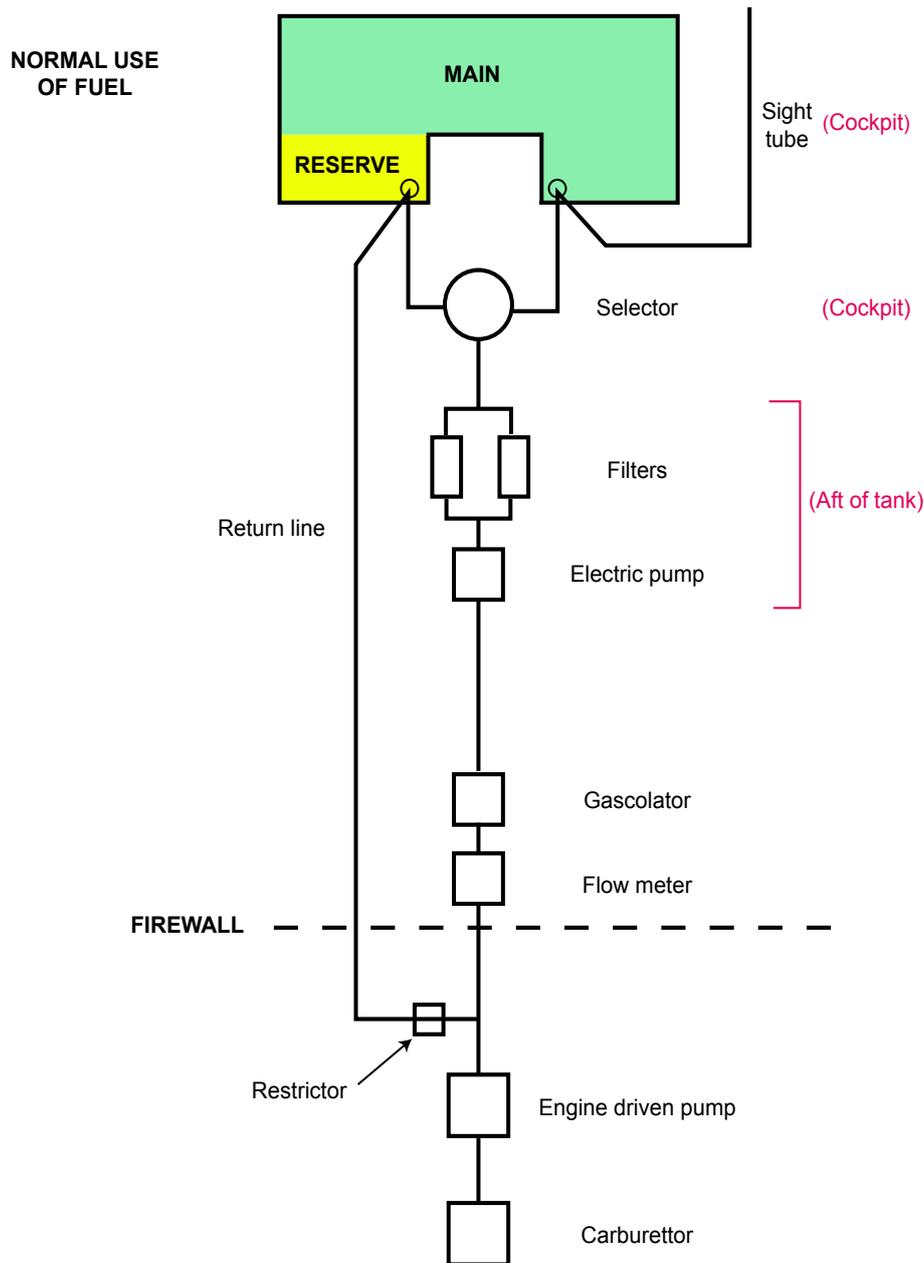
Figure 1

fuel supply. A schematic of the fuel system is provided in Figure 1. According to the engine manufacturer the fuel consumption of this engine type at 75% power is 26 litres per hour, with the caveat that: ‘actual consumption will vary depending on installation, propeller and power settings’.

G-BYFG fuel system schematic

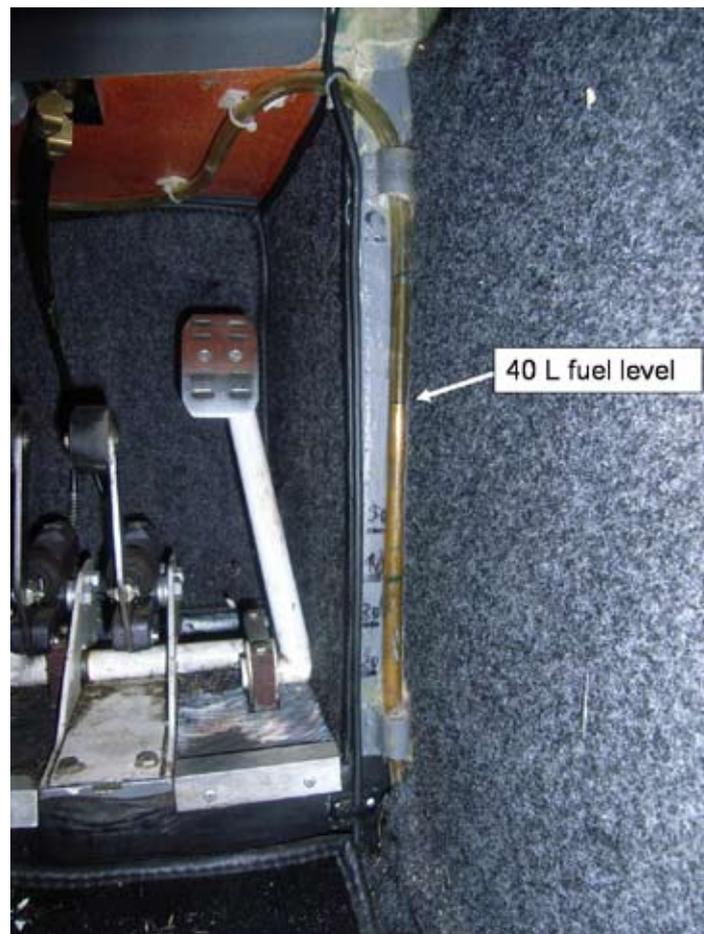
**Figure 2**

Fuel quantity indication was provided by means of a clear plastic sight tube mounted on the centre tunnel, close to the pilot's right lower leg (Figure 2). The sight tube must be calibrated during aircraft construction. The kit manufacturer's build manual suggests adding a card with dark and light stripes behind the tube to make the fuel level in the sight more visible; however, this was not used on this aircraft. Due to its location forward of the tank, the indicated fuel level is sensitive to changes in pitch attitude.

Fuel sight tube

The fuel sight tube on G-BYFG was discoloured and it was therefore difficult to read the fuel level in the tube. Graduation markings (20, 30, 40 and 50) were visible on the structure behind the sight tube (Figure 2), but it was not clear what these markings represented. Close examination of the sight tube revealed a line marked on the sight tube next to the '40' graduation. The significance of this line was not established. During the wreckage examination by the AAIB, water was poured into the fuel tank with the aircraft in its normal ground attitude, until the level in the sight tube reached the '40' graduation. This corresponded to an actual quantity in the tank of only 20 litres. When 40 litres were added to the tank, the level in the sight tube was well above all the graduations. With the level at the top of the sight tube, the total quantity in the tank was in excess of 60 litres.
