CONTENTS

SPECIAL BULLETINS / INTERIM REPORTS

AAIB Special Bulletins / Interim Reports

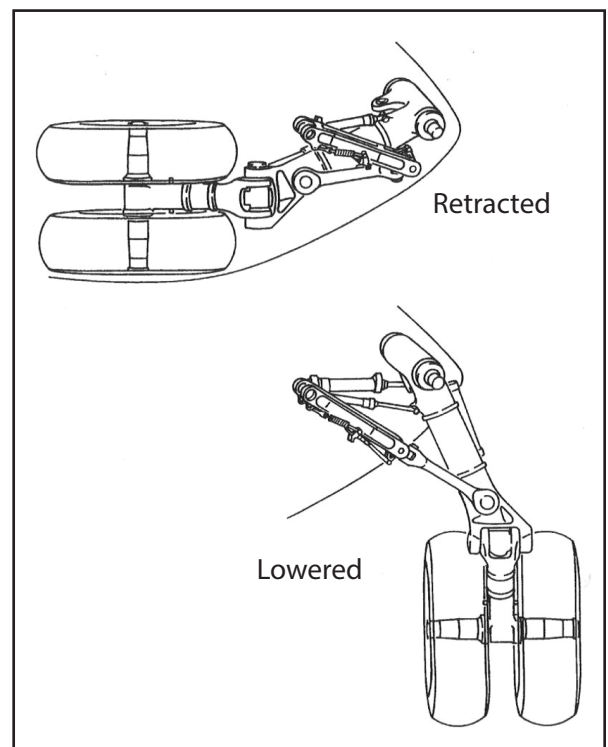
Figure 3

Each main landing gear consists of a twin wheel unit mounted on a trailing arm, pivoted on the lower end of a trunnion (Figure 3). The latter is pivoted about an approximately longitudinal axis from a faired structure protruding laterally beyond the profile of the lower fuselage. With the gear retracted, the wheel/axle unit is housed in a recess in the pressure hull below the cabin floor with the axle in a vertical orientation. The trunnion swings through 90° during lowering, to orientate the axle horizontally. Retraction and extension are carried out by means of a double acting hydraulic cylinder connecting the trunnion to the fuselage structure.

Landing Gear general view looking aft

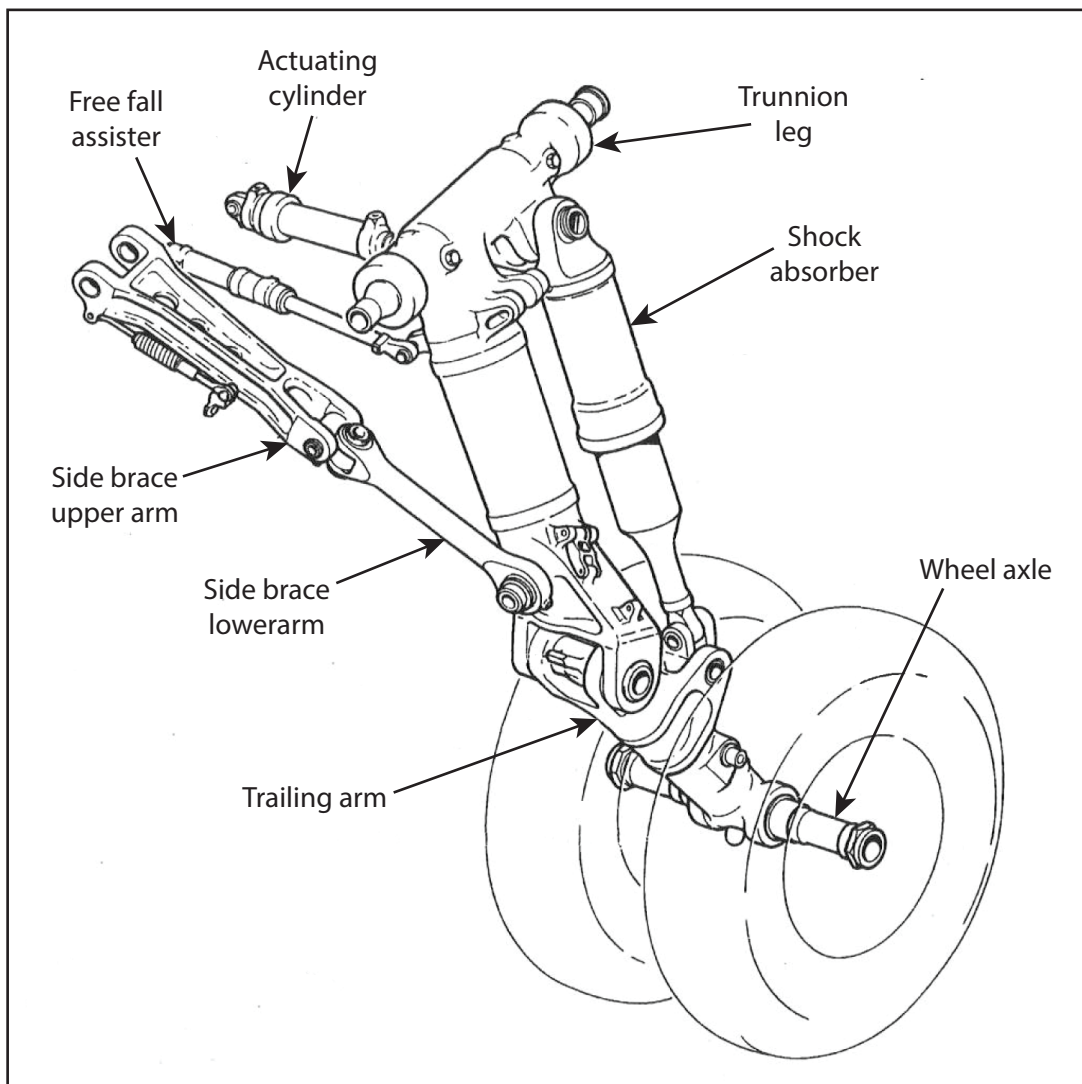
Figure 4

It was found that the side brace upper arm of the left main landing gear had suffered a structural failure. This had taken the form of a fracture of both lugs at their attachment to the through bolt in the fuselage-mounted pivot bracket (Figure 5). The failure

had rendered the side brace ineffective allowing the main leg to pivot outboard beyond its normal fully deployed position. This had resulted in non-design loading being transferred to the actuating cylinder and overload failure occurring in its attachment bracket to the fuselage structure. The unrestrained main trunnion had thus continued to translate outboard. Part of the lower fuselage had ultimately come into contact with the runway surface. The fractured lug recovered from the runway was found to be the forward of the two lugs of the side brace upper arm.

Main landing gear general arrangement

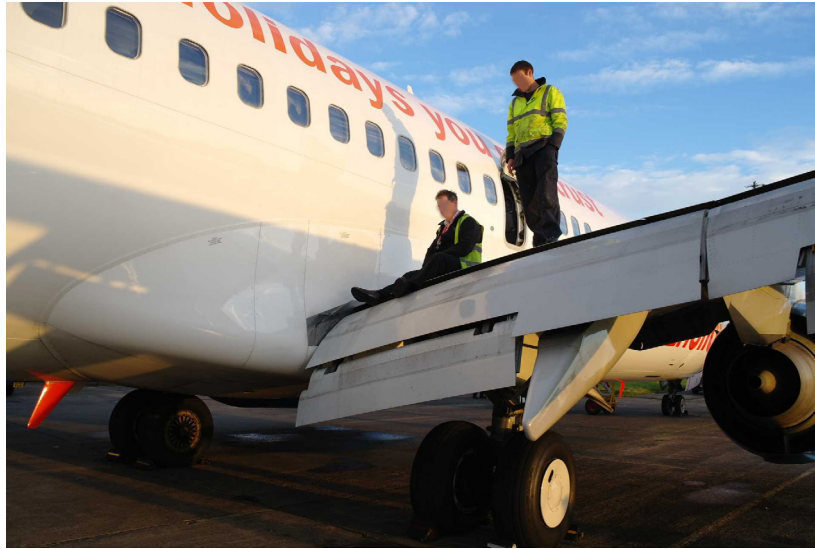
Figure 5

Showing the flaps in the fully lowered position.

height of the lowest part of the flap trailing edge with the flap fully lowered (see Figure 5) is 42 inches.

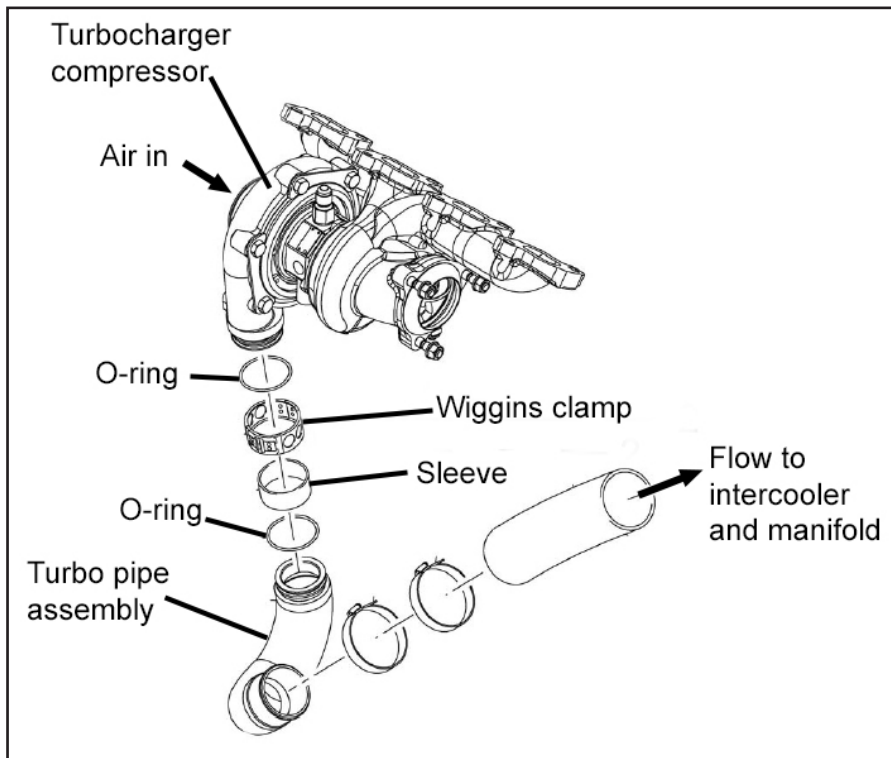
Figure 6

Location of Wiggins clamp
