Rail Accident Investigation Branch

Rail Accident Report

Derailment of a tram on the Seaton Tramway 18 March 2007

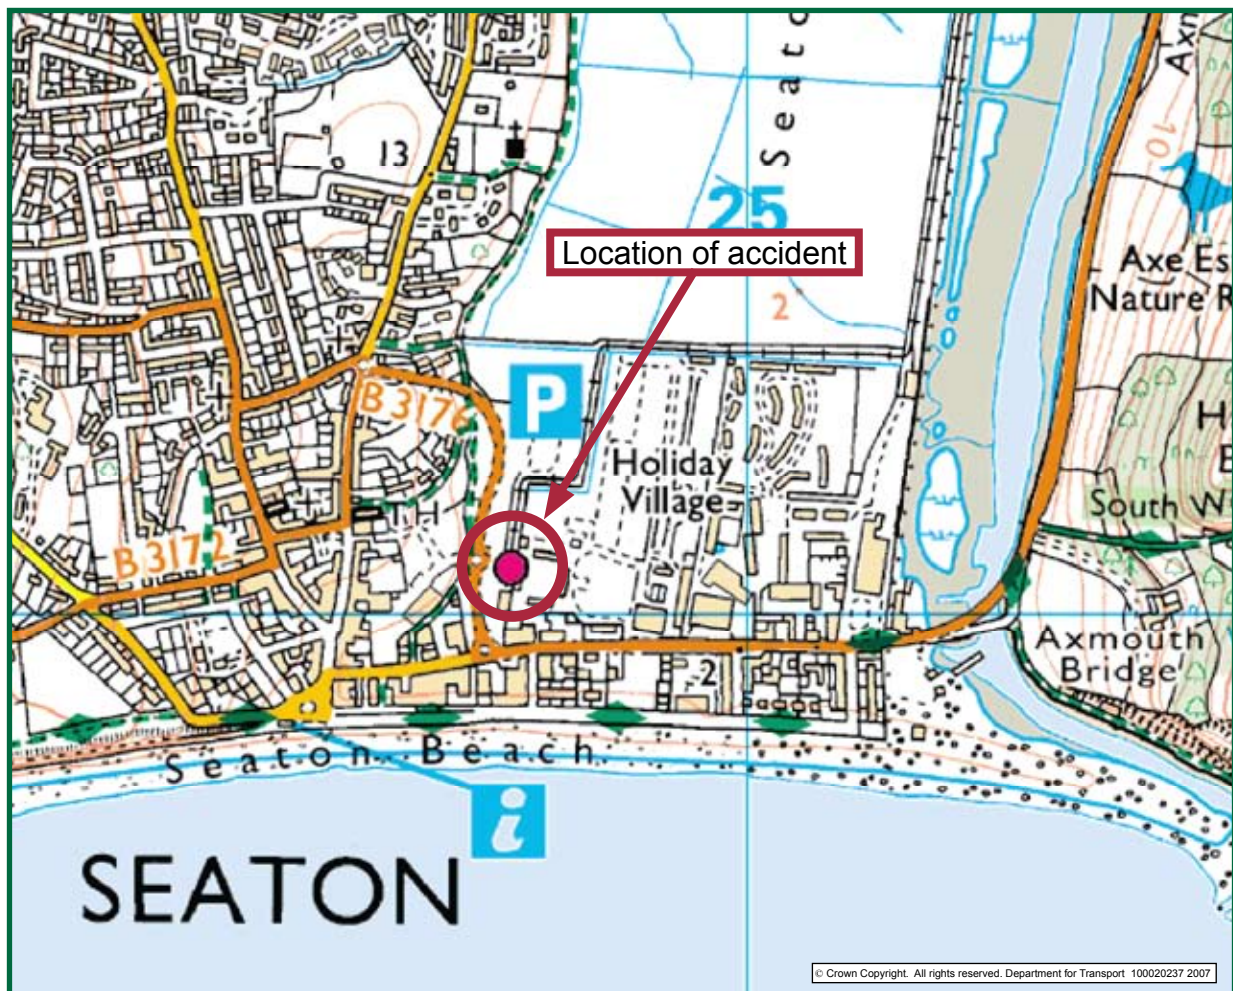
Figure 1: Extract from Ordnance Survey map showing location of accident

You may re-use this document/publication (not including departmental or agency logos) free of charge in any format or medium. You must re-use it accurately and not in a misleading context. The material must be acknowledged as Crown copyright and you must give the title of the source publication. Where we have identified any third party copyright material you will need to obtain permission from the copyright holders concerned. This document/publication is also available at www.raib.gov.uk.

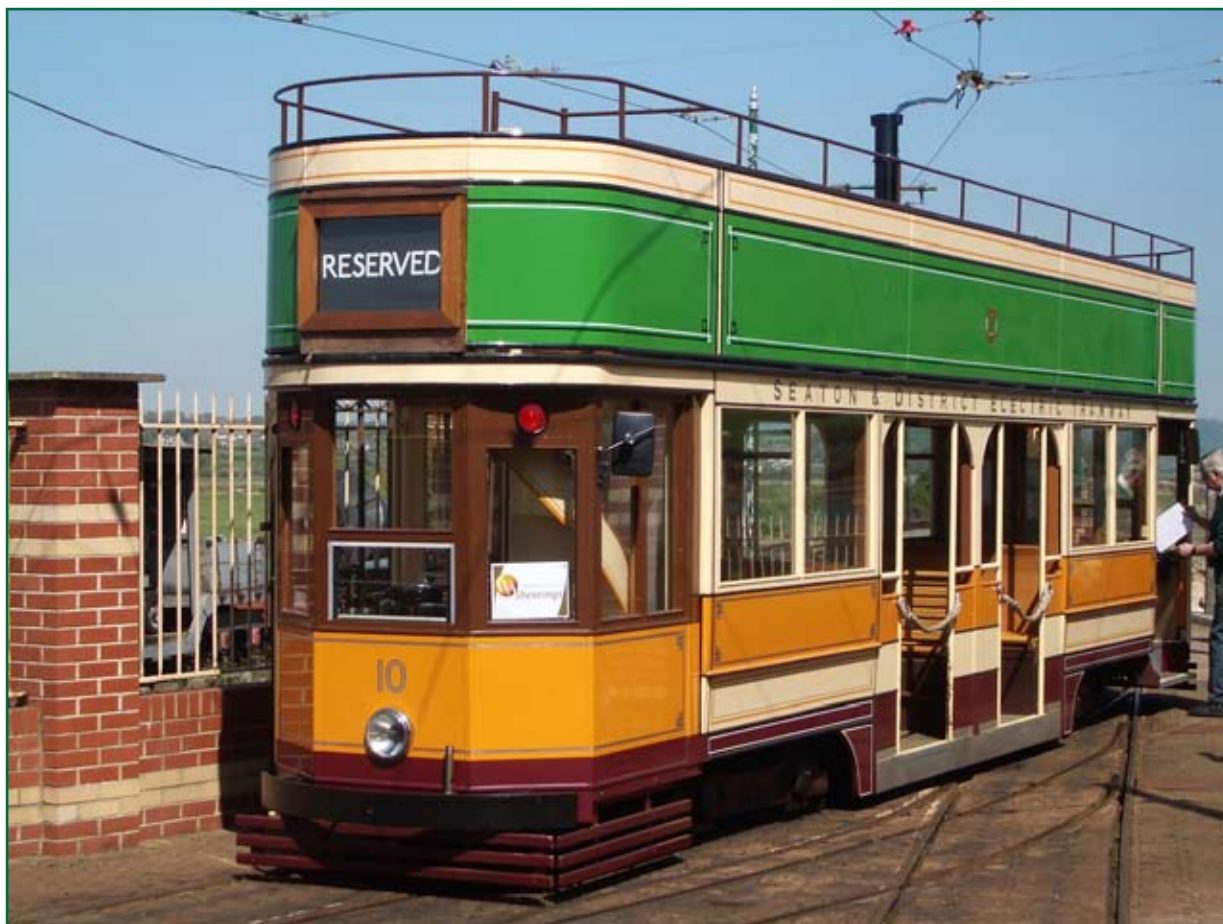
Figure 2: Seaton Tram no. 10

9. The tramway uses a fleet of electrically powered trams, some rebuilt from historic vehicles, and some purpose built for the system. The most modern trams are a fleet of three, purpose built for the line between 2002 and 2005. The tram involved in the derailment, No 10, was one of these trams, and was operating on the 12:31 hrs service from Colyton to Seaton (Figure 2). The only crew on the tram was the driver, and it was carrying ten passengers.

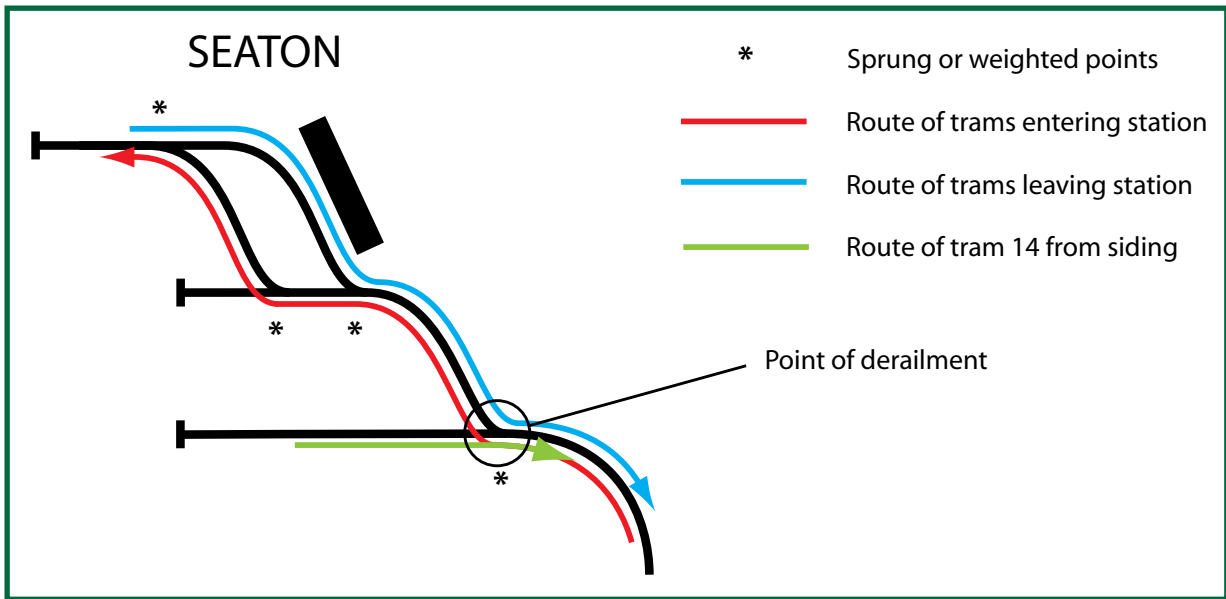
Figure 3: Track layout at Seaton

10. Located at the entry to Seaton station is a pair of points, leading to a siding (Figure 3). These points are normally set so that trams run into the station platform. The points are operated by a weighted lever, which is secured by a pin; the pin, in turn, is padlocked in position, and are not *detected*. A tram can only enter the siding if the pin is removed and the points fully thrown to *reverse*. However, the pin allows sufficient movement of the lever for trams to *trail* the point when leaving the siding; the weight of the lever then ensures that the points then return to their normal position. As a result the lever can be manually lifted sufficiently that the *switches* partially open (Figure 4).

11. The safe operation of the points depends on the points being fully closed, or the driver, acting in accordance with Seaton Tramway Rule 60, being able to see whether they are set correctly as he drives his tram towards the points.

1. The Seaton Tramway should replace the weighted lever at the entry to Seaton station with a point lever that is capable of being locked when not in use, in order to prevent it from being used to move the points without authority. The points could be operated from the lever via a slotted joint, and be spring loaded, so that operational flexibility is not lost.
2. The Seaton Tramway should implement, so far as is reasonably practicable, the provision of visual indicators that show to drivers whether sprung and weighted points on the system that are used by trams carrying passengers are correctly set for the normal route.
