Rail Accident Investigation Branch

Rail Accident Report

Dangerous occurrence at Lindridge Farm user worked crossing, near Bagworth, Leicestershire 22 March 2012

Report 11/2013
July 2013

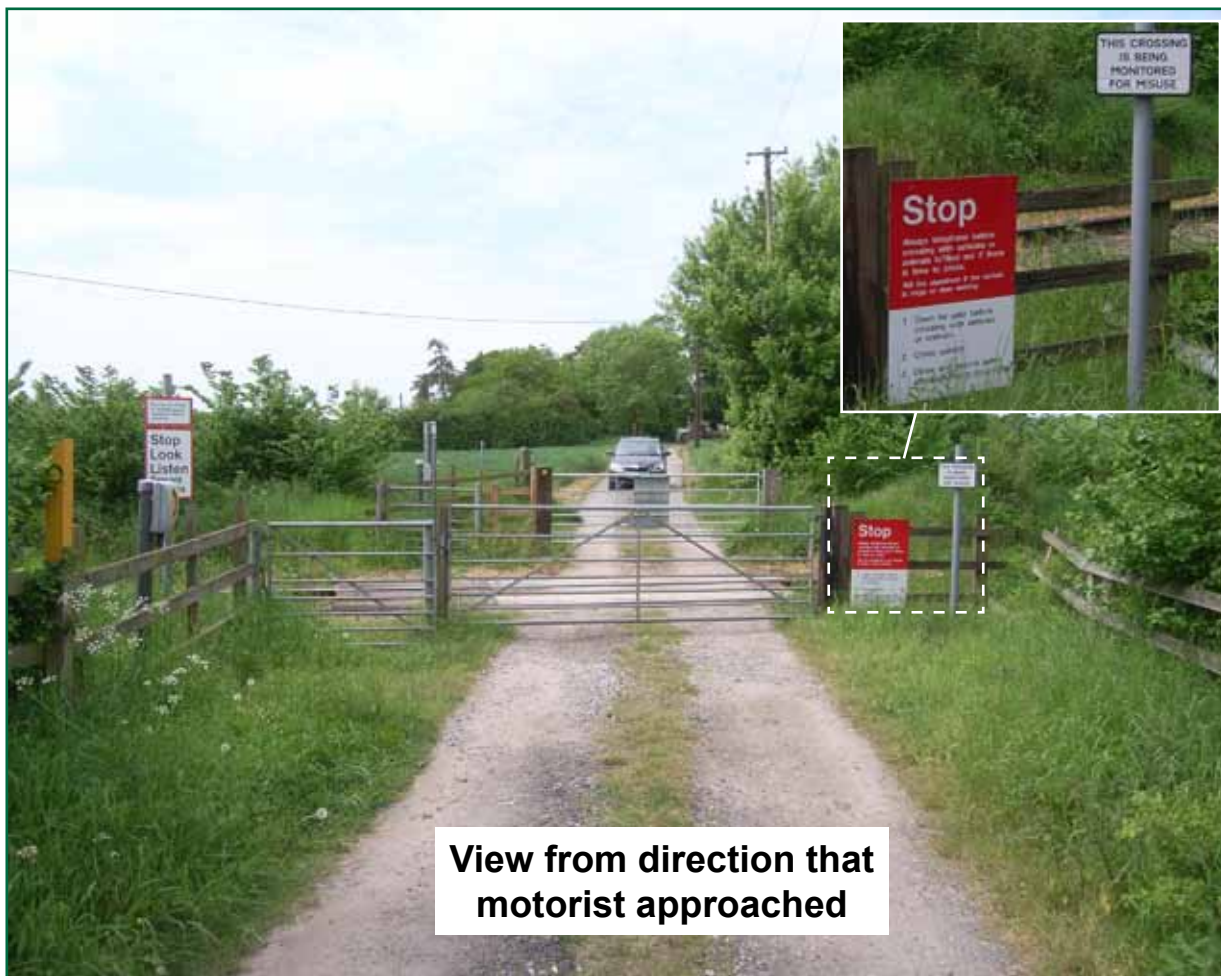
Figure 4: The approach to Lindridge Farm user worked crossing and its signage

- 16 At this crossing the railway intersects a private road, which gives access to and from a dwelling and some farm buildings. The approach to the crossing taken by the motorist is shown in figure 4.
- 17 The crossing is fitted with a telephone on each side to provide a direct connection to the signaller on the Leicester workstation at the EMCC. Signs at the crossing (figure 4) require all vehicle users to stop and call the signaller to get permission to cross. Once the signaller has given permission, a vehicle user must open a five bar metal gate on each side, drive their vehicle over the crossing and then close both gates. A separate gate is provided on each side for pedestrians, who are not required to call the signaller before crossing.

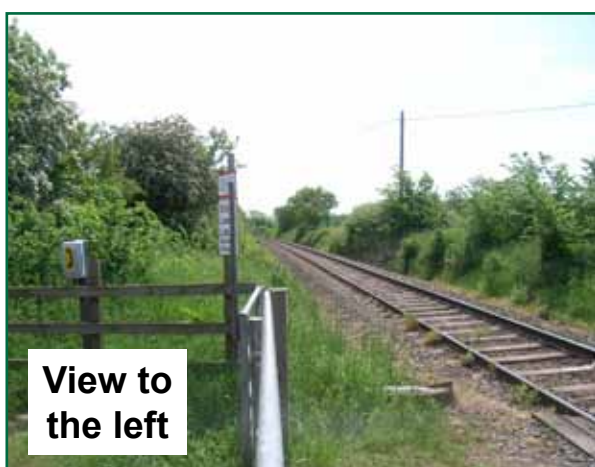
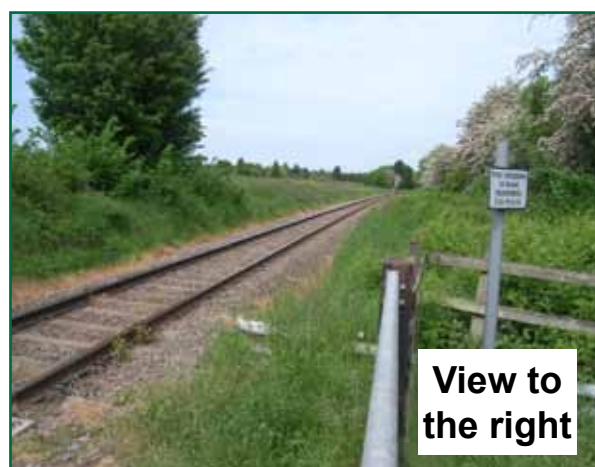
Figure 5: The view of approaching trains in both directions from the gate on the side of the crossing that the motorist approached

18 The crossing is located on a curve in the railway (figure 5). The motorist approached from the inside of the curve. From the gate on this side, in clear conditions and in daylight, trains approaching from the right (from the Bagworth Junction direction) can be seen about 250 metres from the crossing, while trains approaching from the left (from the Knighton Junction direction) can be seen from about 230 metres away.

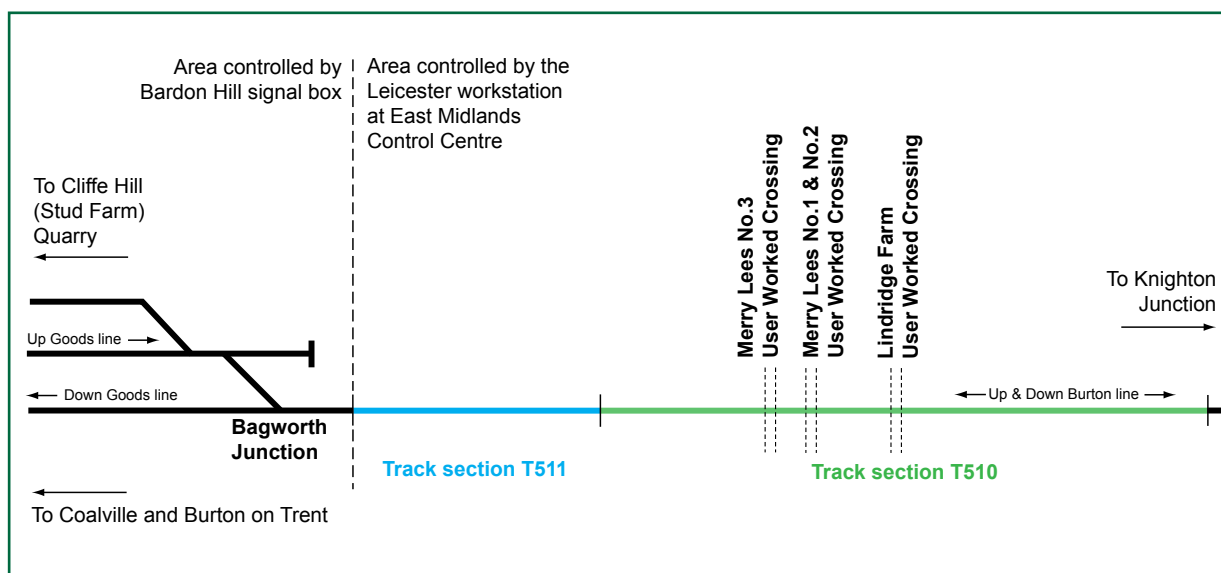
Figure 7: The track layout on the Up and Down line in the vicinity of Lindridge Farm user worked crossing showing the extent of track sections T511 and T510

- 29 At 07:37:25 hrs, the train occupied track section T510 and at 07:37:43 hrs track section T511 became unoccupied as the rear of the train moved clear of it. At about this time, the motorist arrived at Lindridge Farm crossing and picked up the telephone at the crossing to call the signaller to ask for permission to cross. The signaller answered the telephone call at 07:37:57 hrs.

- 35 Network Rail's technical and operations staff investigated and by 10:30 hrs they had found that Lindridge Farm user worked crossing and also Merry Lees No.1 & No.2 and Merry Lees No.3 user worked crossings were all shown in the wrong place on the signaller's workstation view. They identified that these crossings were shown on track section T511 when they should have been shown on track section T510 (figure 8).

55 The immediate cause of the incident was that the signaller believed that train 6Z75 had already passed Lindridge Farm user worked crossing when he gave the motorist permission to cross, because his workstation view showed the level crossing on track section T511 and the train on track section T510.

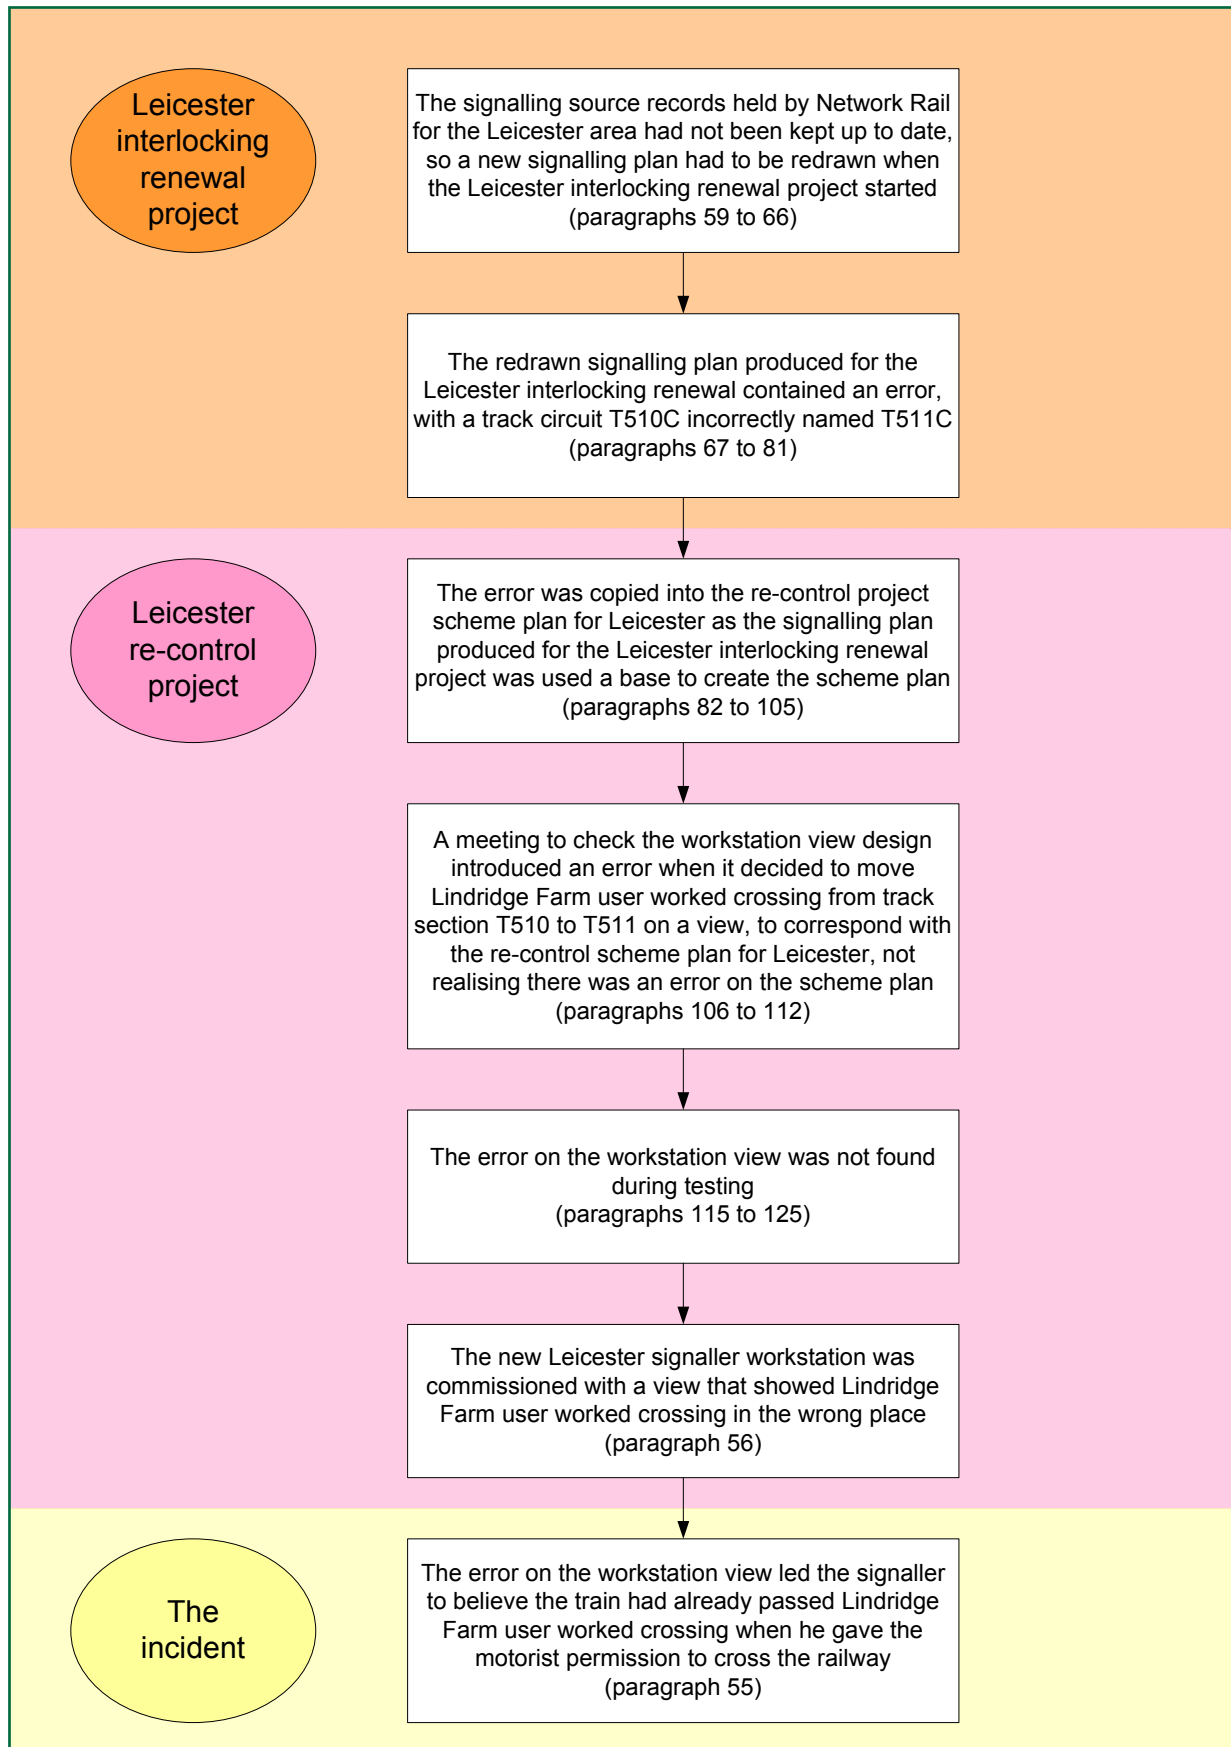
Figure 11: Diagram showing the sequence of events

- 57 The error on the Leicester workstation view was introduced during the process for designing and reviewing the views and was not identified when the workstation was tested before it was commissioned.
- 58 The sequence of events that led to the incident occurring is shown in figure 11. Each of these events and the factors associated with them are now considered in turn.

None of the user worked crossings, including Lindridge Farm, are shown on this signalling plan

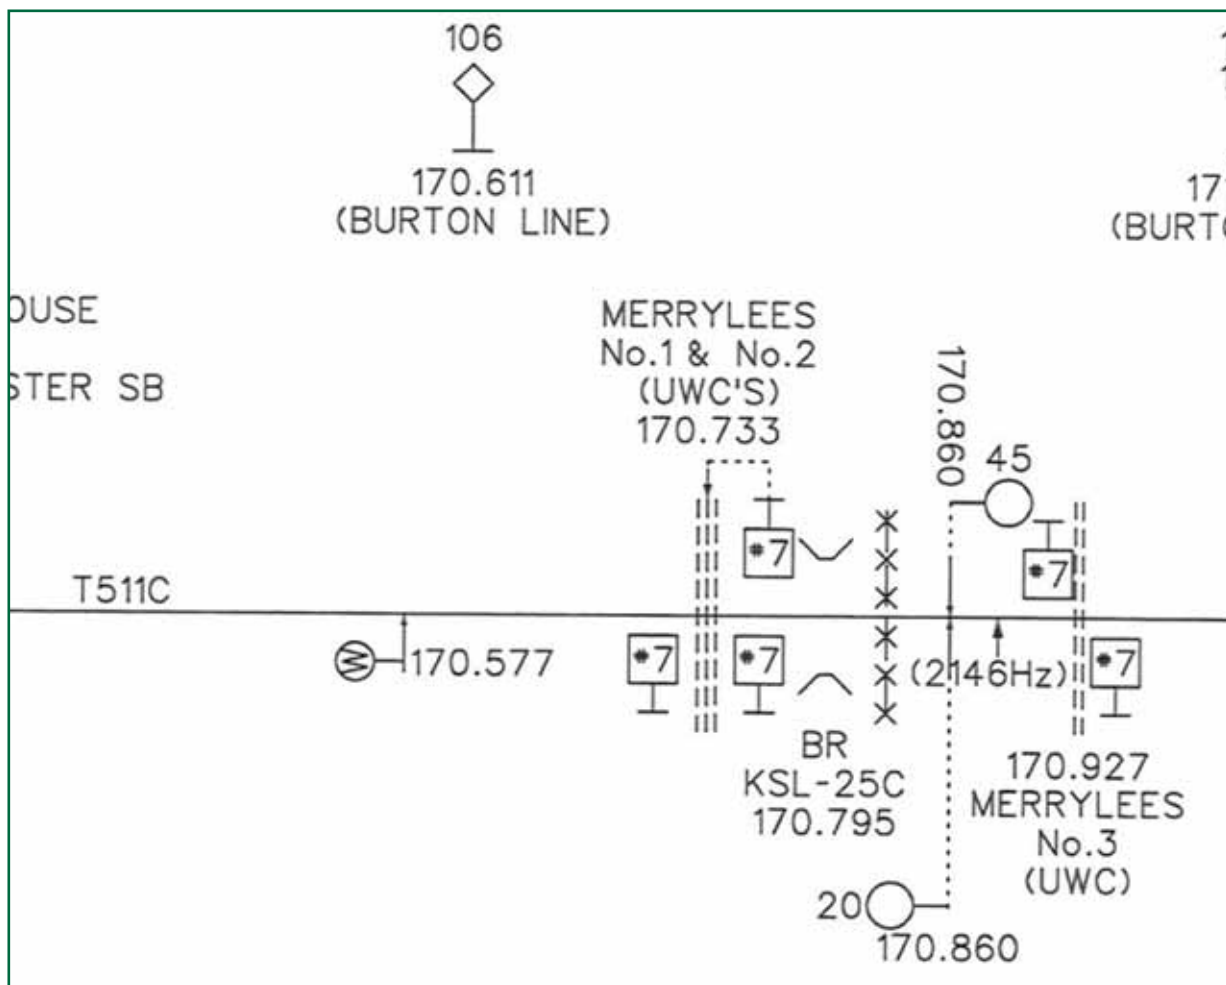
Figure 18: Snapshot of the signalling plan for the Leicester interlocking renewal

131 The only track circuit name shown on this snapshot was T511C, so on 28 April, the Local Operations Manager marked the signaller's panel up with the Merry Lees crossings shown on track section T511 (figure 19). As explained earlier (paragraph 67), the signalling plan for the Leicester interlocking renewal contained an error with track circuit T510C incorrectly named as T511C. This led him to incorrectly mark the Merry Lees crossings on track section T511 instead of T510. The signaller's panel at Leicester signal box remained like this until it was decommissioned on 31 December.
