CONTENTS**SPECIAL BULLETINS**

COMMERCIAL AIR TRANSPORT**FIXED WING**

Airbus A319-131	G-DBCI	24-Jan-07	4
Airbus A321-231	G-MIDC	13-Nov-06	8
BAE Systems Jetstream 4100	G-MAJI	12-Jan-07	11
BAE Systems Jetstream 4100	G-MAJI	26-Feb-07	14

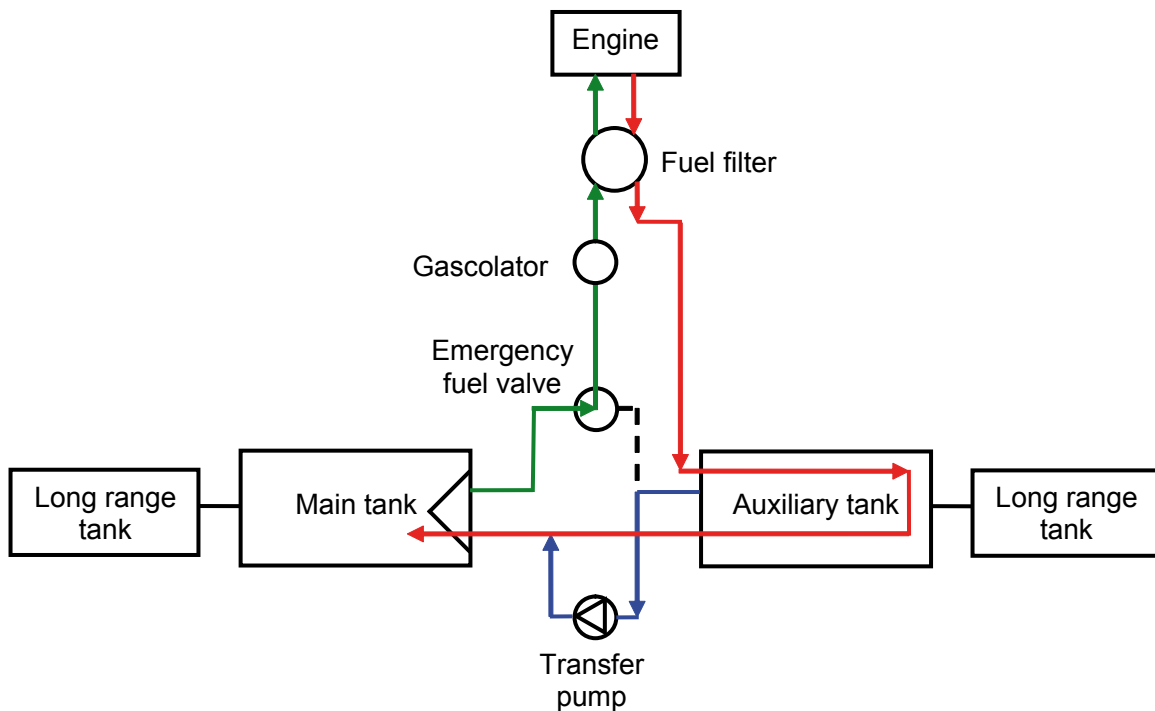
Figure 1
Fuel System Schematic

The engine is supplied with fuel from the left wing inboard tank only, which is designated the main tank. The right inboard 'auxiliary' tank feeds the main tank

and the pilot must periodically transfer fuel from the auxiliary tank to the main tank as the engine consumes fuel. The fuel is transferred via an electrically driven transfer pump, operated by a switch in the cockpit. Any unused fuel from the engine fuel rail is returned to the main tank and, as the fuel may be hot, it is cooled by routing it through the auxiliary tank.

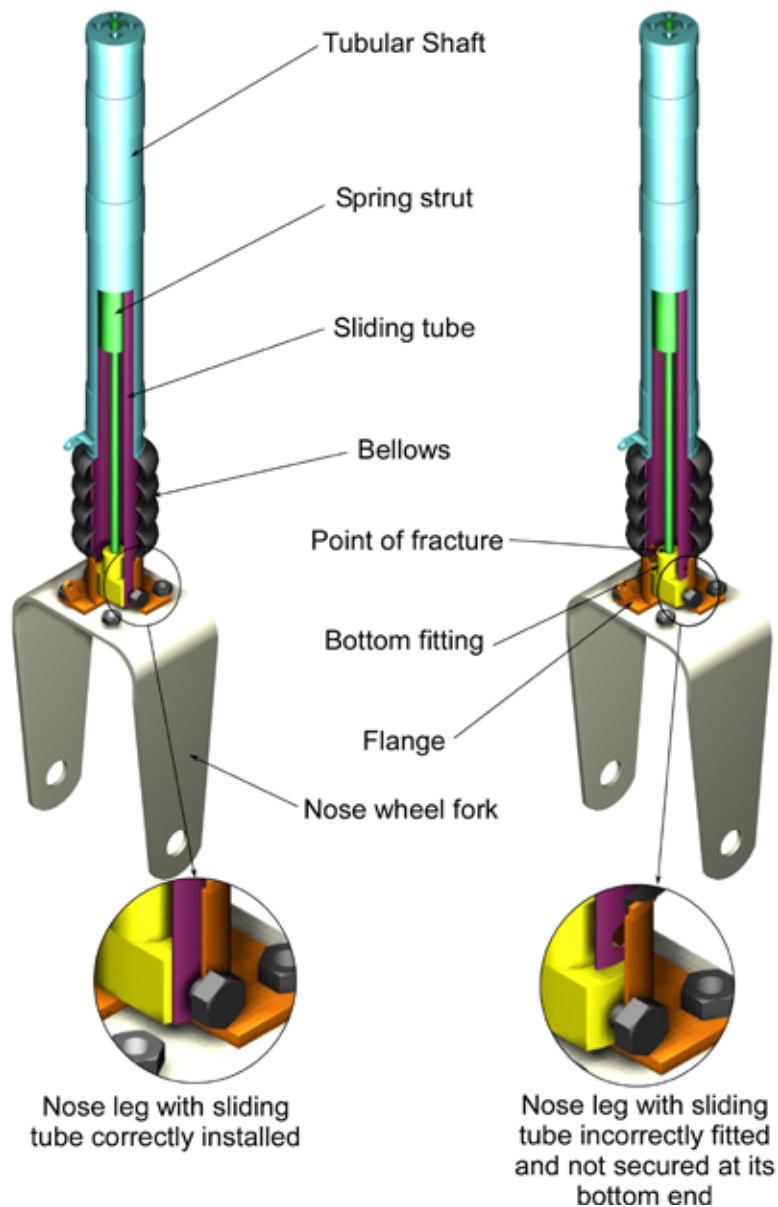
Figure 1

The nose leg of the Grob 115 consists of a steel housing secured to the airframe, into which fits a tubular shaft. A diagram of the nose leg is shown in Figure 1. Fitted within the tubular shaft is a gas spring strut shock-absorber. The upper end of the strut is attached to the tubular shaft; the lower end is screwed into the bottom fitting. A sliding tube surrounds the spring strut and the bottom fitting, and is secured at its

Simplified drawing of the nose leg, with the steel housing, wheel and torque links removed for clarity

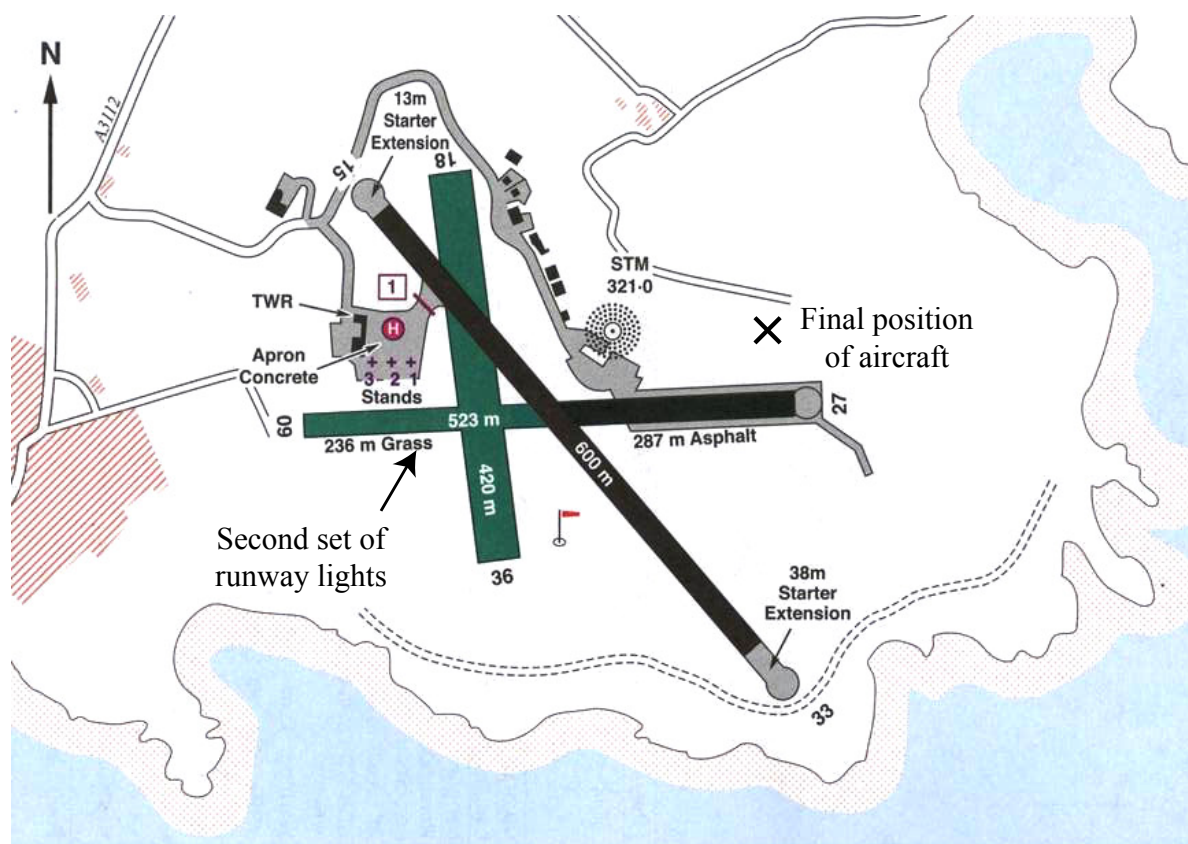
Figure 1
Scilly Isles Airport

The ATCO in the control tower at the time of the accident witnessed the accident. He stated that having cleared G-BIWL to land he observed it high on the final approach, prior to a rapid descent. It landed firmly abeam the second set of runway side lights from the threshold of Runway 09. He saw the aircraft drift to the left edge of the runway but maintain runway heading. It then became airborne briefly in a nose-up attitude, with the tail almost touching the runway, before settling back onto the grass. As G-BIWL reached the intersection of Runways 15/33 it became airborne again, remaining "very low" in a pronounced nose-up attitude. The left wing dropped and the aircraft "started turning" rapidly

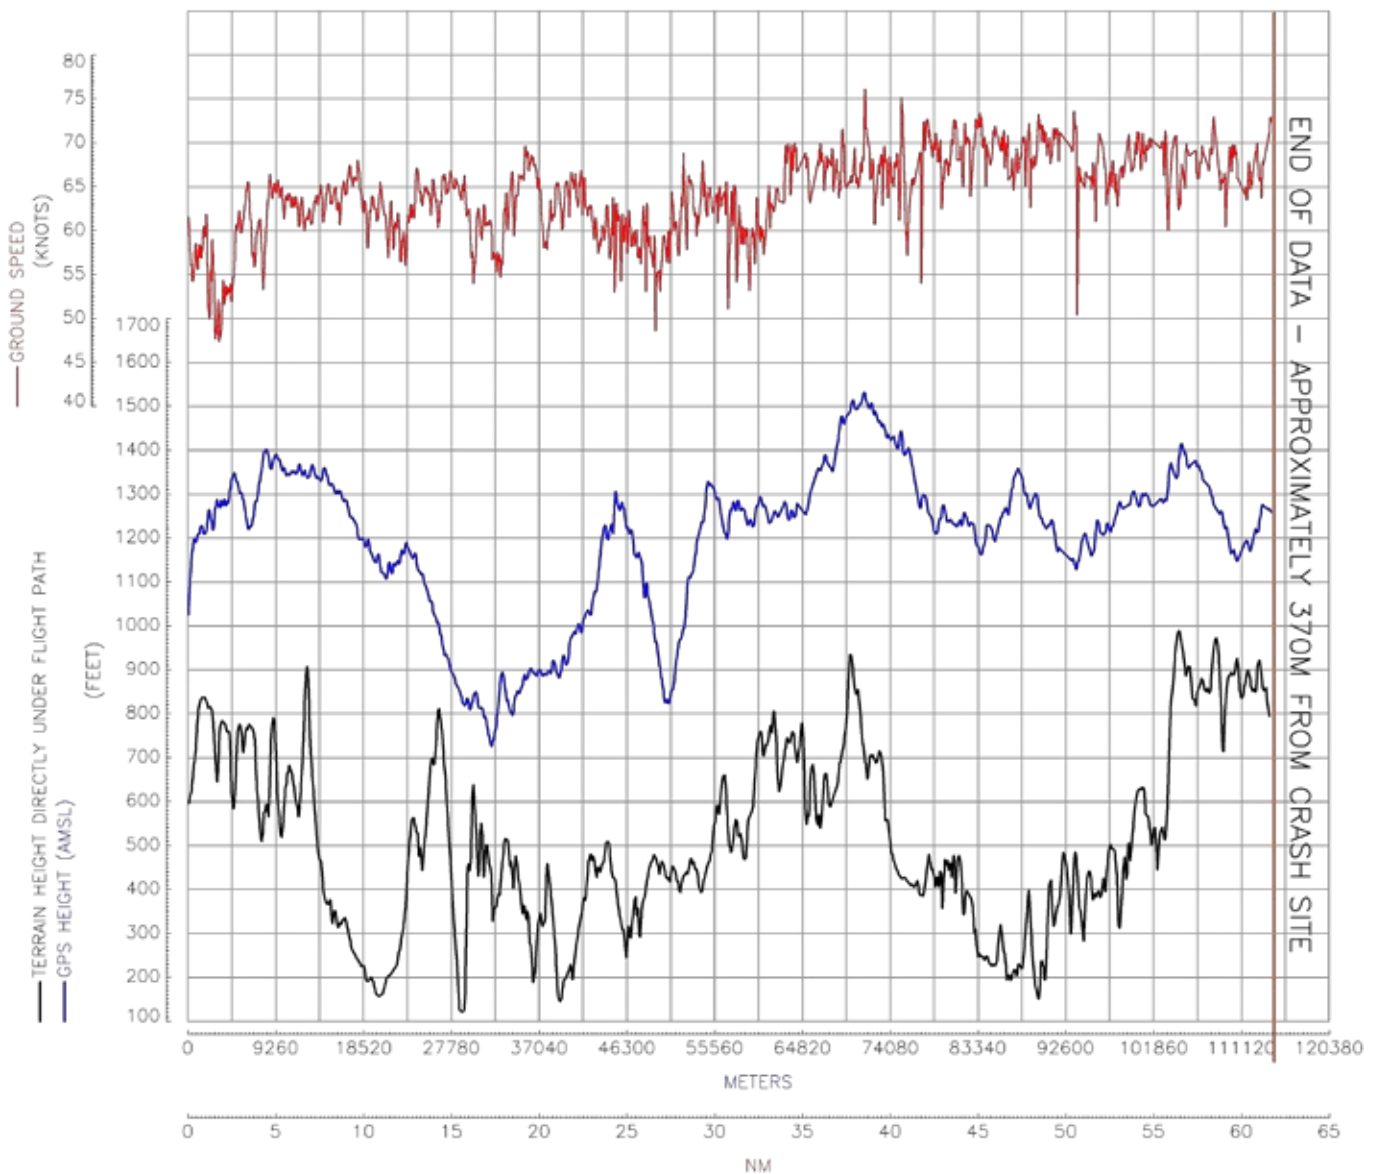
Figure 1
PDA GPS Data

If the aircraft track had been maintained, the aircraft would have passed almost overhead of Bodmin Aerodrome. Had the aircraft been maintaining the last recorded GPS height amsl, which was about 1,250 ft, the height agl would have been no less than about 500 ft before reaching Bodmin Aerodrome.

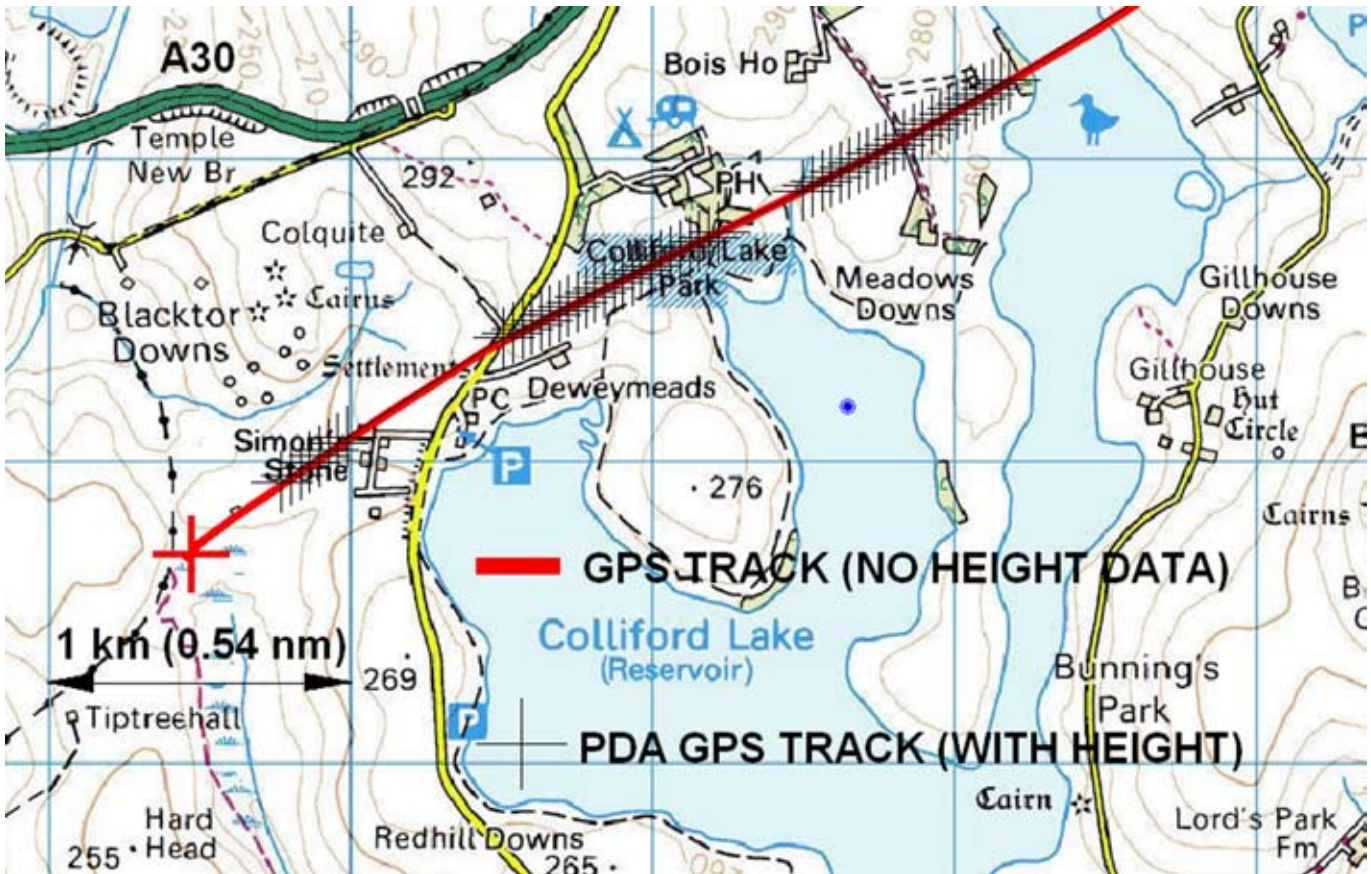
Figure 2
GPS and PDA GPS tracks

The elapsed time between the last recorded GPS data point and PDA GPS data point was about 13 seconds. Figure 2 provides the two tracks overlaid on an OS map.
