# ***AAIB Bulletin***

***2/2016***

Published 11 February 2016

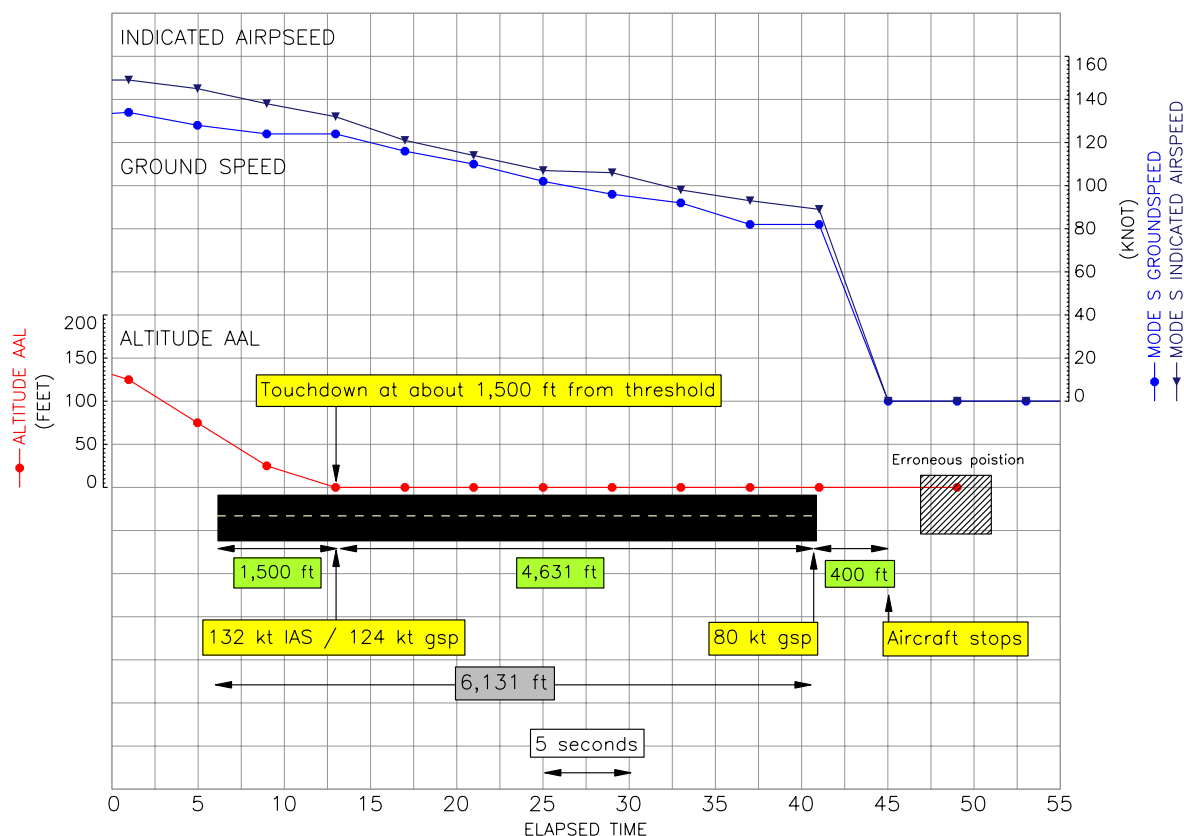
**Figure 2**  
Salient final approach and landing data

The salient recorded data for the approach and landing are presented in Figure 2.

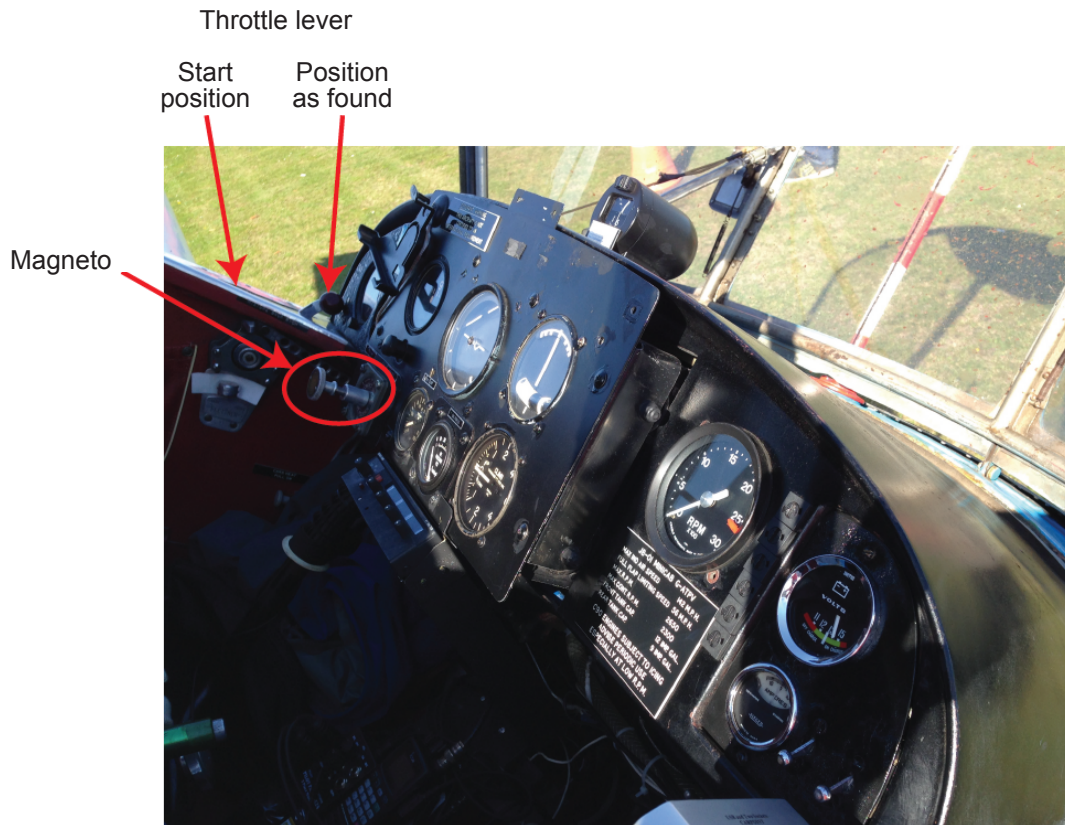
**Figure 1**

Photographs taken shortly after the accident (Figure 1) showed the throttle lever in the fully open position and the stick forward of the neutral position.

G-ATPV instrument panel (photograph taken by Fenland Aero Club)

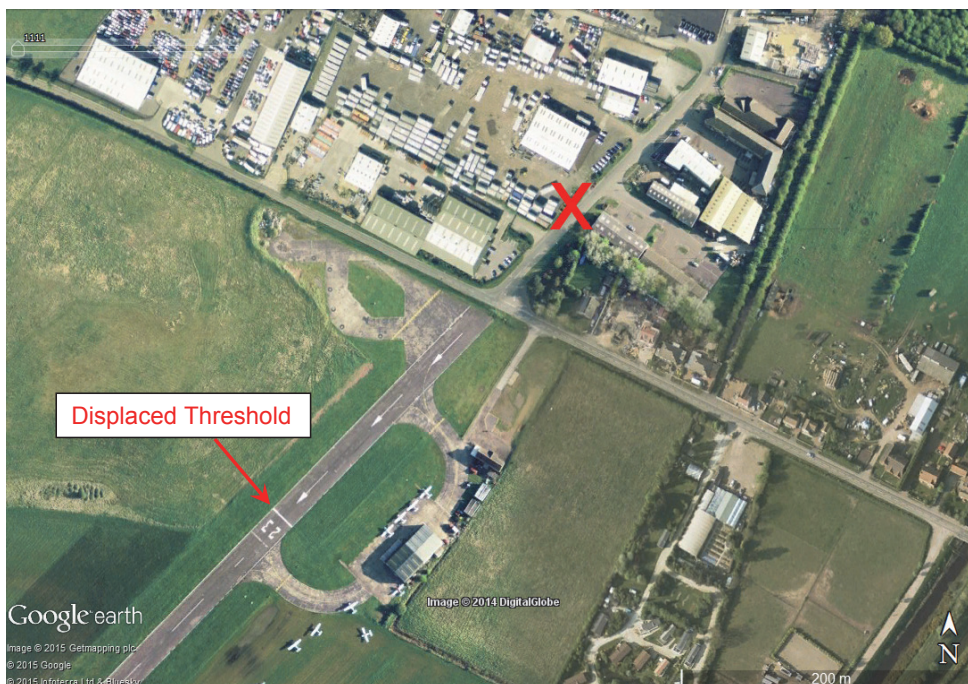
**Figure 1**

The pilot commenced his approach to Runway 23 and was targeting an approach speed of 57 kt with full flap. Runway 23 has a 190 m displaced threshold but he was aiming to land at the beginning of the paved surface (Figure 1). He "got a bit low" during the approach and

at one point added power to climb, then he heard his passenger saying “there’s a lighting column”, or words to that effect, and a second later he felt an impact. CCTV captured the moment when the aircraft’s tailplane struck a lamp post (Figure 2). The aircraft then pitched nose-down, hit a road and slid about 35 m before coming to rest against the airfield perimeter fence. Both the pilot and his passenger were seriously injured and were assisted by emergency services.

Sandtoft Runway 23. Location of the lamp post struck by the aircraft marked with an 'x' (Image courtesy Google Earth)

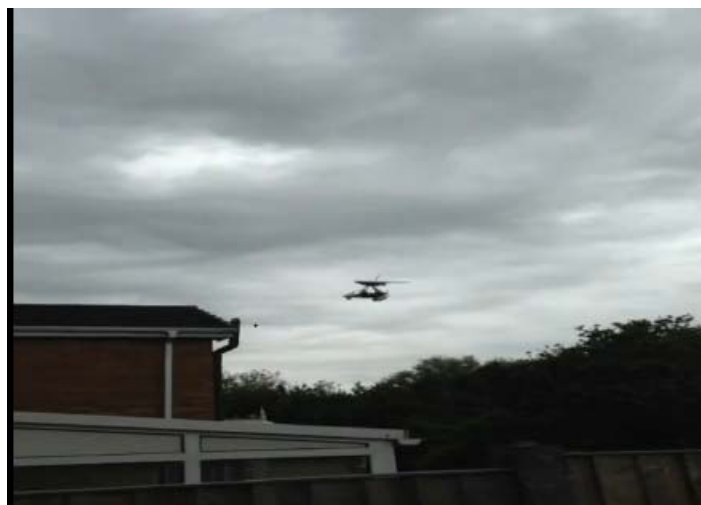
**Figure 1**

A witness who lived in the southern part of Newton-le-Willows saw the aircraft manoeuvring close to the houses. He said that many people had come out of their homes to watch the microlight, which he captured on video as it flew south along the route of the canal, which the AAIB estimated was approximately 75 m (260 ft) from where the video was taken. A still from the video is shown at Figure 1. The witness noted that the engine noise was heard to change as the aircraft manoeuvred and the aircraft crashed shortly after the video was recorded. The AAIB estimated that the accident site was approximately 440 m south of where the video was taken and from GPS data it was established that the aircraft would have taken 10 seconds to fly this distance.

Still taken from the video clip provided by a witness
