CONTENTS

INCIDENT

Aircraft Type and Registration:	Boeing 767-300 ER, V8-RBH	
No & Type of Engines:	2 Pratt & Whitney 4060 turbofan engines	
Year of Manufacture:	1993	
Date & Time (UTC):	3 March 2007 at 1630 hrs	
Location:	London Heathrow Airport	
Type of Flight:	Commercial Air Transport (Passenger)	
Persons on Board:	Crew - 11	Passengers - 189
Injuries:	Crew - None	Passengers - None
Nature of Damage:	Failure of No 1 wheel hub	
Commander's Licence:	Airline Transport Pilot's Licence	
Commander's Age:	56 years	
Commander's Flying Experience:	16,635 hours (of which 7,654 were on type) Last 90 days - 162 hours Last 28 days - 60 hours	
Information Source:	Aircraft Accident Report Form submitted by the pilot, and metallurgical examination of components

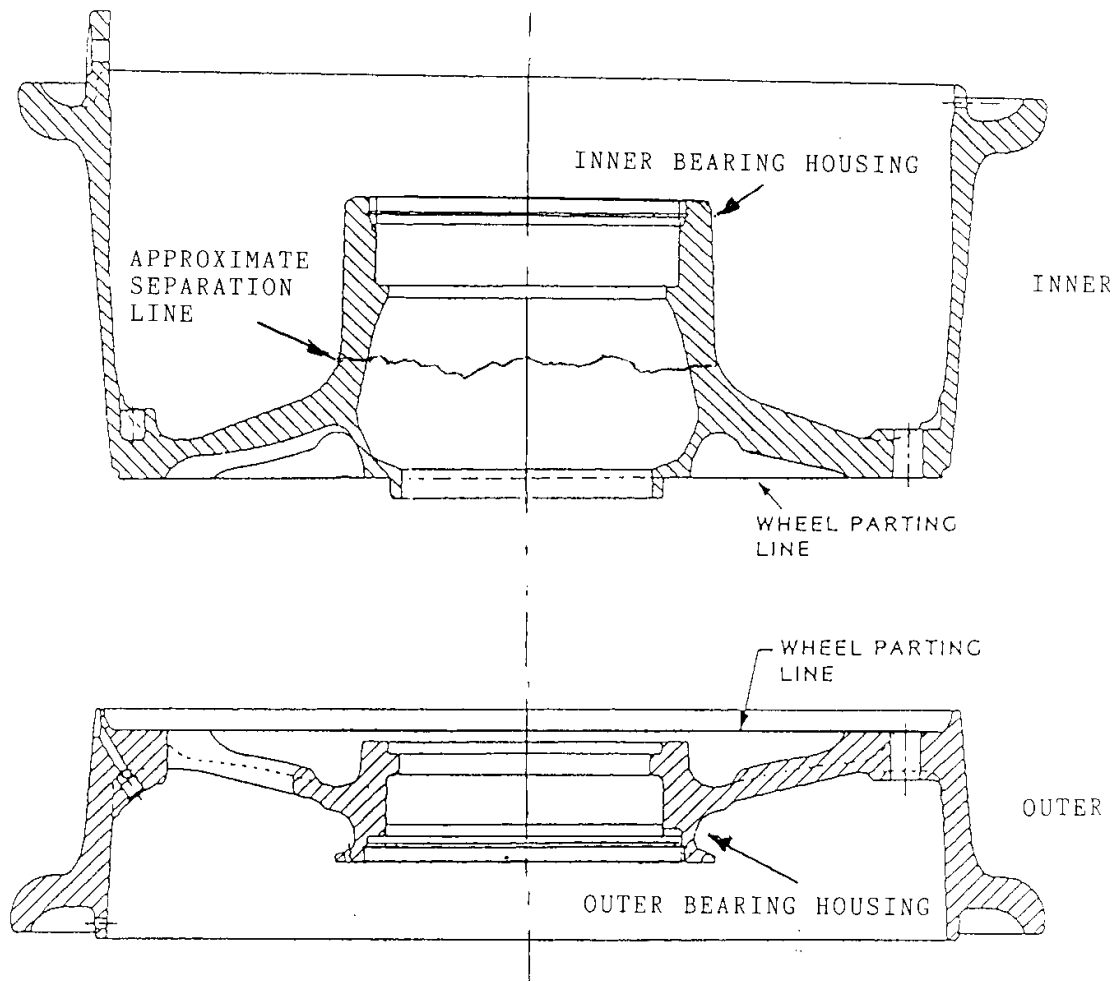
Figure 1

The wheel hub is in two parts. The outer hub houses the outer bearing and the inner hub, which is deeper, houses the inner bearing, (see Figure 1).

A large, almost-cylindrical section of the inner hub had become detached (see Figures 2, 3 and 4). The approximate location of the separation of the inner hub into two parts is also shown in Figure 1. The wheel was disassembled into its inner and outer hub parts and subjected to a detailed metallurgical examination. The conclusions from the examination were:

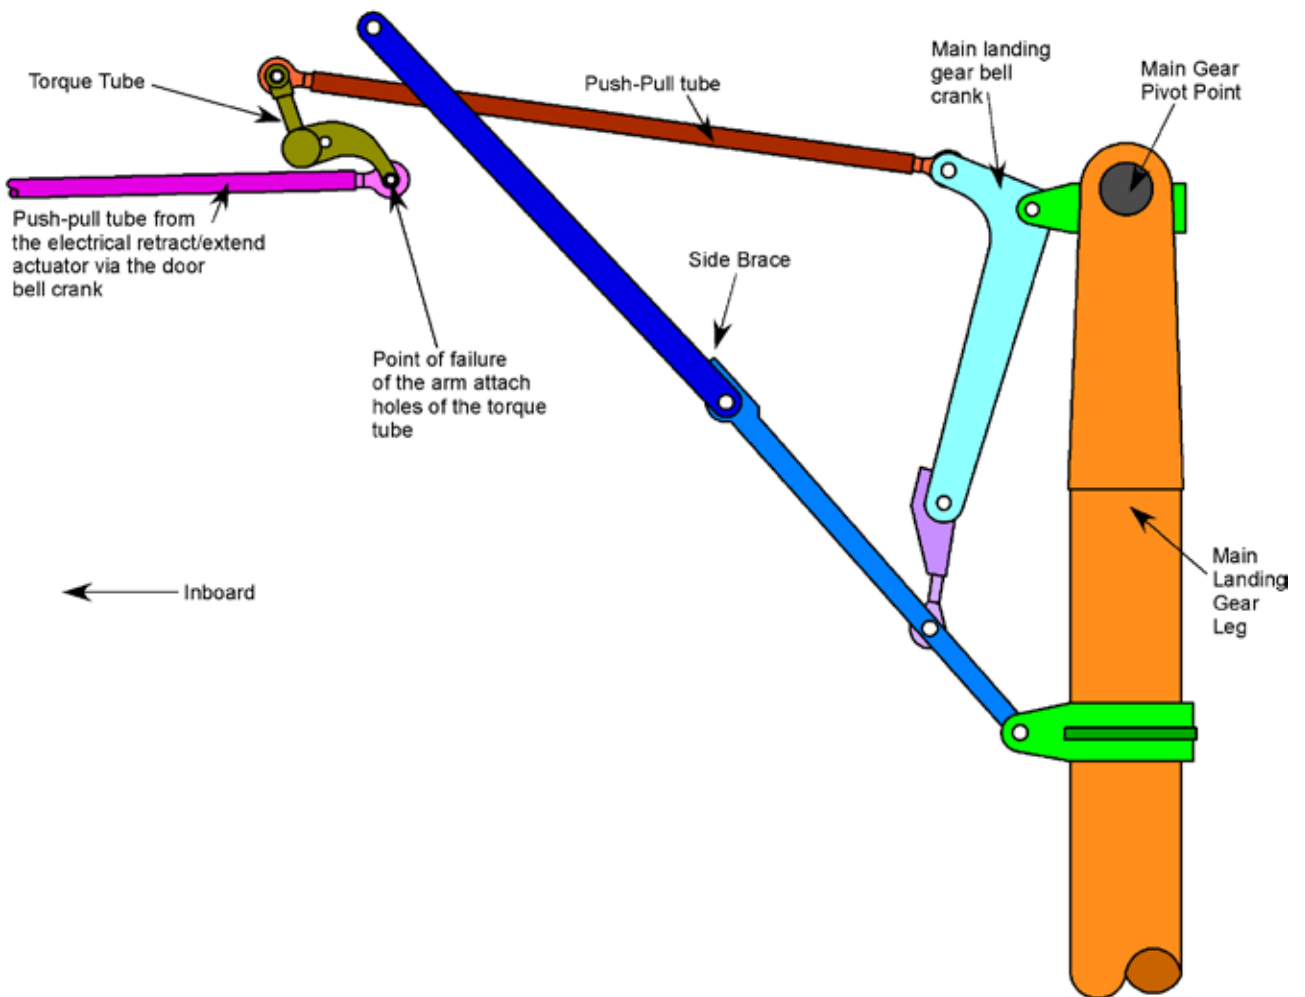
Figure 1

The rod end of the drive push-pull tube fits into an arm assembly of a torque tube and is secured by a nut and bolt through arm attachment holes, (see Figure 1). The torque tube drives a push-pull tube attached to the main landing gear bellcrank, which allows the gear to retract and extend around the main pivot point. To achieve a positive downlock the side brace of the gear is rigged to be over centre when the gear is locked down.

Representative diagram of the right main landing gear extend/retract mechanism

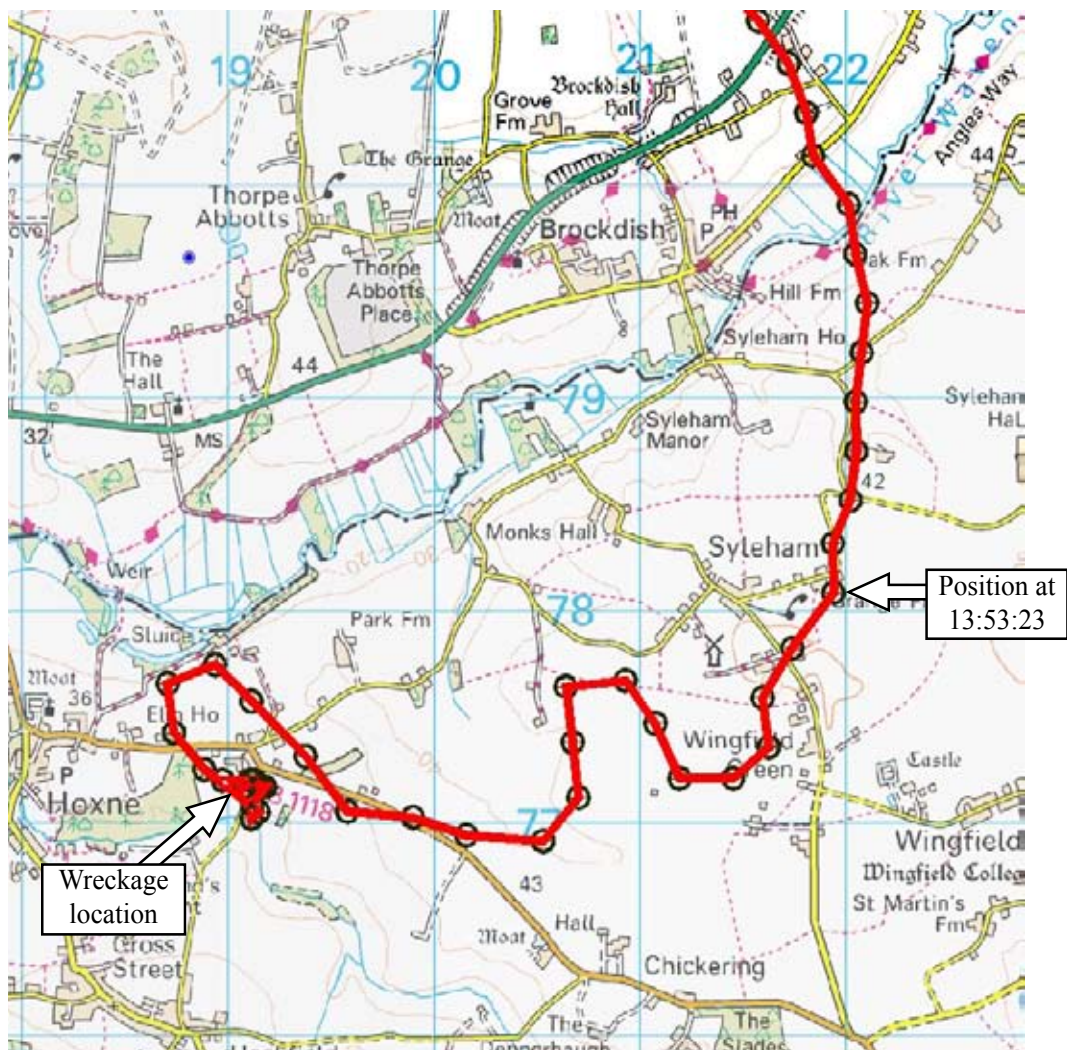
Figure 1

Plan view of G-BUUD recorded radar

At 13:53:23, at a recorded altitude of 5,000 ft, G-BUUD began a turn to the right towards Hoxne (Figure 1). Correcting this altitude for a QNH of

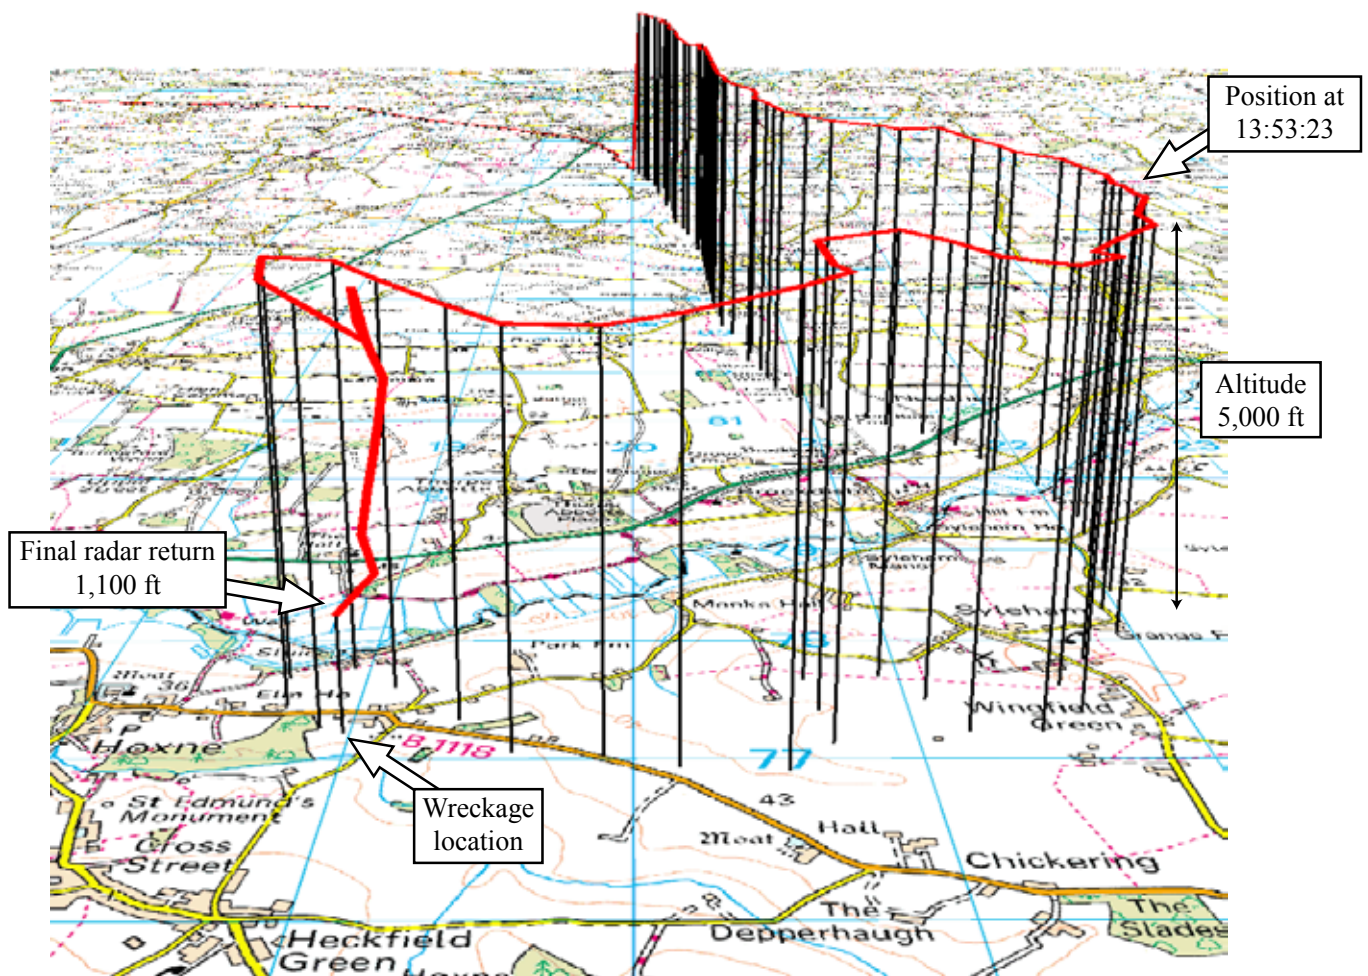
Figure 2

The data shows the aircraft continuing in the general direction of Hoxne (Figure 2), making several turns on the way whilst maintaining an altitude of about 5,000 ft. The final concentration of 10 radar returns occupy a small area, which contained G-BUUD's ground impact position, with the final radar return recording an altitude of 1,100 ft.

Isometric view of G-BUUD recorded radar

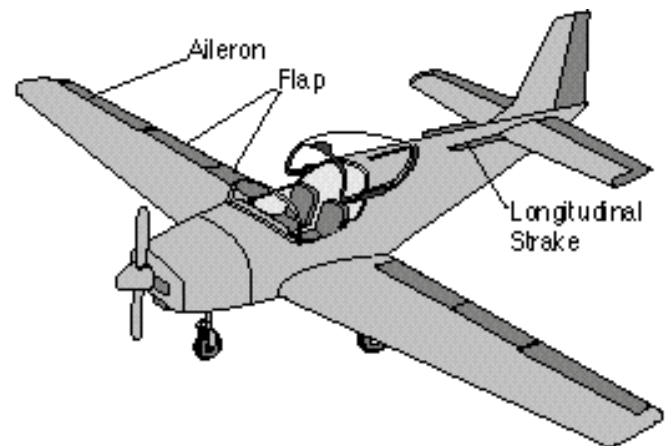
Figure 3

The Slingsby T67M-MkII Firefly is a single-engined low-winged monoplane with a low-mounted tailplane and fixed tricycle landing gear (Figure 3), designed to be fully aerobatic. Two side-by-side seats are provided. The aircraft is constructed principally of glass reinforced plastic; carbon fibre reinforced plastic and timber are also used in some areas. It is powered by a 160 shp, fuel-injected, petrol, reciprocating engine driving a constant-speed, two-bladed propeller. The aircraft's wingspan is 34.8 ft, the length 23.9 ft and the maximum takeoff weight 2,150 lb.
