## **Service Inquiry**

1 Rifles Parachuting  
Accident

29 Sep 15

**SERVICE INQUIRY INVESTIGATION INTO THE DEATH OF LCPL ALI JOHN WOODFORD ON 29 SEP 15**

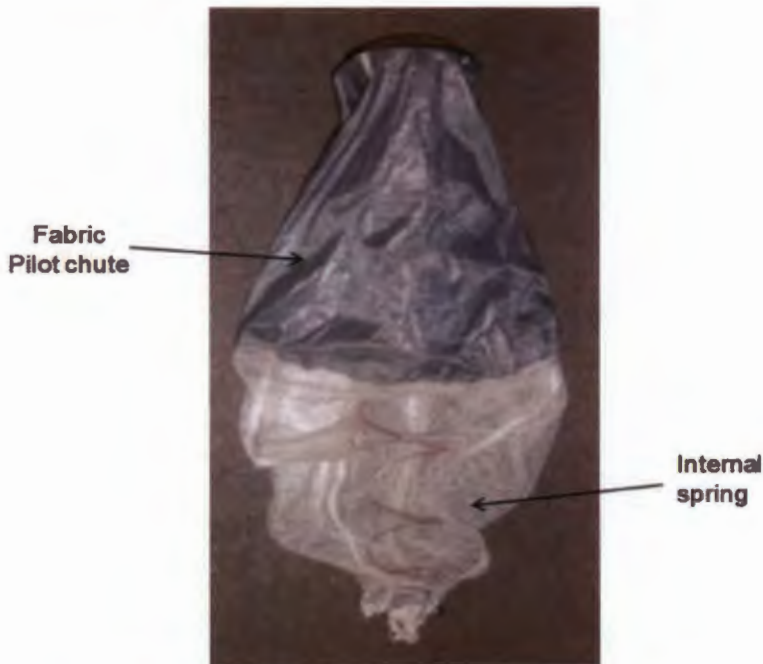
Fig 1.4.5 – Reserve pilot chute and spring.

1.4.26 **Reserve Pilot Chute Spring.** The reserve parachute system contains a spring loaded pilot chute, as depicted in Fig 1.4.5, which is compressed in the reserve parachute container and held closed with the reserve pin (Fig 1.4.8). When the reserve handle is pulled to remove the pin, the container opens and the pilot chute spring rapidly expands and launches itself into the airstream. The reserve pilot chute acts as a drag device to withdraw the reserve canopy from the container for deployment. The Panel found that once the spring is fitted into the reserve system it is then inspected as part of the repack checks for the reserve parachute. The Panel found no evidence of a defined spring compression force standard for the system used in the accident.

1.4.27 Photographs taken immediately after the accident of LCpl Woodford's spring loaded pilot chute, bridle line and free bag by Staff C and D indicated that LCpl Woodford's pilot chute spring had initiated the deployment of his reserve parachute. RAF CAM examined LCpl Woodford's and Student A's pilot chute springs and found them to be intact and functional. Based on the evidence the Panel concluded that the reserve pilot chute spring was **not a factor**. However, the Panel **observed** that although there is evidence of spring tension/compression tests on other parachute systems there is no minimum spring compression force stated either in published documentation from Rigging Innovations or the spring manufacturer for the system used in the accident. In contrast, military parachute systems have standards applied to each equipment item and tests are conducted periodically once fitted.

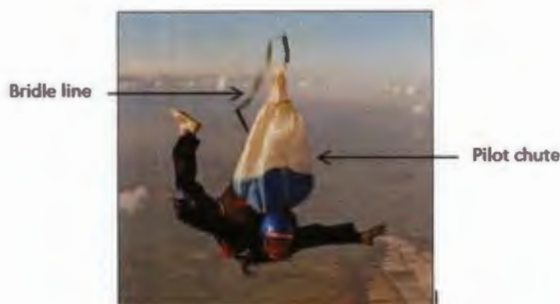
Fig 1.4.7 – Pilot Chute Delay.

1.4.29 **Parachutist's Airflow.** The airflow around a parachutist could cause a delay in the deployment of the reserve parachute by trapping the reserve pilot chute in the turbulent air immediately behind the body of the parachutist. This is more likely to be experienced when a parachutist is in freefall with a flat, stable and face to earth body position. Fig 1.4.7 shows a pilot chute trapped in turbulent air behind a free falling parachutist; the loose bridle line is also evident. LCpl Woodford had been despatched using the static line method to deploy the main parachute and the reserve was fitted with a spring loaded pilot chute. This apparatus is specifically designed to overcome airflow turbulence by breaking through the airflow when deployed. Given also that LCpl Woodford was probably not in a flat, stable and face to earth body position, the Panel concluded that the parachutist's airflow was **not a factor**.

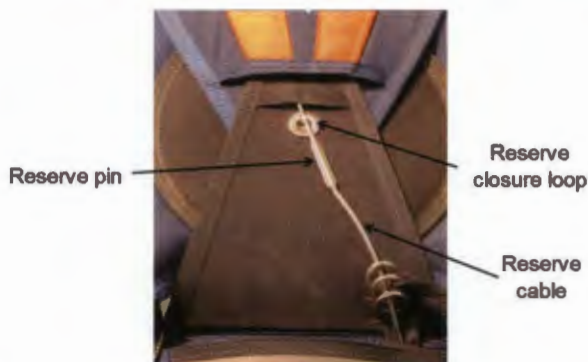
Fig 1.4.8 – Reserve Closure Loop and Pin Fitted into the Container.

1.4.30 **Pull Off Tension.** The reserve parachute and spring extractor are held in place in the container by the pin of the reserve cable inserted through the reserve closure loop line (see Fig 1.4.8). A Pull-off tension test applied to the handle of the reserve cable is the last phase of the packing process. The reserve handle pull off tension tolerances for this container system were not to exceed 22 lbs.

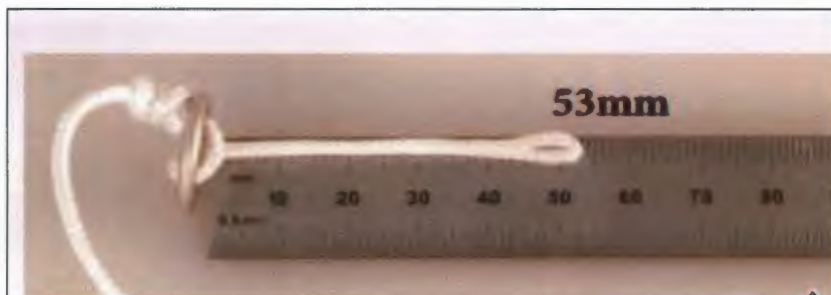
Fig 1.4.9 – Closure Loop Length Measurement.

1.4.31 The length of the reserve closure loop line for this system was not defined in the manufacturer’s documentation. A closure loop is measured from the base of the washer to the top of the loop. Fig 1.4.9 shows an example of a reserve closure loop set to 53 mm but they can be set to different lengths according to a number of factors discussed at para 1.4.32.

1.4.32 The Panel found that LCpl Woodford’s reserve closure loop length was 154 mm and Student A’s was 127 mm. The reserve closure loop length is determined by canopy volume, environmental influences at the time of packing, such as temperature and humidity, the AAD cutter installation and the packing technique of the rigger. The containers and reserve parachutes utilised by both students were the same size and packed by the same rigger. The reserve parachutes were Performance Designs, PD PR

1.4.33 Both LCpl Woodford and Student A pulled the cut away pad and reserve handles and their reserve parachutes were extracted. The Panel therefore concluded that the reserve closure loop of LCpl Woodford, whilst different in length to that of Student A, was **not a factor**. The Panel found that the pull off tensions recorded for both parachutes to be the same and within the specified tolerances. The Panel concluded that pull off tension was **not a factor**.

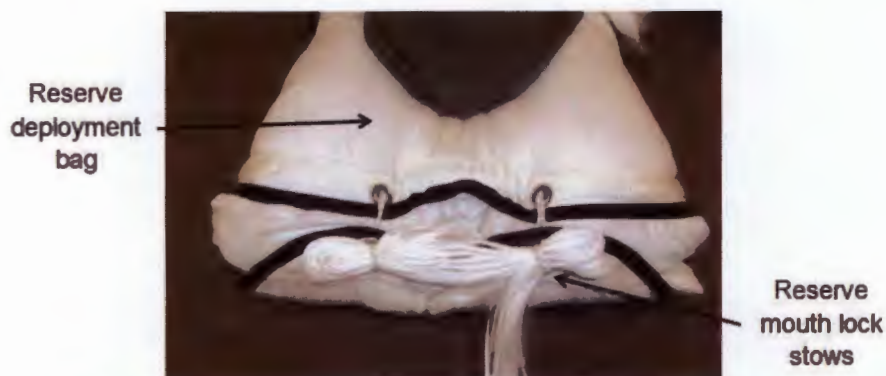
Fig 1.4.11 – Mouth Lock of the Reserve Deployment Bag.

1.4.34 **Rigging Line.** Rigging lines can snag on the mouth lock stows (Fig 1.4.11) of the reserve deployment bag when the parachute is in the process of deploying. This could cause a delay in the deployment of the parachute. During the accident sequence, both reserve parachutes were extracted; one fully deployed and the other was in the process of deploying. The reserve rigging lines were not damaged. The Panel could find no evidence to suggest that the rigging lines had snagged and therefore concluded they were **not a factor**.

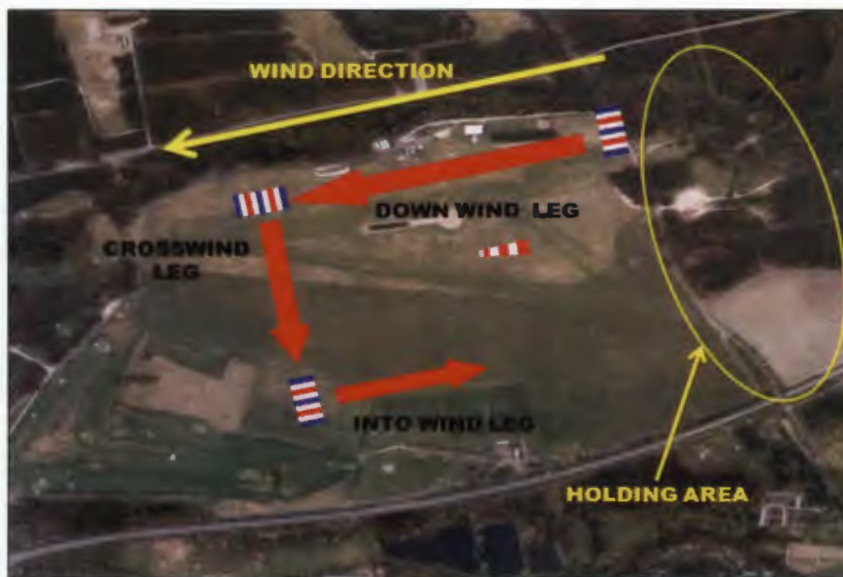
Fig 1.4.19 – Landing Pattern used at RAPA.

1.4.72 The LP at RAPA was described as flight drill number 5 of the canopy control lesson (Lesson 7); EX DBF were taught this lesson. At RAPA the LP was always a left handed pattern. The LP used at RAPA at the time of the accident is at Fig 1.4.19. The downwind leg at RAPA was initiated from the holding area at a height of 1000ft, the crosswind leg at 500ft and the into wind leg at 250ft. Just prior to commencing the downwind leg the parachutists are instructed to check their altimeter and also check for other canopies that could interfere with the planned route; adjustments are made as necessary to maintain separation. This sequence of checks should continue until the parachutist has landed.
