Rail Accident Investigation Branch

# Rail Accident Report

## The derailment of a freight train at Washwood Heath 8 September 2006

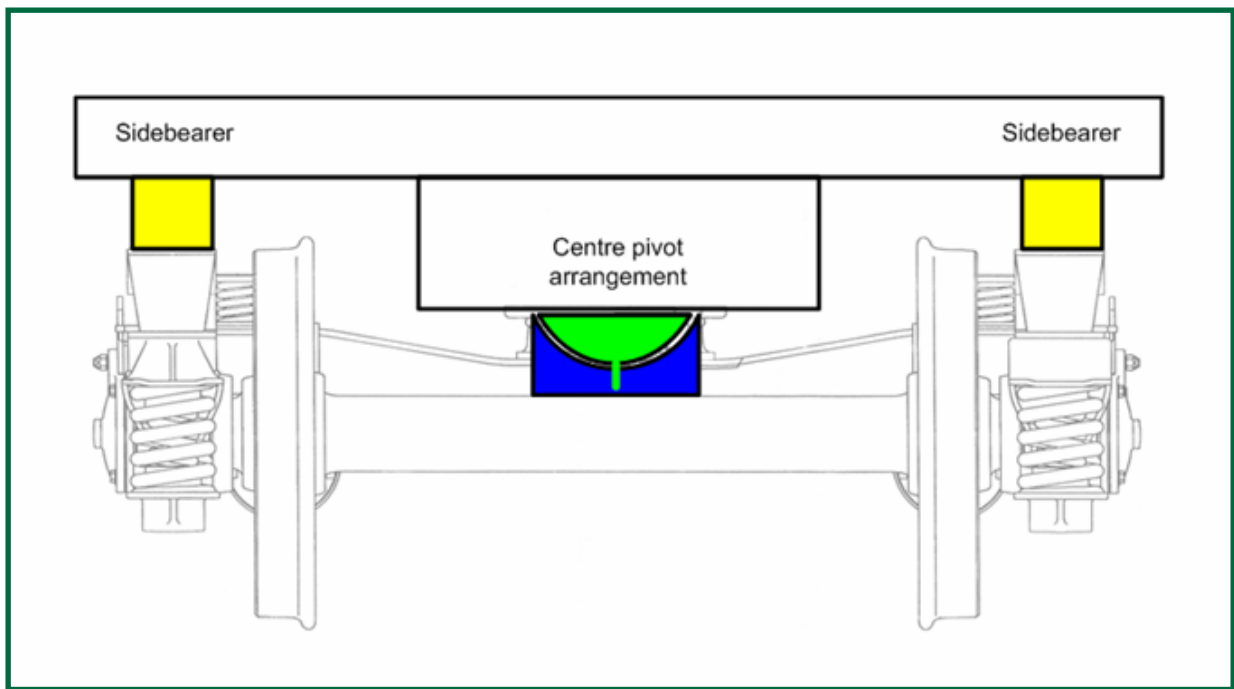
- 43 The FAA wagon is fitted with two bogies. The weight of the wagon body is transferred to the bogies via a centre pivot assembly. This incorporates a concave centre casting located on top of the bogie into which is lowered a matching hemispherical centre pivot located on the underside of the wagon's underframe. These two elements act as a 'ball and socket' joint, enabling weight to be transferred from wagon to bogie whilst enabling the bogie to rotate in relation to the wagon (Figure 4).

Figure 4: Schematic of centre pivot and side bearer arrangement

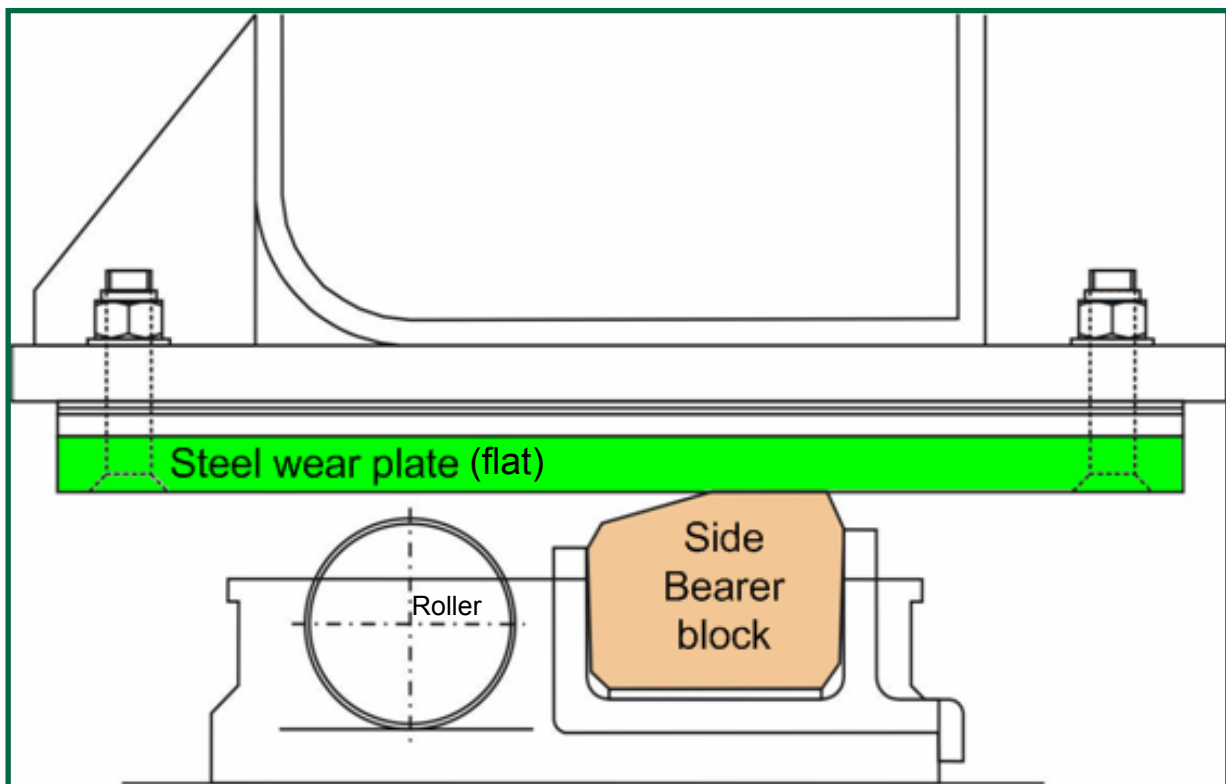
Figure 6: Diagram of the modified side bearer assembly with flat wear plate

- 53 The design scrutiny also contained an argument that the risk of *gauge infringement* by FAA wagons conveying 9 foot 6 inch (2896 mm) high containers could be managed without the need for inclined underframe wear plates. This argument was based on applying Network Rail's accepted method of *absolute gauging*. This showed that the *static gauge* of the FAA type wagon conveying a 9 foot 6 inch high container was compatible with Network Rail infrastructure.
- 54 Following the design scrutiny the inclined underframe wear plates were removed and replaced with flat plates. The modified assembly incorporated the following (see Figure 6):
- a flat underframe wear plate; and
  - a resilient side bearer block and roller.

- 55 EWS modified the FAA fleet during 2004. The modification of wagon 609001 was completed on 22 July 2004.
- 56 No further incidents were recorded involving FAA wagons until 8 September 2006 at Washwood Heath.
