## CONTENTS

### SPECIAL BULLETINS

**SERIOUS INCIDENT**

<b>Aircraft Type and Registration:</b>	Boeing 737-73V, G-EZKG	
<b>No &amp; Type of Engines:</b>	2 CFM56-7B20 turbofan engines	
<b>Year of Manufacture:</b>	2004	
<b>Date &amp; Time (UTC):</b>	11 August 2010 at 1640 hrs	
<b>Location:</b>	West of Nantes, France	
<b>Type of Flight:</b>	Commercial Air Transport (Passenger)	
<b>Persons on Board:</b>	Crew - 5	Passengers - 144
<b>Injuries:</b>	Crew - None	Passengers - None
<b>Nature of Damage:</b>	None	
<b>Commander's Licence:</b>	Airline Transport Pilot's Licence	
<b>Commander's Age:</b>	60 years	
<b>Commander's Flying Experience:</b>	17,950 hours (of which 13,430 were on type) Last 90 days - 236 hours Last 28 days - 82 hours	
<b>Information Source:</b>	Aircraft Accident Report Form submitted by the pilot and further enquiries by the AAIB

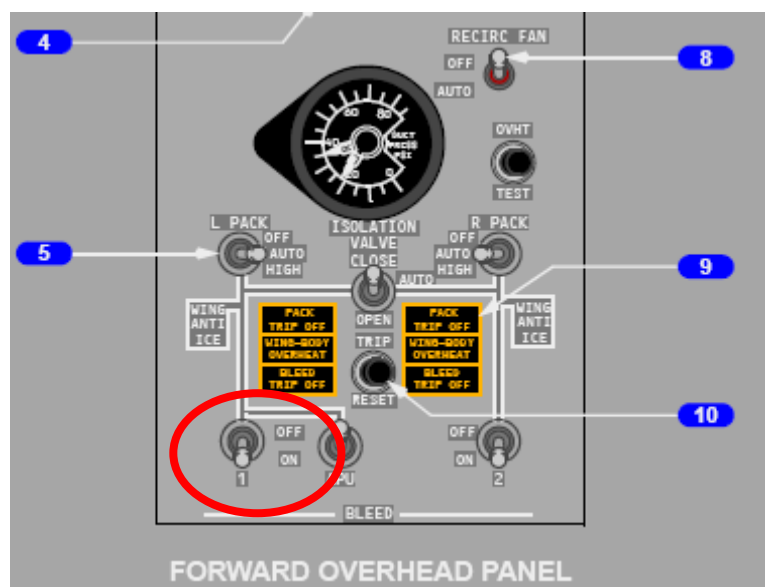
**Figure 1**

The co-pilot stated that he had incorrectly selected the bleed switch to OFF instead of the pack switch to OFF when he completed the left BLEED TRIP OFF checklist. Recorded data confirmed this. The bleed system was then configured with one engine bleed supplying two air conditioning packs. The right engine bleed was unable to meet the demand from two packs and tripped off, resulting in the loss of cabin pressure.

Bleed air section of Boeing 737-700 overhead panel.

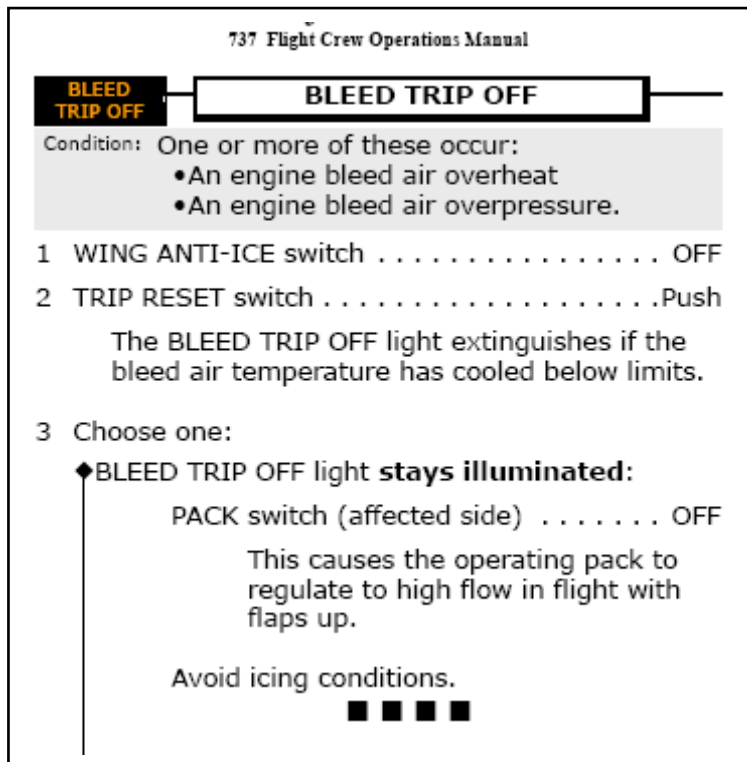
Figure 2

The co-pilot commented that within the given procedure (Figure 2), the words "BLEED TRIP OFF" may have caught his attention, because they appear several times in the checklist.

BLEED TRIP OFF checklist

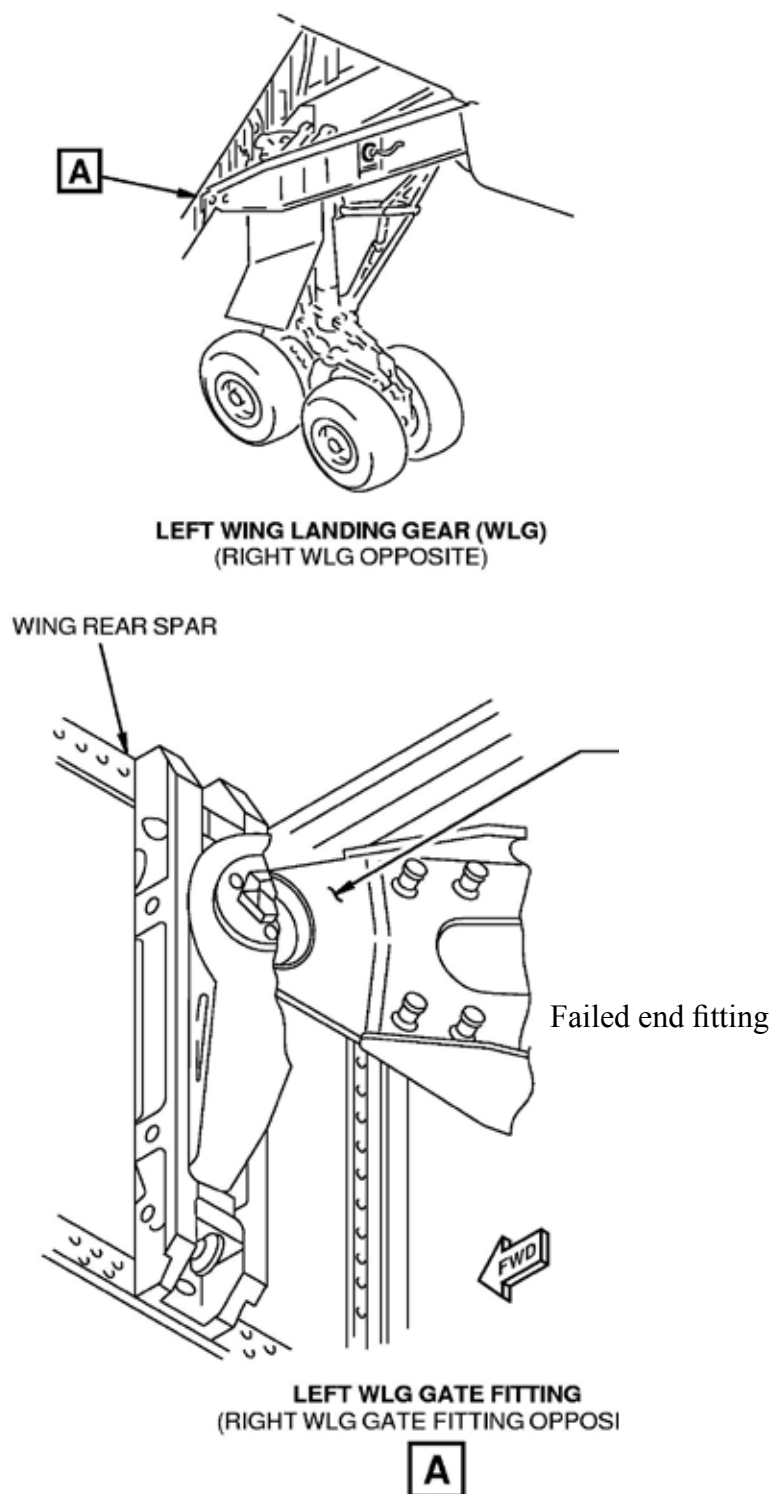
**Figure 2**

Both fittings on the right wing had failed due to cracks radiating from the main bore of the fittings (Figure 3a and 3b). Significant areas of corrosion were apparent in the bore close to the cracks.

Illustration showing location of failed component  
(left wing shown but actual failure on right wing)

The failed components from the right wing were removed from the aircraft and taken to a specialist forensic metallurgical laboratory for detailed examination. Extensive corrosion was found in the main bore of the fittings. This had allowed the initiation and the development of cracks which had propagated extensively through a 'fatigue' mechanism before separation occurred. It was not possible to determine how long the failure had taken to propagate before final failure occurred. There was no evidence to suggest that

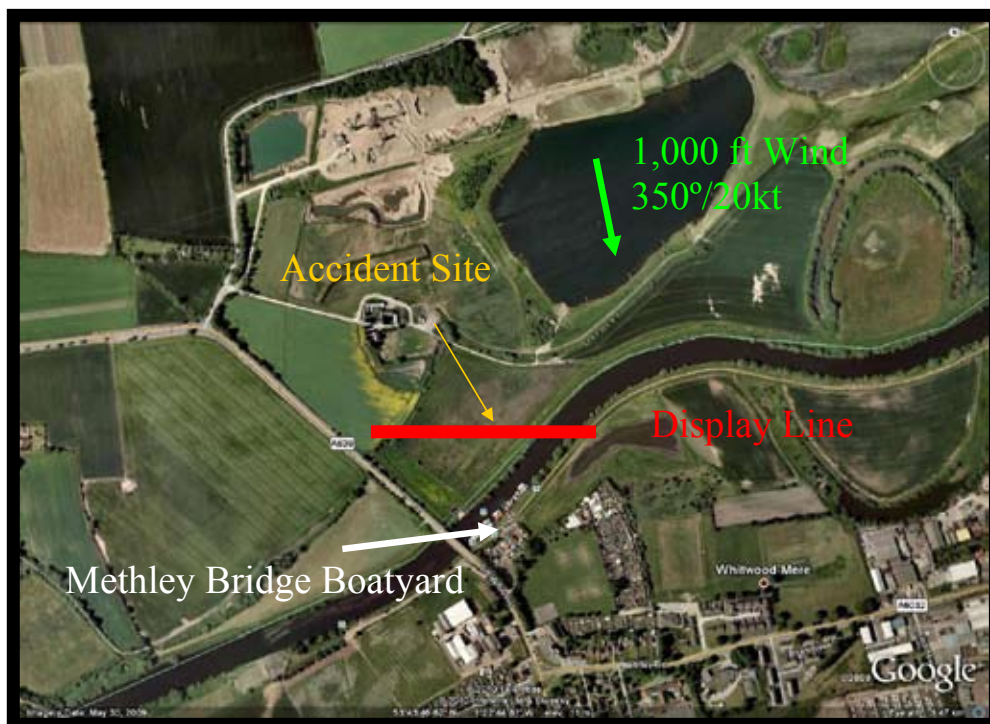
Figure 1

Shortly before 1500 hrs the aircraft performed a flypast and commenced its display at the boatyard. The display started with the aircraft flying past the crowd on its side, a manoeuvre known as a knife-edge pass. It then performed an inverted flypast, during which the pilot could be seen waving to the crowd. The aircraft's subsequent manoeuvres were not in the sequence shown on the pilot's display card. After several standard aerobatic manoeuvres the aircraft performed a vertical manoeuvre which the pilot may have intended to be a Muller Tower. The aircraft fell out of this manoeuvre into a dive, which was followed by the aircraft pulling up to the vertical and rolling right once more. The evidence indicates that this was also intended to be a Muller Tower. The aircraft then made five descending turns in a flat spin before it was seen to recover from the spin into a steep dive. The aircraft was now very low, and it flew into the ground. Witnesses rushed to the scene but it was immediately apparent that nothing could be done to assist the pilot. There was no fire.

Location of the display line and accident site

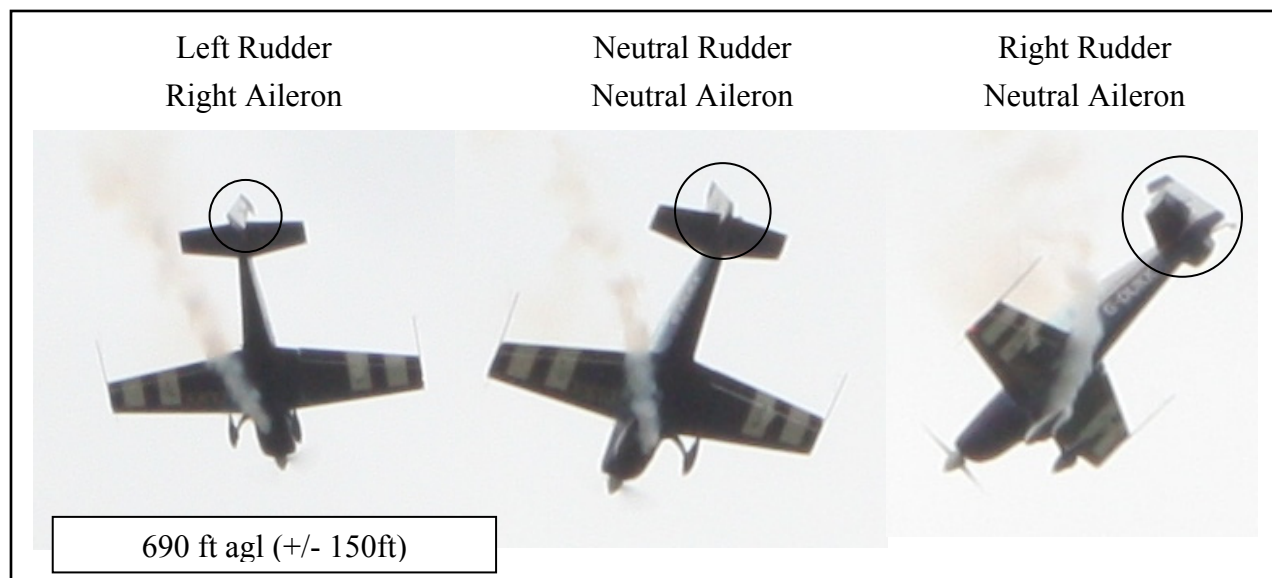
**Figure 2**

G-DUKK spin recovery initiation from a left turning flat spin

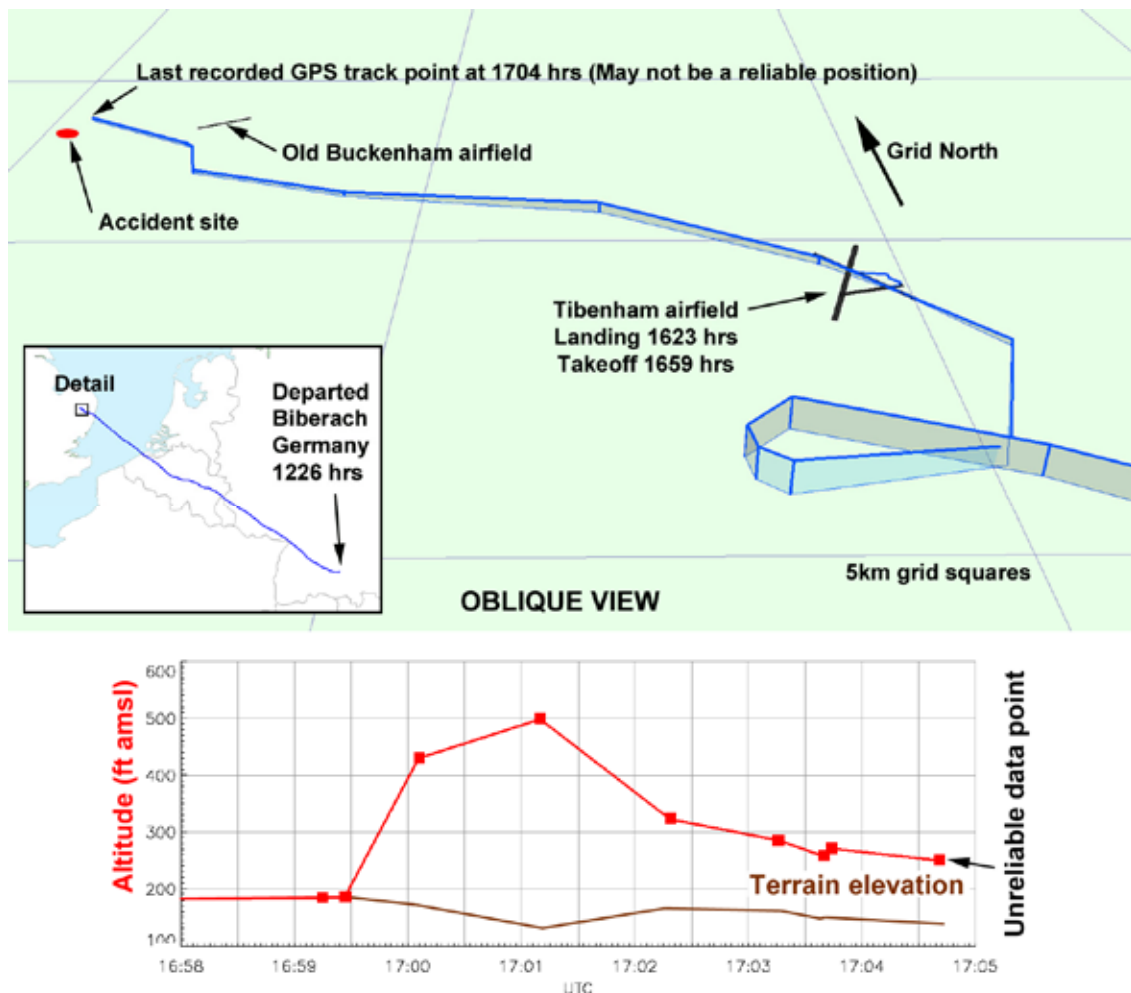
**Figure 1**

in contact with Old Buckenham, the aircraft was flying in the vicinity of Tibenham, and completed an orbit before making an approach to Runway 33 (Figure 1).

Overview of the last recorded GPS track and an oblique view showing the arrival at Tibenham, ground manoeuvring and onward flight. Graph depicts aircraft altitude for the accident flight

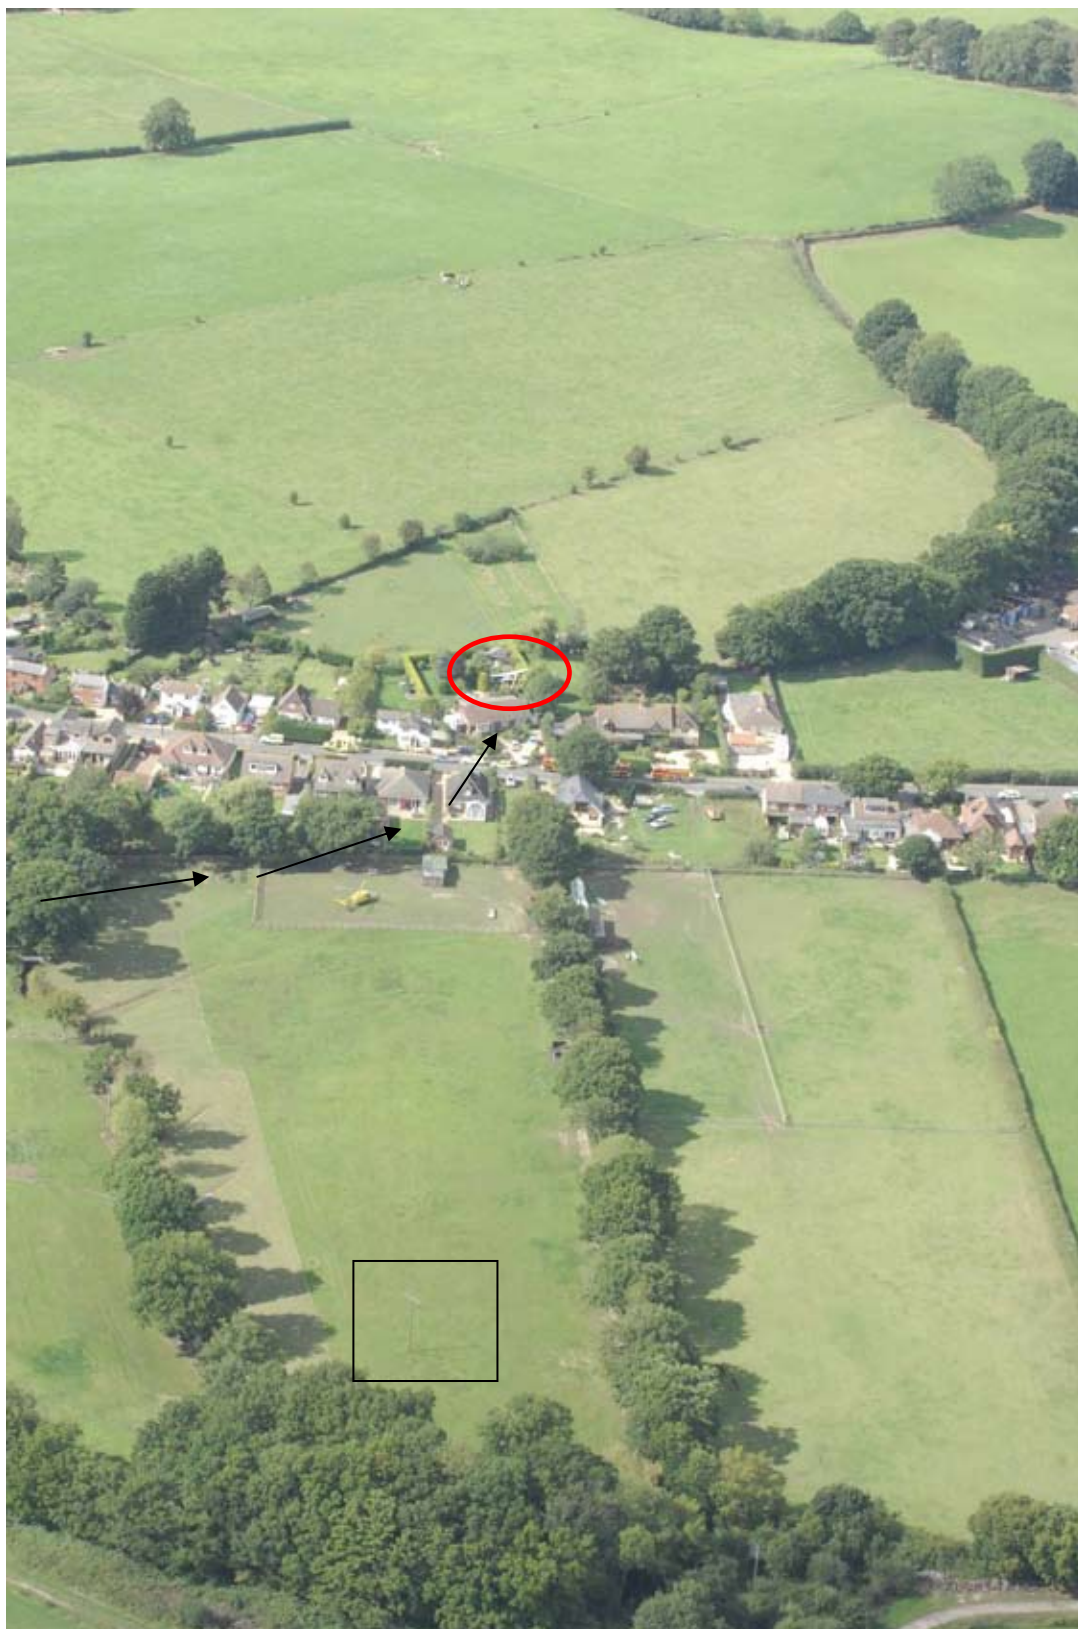
**Figure 1**

One witness described the aircraft as passing over them in a curving flight path. (Figure 1)

G-ARHN circled, witness ground track arrowed, note wires crossing field in foreground, pylon boxed.
