CONTENTS

SERIOUS INCIDENT

Aircraft Type and Registration:	Airbus A330-243, G-OJMC	
No & Type of Engines:	2 Rolls-Royce RB211 Trent 772B-60 turbofan engines	
Year of Manufacture:	2002	
Date & Time (UTC):	28 October 2008 at 0426 hrs	
Location:	Sangster International Airport, Montego Bay, Jamaica	
Type of Flight:	Commercial Air Transport (Passenger)	
Persons on Board:	Crew - 13	Passengers - 318
Injuries:	Crew - None	Passengers - None
Nature of Damage:	None	
Commander's Licence:	Airline Transport Pilot's Licence	
Commander's Age:	47 years	
Commander's Flying Experience:	14,500 hours (of which 3,000 were on type) Last 90 days - 170 hours Last 28 days - 40 hours	
Information Source:	AAIB Field Investigation

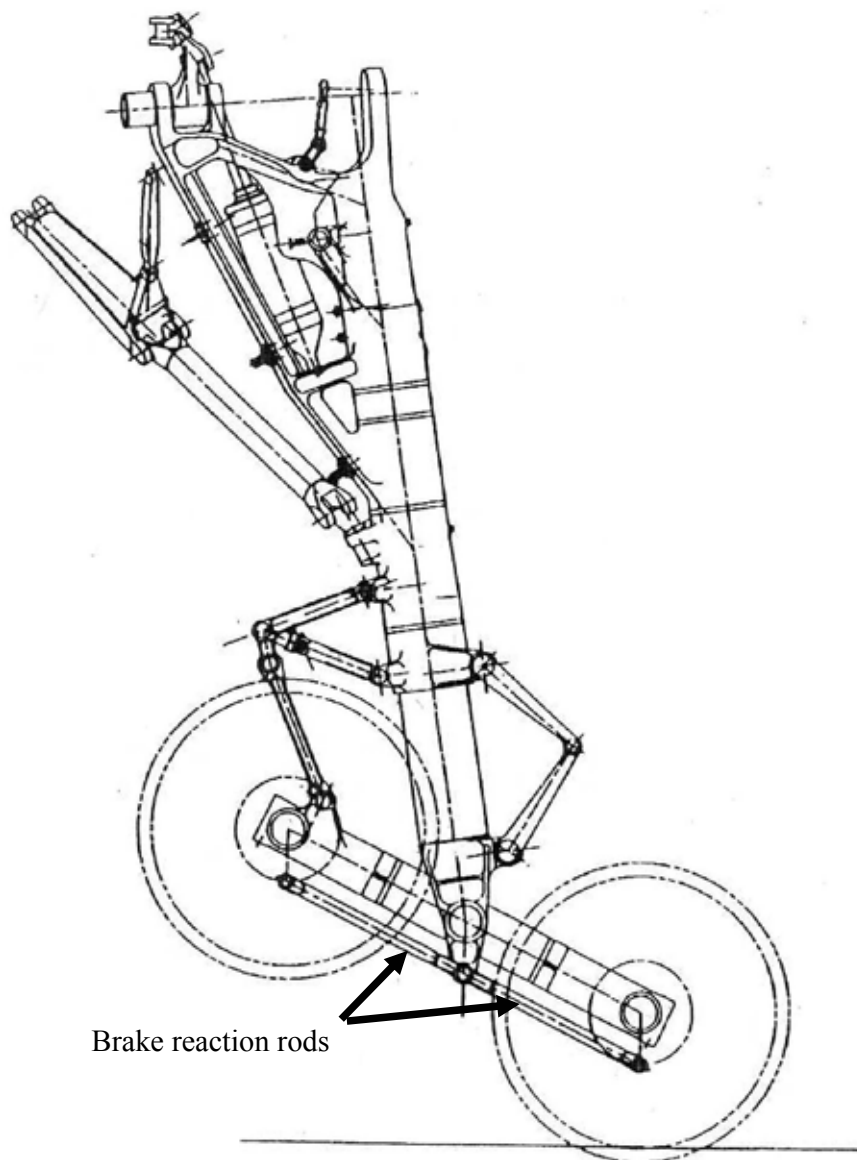
Figure 1

The brake rod attachment pin, or torque pin, is inserted through the brake rod from the bogie beam side and passes through the brake housing. It is retained by an end cap, which is itself retained by a cross-bolt, nut and split pin.

Main landing gear shown in 'flying attitude'

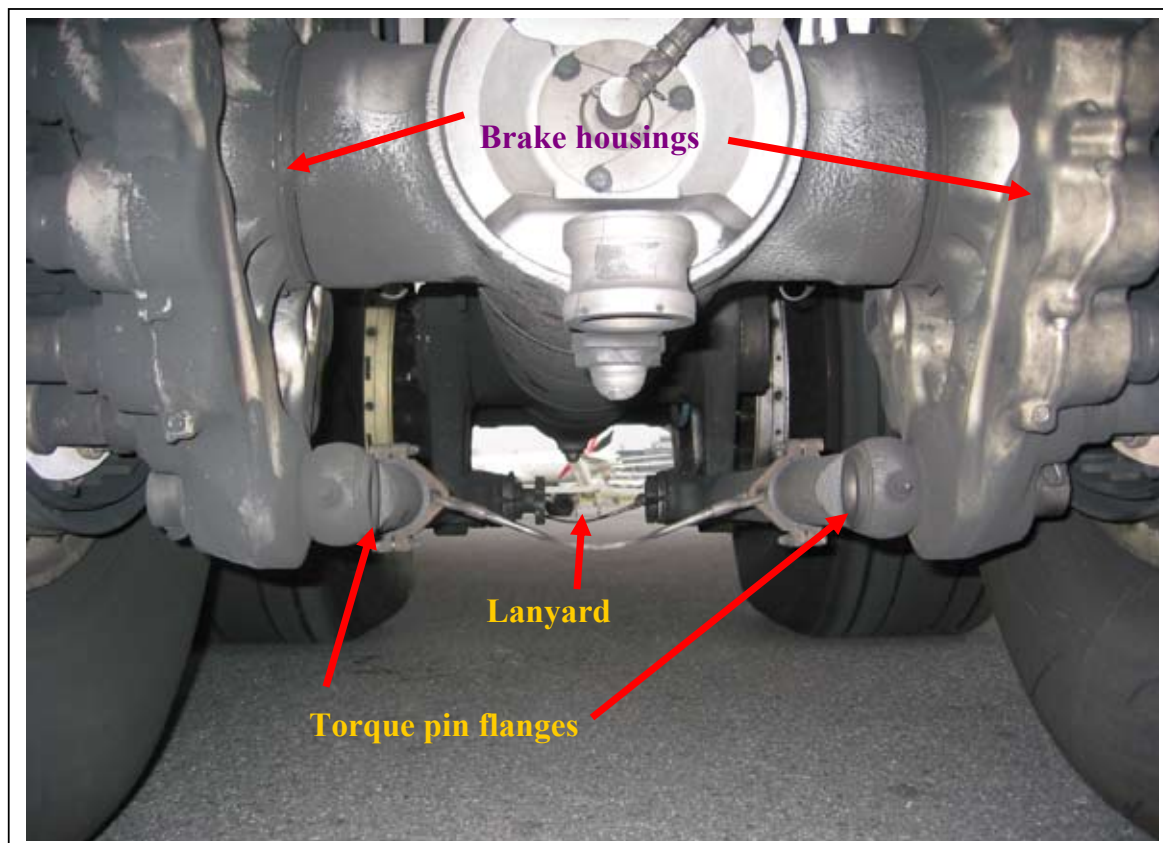
Figure 3 shows a photograph of the unaffected right landing gear of N270AY, showing the layout of the components described above.

View looking forward on intact right landing gear, showing layout of components

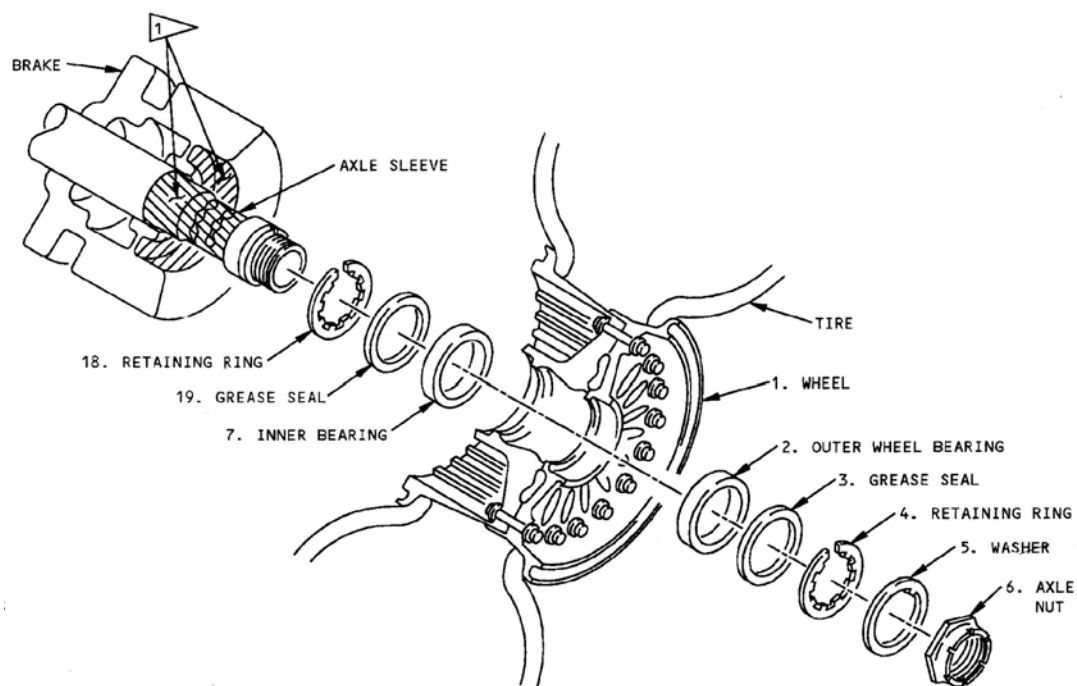
Figure 2

Boeing 747-400 main wheel bearing installation diagram

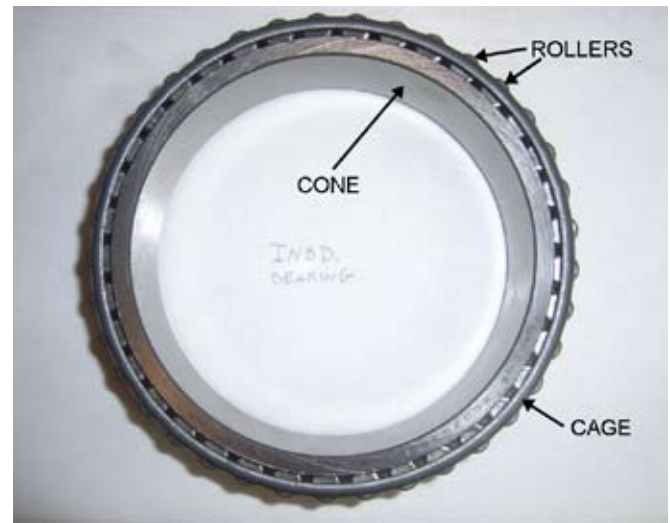
Figure 7 shows new rollers installed in their cage and fitted around the cone.

Example of a new inner bearing showing the cone, rollers and cage

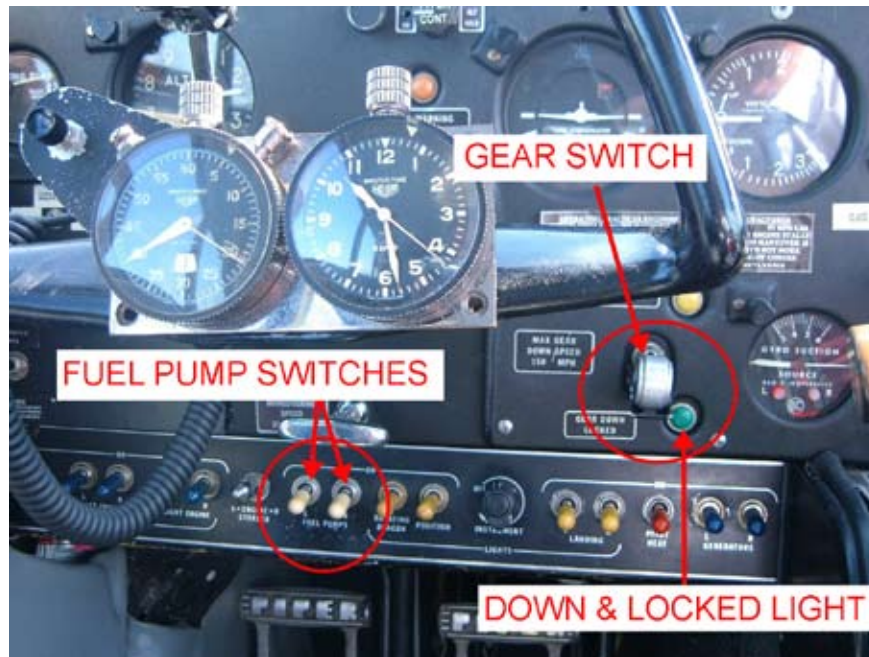
Figure 1

According to the pilot the aircraft made a harder than normal landing and then had a ground roll of about 300 feet. If the gear had not been locked down prior to

Location of gear switch and fuel pump switches on G-ATEW

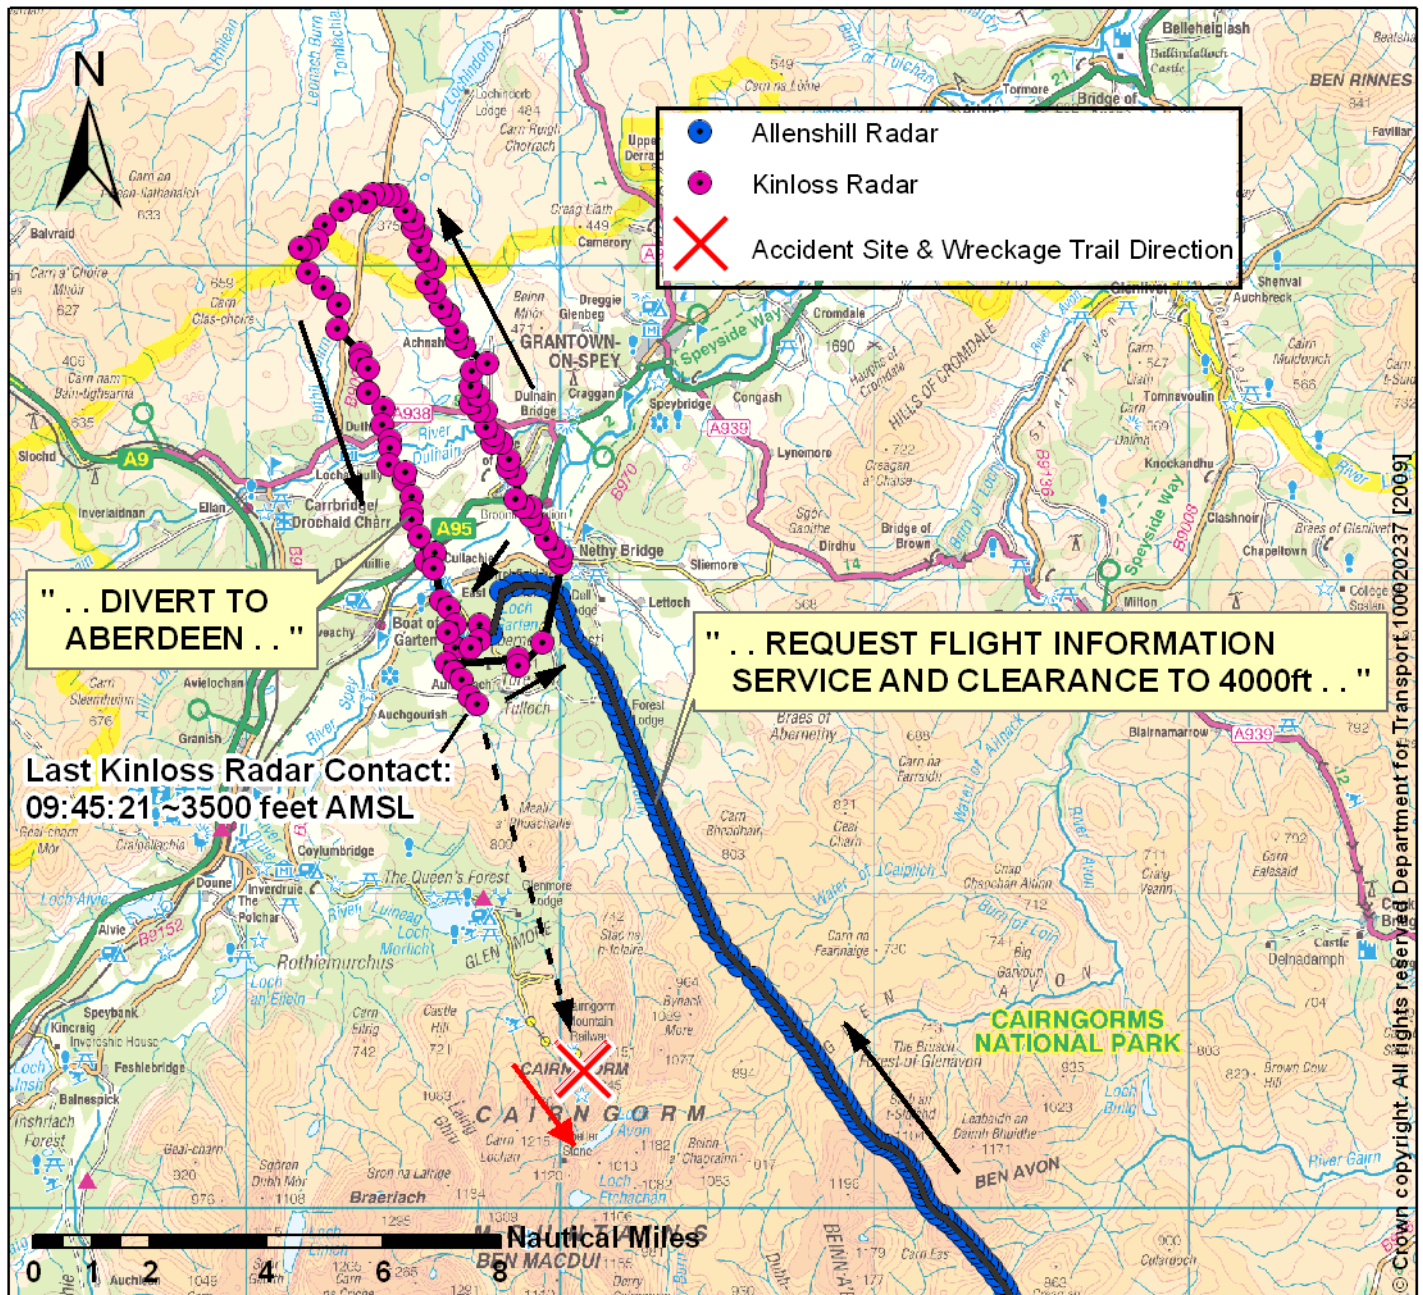
Figure 1

G-BSYC radar track near Cairn Gorm and location of accident site

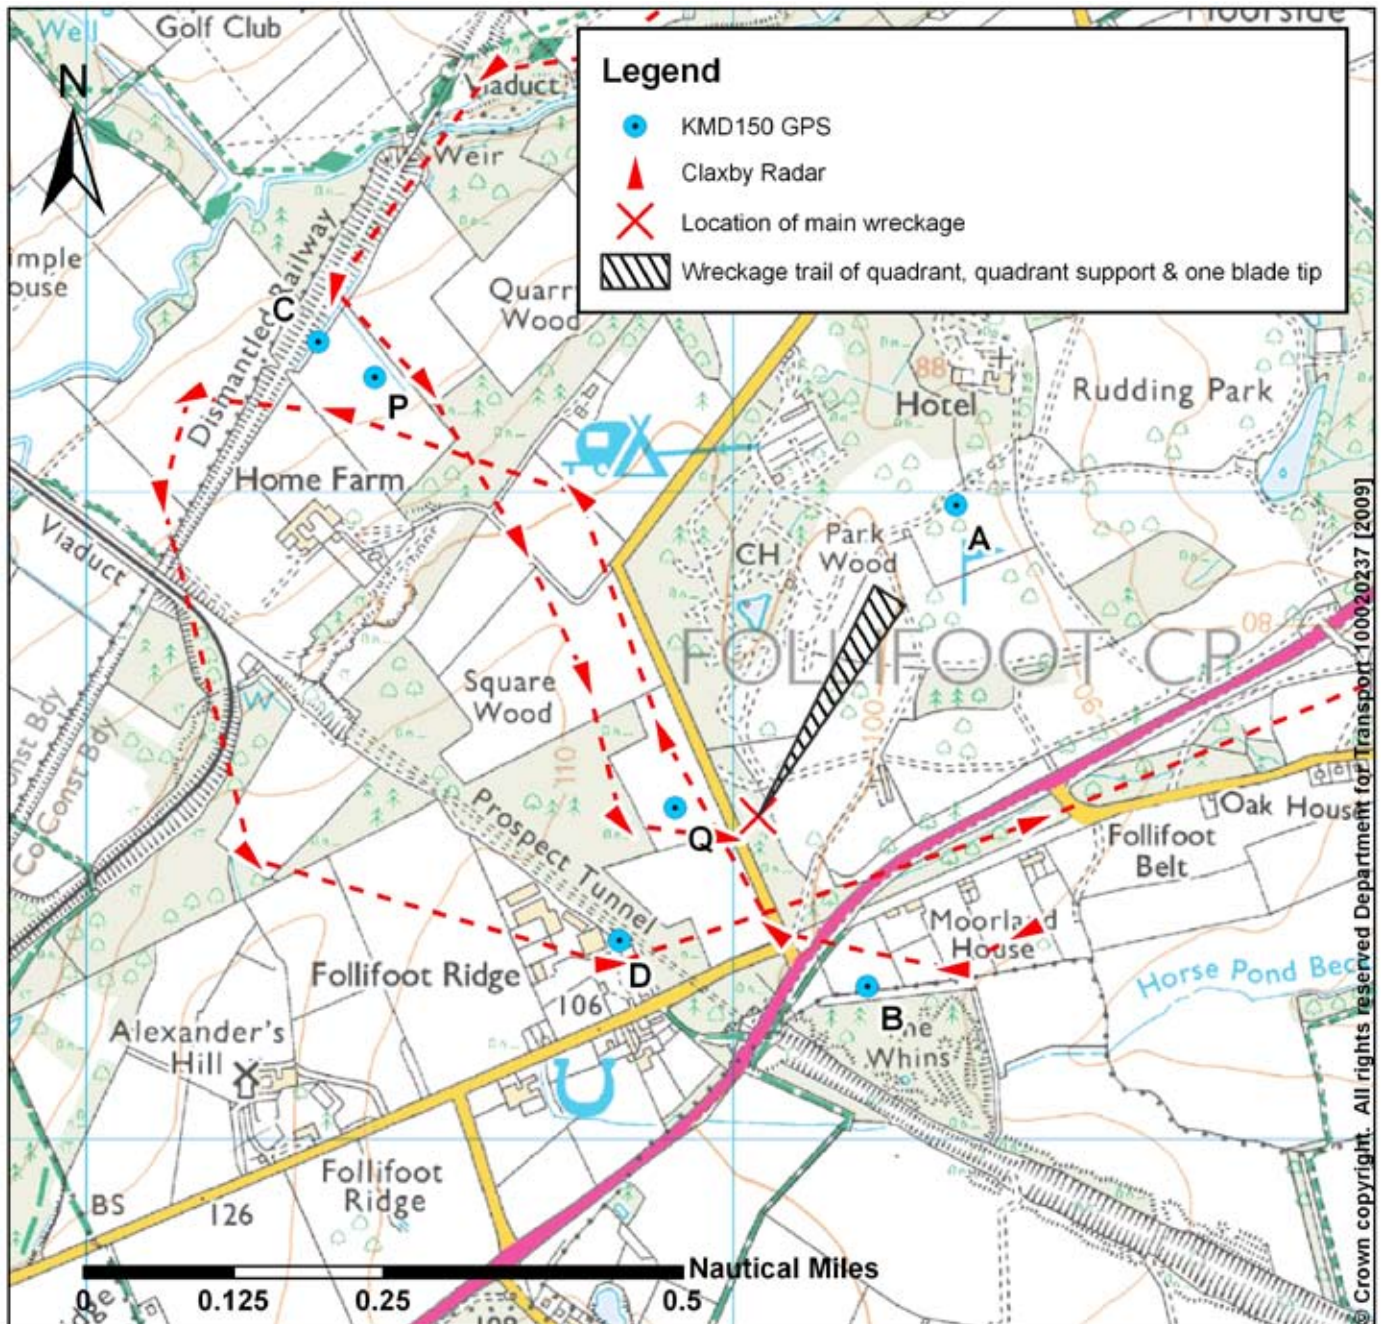
Figure 3

Expanded view of flight track, with wreckage locations

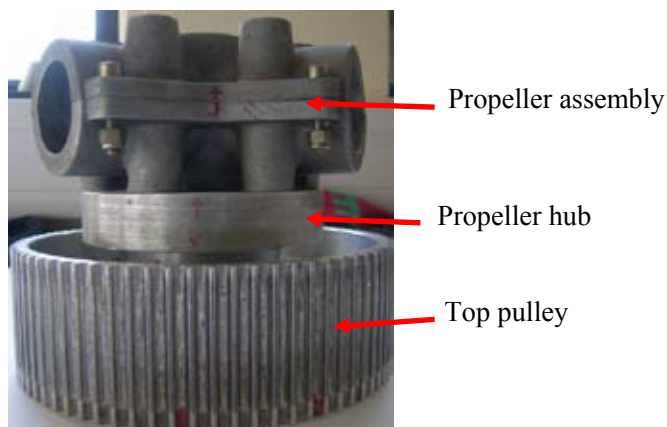
Figure 1

Reduction drive assembly

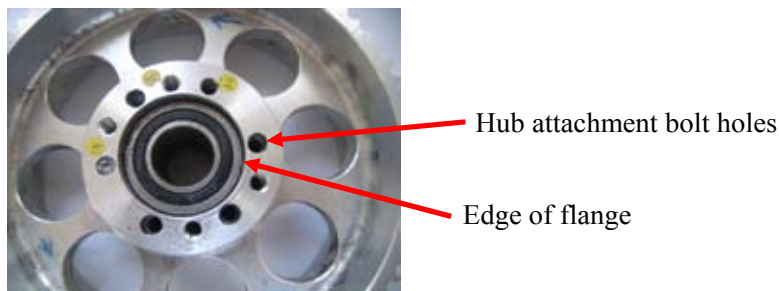
Figure 4

Following this accident, the LAA were concerned that the distance between the side of the threaded hub attachment bolt holes and the edge of the flange of the top pulley might have been insufficient to prevent distortion of the hole and failure of the threads (Figure 4). Therefore, with the permission of the AAIB, the LAA drilled and tapped an additional hole in the flange of the top pulley and established that the threads failed at a torque of 35 lbf ft. This is approximately 2.3 times greater than the torque specified in the build instructions for the hub attachment bolts.

Top pulley
