SPECIAL BULLETINS

S2/2010 Airbus A321-231	G-MEDJ	24-Aug-10	1
-------------------------	--------	-----------	---

COMMERCIAL AIR TRANSPORT

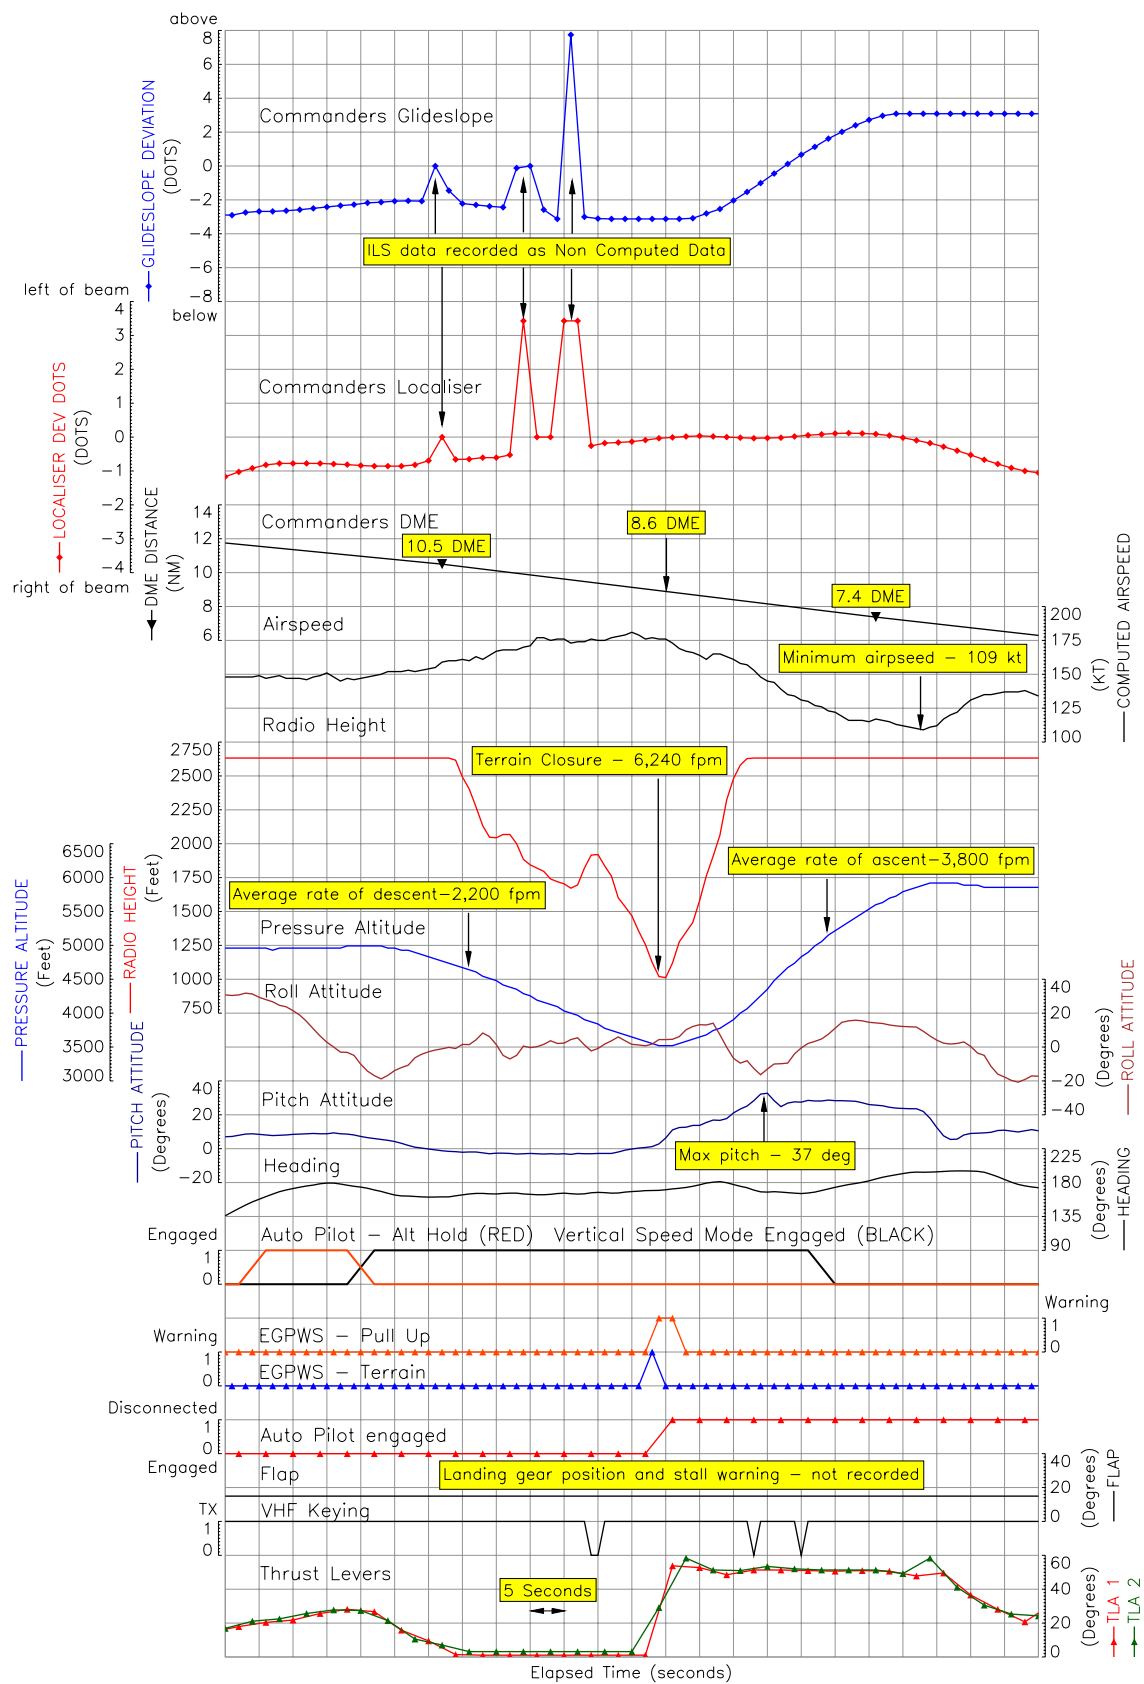
Figure 2

Approaching a range of 11 nm, the autopilot VS mode was engaged. At this stage, the aircraft was about 850 ft below the glideslope. The aircraft started to descend at about 2,200 fpm (see Figure 2). About ten seconds later, the commander's localiser and glideslope signals were both briefly recorded as non computed data (NCD) – indicative that the raw data was no longer reliable or not available. Recorded at almost the same time, the DME indicated 10.5 nm, which was accurate. Due to the low recording frequency of the DME parameter, the reliability of the data in the seconds prior to the descent could not be established. As the aircraft descended, two further recordings were made of the commander's localiser and glideslope signals temporarily being NCD.

Recorded FDR data for the (first) ILS approach to Chambéry Airport

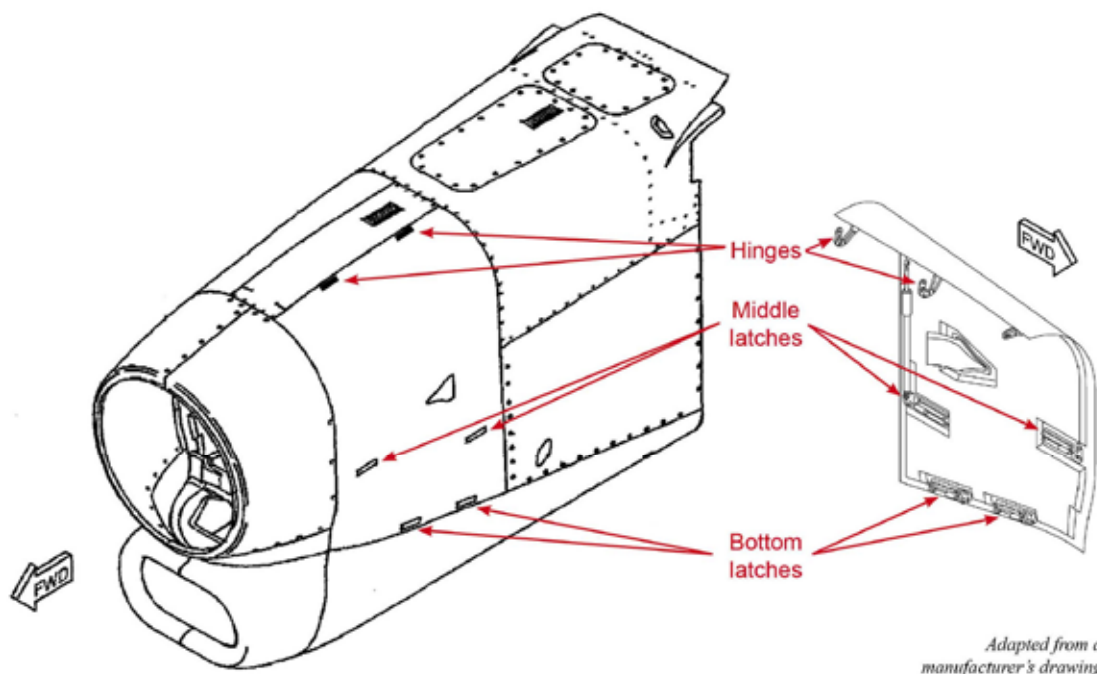
Figure 2

During the takeoff roll the No 2 engine inboard forward access door detached from the aircraft, colliding with and damaging the leading edge of the right wing. The lower latches of the door were found in the fully open position, indicating that the door had not been secured following maintenance.

The main engine bay has two large forward access doors, one inboard and one outboard. These access doors are made from a carbon/epoxy composite material with integral foam filled stiffening ribs. Each door is hinged at the top and is held in the closed position by four quick release positive-lock pin latches. Each latch, when closed, engages a pin into a receiver mounted within the engine nacelle structure (Figure 2).

Forward engine bay access door

Following this event the operator launched a safety campaign to highlight to aircrew, engineering and ground staff the importance of securing and checking of engine access doors on all its aircraft types.

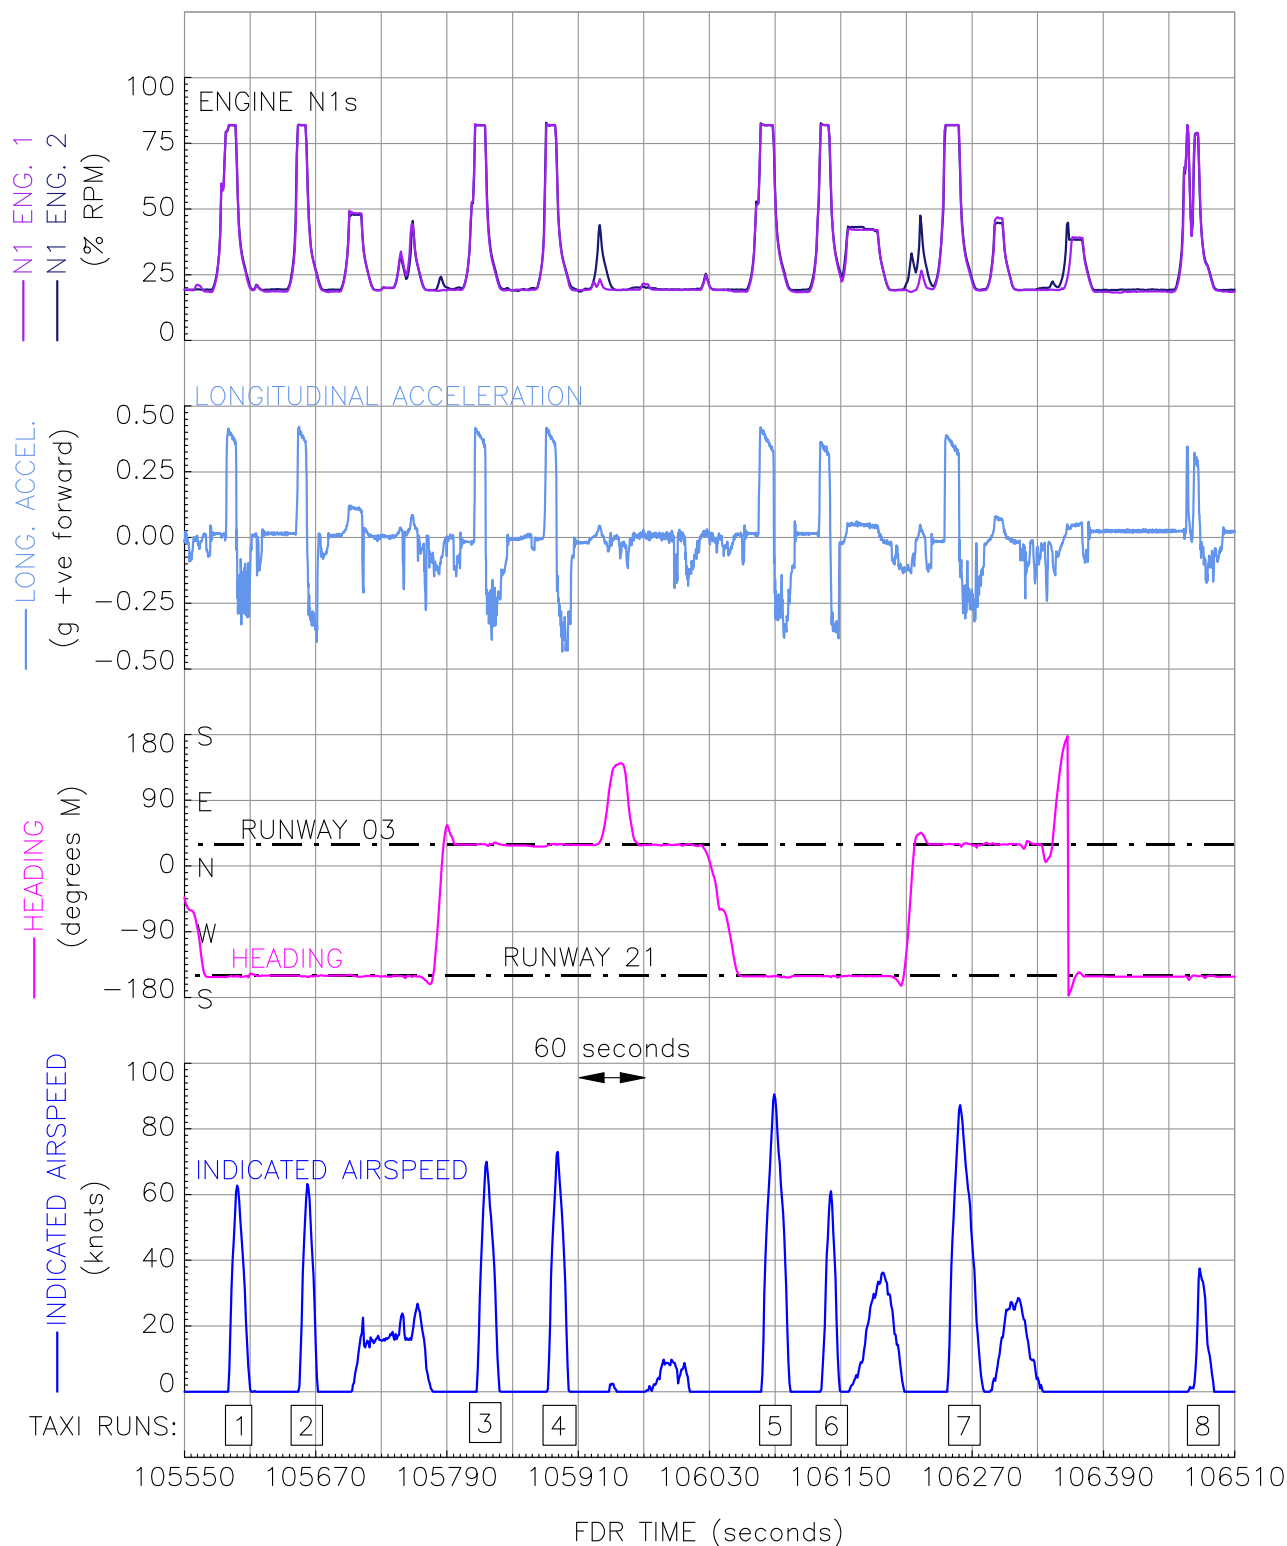
The salient FDR parameters are presented at Figure 2 and show that in total, eight high-speed taxi runs were completed over a period of just under 16 minutes. The first seven runs achieved speeds of between 60 kt and 90 kt. The final run was aborted at just over 35 kt¹ when

Salient FDR parameters from CS-DFE of high-speed taxi runs

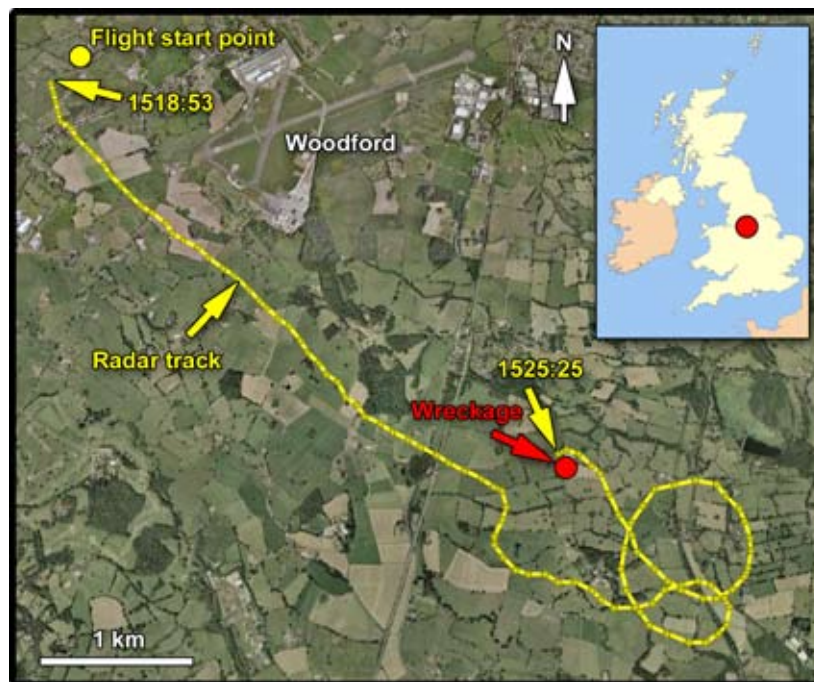
**Figure 1**

The flight path of the helicopter was, however, captured by Manchester Airport’s radar (Figure 1). The helicopter’s transponder was not set to report its altitude, so only its ground track could be assessed.

G-RIDL radar track

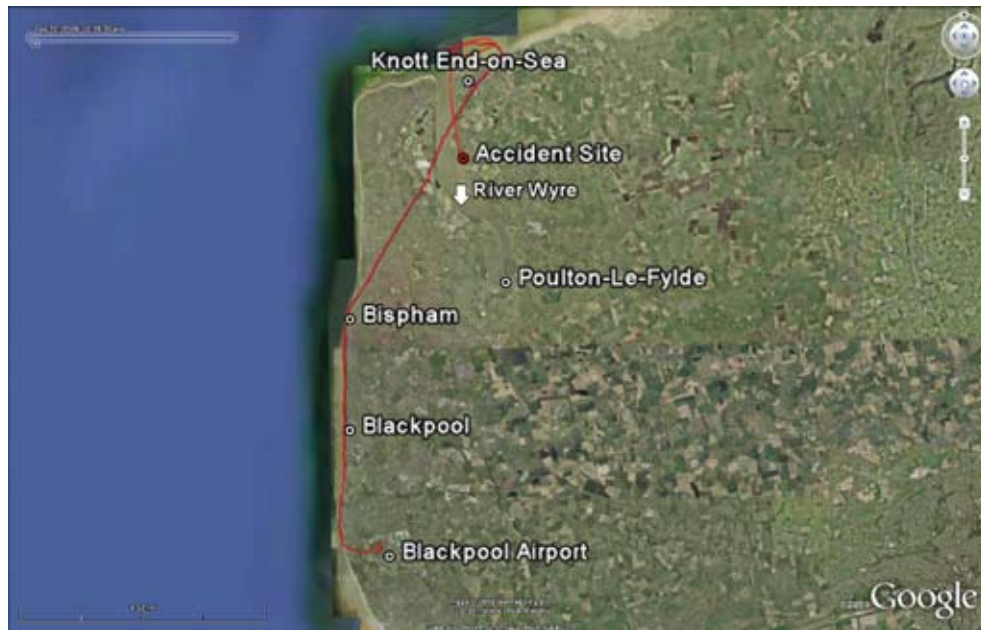
**Figure 1**

Recorded radar information was available from two radar sites, located at Great Dunn Fell and St Annes. St Annes radar is located approximately 8 nm south of the accident site and Great Dunn Fell approximately 50 nm to the north-east. Primary and secondary radar information was recorded approximately once every four seconds by the radar at St Annes and approximately once every eight seconds by the radar at Great Dunn Fell. Both radars recorded G-LINX manoeuvring in the vicinity of Knott End-on-Sea before tracking south to follow the River Wyre. About 1.5 nm south of Knott End, 1.2 nm west of the village of Stalmine, it altered track towards the east and descended, disappearing from radar shortly thereafter. The final radar positions were within 45 metres of the accident site. Figure 1 shows the helicopter’s radar track.

G-LINX –Radar track

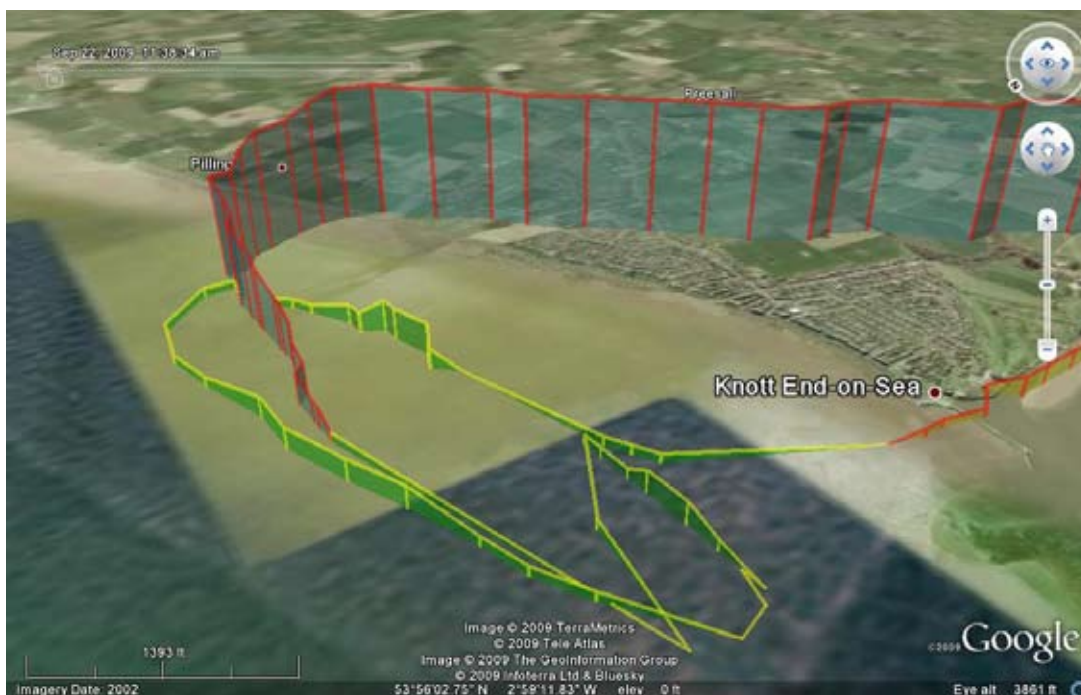
Figure 2

flew in a predominantly right-hand circuit direction, at heights not above about 400 ft. During this period the helicopter climbed and descended twice (Figures 2 and 3). Both descents occurred whilst heading into wind. During the first descent, the average descent rate was 1,570 ft/min +/- 786 ft/min and the second was 1,570 ft/min +/- 524 ft/min. The average ground speeds during both descents were similar, at about 35 kt, giving an airspeed of approximately 50 to 55 kt in the prevailing conditions.

G-LINX - Flight in the vicinity of Knott End-on-Sea

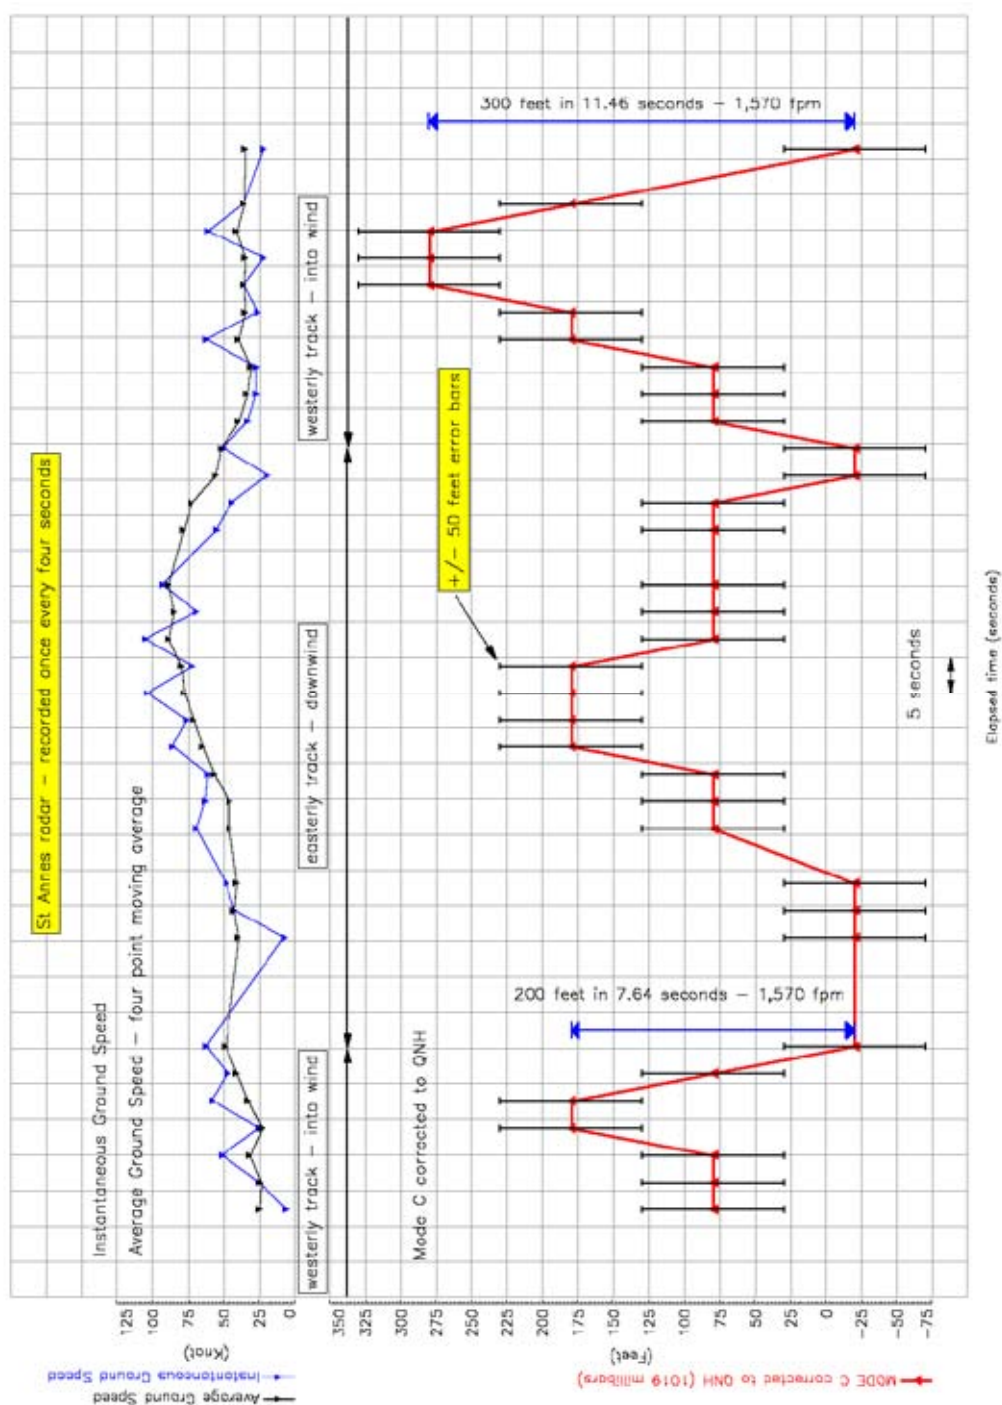
Figure 3

G-LINX - Flight in the vicinity of Knott End-on-Sea

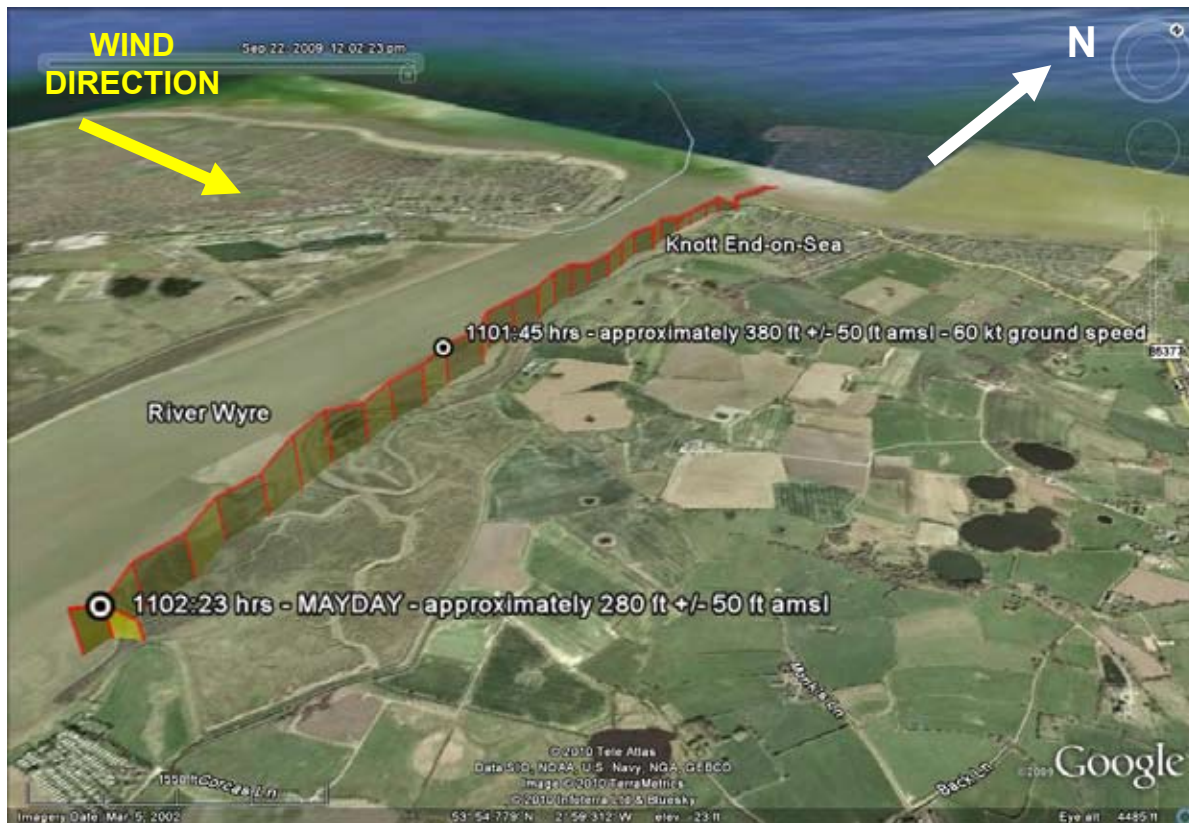
Figure 4

indicating that G-LINX was at about 430 ft. The ground speed remained stable at about 60 kt after departing the area near Knott End (Figures 4, 5 and 6).

G-LINX - Flight from Knott End-on-Sea

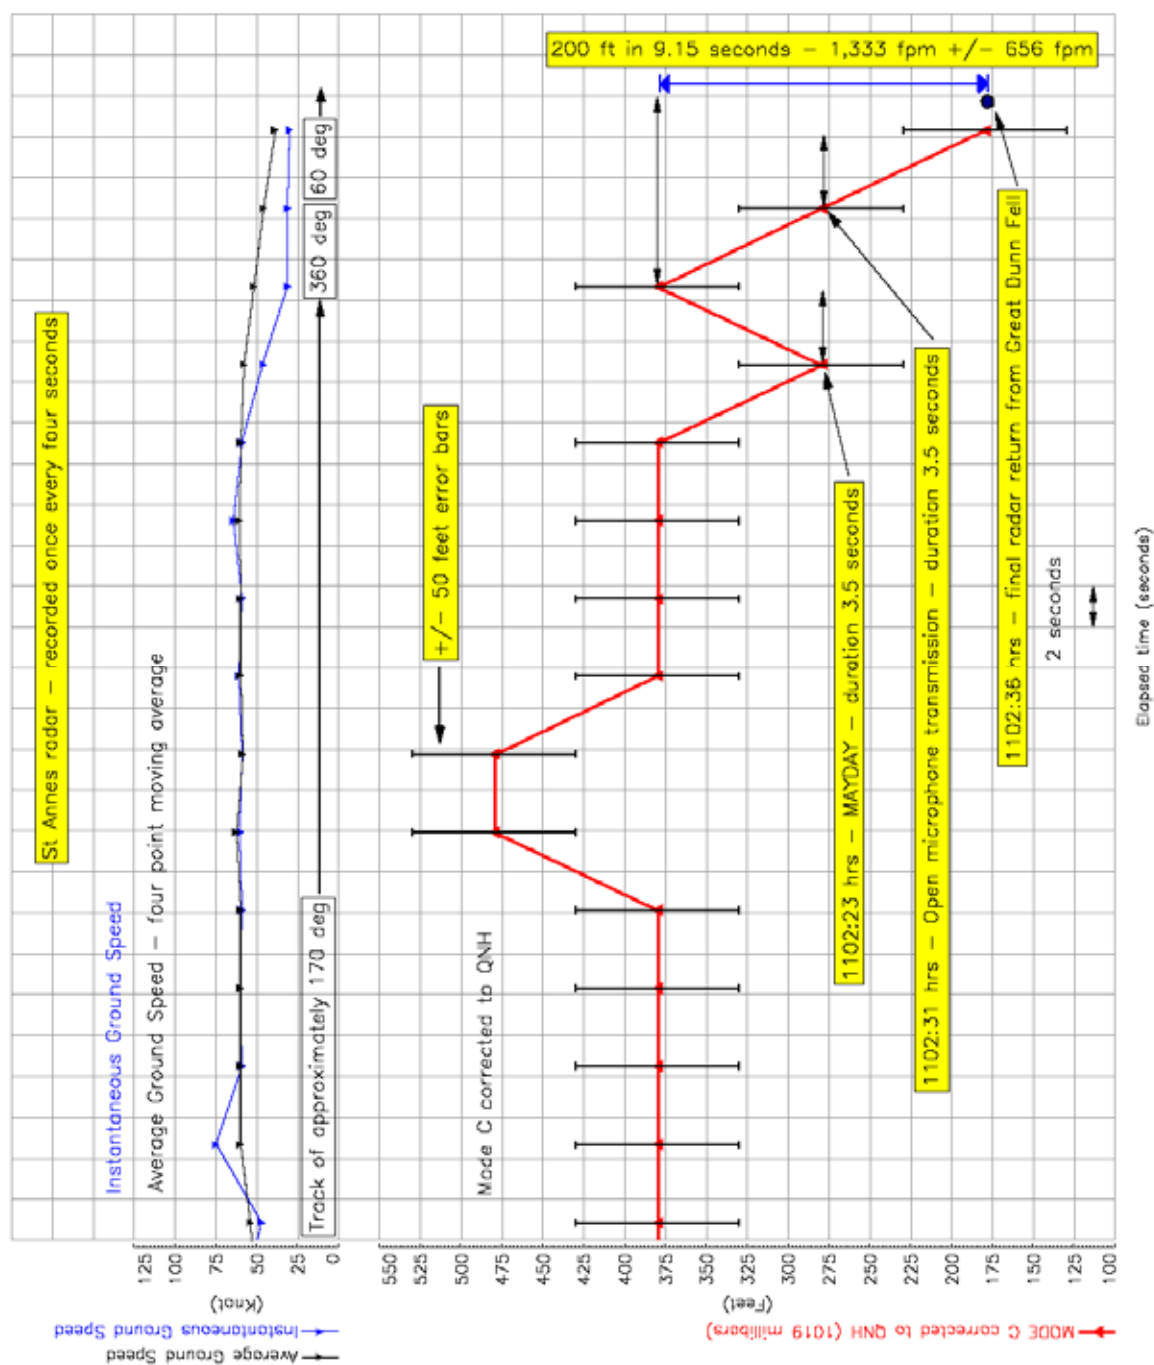
**Figure 5**

G-LINX - Flight from Knott End-on-Sea

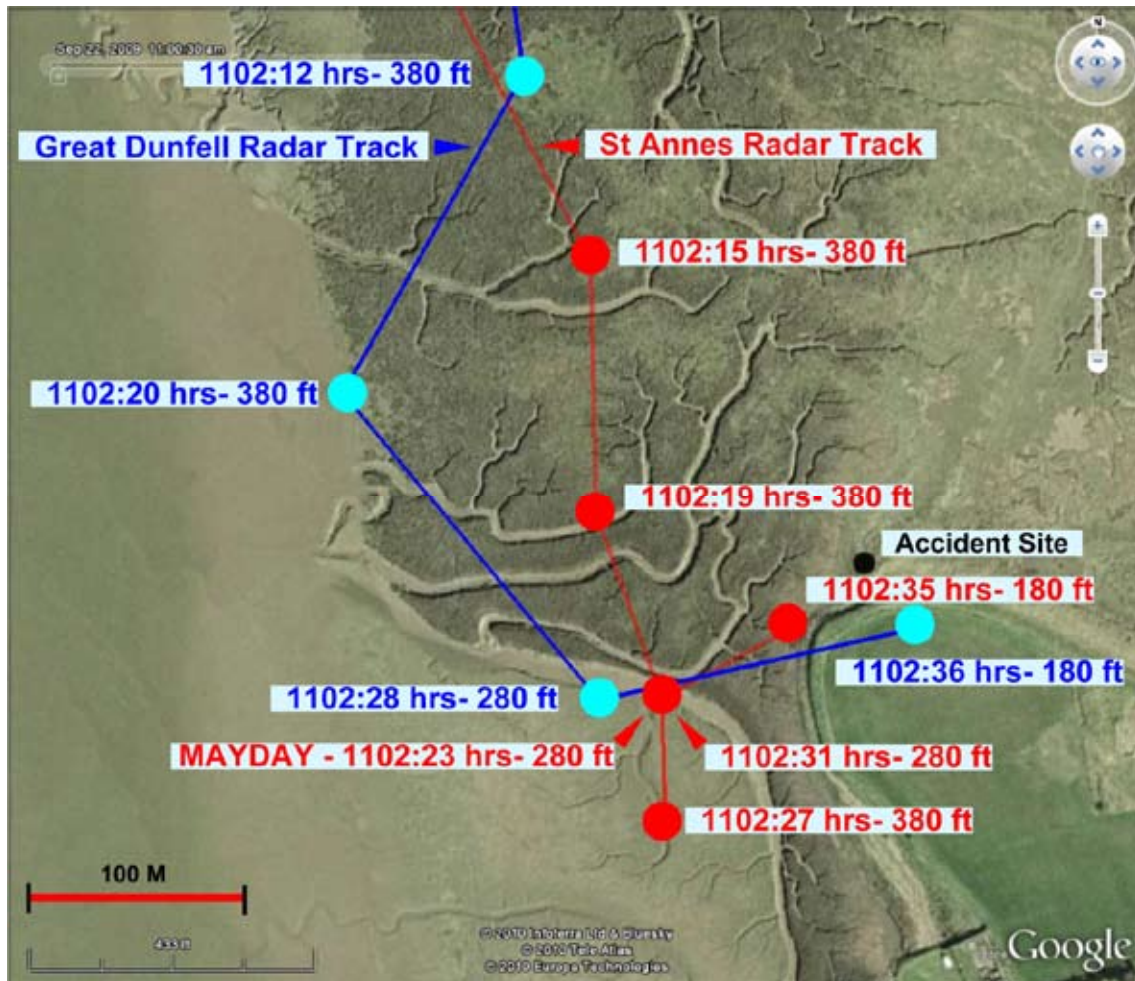
Figure 6

At 1102:23 hrs, the instructor transmitted a MAYDAY on the Blackpool Approach frequency. At that moment the helicopter was at a height of approximately² 280 ft +/- 50 ft, and its average ground speed had reduced from 60 kt to 45 kt. During the next 13 seconds, its ground speed stabilised at about 30 kt and the helicopter altered track to the east and descended. It was then approximately 0.5 nm east of the west (upwind) bank of the River Wyre. The final radar point, recorded at 1102:36 hrs, indicated the helicopter was at a height of about 180 ft +/- 50 ft. The average descent rate during the final nine seconds of data was 1,311 ft/min +/- 656 ft/min.

G-LINX – Final radar positions
