# Kit!

## ENGINEER'S CORNER THE PRINCIPAL ENGINEER FOR LAND EQUIPMENT

### KiT 81 | 2012

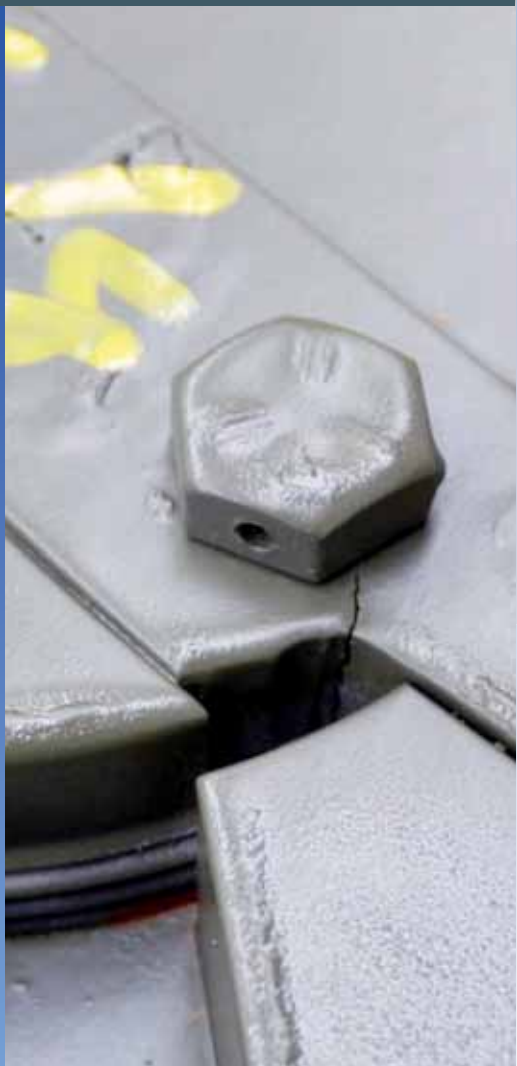
Prevents the hub nut from working loose whilst the vehicle is moving. This lock plate (picture) is cracked through to the securing hole and was discovered during receipt inspection of a repaired final drive.

Failure of the lock plate would allow the hub nut to work loose, causing damage to the final drive output shaft and possibly complete loss of the sprocket carrier and track.

Safety of unit personnel and the general public depend upon inspections being carried out thoroughly and in accordance with the relevant AESPs.

All equipment is subject to inspection, **even new equipment.**

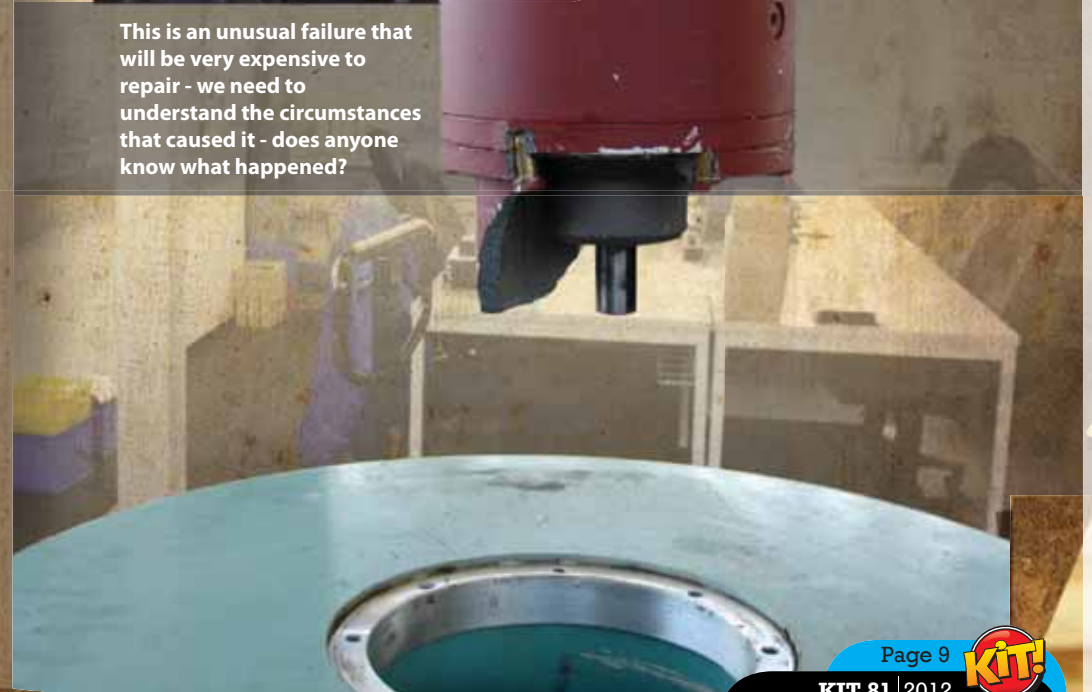
**This is an unusual failure that will be very expensive to repair - we need to understand the circumstances that caused it - does anyone know what happened?**

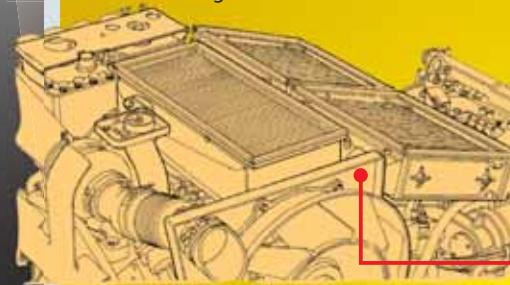
The OPR companies who carry out, power pack regeneration are unable to despatch repaired packs because there are duplicate power pack serial numbers recorded on JAMES. Power pack serial numbers have been entered in various formats and do not appear to have been kept up to date, as packs have been exchanged.

**Pack serial numbers have been recorded incorrectly in the following formats:**

- The correct PP number but with a gap between the letters and numbers, for example PW 0499 instead of PW0499, or a hyphen between the letters and numbers, for example PW-2598
- The correct PP format but with '0's dropped, for example PW323
- ABRO or DSG and then a number, for example ABRO45; this is possibly because the PP serial number plate is missing and a local serial number has been created
- Original parent equipment VRN
- The digits of the serial number, for example 639
- A completely random number - 123456789 is recorded on JAMES!
- A mix of the above.

The serial number plate can be accessed by lifting the exhaust outlet louvre so that the RH top corner of the fan plate can be seen.

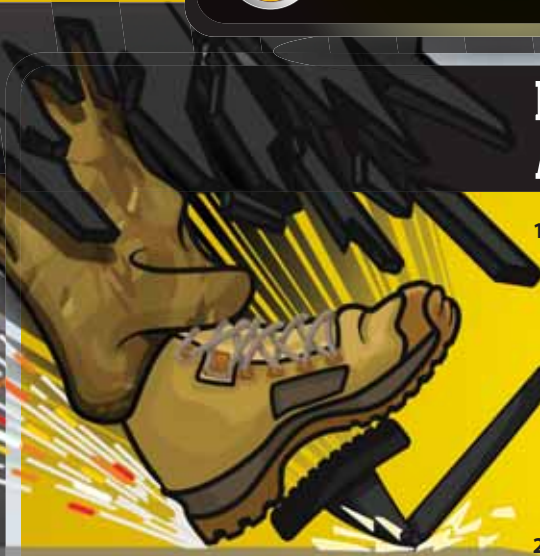
### BRAKE ADJUSTMENT

The clearance is greater between the carbon brake plates and the original brake plates - **This can cause the foot brake pedal to bottom out - before the brakes are fully applied.**

1. Adjust the transmission brake plate clearance in accordance with AESP 2350-T-200-522 Chapter 1-7, paragraphs 14 - 21 (Adjustment method 2).

**Note that the minimum clearance in each brake pack is 4.19 - 4.32 mm (0.165 - 0.170 in).** The clearance will have to be measured using standard feeler gauges or a locally manufactured tool similar to the standard acceptance gauge (which is 3.2 mm thick).

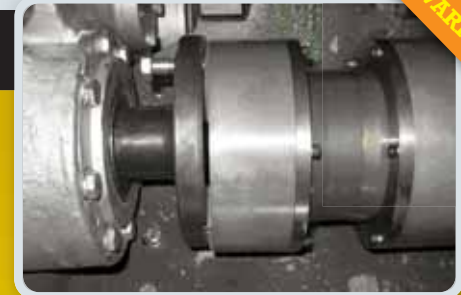
There is an obvious misalignment between the transmission output flange and the final drive input flange on this vehicle. SEFIT must be informed if difficulty is experienced in fitting the LHDS - **do not be tempted to fit the shaft as overheating and possible catastrophic failure may occur.** The misalignment between final drive and transmission cannot be corrected at unit level as both the pack and final drive are bolted rigidly to the hull. **In cases of misalignment Units are to initially ensure that:**

- The pack is correctly located and secured in the hull and that the RH trunnion alignment ring is fitted correctly
- The final drive input bearing is serviceable
- The bulkhead bearing through which the transmission output shaft runs is serviceable
- The transmission output shaft snap ring is correctly located in the groove - **see detail in Fig 1** and that the output shaft is pushed fully into the transmission so that the snap ring prevents the shaft from inadvertent disengagement.

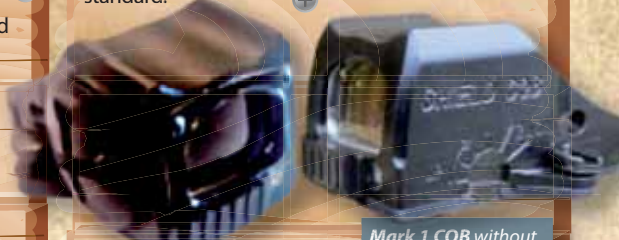
Mark 2 CQB - with new faceplate for improved pressure sealing

Mark 1 CQB without the front faceplate

All FIST CQB sights should now be at the Mk2 standard.

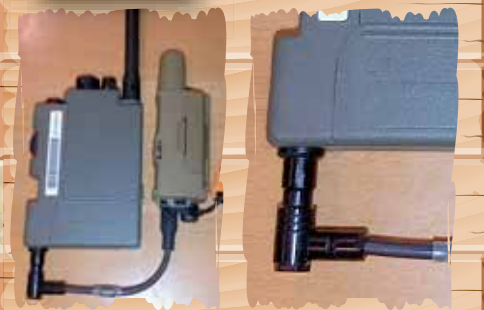
CLB as carried

Users should take care, where possible, to protect the connector while a protective shroud is being trialled.

**Users please continue to submit EFRs.**
