Published 9 March 2017

DA 40 Diamond Star	G-CBFA	16-Jul-16	3
--------------------	--------	-----------	---

<b>Aircraft Type and Registration:</b>	DA 40 Diamond Star, G-CBFA	
<b>No &amp; Type of Engines:</b>	1 Lycoming IO-360-M1A piston engine	
<b>Year of Manufacture:</b>	2001 (Serial no: 40.063)	
<b>Date &amp; Time (UTC):</b>	16 July 2016 at 1546 hrs	
<b>Location:</b>	Old Warden Aerodrome, Bedfordshire	
<b>Type of Flight:</b>	Private	
<b>Persons on Board:</b>	Crew - 1	Passengers - 2
<b>Injuries:</b>	Crew - None	Passengers - None
<b>Nature of Damage:</b>	Nose landing gear leg, nose wheel, propeller and possible damage to engine	
<b>Commander's Licence:</b>	Private Pilot's Licence	
<b>Commander's Age:</b>	42 years	
<b>Commander's Flying Experience:</b>	269 hours (of which 38 were on type) Last 90 days - 26 hours Last 28 days - 21 hours	
<b>Information Source:</b>	Aircraft Accident Report Form submitted by the pilot

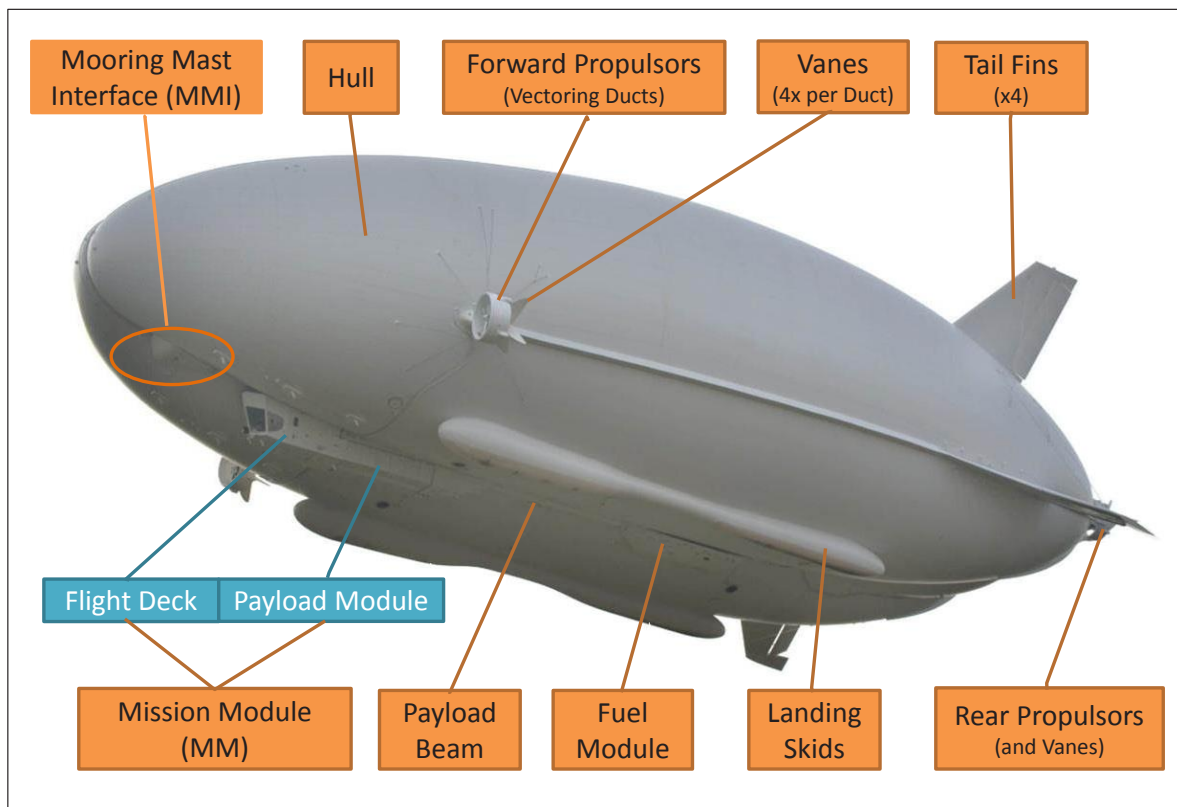
**Figure 1**

The Airlander 10 (Figure 1) is a development of the HAV 304 hybrid aircraft which was designed and produced as a long-endurance surveillance platform for the US military. The hull is a large pressure-stabilised fabric structure containing helium and air in separate compartments. Its aerodynamic shape contributes up to 40% of the vehicle's total lift. The Airlander 10 made its first test flight on 17 August 2016.

Main assemblies of the Airlander 10 (*Courtesy Ivor Pope / HAV*)
