CONTENTS

COMMERCIAL AIR TRANSPORT

Summary of:	Aircraft Accident Report No: 5/2007	102
	Report on the incident to Airbus A321-231, G-MEDG during an approach to Khartoum Airport, Sudan on 11 March 2005	
List of recent aircraft accident reports issued by the AAIB		107
	(ALL TIMES IN THIS BULLETIN ARE UTC)

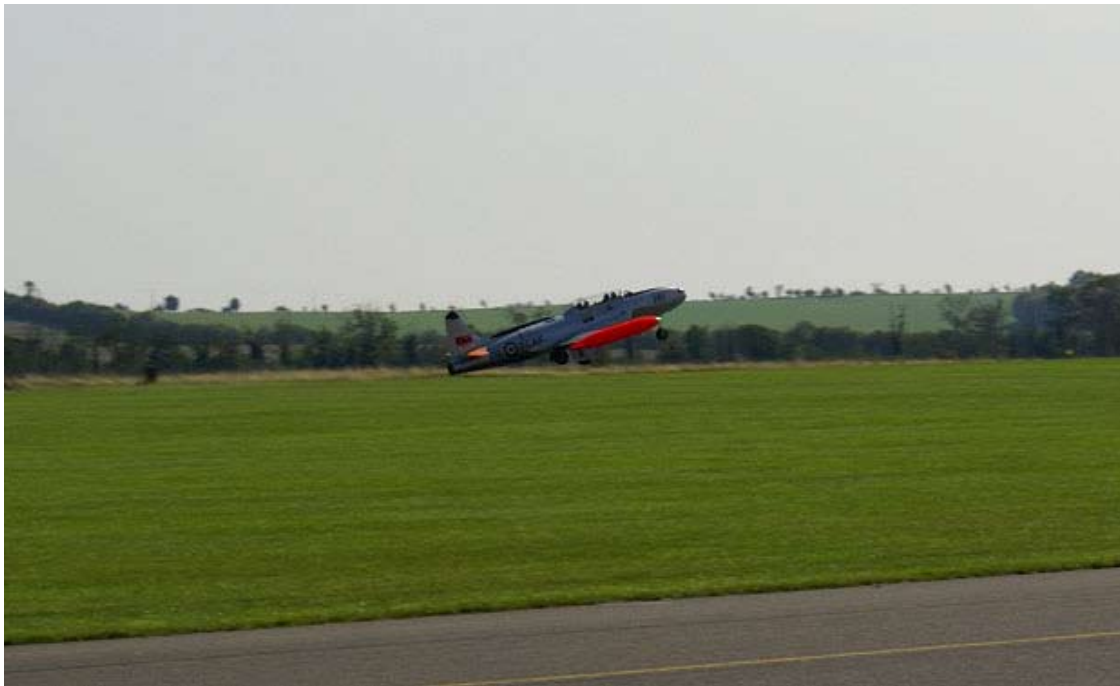
Figure 1

One witness, who was positioned to the north of the runway, recorded the takeoff on a series of photographs. He had set his camera to take a rapid sequence of still images, automatically, at a rate of 34 photographs every 15 seconds. The series of photographs started when G-TBRD was still in the early stages of its takeoff roll and provided good evidence of the subsequent chain of events and the pitch attitude that was achieved during the takeoff, which was approximately 15° nose-up (see Figure 1).

The photographs showed the aircraft maintaining the same level beyond the end of the runway as the ground dropped away, enabling it to become airborne for the second time, until the left wing dropped by about 50° and the aircraft disappeared from view. The photographs continued until after the aircraft had struck the ground.

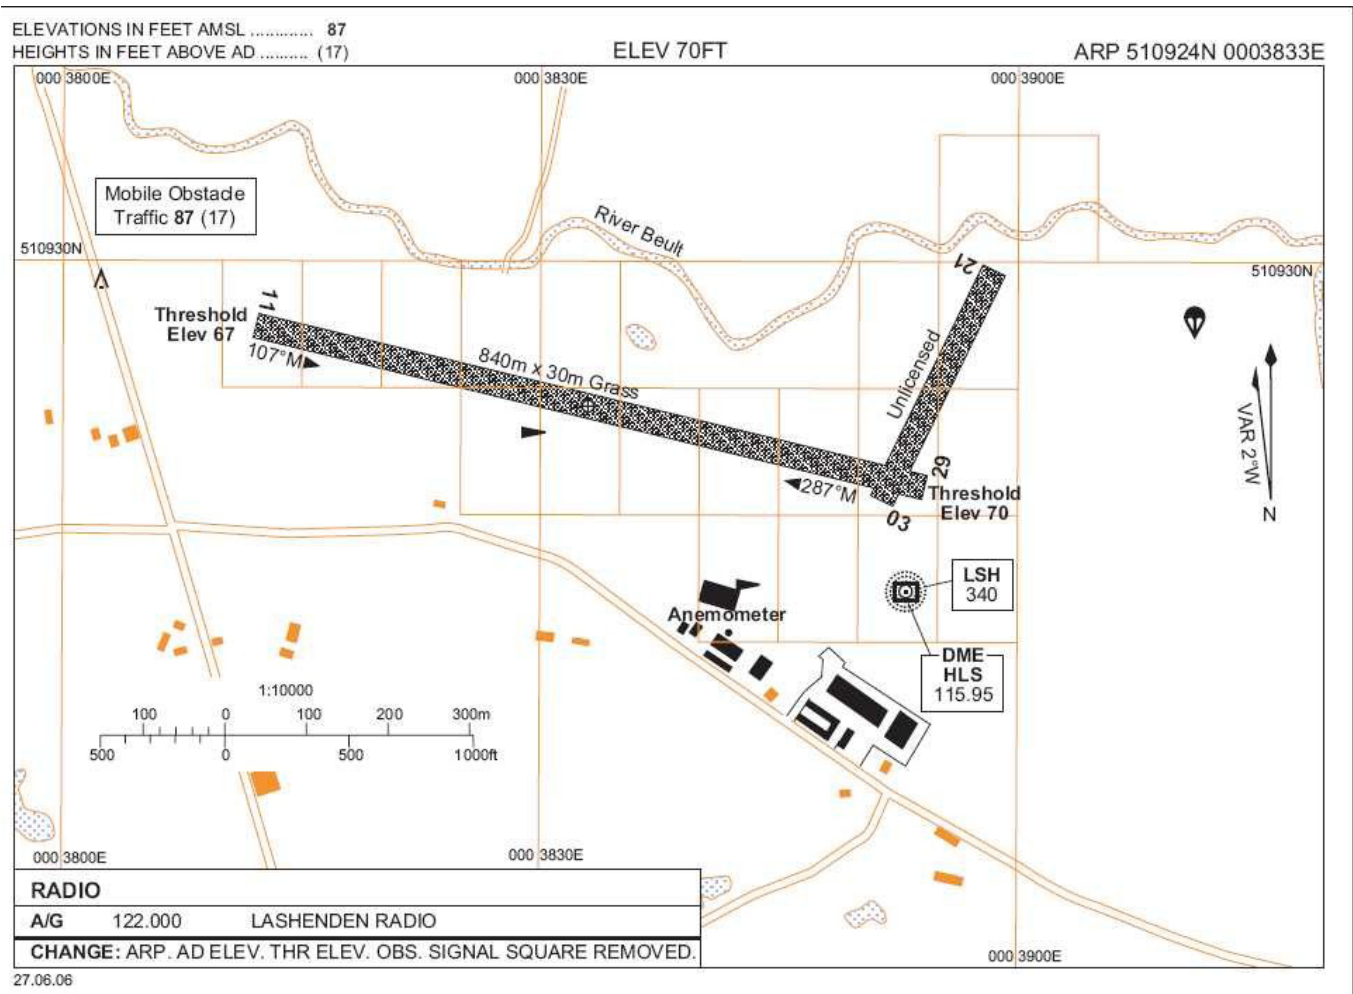
Figure 1

The UK Aeronautical Information Package (AIP) contains information about individual licensed aerodromes. The edition of the AIP current at the time of the accident concurred with the declared length of Runway 11/29 but did not report the length of the unlicensed Runway 21/03 (see Figure 1). One of the commercially available aerodrome guides noted that Runway 21/03 was unlicensed but had a length of 312 m. Another such guide, whilst also referring to this runway as unlicensed, gave its length as 549 m. The publishers of both guides commented that in respect of unlicensed runways they rely on information provided by the aerodrome operator except where graphical representation of the aerodrome shows an obvious geometric error.

A diagram on the Headcorn Aerodrome website depicted the runway layout. It showed Runway 21/03 extending south beyond the location shown in the Headcorn Aerodrome Manual so that it resembled the depiction in the aerodrome guide which quoted its length as 549 m.

The aerodrome operator commented that historically Runway 21/03 was considered to be 549 m long. More recently, whilst applying to license this runway, the aerodrome operator reduced its nominal length to 312 m in order to comply with the provisions of CAP 168 in relation to obstacles. The operator considered, however, that the provision of threshold markings, in accordance with CAP 168, would have been confusing visually. Consequently, these markings were not provided and the runway remained unlicensed, albeit at the reduced published length of 312 m.

Aerodrome chart, UK AIP
