CONTENTS

COMMERCIAL AIR TRANSPORT

(ALL TIMES IN THIS BULLETIN ARE UTC)

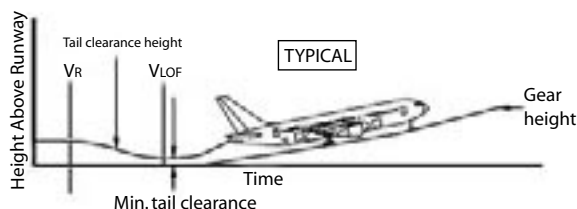
The following diagram and table show the effect of flap position on liftoff pitch attitude and aft fuselage clearance during takeoff. Additionally, the last column shows the pitch attitude for aft fuselage contact with wheels on runway and landing gear struts extended....

Model	Flap	Liftoff Attitude	Minimum Tail Clearance inches (cm)	Tail Strike Pitch Attitude degrees)
757-200	1	10.3	30 (76)	12.3
	5	10.0	33 (84)	
	15	9.5	38 (97)	
	20	8.5	47 (119)	
757-300	5, 15, 20	7.5	26 (66)	9.5

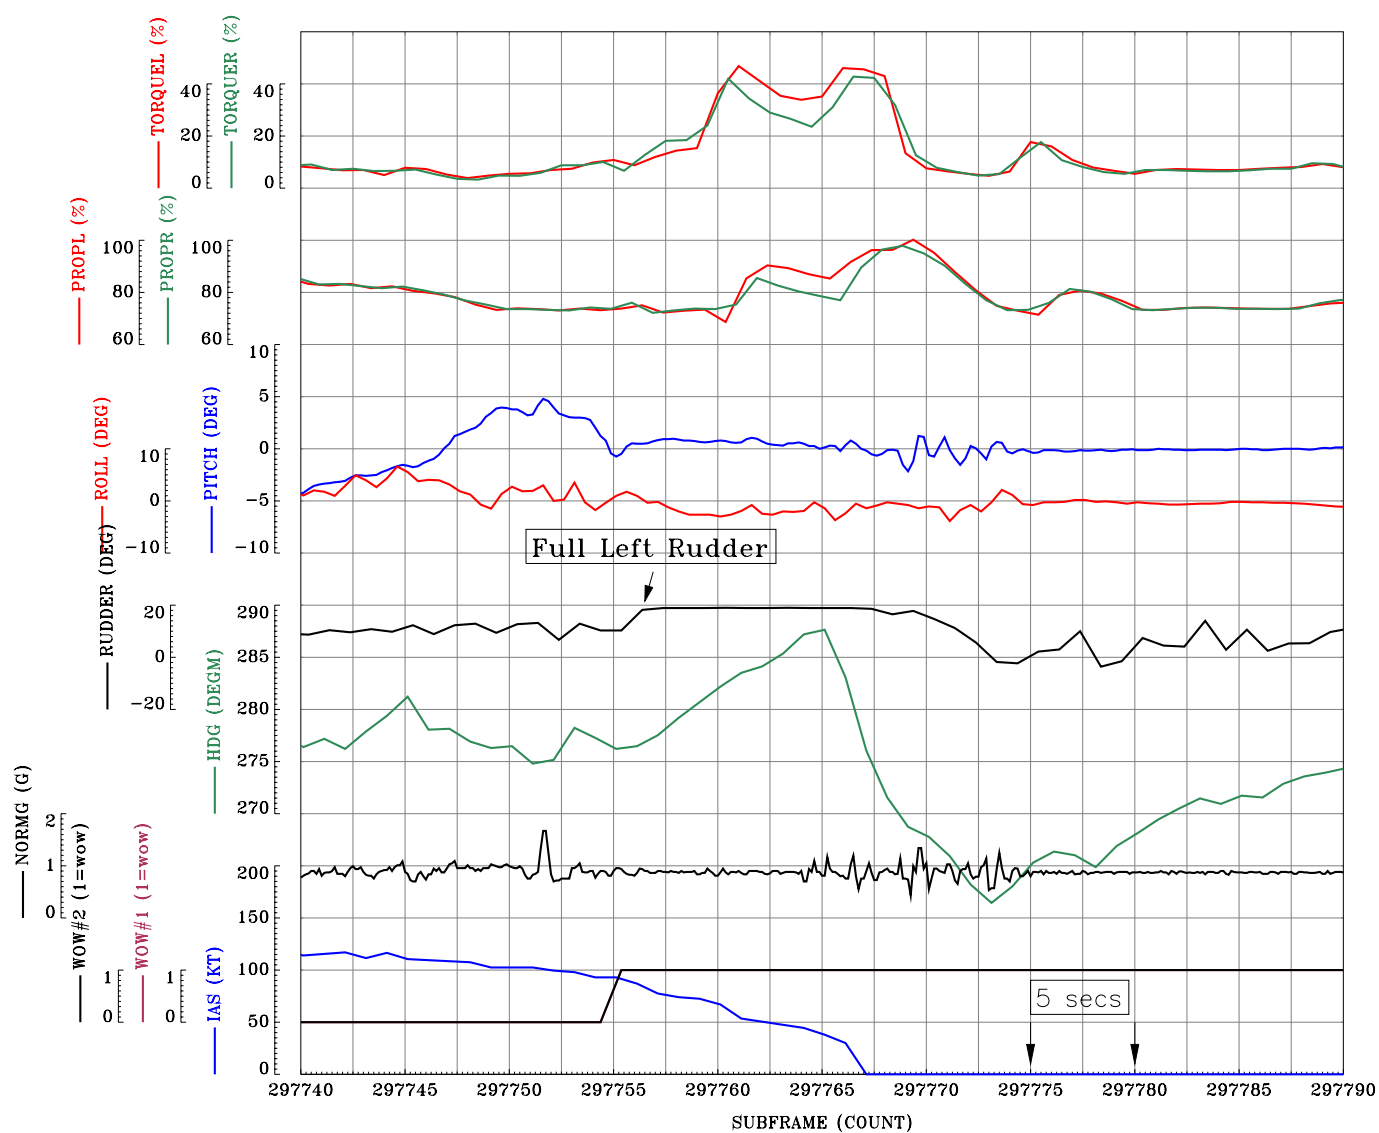
It can be seen from Figure 1 that, at about 5 seconds after touch-down, the difference in torque between the left and right engines was reversed (left torque greater than right torque). This difference was of the order of 4% and lasted for about 9 seconds. This is consistent with the crew attempting to control the yawing motion with differential propeller settings. Also, it can be seen that the pitch attitude remained at about 1° nose up during this part of the landing run and that the elevators remained slightly in the nose up sense until the turn to the right was arrested.

Salient Flight Data Parameters

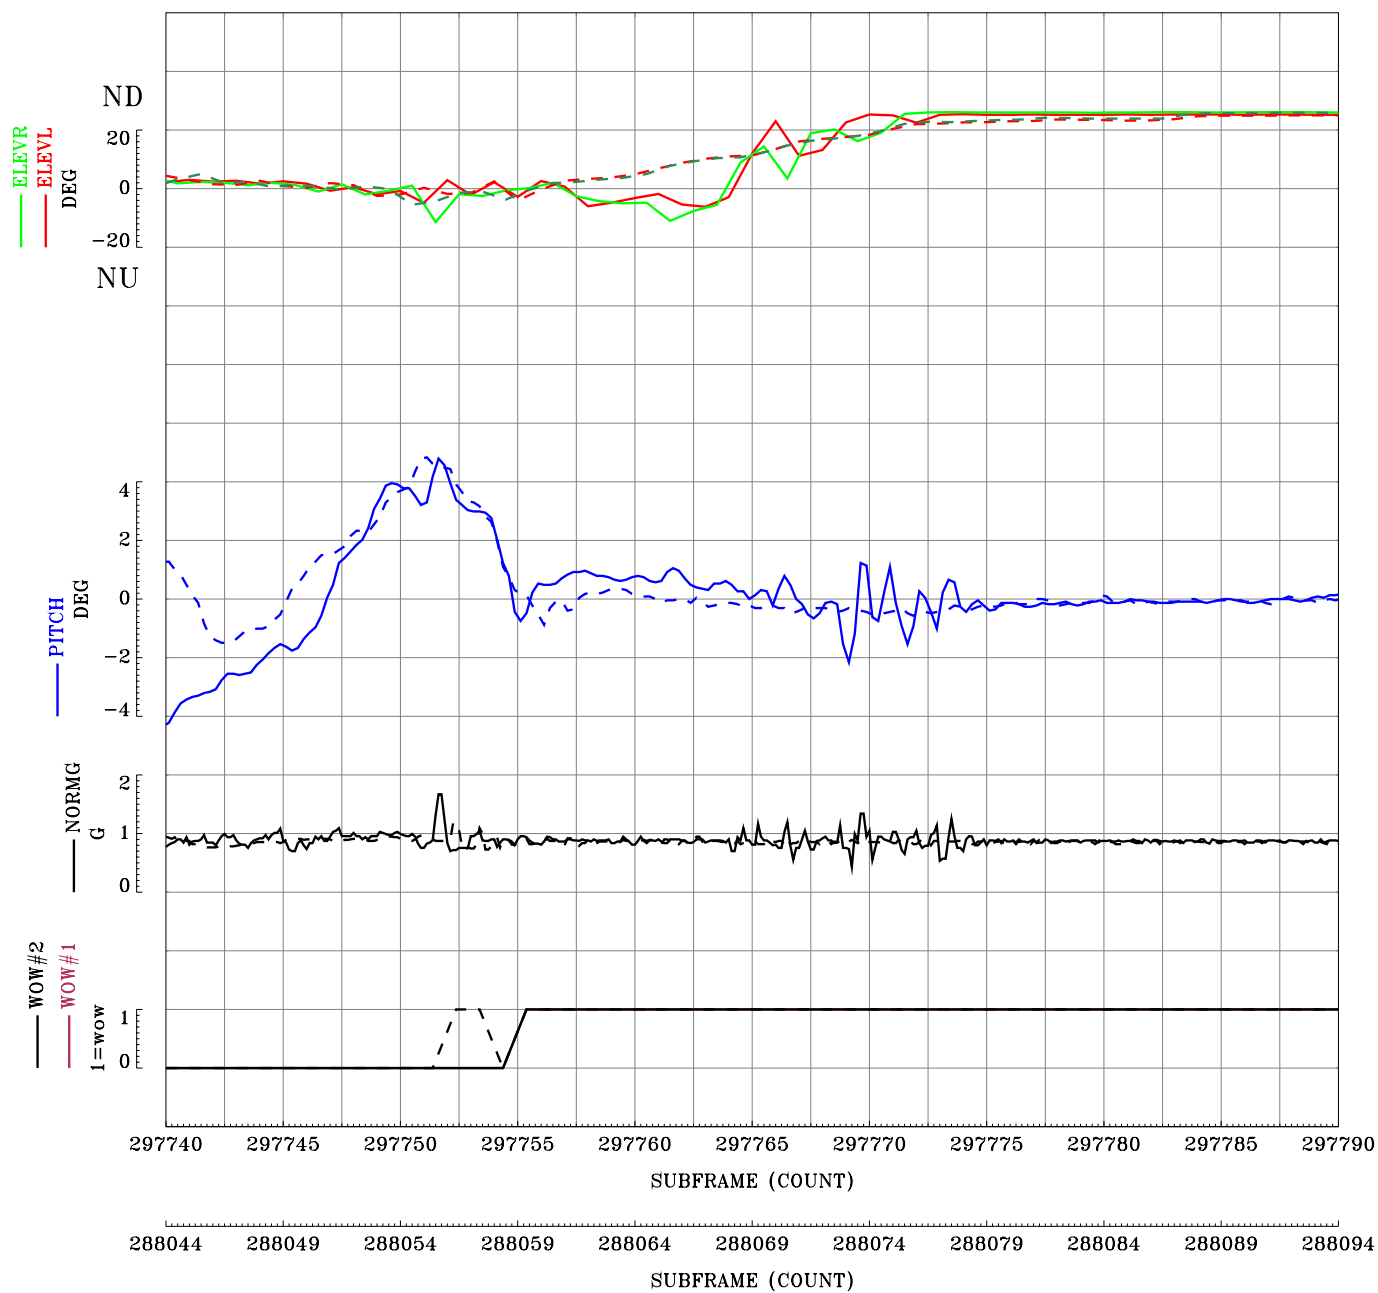
Figure 2

A comparison of the pitch parameters during the incident and during the previous landing is shown in Figure 2. It can be seen that the pitch attitude is about 0° during the previous landing and this was also the case for the other previous recorded landings.

Comparison of Accident Pitch Parameters (solid) with Previous Landing (dotted)
Accident to Dornier 328, G-BWIR, at London City Airport on 20 February 2005

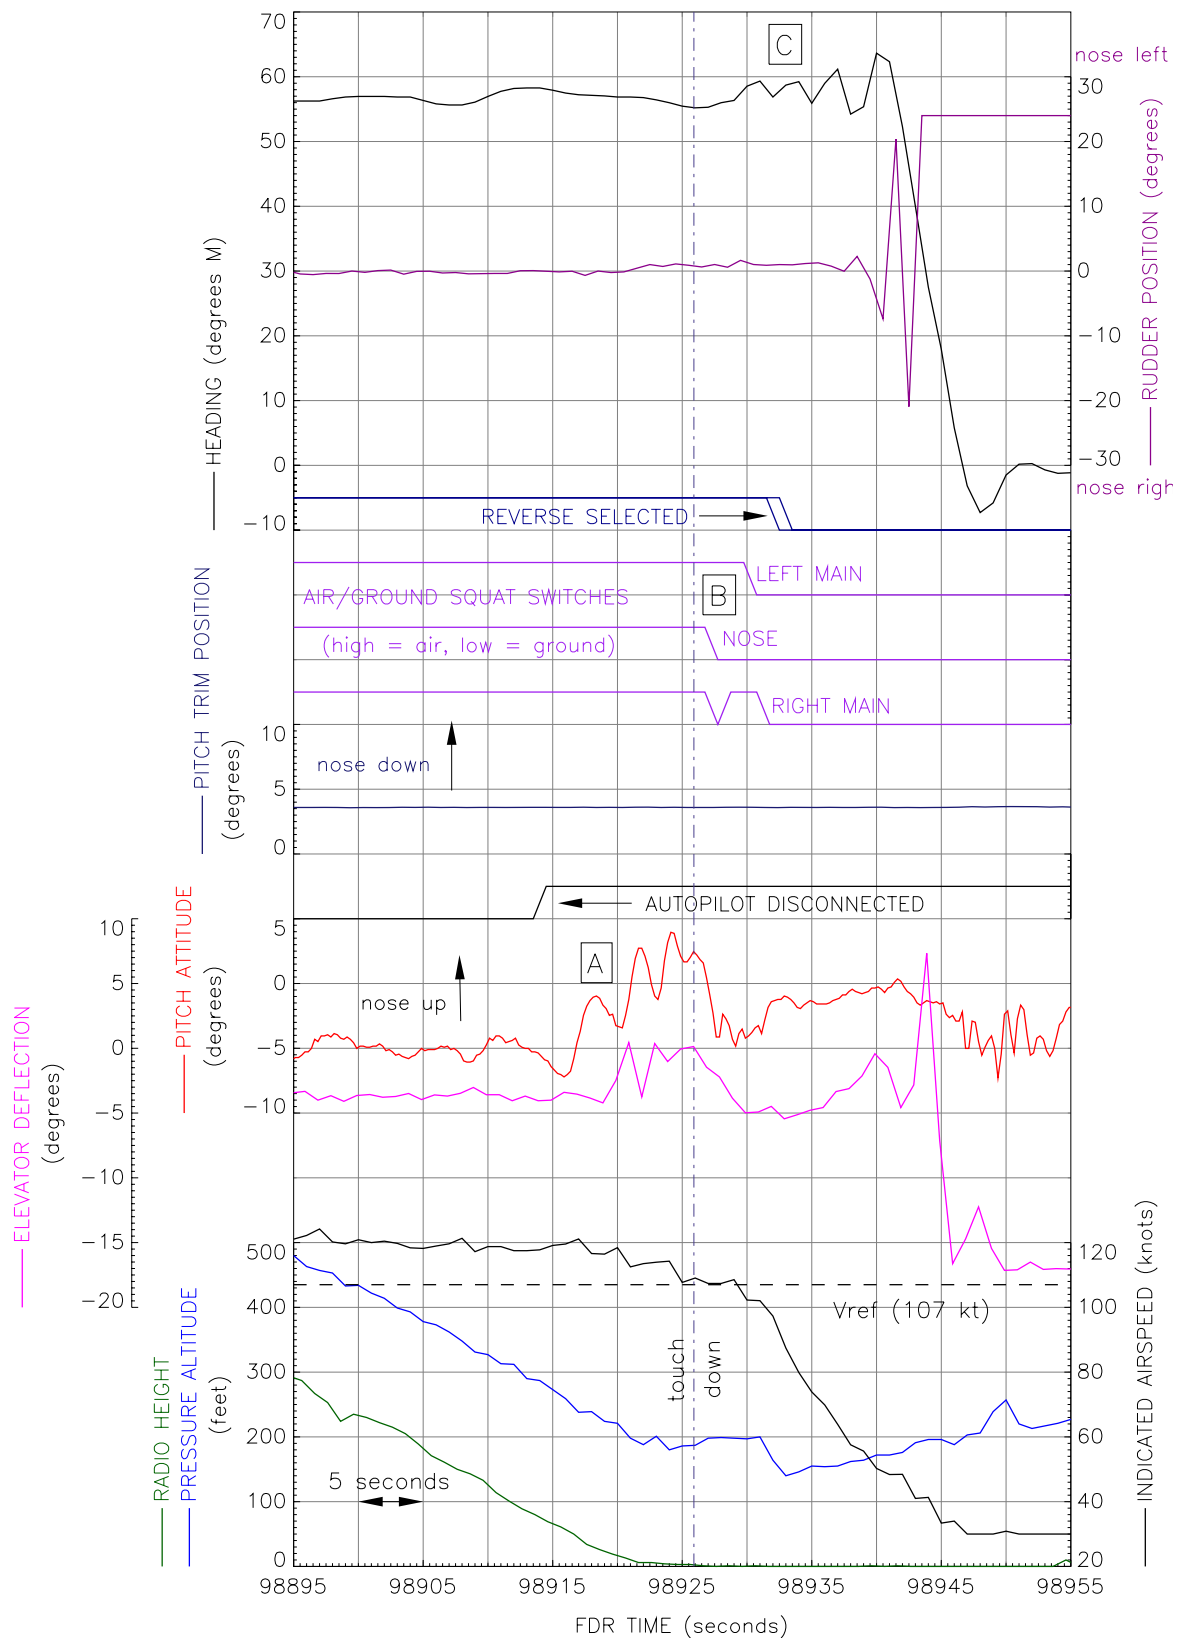
At approximately 80 ft agl the autopilot³ was disconnected. Coincident with the autopilot disconnect, and about 12 seconds before touchdown, the aircraft pitched nose down from -5° to -7°. Following an application of nose up elevator the pitch angle increased by 6° to -1°. Two further pitch oscillations were recorded prior to the flare. These pitch oscillations are indicated by Point A at Figure 3.

air/ground landing gear squat switch positions after touchdown are indicated by Point B at Figure 3. Reverse thrust from the propeller blades was selected shortly after this without any noticeable change in aircraft pitch or heading.

Figure 3
Salient FDR Parameters
 (Serious Incident to G-MAJA on 29 June 2005)
