Rail Accident Investigation Branch

Rail Accident Report

Two signal passed at danger incidents, at Reading Westbury Line Junction, 28 March 2015, and Ruscombe Junction, 3 November 2015

Report 18/2016
September 2016

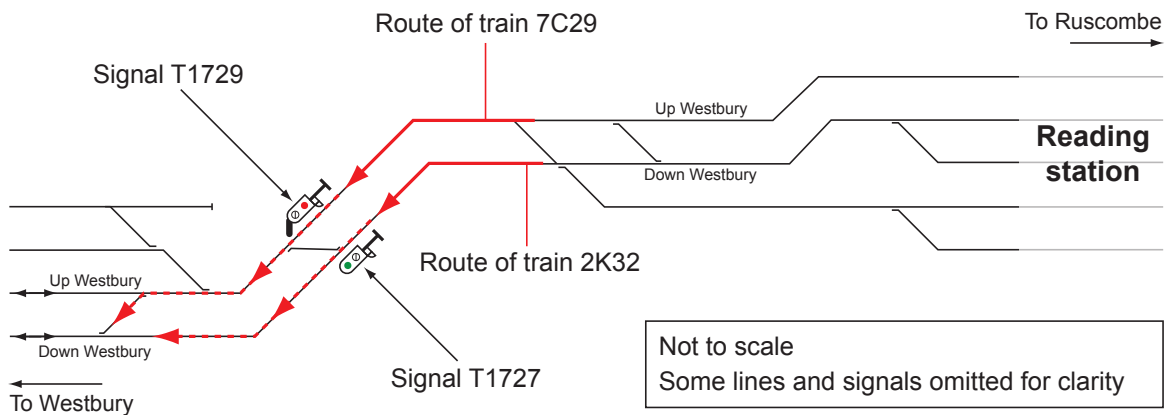
Figure 3: Simplified track layout showing the location of signal T1729 and the intended paths of both trains

- 7 T1729 is a four-aspect LED signal located on the right-hand side of the *bidirectional* Up Westbury line at 36 miles 29 *chains*, approaching Reading Westbury Line Junction to the west of Reading station (figure 2). For the path that train 7C29 took on 28 March 2015, this signal is preceded by two similar four-aspect signals. Permissible speed at this location is 40 mph (64 km/h).
- 8 On the morning of 28 March 2015, signal T1729 was being held at danger because the parallel signal (T1727) was showing a proceed aspect to allow for the passage of passenger train 2K32 (figure 3).

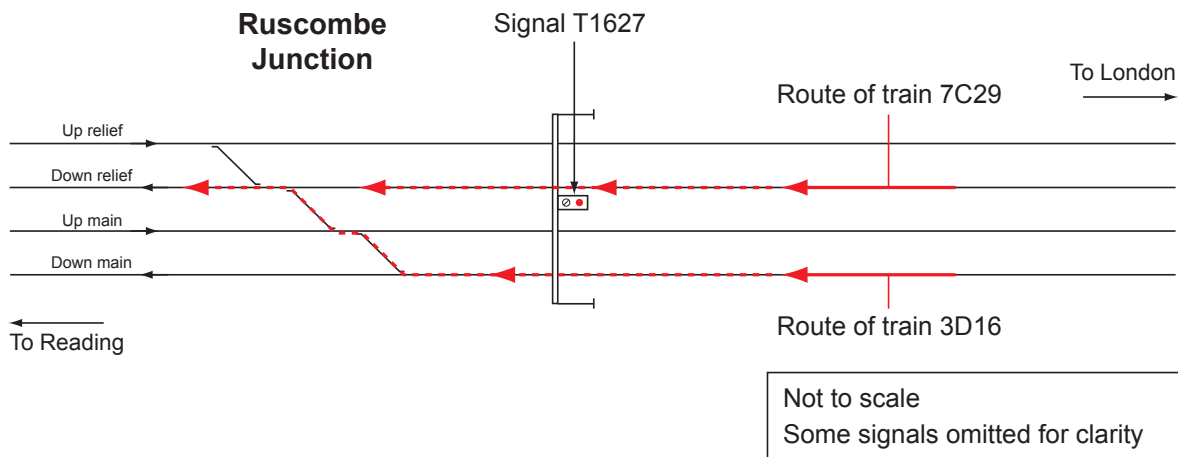
Figure 5: Simplified track layout showing the location of signal T1627

- 10 When the incident occurred on 3 November 2015, signal T1627 was showing a red aspect, protecting a route which had been set for train 3D16, an empty high speed passenger train (HST), to cross from the Down Main to the Down Relief line at Ruscombe Junction (figure 5).
