AAIB Bulletin

2/2015

Aircraft Type and Registration:	Gulfstream 550, HZ-A6	
No & Type of Engines:	2 Rolls-Royce BR710C4-11 turbofan engines	
Year of Manufacture:	2004	
Date & Time (UTC):	10 December 2013 at 0325 hrs	
Location:	Stansted Airport, Essex	
Type of Flight:	Commercial Air Transport	
Persons on Board:	Crew - 4	Passengers - 3
Injuries:	Crew - None	Passengers - None
Nature of Damage:	Underside of left wing and left landing gear door	
Commander's Licence:	Airline Transport Pilot's Licence	
Commander's Age:	53	
Commander's Flying Experience:	8,685 hours (of which 1,311 were on type) Last 90 days - 70 hours Last 28 days - 0 hours	
Information Source:	AAIB Field Investigation

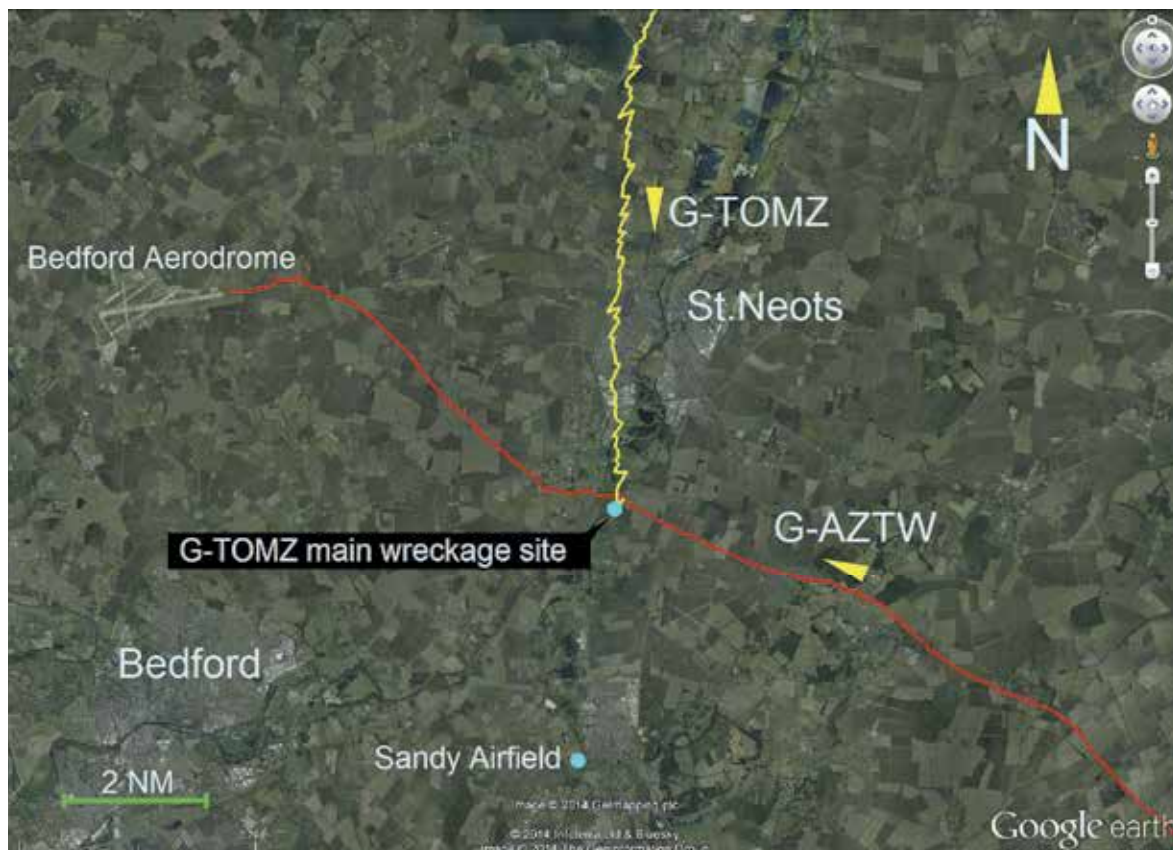
Recorded radar information was available for both aircraft, with primary and secondary (Mode A and C) recorded for G-AZTW and primary for G-TOMZ. Figure 3 provides the radar tracks of the aircraft. Figure 4 plots the positions of both aircraft commencing at a separation of just over 1 nm, with the relative positions identified at four second intervals and angular sizes of 0.2° and 0.5° when viewed from either aircraft. For clarity, the tracks have been illustrated in Figure 4 rather than the actual radar tracks.

Figure 3
Radar tracks of G-TOMZ and G-AZTW

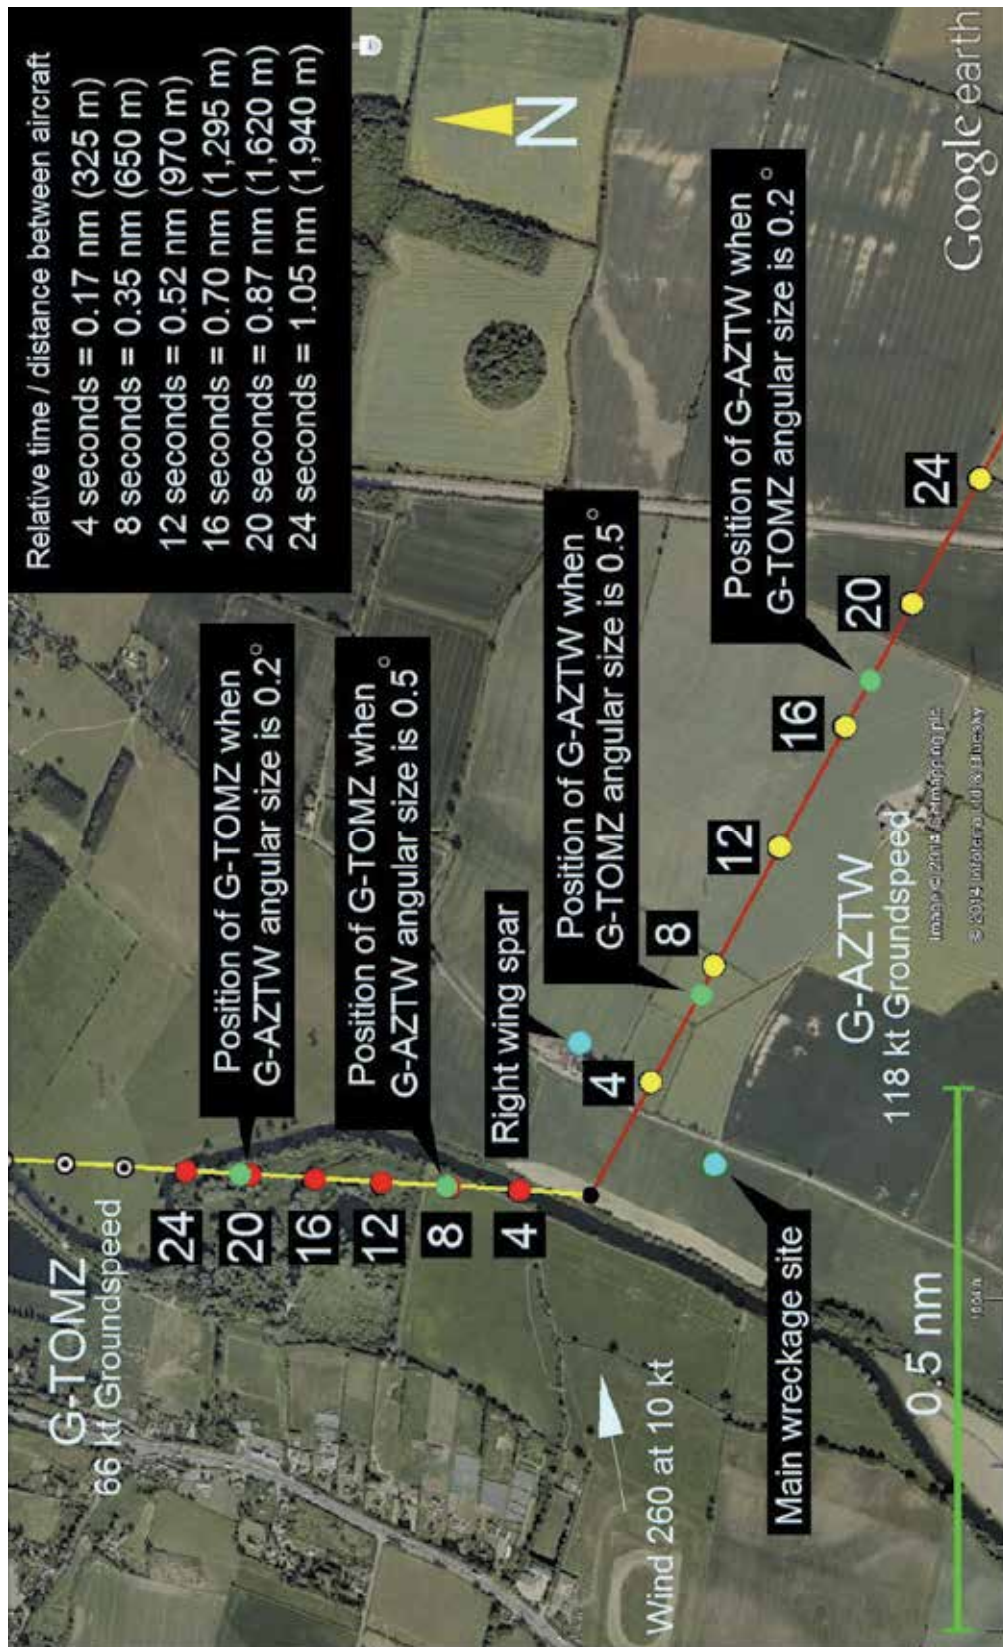
Figure 4

Relative positions of G-TOMZ and G-AZTW prior to collision

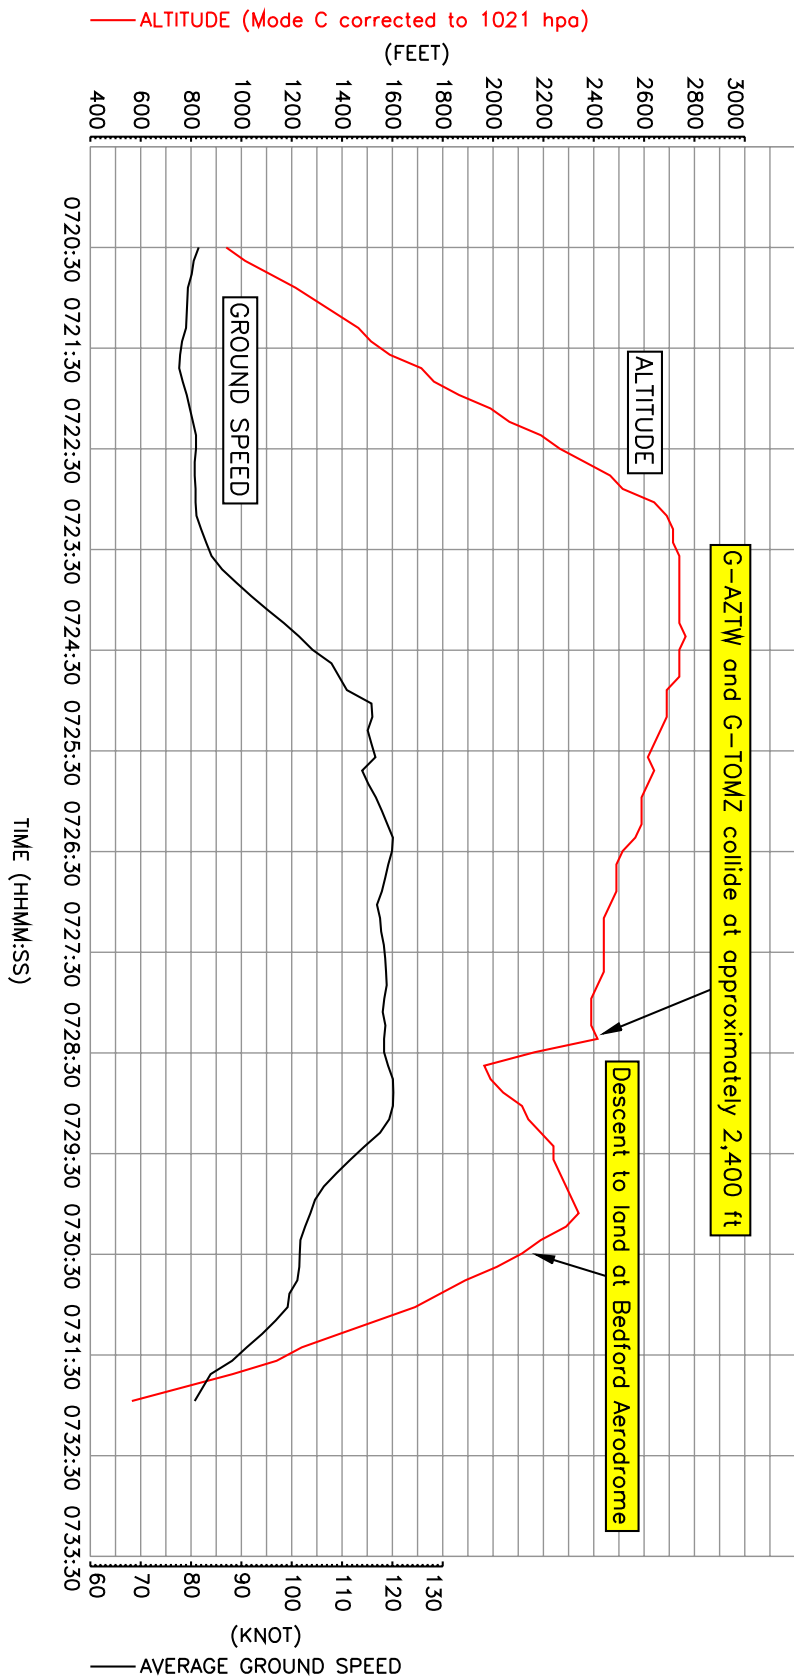
Immediately following the collision, G-AZTW descended rapidly for about 16 seconds at an average rate of 1,700 fpm before recovering at about 1,950 ft (see Figure 5). It then climbed to about 2,350 ft before descending to land on Runway 26 at Bedford Aerodrome.

Figure 5
G-AZTW Altitude and groundspeed
