Rail Accident Investigation Branch

Rail Accident Report

**Serious injury sustained by a signal technician
at Kennington Junction
23 May 2008**

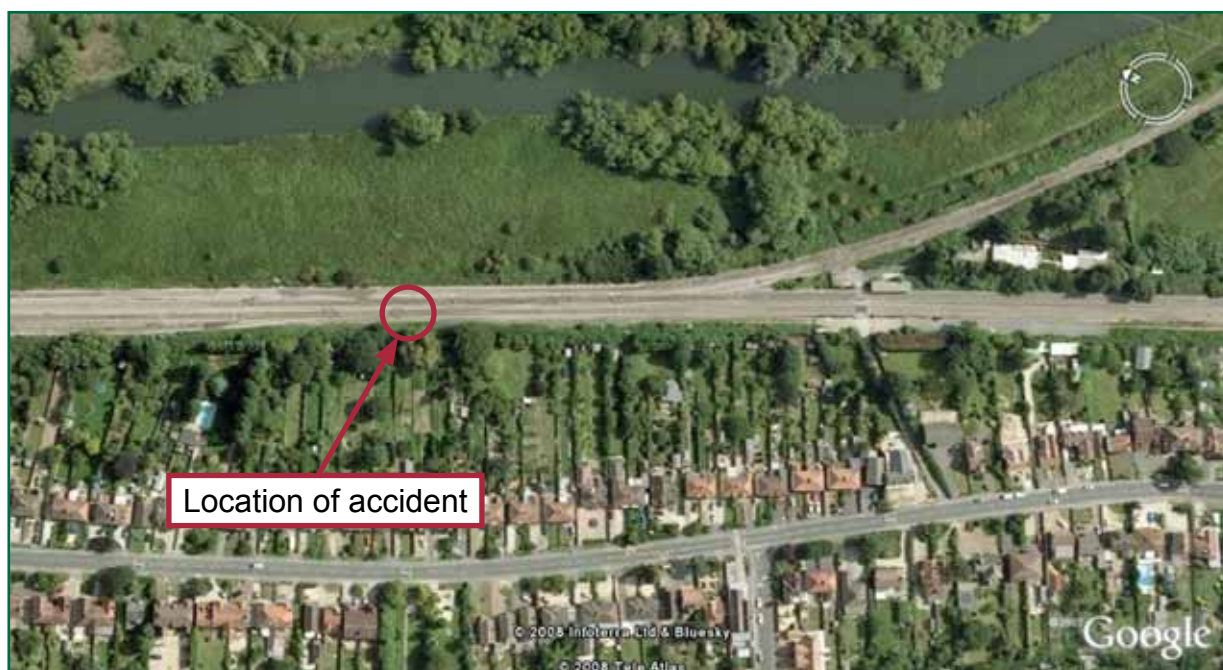
Figure 2: Aerial view of the accident site (image courtesy of Google Earth)

23. The highest permitted speed over the *crossover* between the up and down lines, and to and from the goods loops and the Cowley Branch is 25 mph (40 km/h). The crossover points on the Down Oxford line where the accident occurred have identification number 207A.

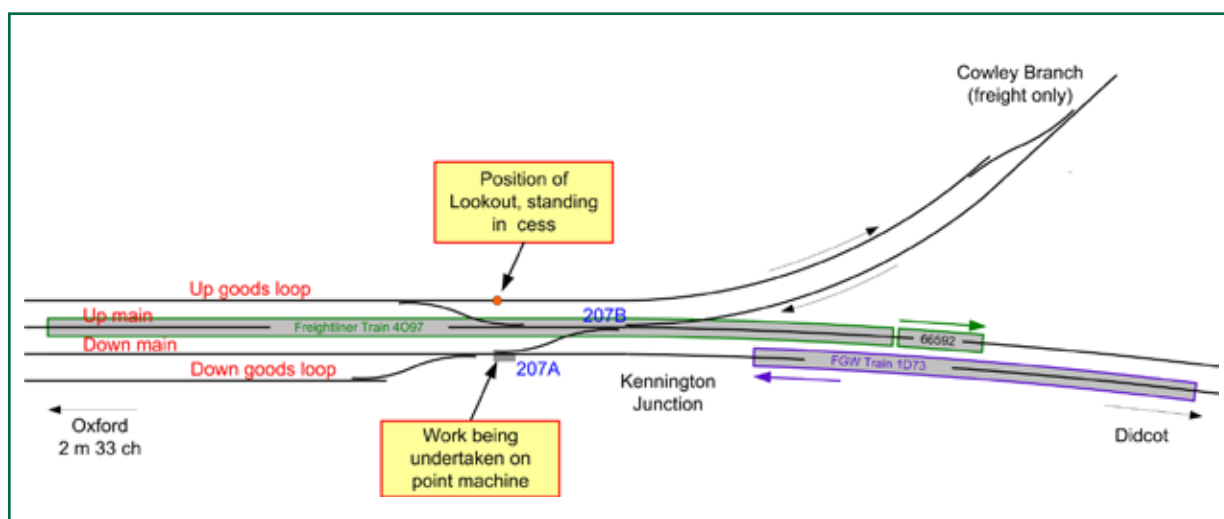
Figure 3: Track layout in the vicinity of Kennington Junction

36. The team arrived at Kennington Junction at about 21:00 hrs when it was still daylight, and left their van close to the junction points. They planned to begin work by undertaking the facing point lock tests on the crossover between the up and down lines (207A and 207B points).
37. Whilst the team leader and his assistant were unloading tools from the van the lookout went to the other side of the line and took up his duties in the customary place for work on 207 points. He was not instructed by the team leader (COSS) where to stand or given any other instruction. He stood at various times in the cress or 4 foot of the up goods loop from where the best possible sighting of approaching trains on the down line could be obtained. However, a passing up train would cut off the lookout's line of sight for the down line.

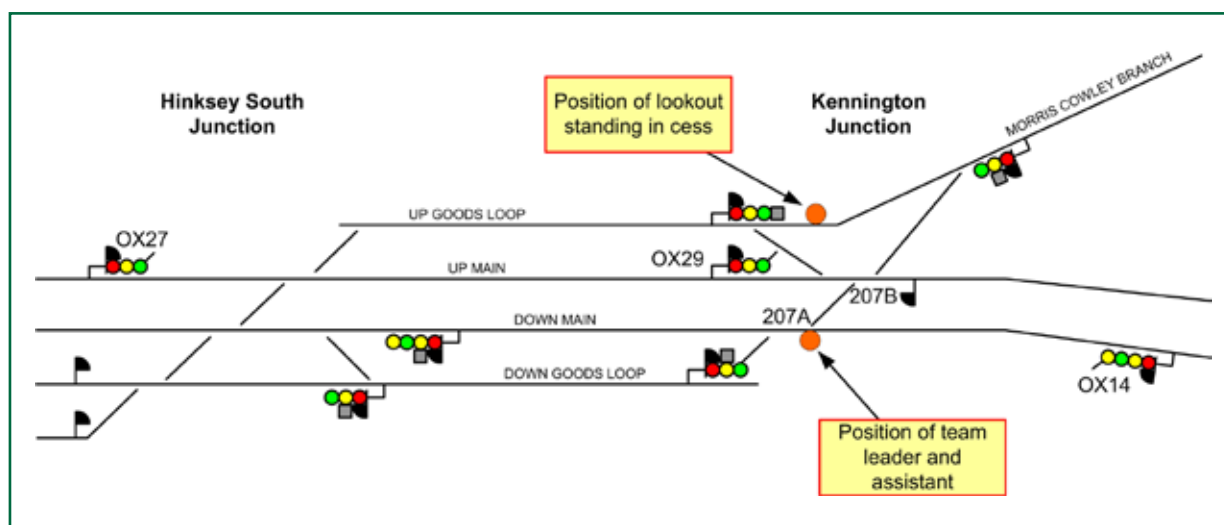
Figure 4: Track diagram showing signals used to protect the site of work

38. At 21:16 hrs the team leader used his mobile phone to contact the signaller and requested permission to start work. When trains were clear of the site of work, the signaller responded by placing to danger signal OX14 on the down line and signals OX27 and OX29 on the up line (Figure 4) so as to prevent trains passing the site of work. He placed *reminder devices* (colloquially known as *collars*, see Figure 12 in Appendix F) on the controls for those signals and then advised the team leader (COSS) that work could commence.

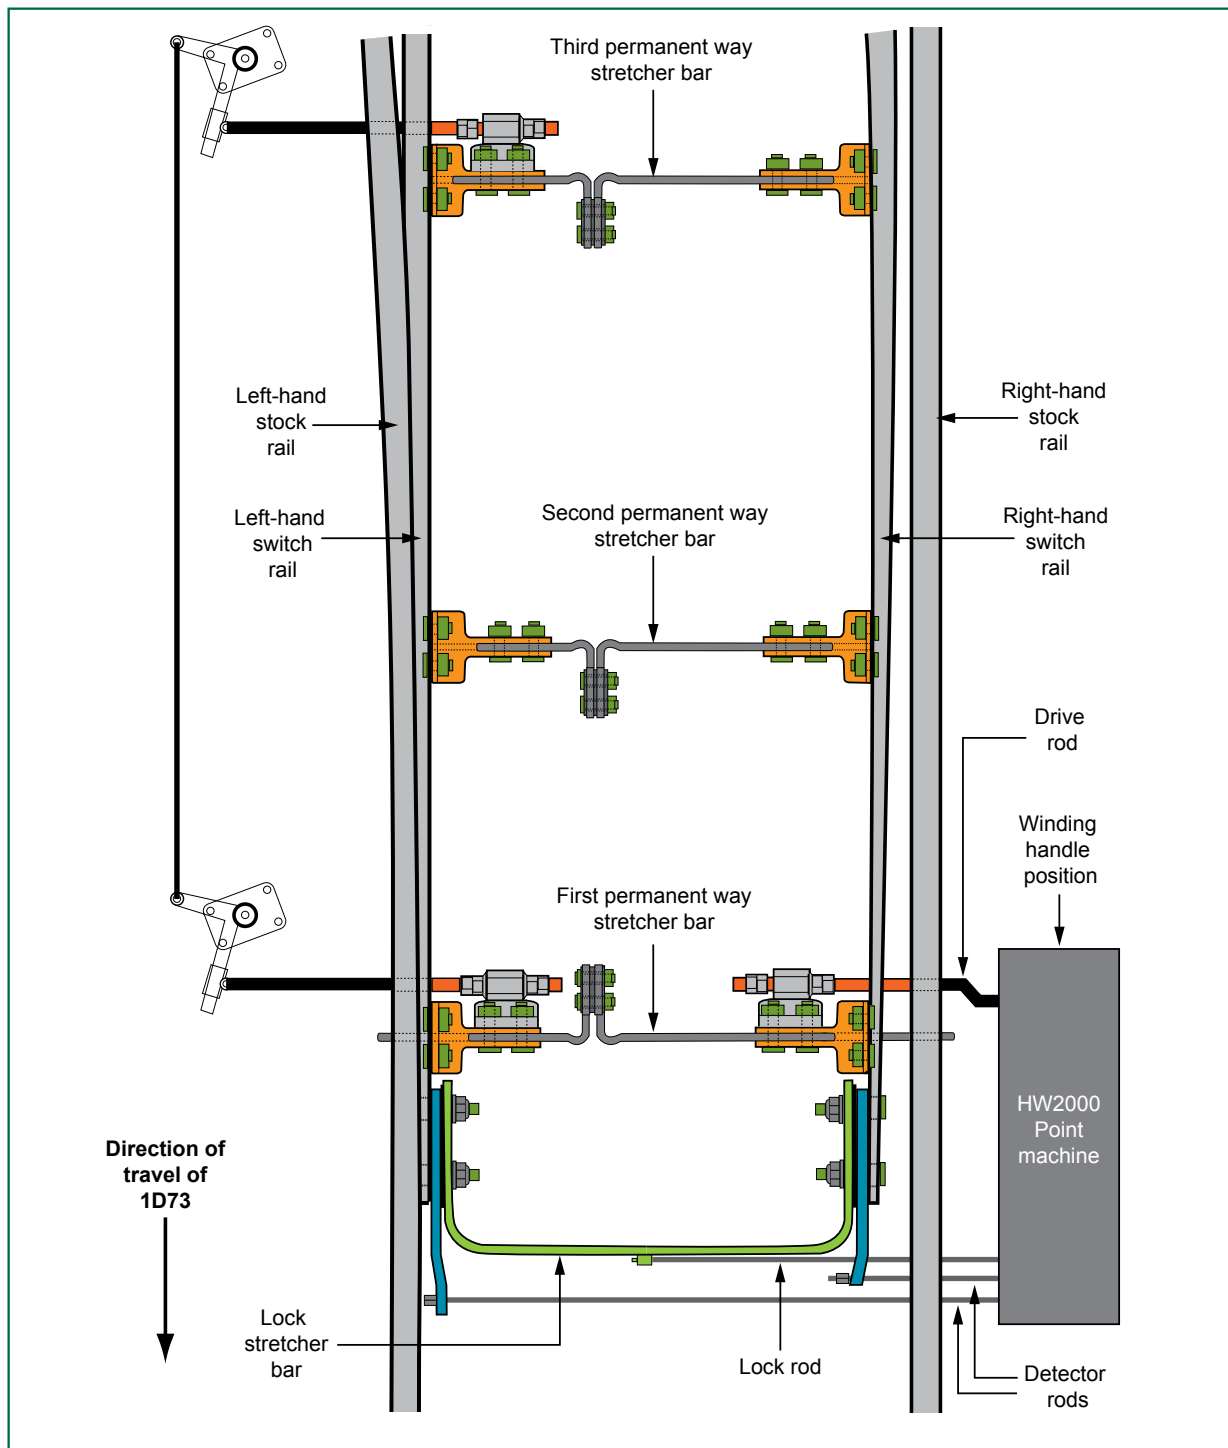
Figure 7: Schematic diagram showing the parts of 207A points and the associated point machine.

41. At 21:24 hrs the team leader requested a further period in which to continue the test which the signaller provided. Soon after, the test unexpectedly failed with the switch rails in the *reverse* position (in this position the points were set for a route between the up and down lines). The team leader and his assistant were then faced with the task of adjusting one or more of the rods linking the point machine to the rails (Appendix F). They commenced this activity immediately.

43. At 21:33 hrs the team leader requested further time to complete the adjustments. This was declined by the signaller as two trains were scheduled to pass. The team leader advised the signaller that the points had failed the facing point lock test in the reverse position, that they were having trouble completing the adjustment, and that they would need more time.

44. Even though the test had failed for the reverse direction, this would not affect the safety of trains running directly between Oxford and Didcot; they would pass over the points in the *trailing* direction whilst they were set normal.
45. Photographic and witness evidence shows that with dark clouds overhead, the light had begun to fade. Whilst waiting for the trains to pass, the team leader and assistant returned to the van to collect a torch and some additional tools. The lookout crossed the line, gave his torch to team leader and provided some guidance about how best to adjust the rods to correct the failure. The lookout then returned to his lookout position.

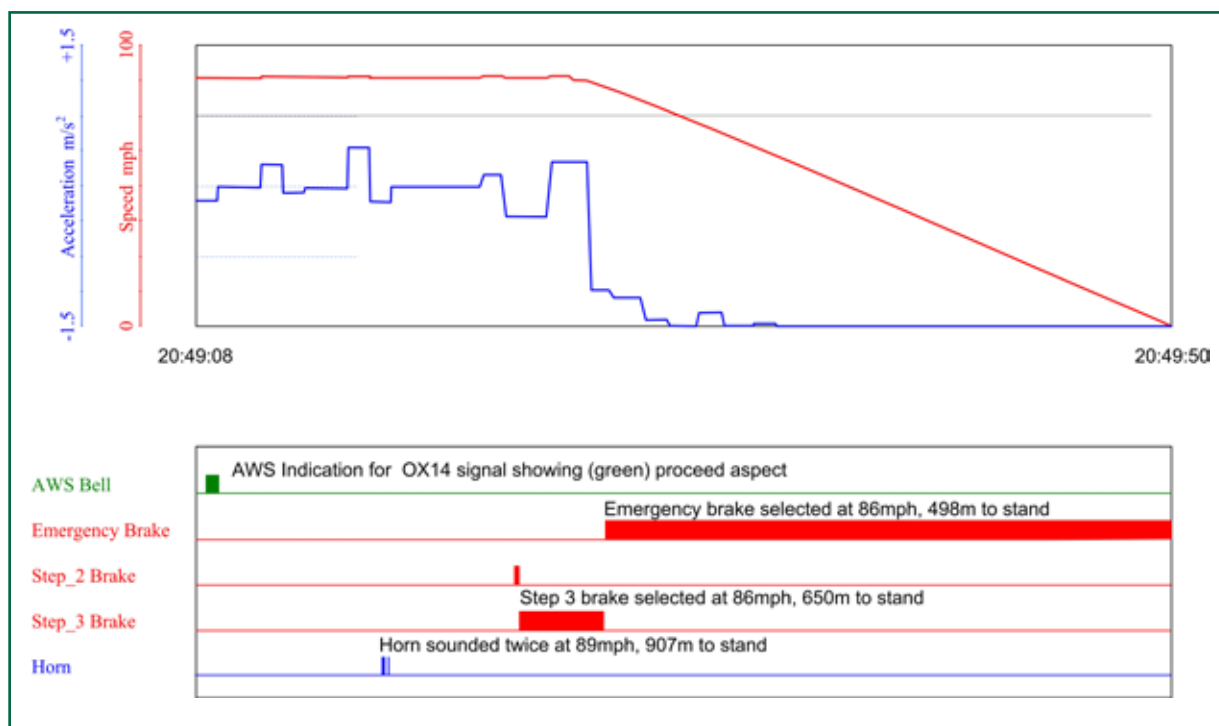
Figure 8: Diagram showing the key elements recorded by the OTDR

55. Passenger train 1D73 was approaching Kennington Junction, from the south. Its on-train data recorder logged the speed of the passenger train at 85 mph (136 km/h) through Radley, the previous station, and then at 89 mph (143 km/h), near the speed limit of the line, on the approach to Kennington Junction. As the train rounded the left-hand curve as viewed in the direction of travel, travelling within the speed limit, the driver observed two people near to, or on the down line. The on-train data recorder shows that the horn was blown twice when the train was about 200 m from them. Reportedly neither the team leader nor his assistant heard this warning.
56. The assistant became aware of the second train on the down line as it passed him. He shouted a warning to the team leader, but there was insufficient time for the team leader to move out of danger.
