PART 1.4 – FINDINGS

1.4.8. **Cause.** The cause of the accident was **engine failure**. Oil starvation resulted in overheating which led to engine failure. (TOR D)

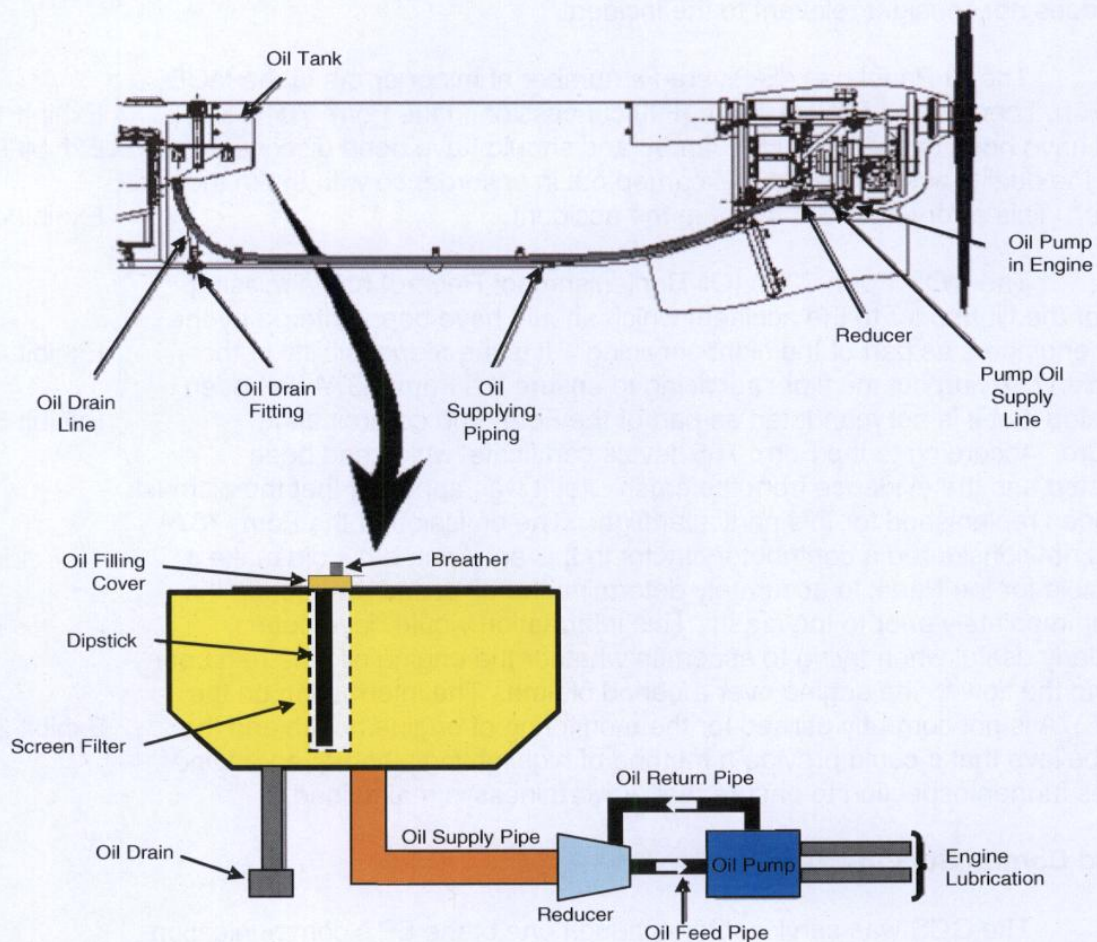
Figure 5 - Oil System Diagram

1.4.23. Post accident, the UA was examined by the SI engineer and the MilAAIB engineering investigator; the aircraft contained both fuel and oil at the time of engine failure and the engine assembly was intact with the propeller still attached. The engine mounting assembly showed signs of significant damage so the decision was made to remove the engine for transit back to the UK. The H450 oil system is shown below:

1.4.24. During the engine removal, the aircraft technician Sergeant who was assisting the MilAAIB investigator, noticed a thick brown congealed substance, which appeared to block the oil feed pipe. The early detection of this phenomenon enabled a fleet-wide check to ensure the serviceability of the other aircraft in theatre. This was particularly relevant as these oil pipes had been subject to a recent engine modification. No further anomalies were found in this area on the other UAs. The area where the blockage was discovered is shown in figure 6 and 7.
