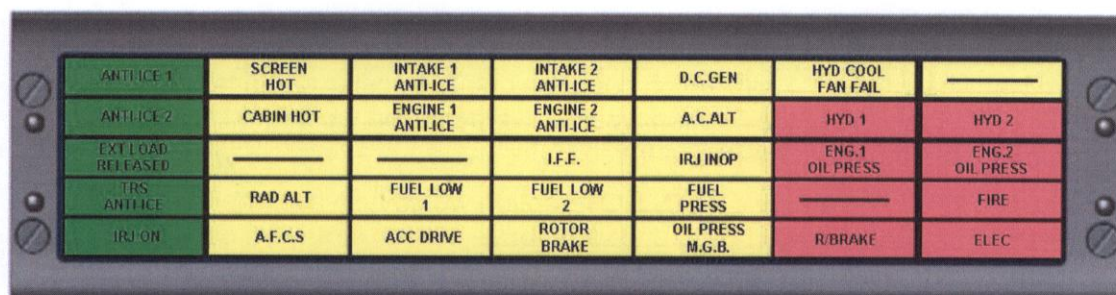
Fig 14 - Lynx Mk7 CWP Indications

1.4.54 **CWP indications /Audio warning.** None of the crew recalled specifically which CWP captions had been activated, but the 2 pilots⁷ heard the Master Caution Audio Warning and the LHS Pilot cancelled the ‘attention getter’. The consensus was that some red captions had been activated, predominantly in the top right section of the CWP.

a. **FIRE.** The red FIRE caption would illuminate when the temperature in either engine bay reached a critical temperature as detected by the firewire loop; this could be caused by a hot gas leak or fire in the engine bay. The FIRE caption would activate the Master Caution audio and illuminate the respective fire button and ECL warning light. In this case, it was likely that the caption was activated immediately after the 2nd stage FPT blade burst which allowed hot gas to escape. There was also the possibility that mechanical damage to the firewire from the FPT blade burst could have resulted in the activation of the caption. In addition, civilian witnesses on the ground reported having seen the ac on fire whilst airborne, which would have activated the caption. Based on the statement by the LHS Pilot, the No1 engine FIRE warning system (ECL fire button indication) also activated at some point during the accident sequence; the Panel judged that this occurred once the heat from the failed engine spread to the No1 engine bay. As the fire in the No2 engine had already illuminated the single FIRE caption, the subsequent activation of the No1 engine fire detection system would not have re-activated the Master Caution audio.

b. **ENG 2 OIL PRESS.** The red ENG 2 OIL PRESS caption would activate when engine oil pressure fell to the level where the pressure gauge pointer moved into the red sector. In this case, the evidence suggested that damage to the oil scavenge system in the form of holes in the scavenge bowls associated with the No 9, No 10 and No 11 bearings resulted from the FPT burst damage; additionally, various oil supply and return pipes were dented and ruptured. It was therefore judged highly likely that oil pressure would have immediately dropped sufficiently to put the gauge into the red “danger zone”, illuminating the CWP caption and activating the audio attention getter.⁸

have illuminated after the failure of No2 engine. In this case, it was possible that damage to the associated wire in the upper starboard loom within the avionics bay (as described in para 1.4.52 above) resulted in the activation of the caption. The No1 engine would have continued to drive the No1 DC starter/generator thereby maintaining the DC supply to the ac.

d. **FUEL PRESS.** The amber FUEL PRESS caption would illuminate when the pressure switches on the LP manifold indicated that the pressure in the system was less than 0.14 bar, which could be due to booster pump failure or fuel leak. In this case, the caption would have activated when the LP fuel pipe was cut by the 2nd stage FPT burst.
