PART 1.3 – NARRATIVE OF EVENTS

1.3.1 At 1405 on 1 Dec 11, Lynx AH Mk7 XZ210 of 1 Regiment Army Air Corps (1 Regt AAC) departed Gütersloh with a crew of 3 on a routine training flight. The sortie was being flown as part of a 6 monthly Qualified Helicopter Instructor (QHI) check for the left hand seat (LHS) Pilot with an intended profile of a standard tasking scenario including some low level navigation. Simulated aircraft (ac) emergencies were introduced by the ac commander (ac cdr) at various stages of the sortie.

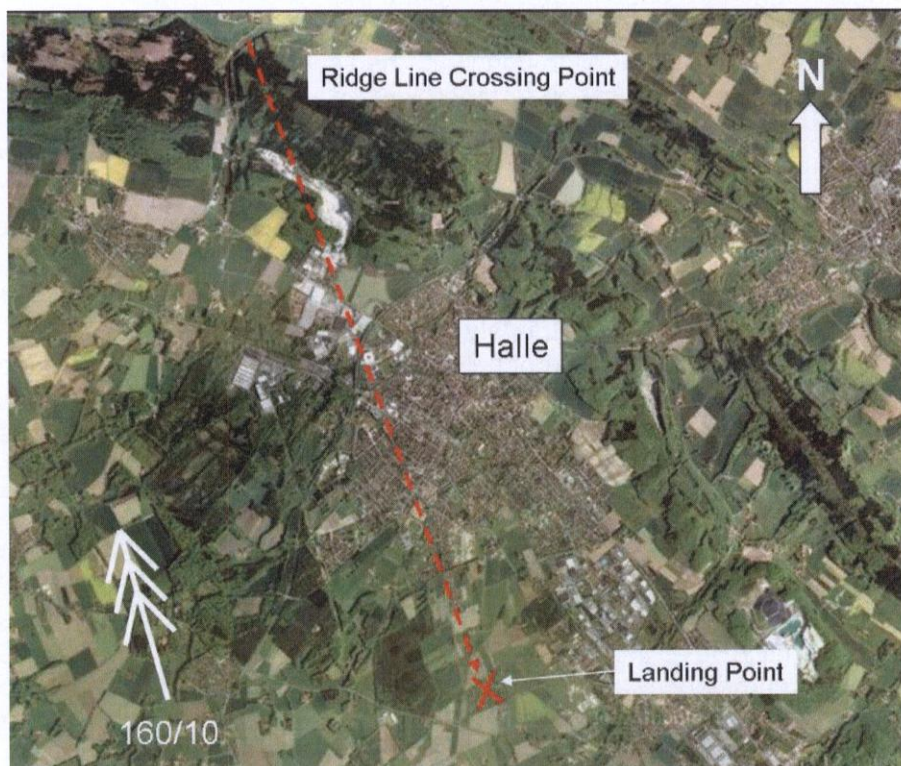
1.3.26 A number of civilian eye witnesses recalled seeing flames emanating from the starboard side of the helicopter as it made an approach to land. Some also reported small amounts of debris falling from the ac. None of the crew recalled seeing any ac fire warning indications at any stage during flight.

Fig 2 - Map of final stages of XZ210 flight

1.3.27 The CM reported that visibility inside the ac improved rapidly after the cabin door was opened. As the ac was nearing the surface, the external visual references improved sufficiently for the QHI to see a tree immediately ahead on the ac flight path. He flared the ac and manoeuvred left to avoid the tree; in so doing, the Rotor Overspeed Audio Warning System (ROAWS) audio was activated in continuous tone, indicating that rotor speed (N_r) exceeded 115.8%. The QHI managed to avoid the main part of tree, albeit minor contact was made with the outer branches by 2 of the main rotors and then he carried out a running landing onto the ploughed field. The ac came to a rapid stop approximately 1 ac length from impact; the QHI estimated the run on to have been at approx 20 knots (kts) ground speed. The ac came to rest level, upright and intact with the skids buried in the soft earth up to the belly of the ac; at this stage the fire had taken hold. The time from the first indication of the emergency to landing was 27 secs, with the ac having been flown on, or close to, an into wind heading throughout.
